BS5837 ARBORICULTURAL REPORT,

ARBORICULTURAL IMPACT ASSESSMENT

OUR REFERENCE	AC.2018.231
CLIENT	Mr Jonathan Freegard
SITE	1 St Marks Crescent, Primrose Hill, London, NW1 7TS
REPORT BY	I S Thompson (known as Tom) M. Arbor. A., BSc. (Hons) Arb,
	MSc. eFor
DATE	5 th December 2018
DATE OF SITE VISIT	21st November 2018

Application Ref No Unknown Basement development under existing terraced

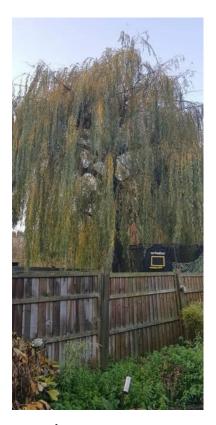
Image 1 T1 in the adjacent rear garden

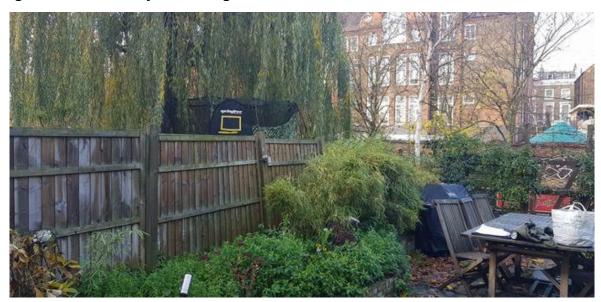
Image 2 Base of RT1 on left and T2 at the rear

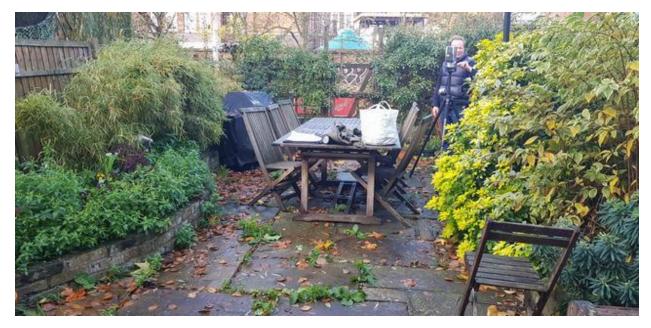
Image 3 Existing paving in the rear garden

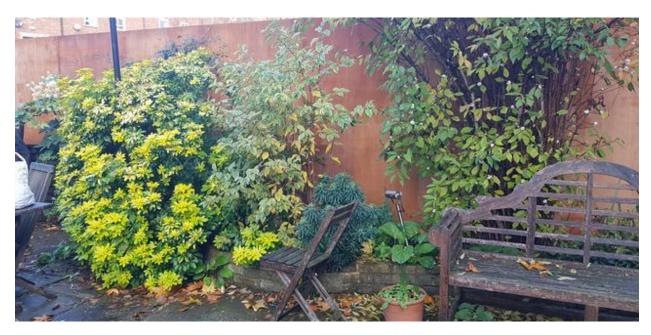
Image 4 G3, a group of small shrubs ion the north of the garden

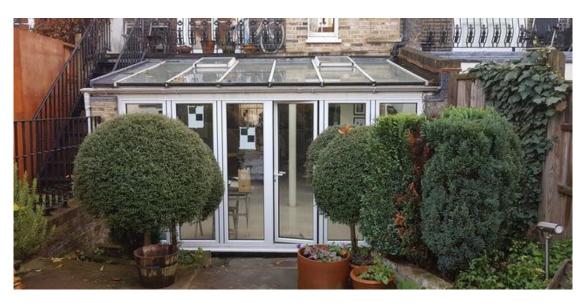
Image 5 G4, group of small plants around the garden steps

These are G4 a group of small box, juniper and cypress around the area of the garden steps.
- 12.3 If at any time additional pruning works are required permission must be sought from the Local Planning Authority first and then carried out in accordance with BS 3998 Recommendations for Tree Works 2010, unless otherwise specified with clear justification for any deviation from the British Standard.

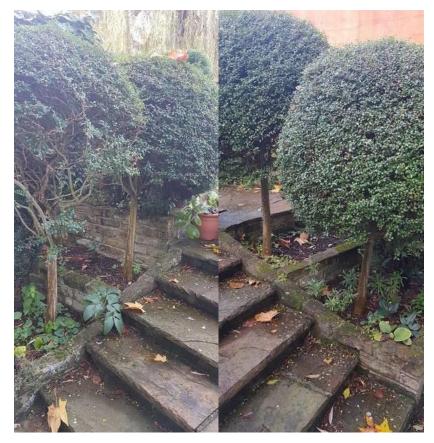
Image 6 G4, group of small plants around the garden steps

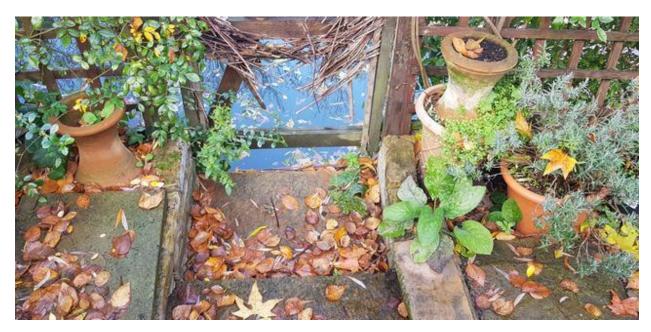
Image 7 Steps down to canal jetty

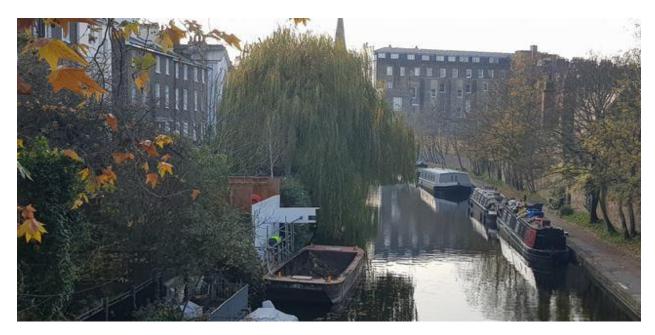
Image 8 Barge being used as a storage area for the adjacent property
