Design and Access Statement:

Alterations to 5 Great James Street, London WC1N 3DB.

Document Ref: 177C-D01-DAS-190110: Design and Access Statement
January 2019

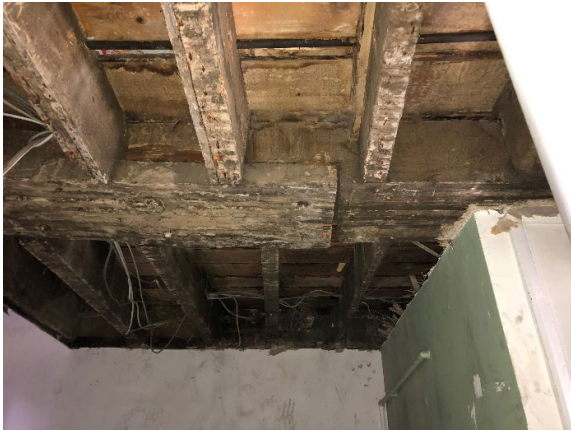
Fig 3 Existing failing timber floor beam that requires strengthening.

As part of the works consented through application 2018/2093/L, the ceilings in the basement have been removed to allow for fire protection and are being reinstated with lath and plaster. Following the exposure of the ground floor joists, a central beam was found to have a lapped joint which is close to failure. A structural engineer has examined the beam and has said it requires to be supported from below immediately.

The first item is to support a failing existing timber beam in the basement with the introduction of a supporting oak beam and post.

MSA initially contacted Camden Planning officer Colette Hatton, who reviewed the previous applications, to discuss how best to address this structural issue. A site visit was arranged on 17th December 2018 where the engineer's proposal for a new supporting oak beam and post was discussed. Due to an existing Fire Brigade Enforcement Notice, the ceilings required to be closed up and fully fire protected immediately, and therefore it was agreed on site to proceed with the installation of the proposed Oak beam, and apply for retrospective approval.

To provide the beam and post with fire protection, it was agreed to enclose them in plasterboard to provide 60minutes protection.

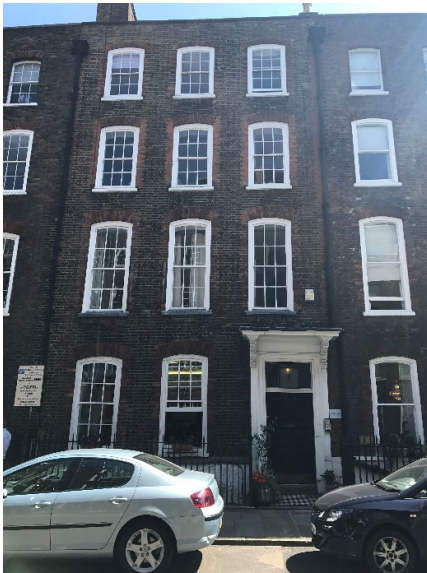
Fig 4 Front elevation of 5 Great James Street requiring re-pointing.

The front façade brickwork has previously been repaired with a strong cement mortar mix which has been poorly keyed into the brickwork. This has caused some bricks to deteriorate and for the remaining mortar around these joints to become loose.

Additionally, the cast iron rainwater pipes have become blocked and are leaking from their joints which has caused further damage to the brickwork.

It is proposed to fully repoint the front elevation brickwork in a more traditional weaker mix mortar of a 1:1:6 Cement:Lime:Sand mixture. The pointing will be completed with a slight recessed flat profile.

It is proposed to use a specialist Torc Wet Abrasive cleaning system on the brickwork. This system is specifically designed for Historic and delicate structures and materials to effectively clean them without damaging the materials. The system uses low pressure water, air and fine granulate particles to remove dirt and staining. An accompanying technical document from the system operators has been submitted with this application in Document 177C-D01-TORC.

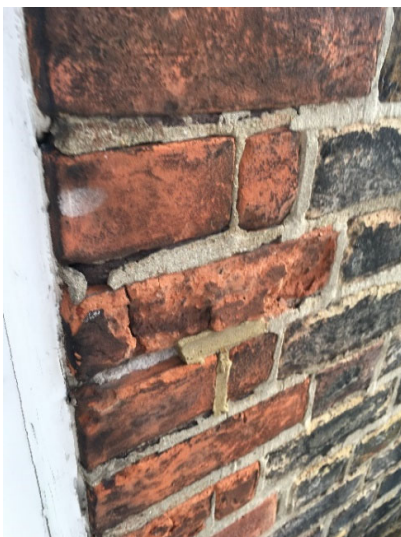
Fig 5 Close up view of poor historic repointing around window reveals

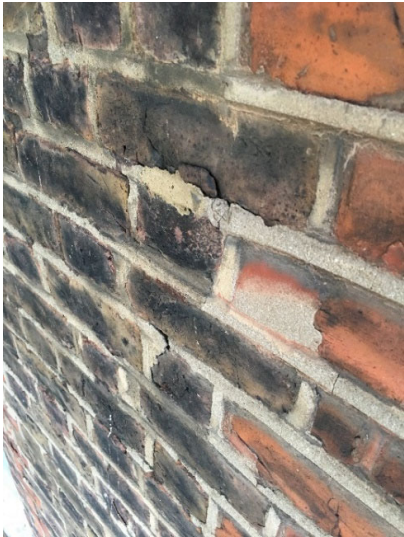
Fig 6 Close up of failing historic repointing.

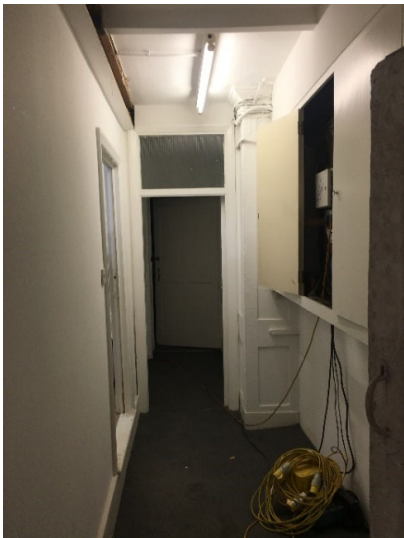
Fig 7 View of non-original Door DR.B.4 proposed to be removed and showing location of new proposed door DR.B.13. Electrical cabinets to be replaced are visible on the right.

The partitions between RM.B.2, RM.B.3 and RM.B.4 are all modern plasterboard stud walls, with doors DR.B.3 & DR.B.4 both light weight modern blank doors. Door DR.B.4 frame interfaces with a historic panelled cabinet which is damaging to the historic fabric and provides insufficient fire separation.

It is therefore proposed to remove door DR.B.4 and its door frame, and create a new door in front of DR.B.3. This will have the effect of creating a contained communal lobby for the containment of the electrical equipment, and allow the historic cabinets to be fully expressed in the lobby RM.B.3. The basement office will have a secure single access door DR.B.13 on basement level and will have sufficient fire separation. The proposed new partition will interface with a new electrical cabinet which was consented to be installed as part of Listed Building application 2018/2093/L and will therefore not damage any historic fabric.

The new Door DR.B.13 will be created in a style to match DR.0.6 on the ground floor, a four panel door.

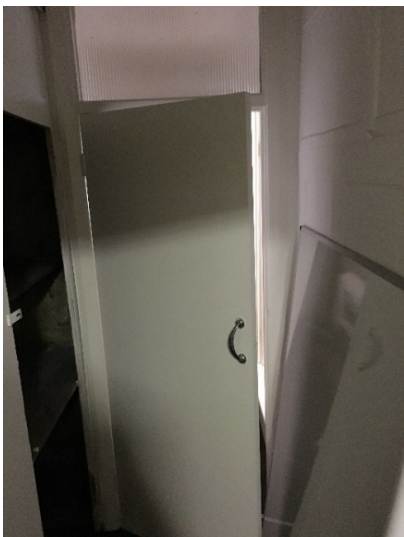
Fig 8 View of non-original door proposed to be removed DR.B.4 showing historic cabinets to the left.

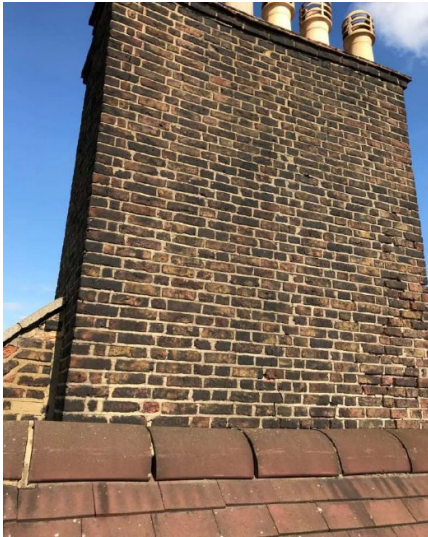
Fig 9 Roof Chimney Stack to be repointed and Terracotta tiles to be repointed as part of maintenance works.

The existing chimney stacks have some weak pointing which needs to be repaired. These pointing works will be undertaken alongside the main façade repointing and will be completed in the same way.

The existing roof tiles are generally in good condition and can be maintained, however some of the hip tile joints require to be repointed.

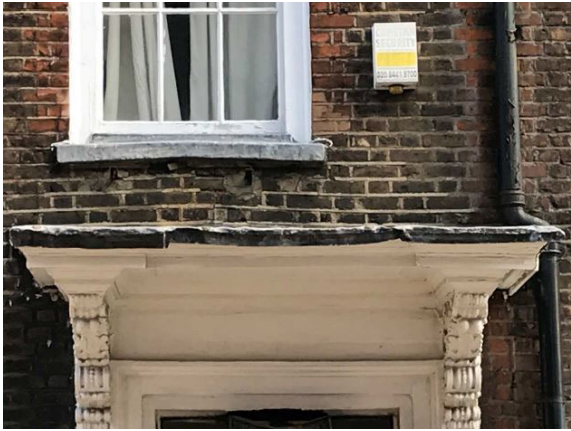
Fig 10 Front door canopy lead repairs.

The front door canopy lead flashing has not been maintained and has become delaminated from the brick wall. The lead work will be refreshed for new to match the existing.
