ARBORICULTURAL IMPACT ASSESSMENT REPORT INCORPORATING TREE RADAR
REPORT

SITE

52 Eton Avenue,

DATE: 16.01.2019

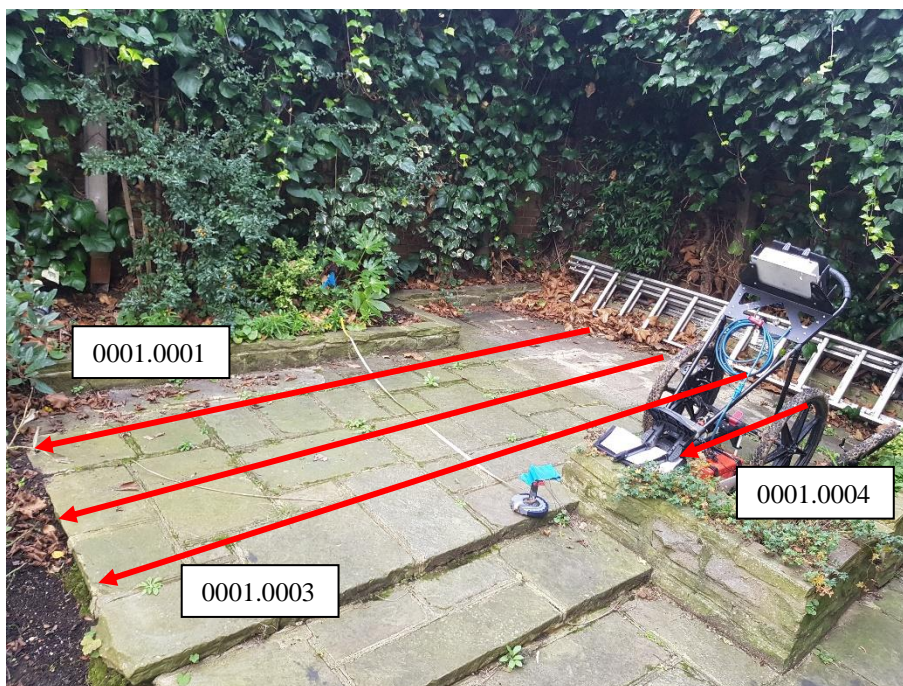
Photo 2. Scan lines 0001.0001-0004 within the patio.

4.1.1. **Results:** Roots are found in moderate/low densities, rapidly falling to low densities with increased distance from the edge of the patio and in an unevenly distributed band between 18-50cm deep. The majority of the roots are found within the southern half of the scan lines, coinciding with their approach towards the tree and shrubs in the shrub bed immediately south of the patio. Given the relatively shallow depth and the distribution it is considered likely that the majority of the roots are associated with the on-site tree and the shrubs, rather than the street trees whose roots would have been forced deeper to pass beneath the footings of the boundary wall. Soils in this location appear very disturbed with poor soil horizon definition.

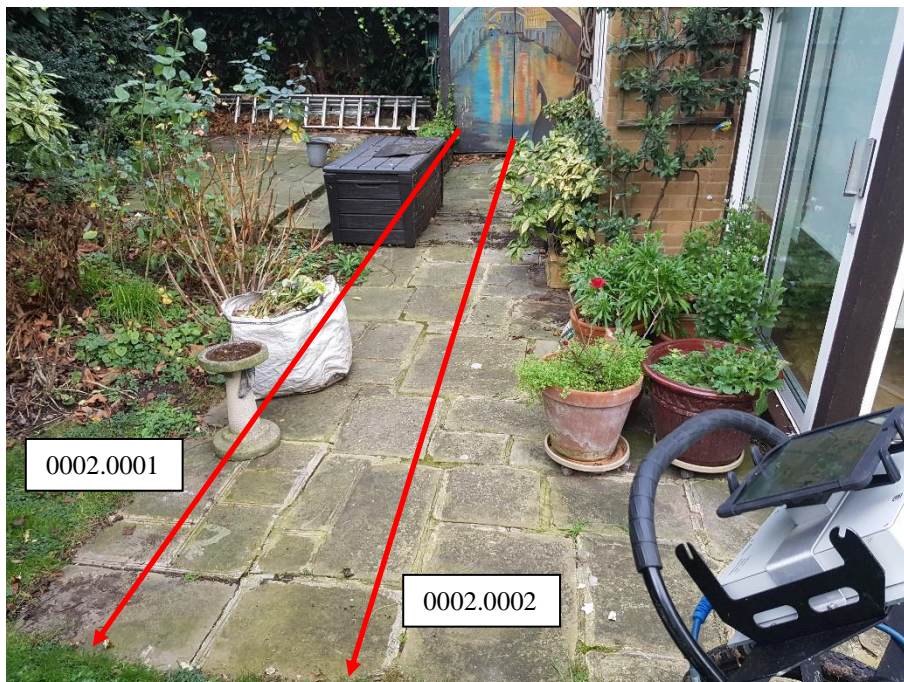
Photo 3. Scan lines 002.0002-0002 within the path.

4.2.1. Results: The roots are found in a very low rooting density in an unevenly distributed band between 15-50cm deep. The majority of the roots are found in the southern half of the lines, nearest the trees and shrubs in the shrub bed. Soils in this location appear very disturbed with poor soil horizon definition.

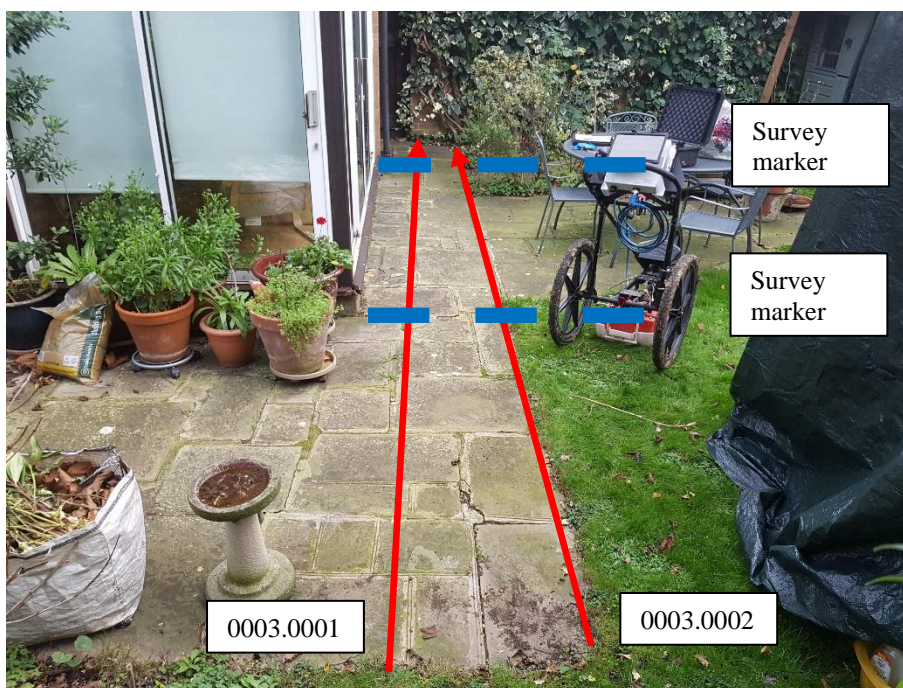
Photo 4. Scan lines 0003.0001-0002 within the path.

4.3.1. **Results:** The results of the scan lines found only one root within scan line 0003.0002, located at the eastern end of the scan line near the shrub bed. No other roots are found within the scan lines and the single root is most likely associated with the woody shrubs rather than a tree.

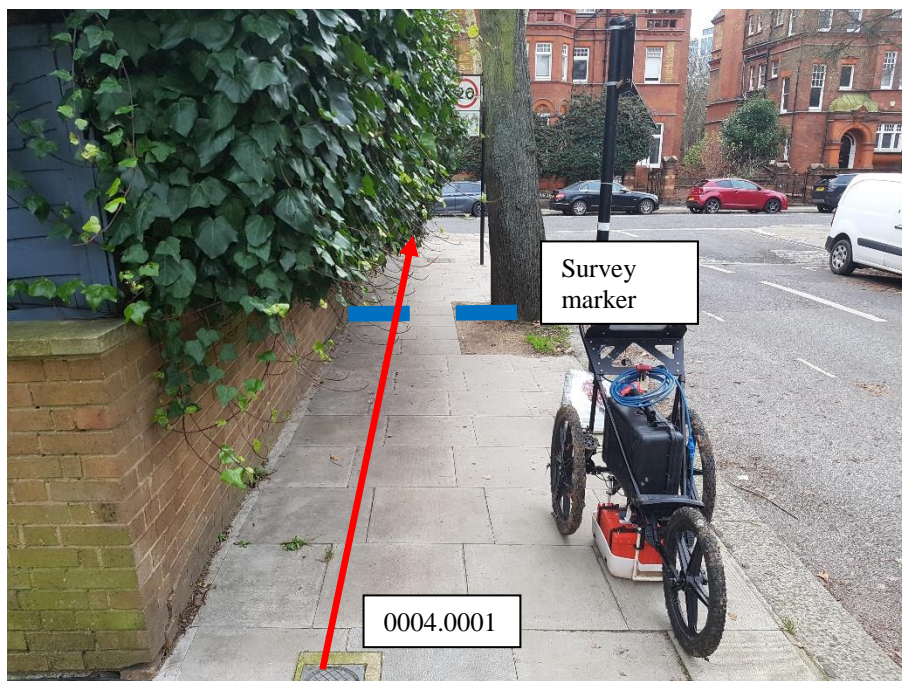
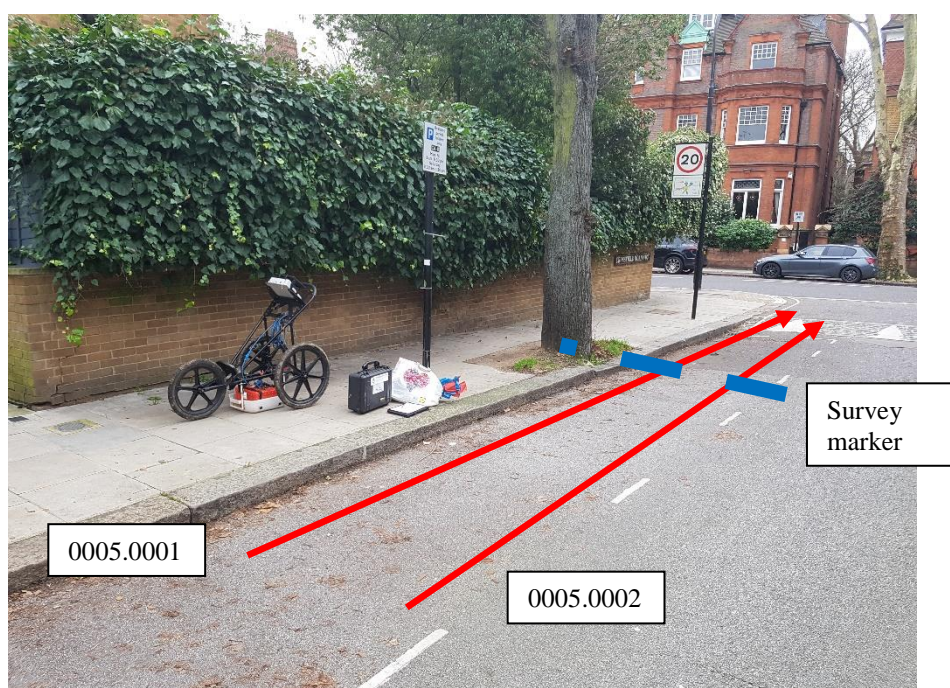
Photo 5. Scan line 0004.0001 within the footpath.

Photo 6. Scan lines 0005.0001-0002 in the road.

4.4.1. Results: Roots are found in an overall low rooting density but in very uneven distributions along all of the scan lines, with areas of higher rooting density found at the start of the scan lines closest to T10, and either side of the point at which the lines pass T9. Within the footpath the roots are found in a band between 25-60 cm deep, with a few shallower roots visibly causing slight lifting of the surfacing, while beneath the road the roots are found predominantly between 70-120cm deep.
