Orms

St Giles Circus

26 DMS - 22 DMP LBC - Design Statement

January 2019

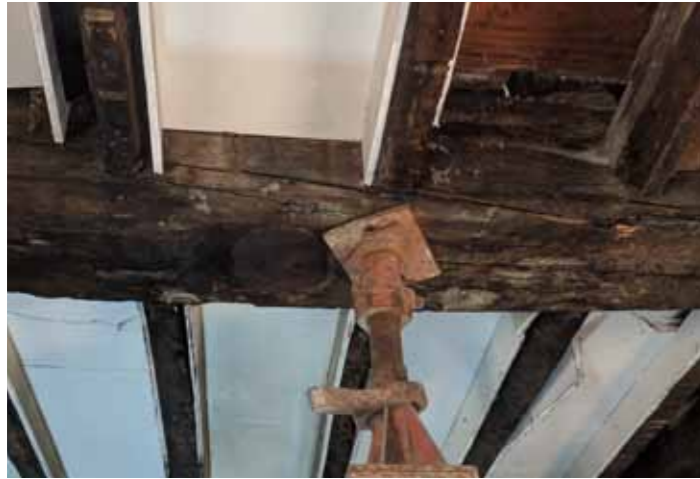
1 Existing spine beam at first floor

Reason: The existing central spine beam is failing due to historic overloading. This beam has been supporting the floors above and roof structure for a number of years.

Historically a spine wall would have been present at ground floor and lower ground floor with the load of the floors and roof being taken down to a stable footing.

Remedy: We propose to retain the existing spine in place and introduce a goalpost structure which will sit on a new footing at lower ground floor.

Steels will run either side of the existing spine beam supported off discreet pairs of PFC columns running down to the new footing at lower ground floor. This will involve the trimming back and resupport of the existing floor joists.

The steels running adjacent to the existing spine beam will have steels bolted below the existing spine beam to resupport the beam and floors above.

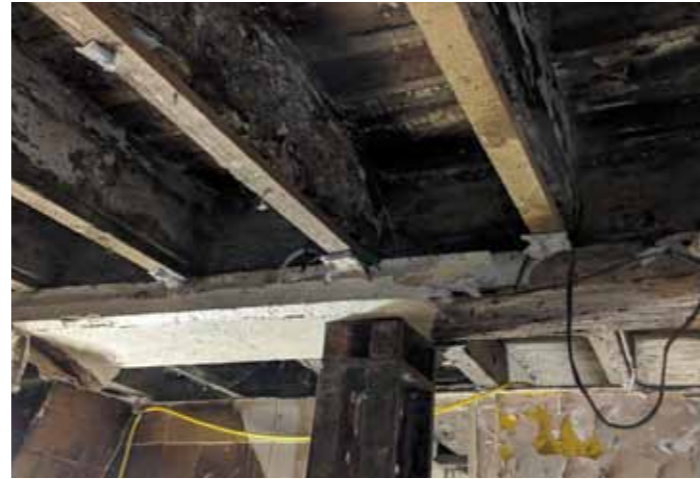
1 Existing spine beam at lower ground

Reason: The existing central spine beam is in poor condition.. This beam has been subject to damp from the bar venue at ground floor level and the kitchen and lower ground floor.

Remedy: We propose to retain the existing spine in place and introduce a goalpost structure which will sit on a new footing at lower ground floor.

Steels will run either side of the existing spine beam supported off discreet pairs of PFC columns running down to the new footing at lower ground floor. This will involve the trimming back and resupport of the existing floor joists.

Where steel posts sit within the residential entrance, these will be concealed with timber panelling to match the existing condition. These details will be developed with ABA at a later date.

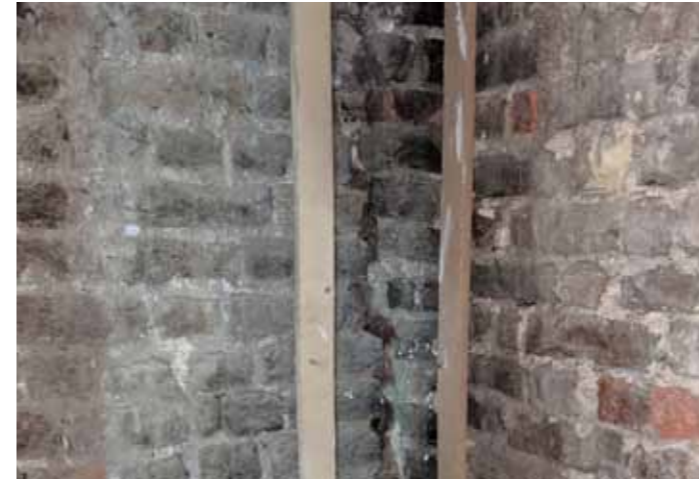
2 Front facade delamination

Reason: It is strongly suspected that the front facade has been historically rebuilt. When rebuilt it was either poorly or not at all tied into the existing party walls.

Remedy: It is proposed to tie the front facade back to the rear facade with discrete steel straps located within the existing joist zone. As a result of the tying together of the facades there is a requirement for cast iron patress plates that will be visible front elevation. - *Please also refer to the front elevation section of this document*

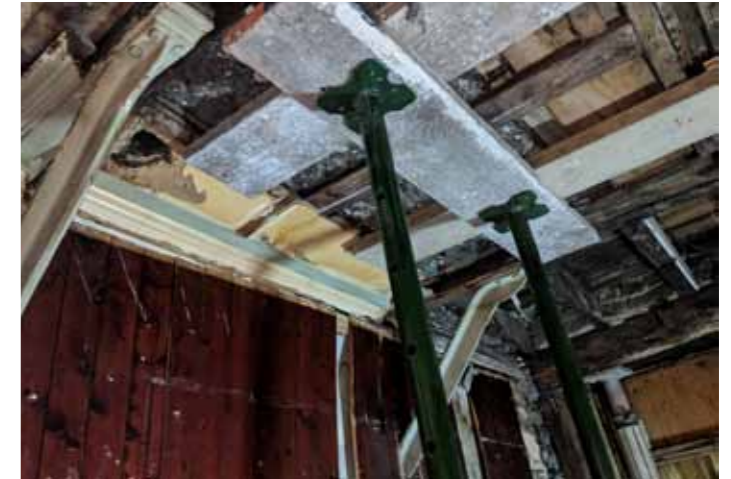
3 Existing chimney support

Reason: Historically the chimney stack at ground floor and lower ground floor have been demolished. To support the chimney stack gallows brackets were installed.

The gallows brackets are failing in part due to the weight of the existing chimney stack, as well as its independence from 26/27 Denmark Street Party Wall, and potentially a later addition to 26 Denmark Street.

Remedy: The proposed solution is to introduce a discreet goalpost frame and resupport the chimney stack at high level ground floor. The steel will be concealed in the existing joist zone

It is also proposed to tie the existing chimney stack back to the 26/27 Denmark Street party wall using concrete elbow ties. These will be concealed by reinstated period timber panelling.

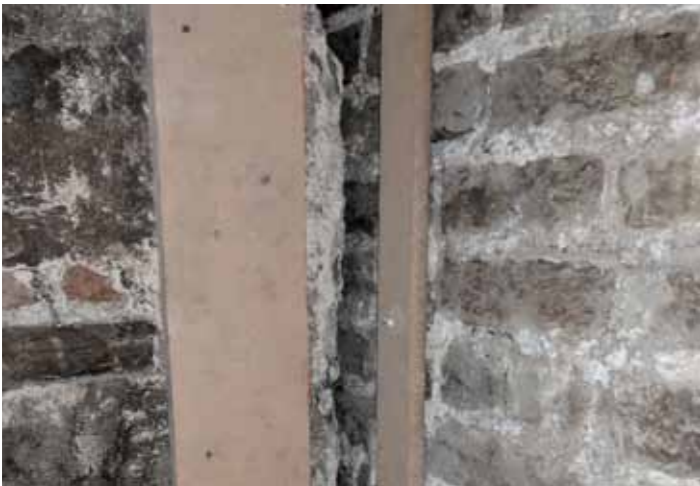
3 Existing chimney independent from party wall

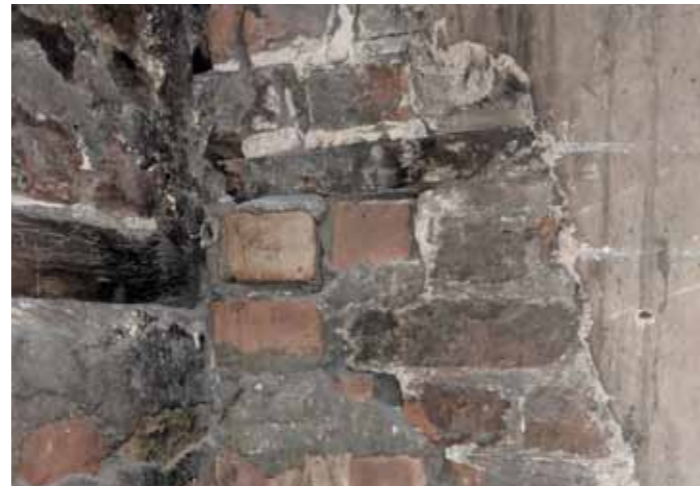
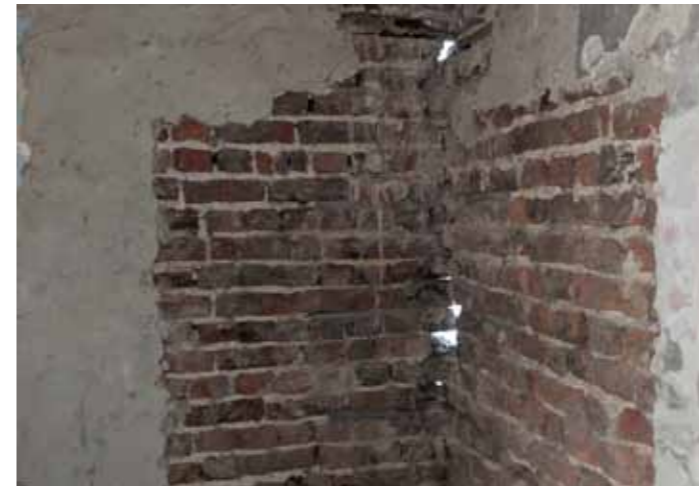
4 Existing masonry corner

Reason: Masonry corners are currently weak, with mortar and bonding visibly damaged at corners, which could be as a result of historic movement, adjacent piling or demolition works.

Remedy: The proposal is to install discreet helibar within the existing mortar joints and repoint with lime mortar.

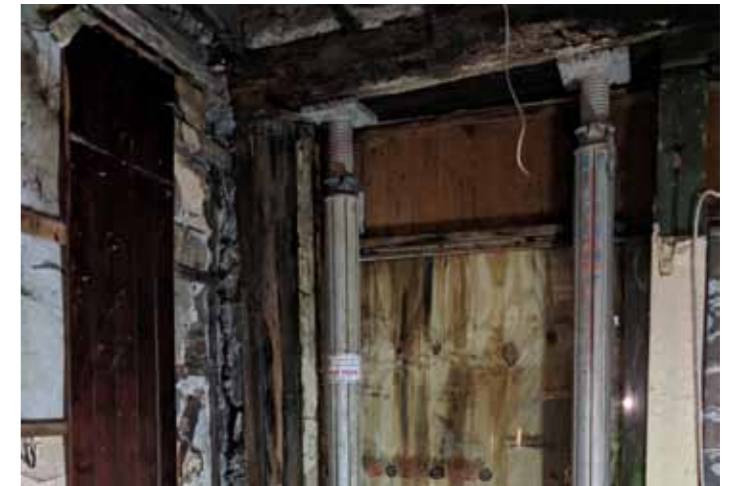
5 Existing bessemer beam support

Reason: The existing bessemer beam supporting the facade above the shopfront is supported on visibly rotten timber posts.

Remedy: We propose resupporting the bessemer beam on toothed in masonry to replicate the support condition on the other side of the shopfront.

The masonry will match existing and be pointed with lime mortar.

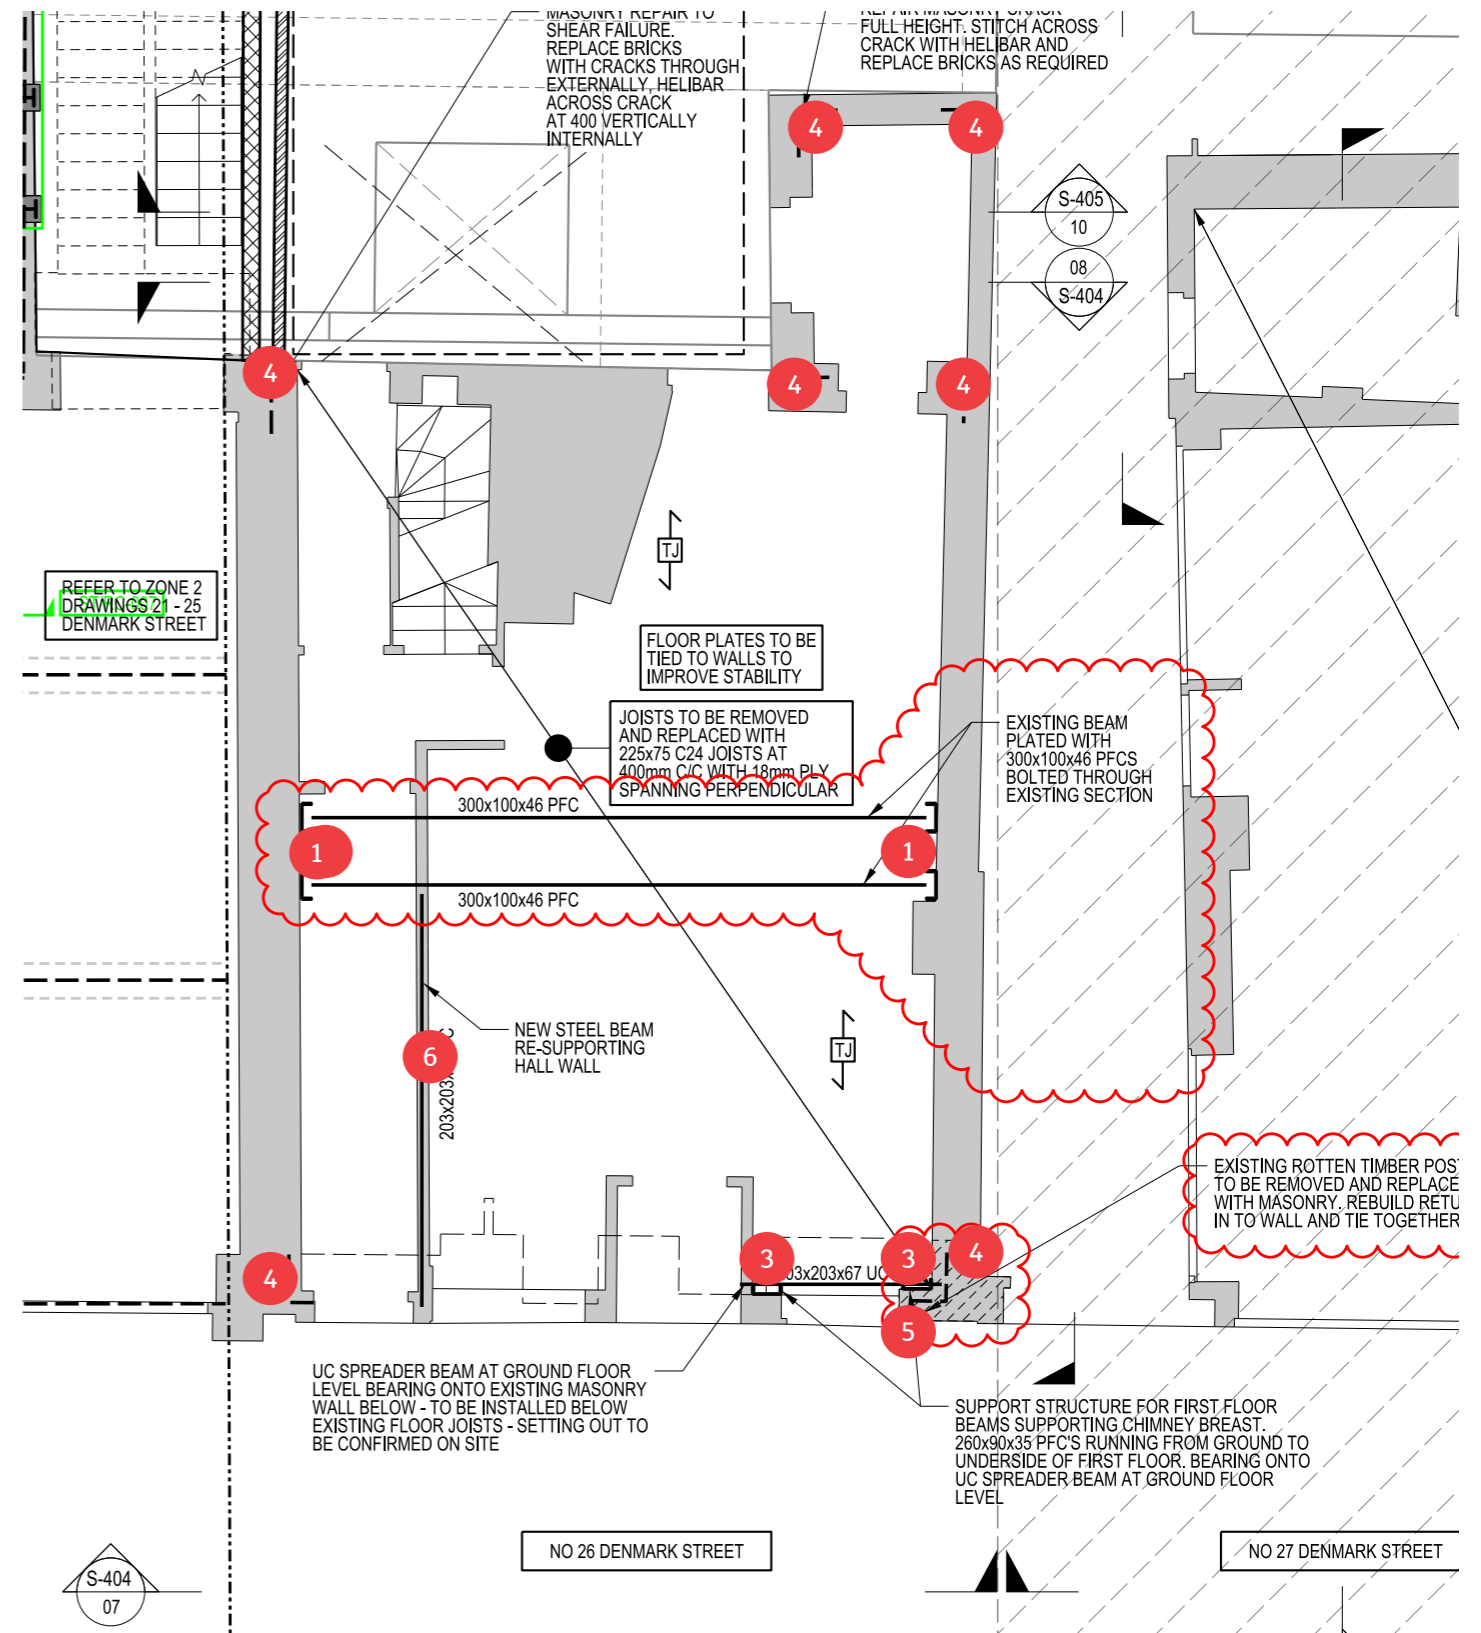
Ground Floor Plan (High Level Lower Ground)

Reason: Historical demolition may have been undertaken, taking away the support above

Remedy: We propose introducing a steel at high level lower ground floor to provide support for the wall.
