24 CHURCH ROW PHOTOGRAPHS

Listed Building Consent Application

Heritage Impact Assessment and Schedule of Works

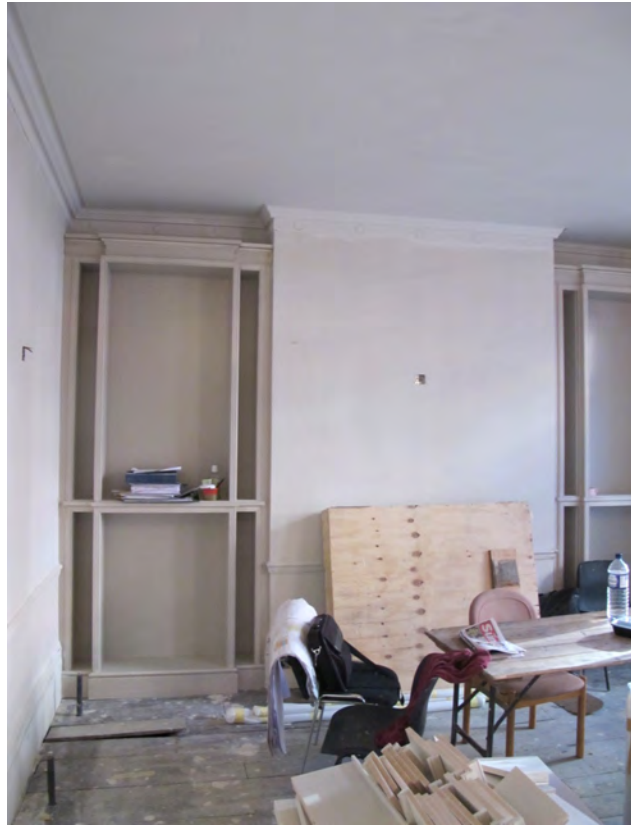
Fig. 2.2A *Over-boarded ceiling, pre-2017 works*

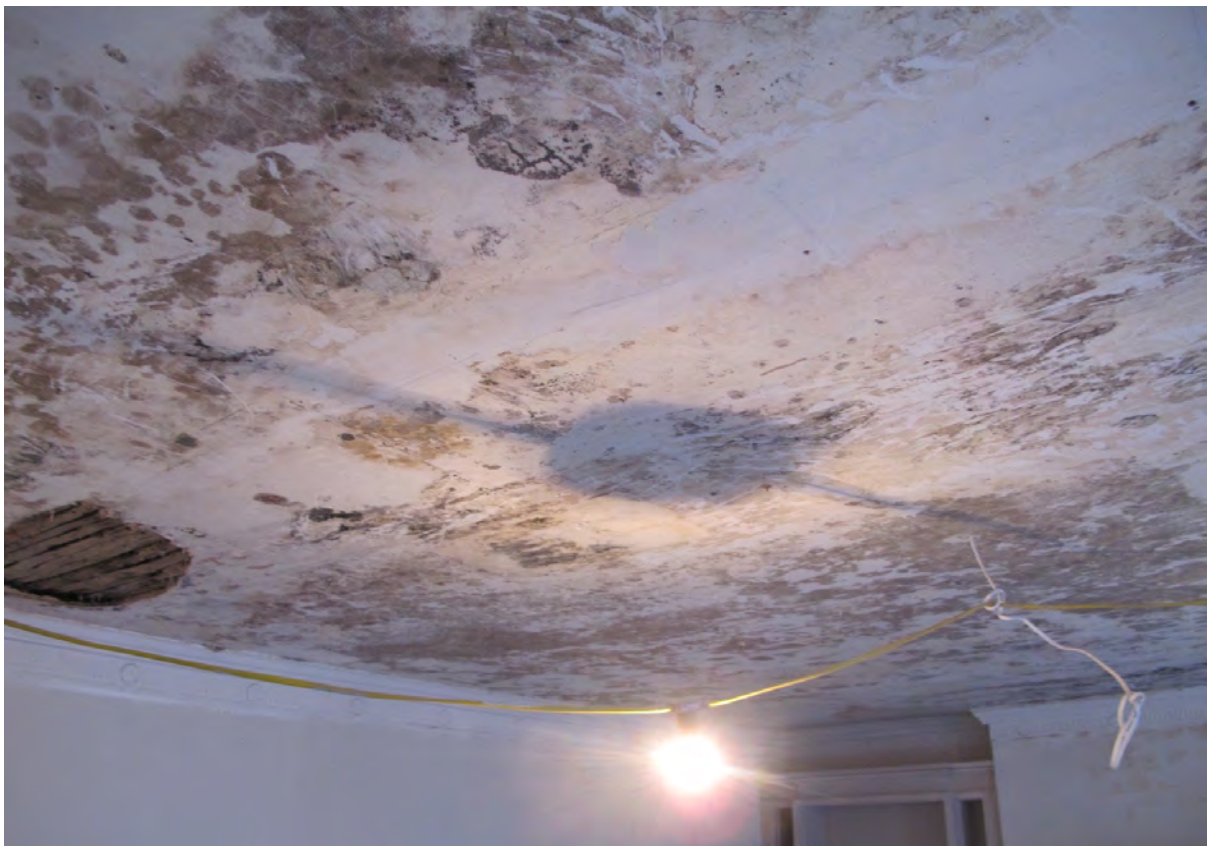
Fig. 2.2B *Removal of over-boarding, revealing mould growth and water damage to original lime plaster and lath ceiling*

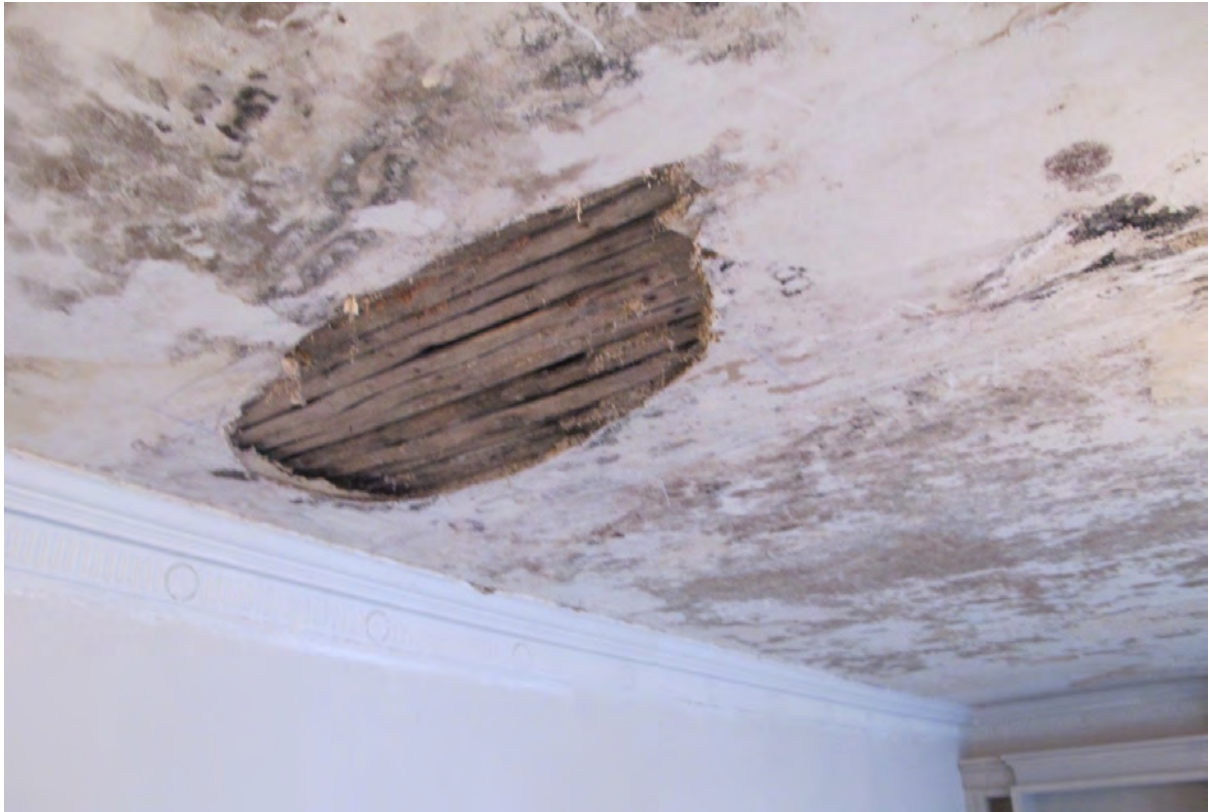
Fig. 2.2C *Water damage and failing lime plaster ceiling*

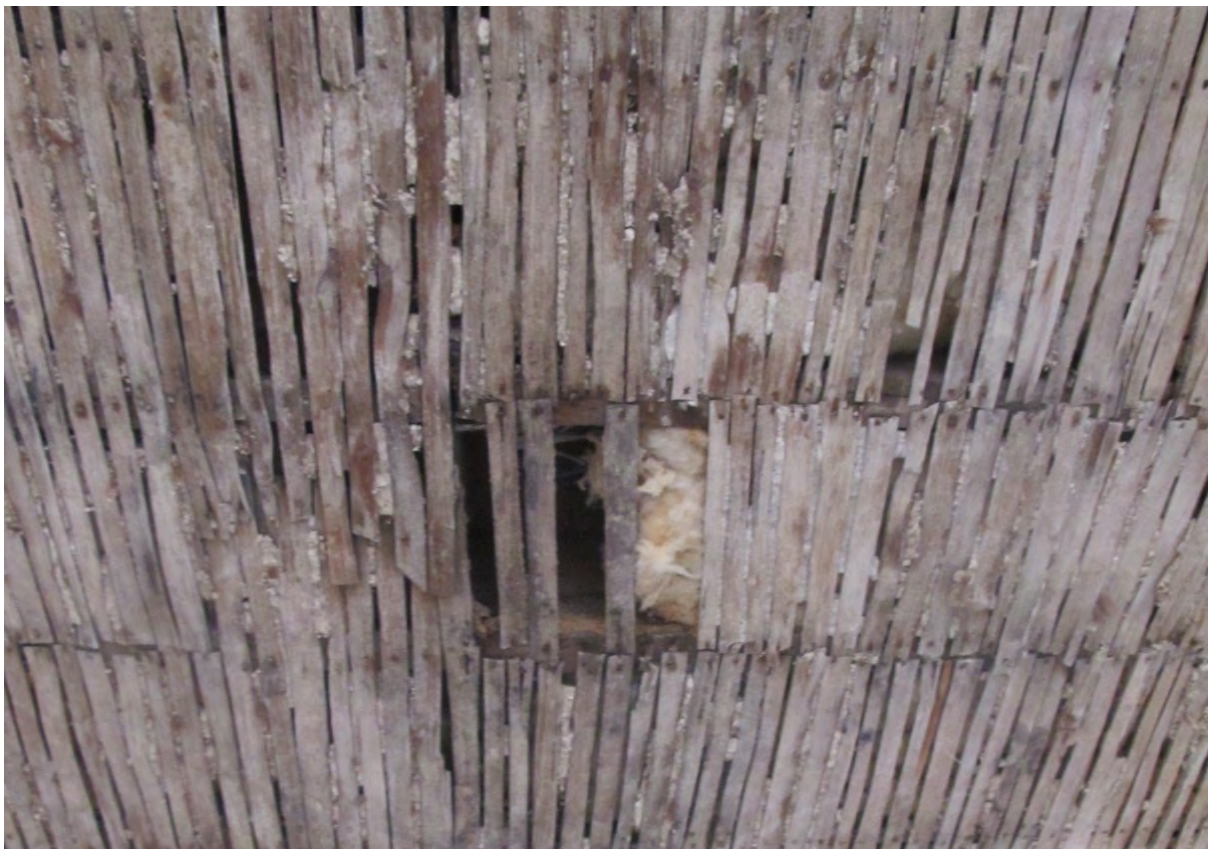
Fig. 2.2D *Frail and water damaged lathing [Note laths also set tightly together]*

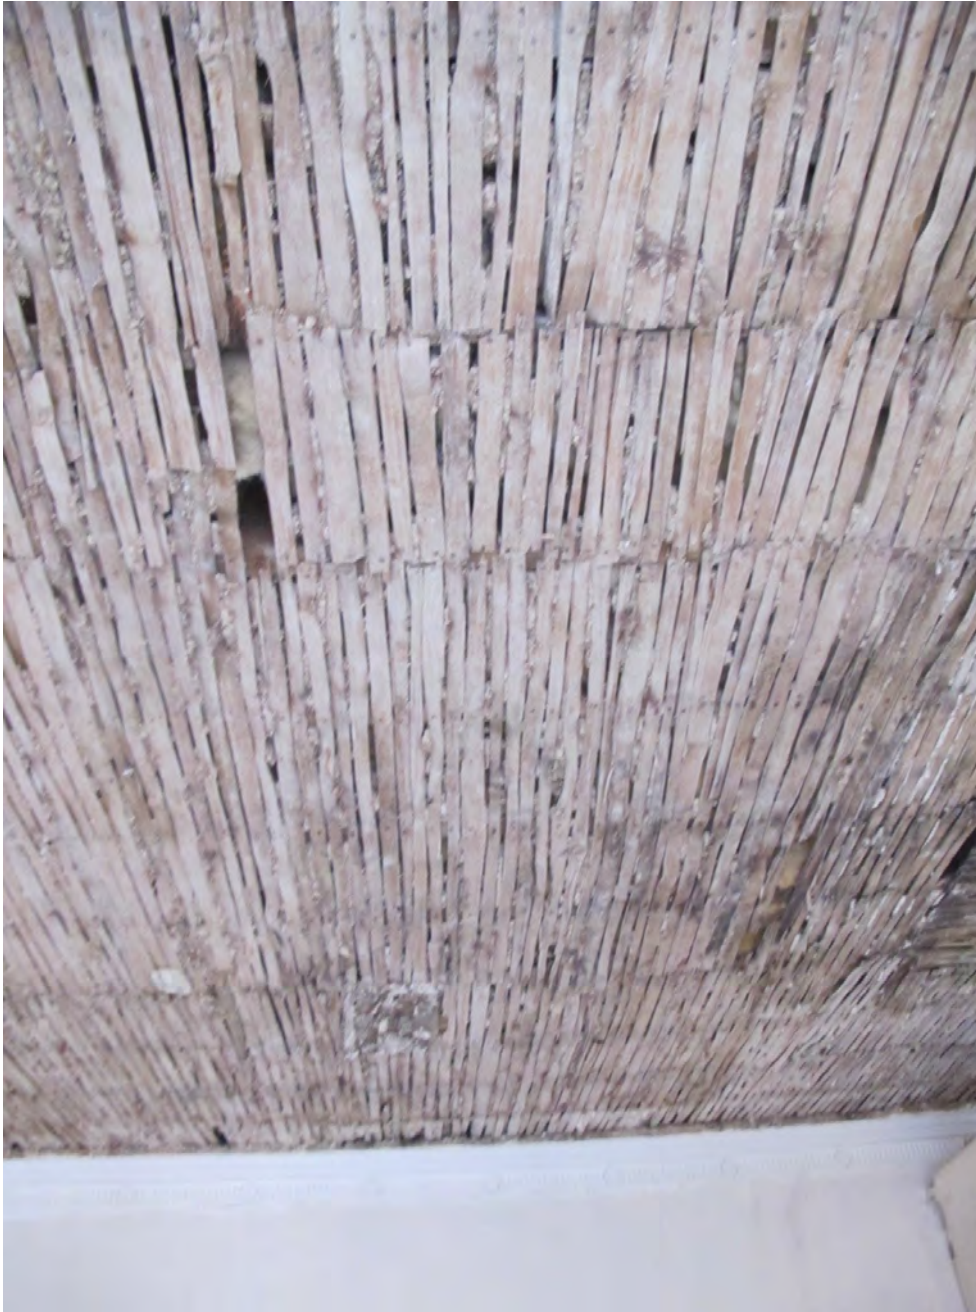
Fig. 2.2E *Lathing with loose lime plaster removed*

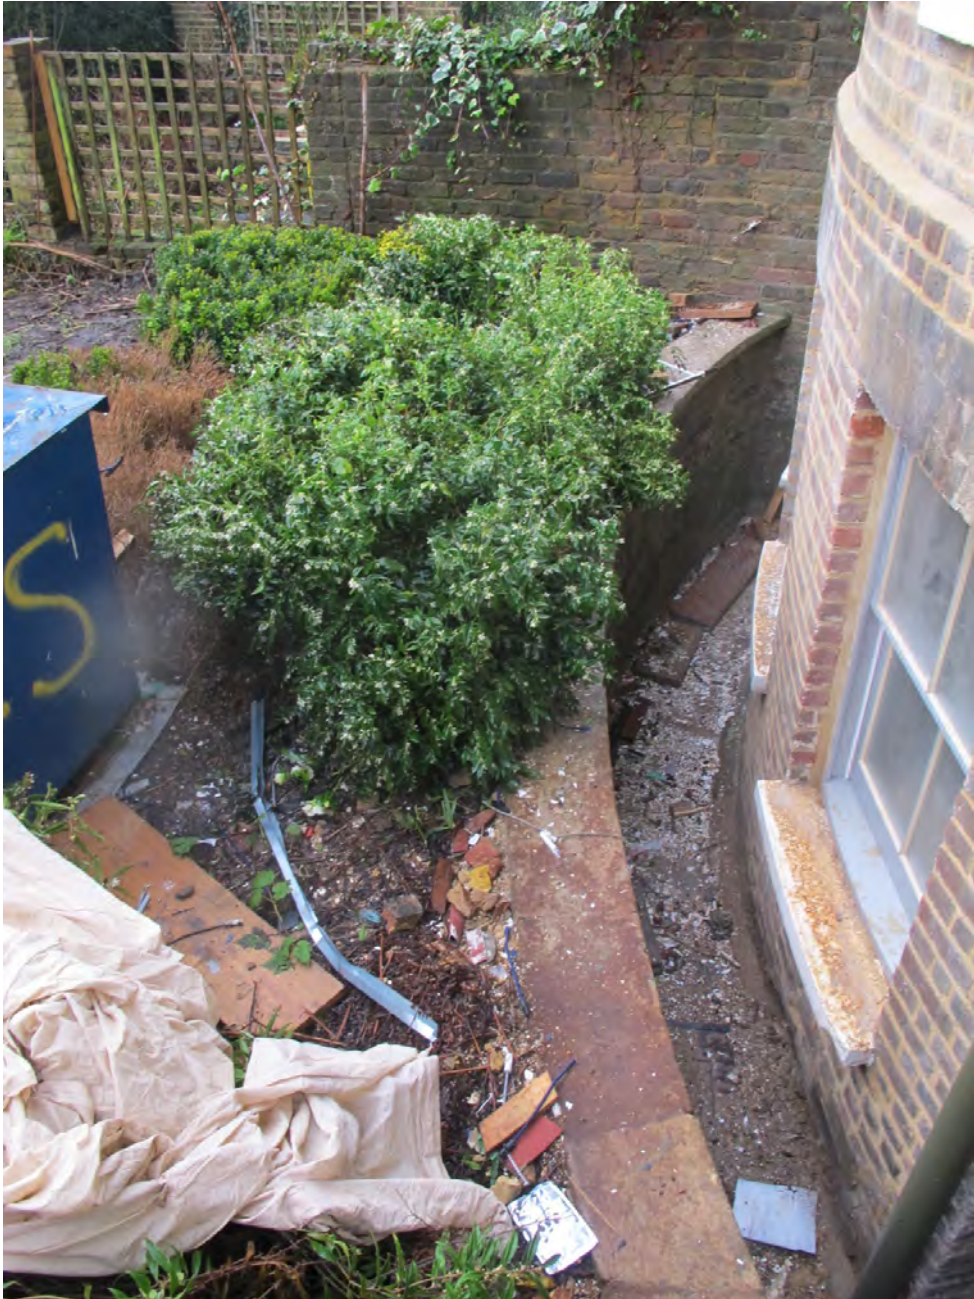
Fig. 4.3A *Existing rear lightwell, unprotected edge*
