12 PARKHILL ROAD, LONDON

**PRELIMINARY ARBORICULTURAL
ASSESSMENT**

Report No: RT-MME-129521-01 REV A

Date: February 2019

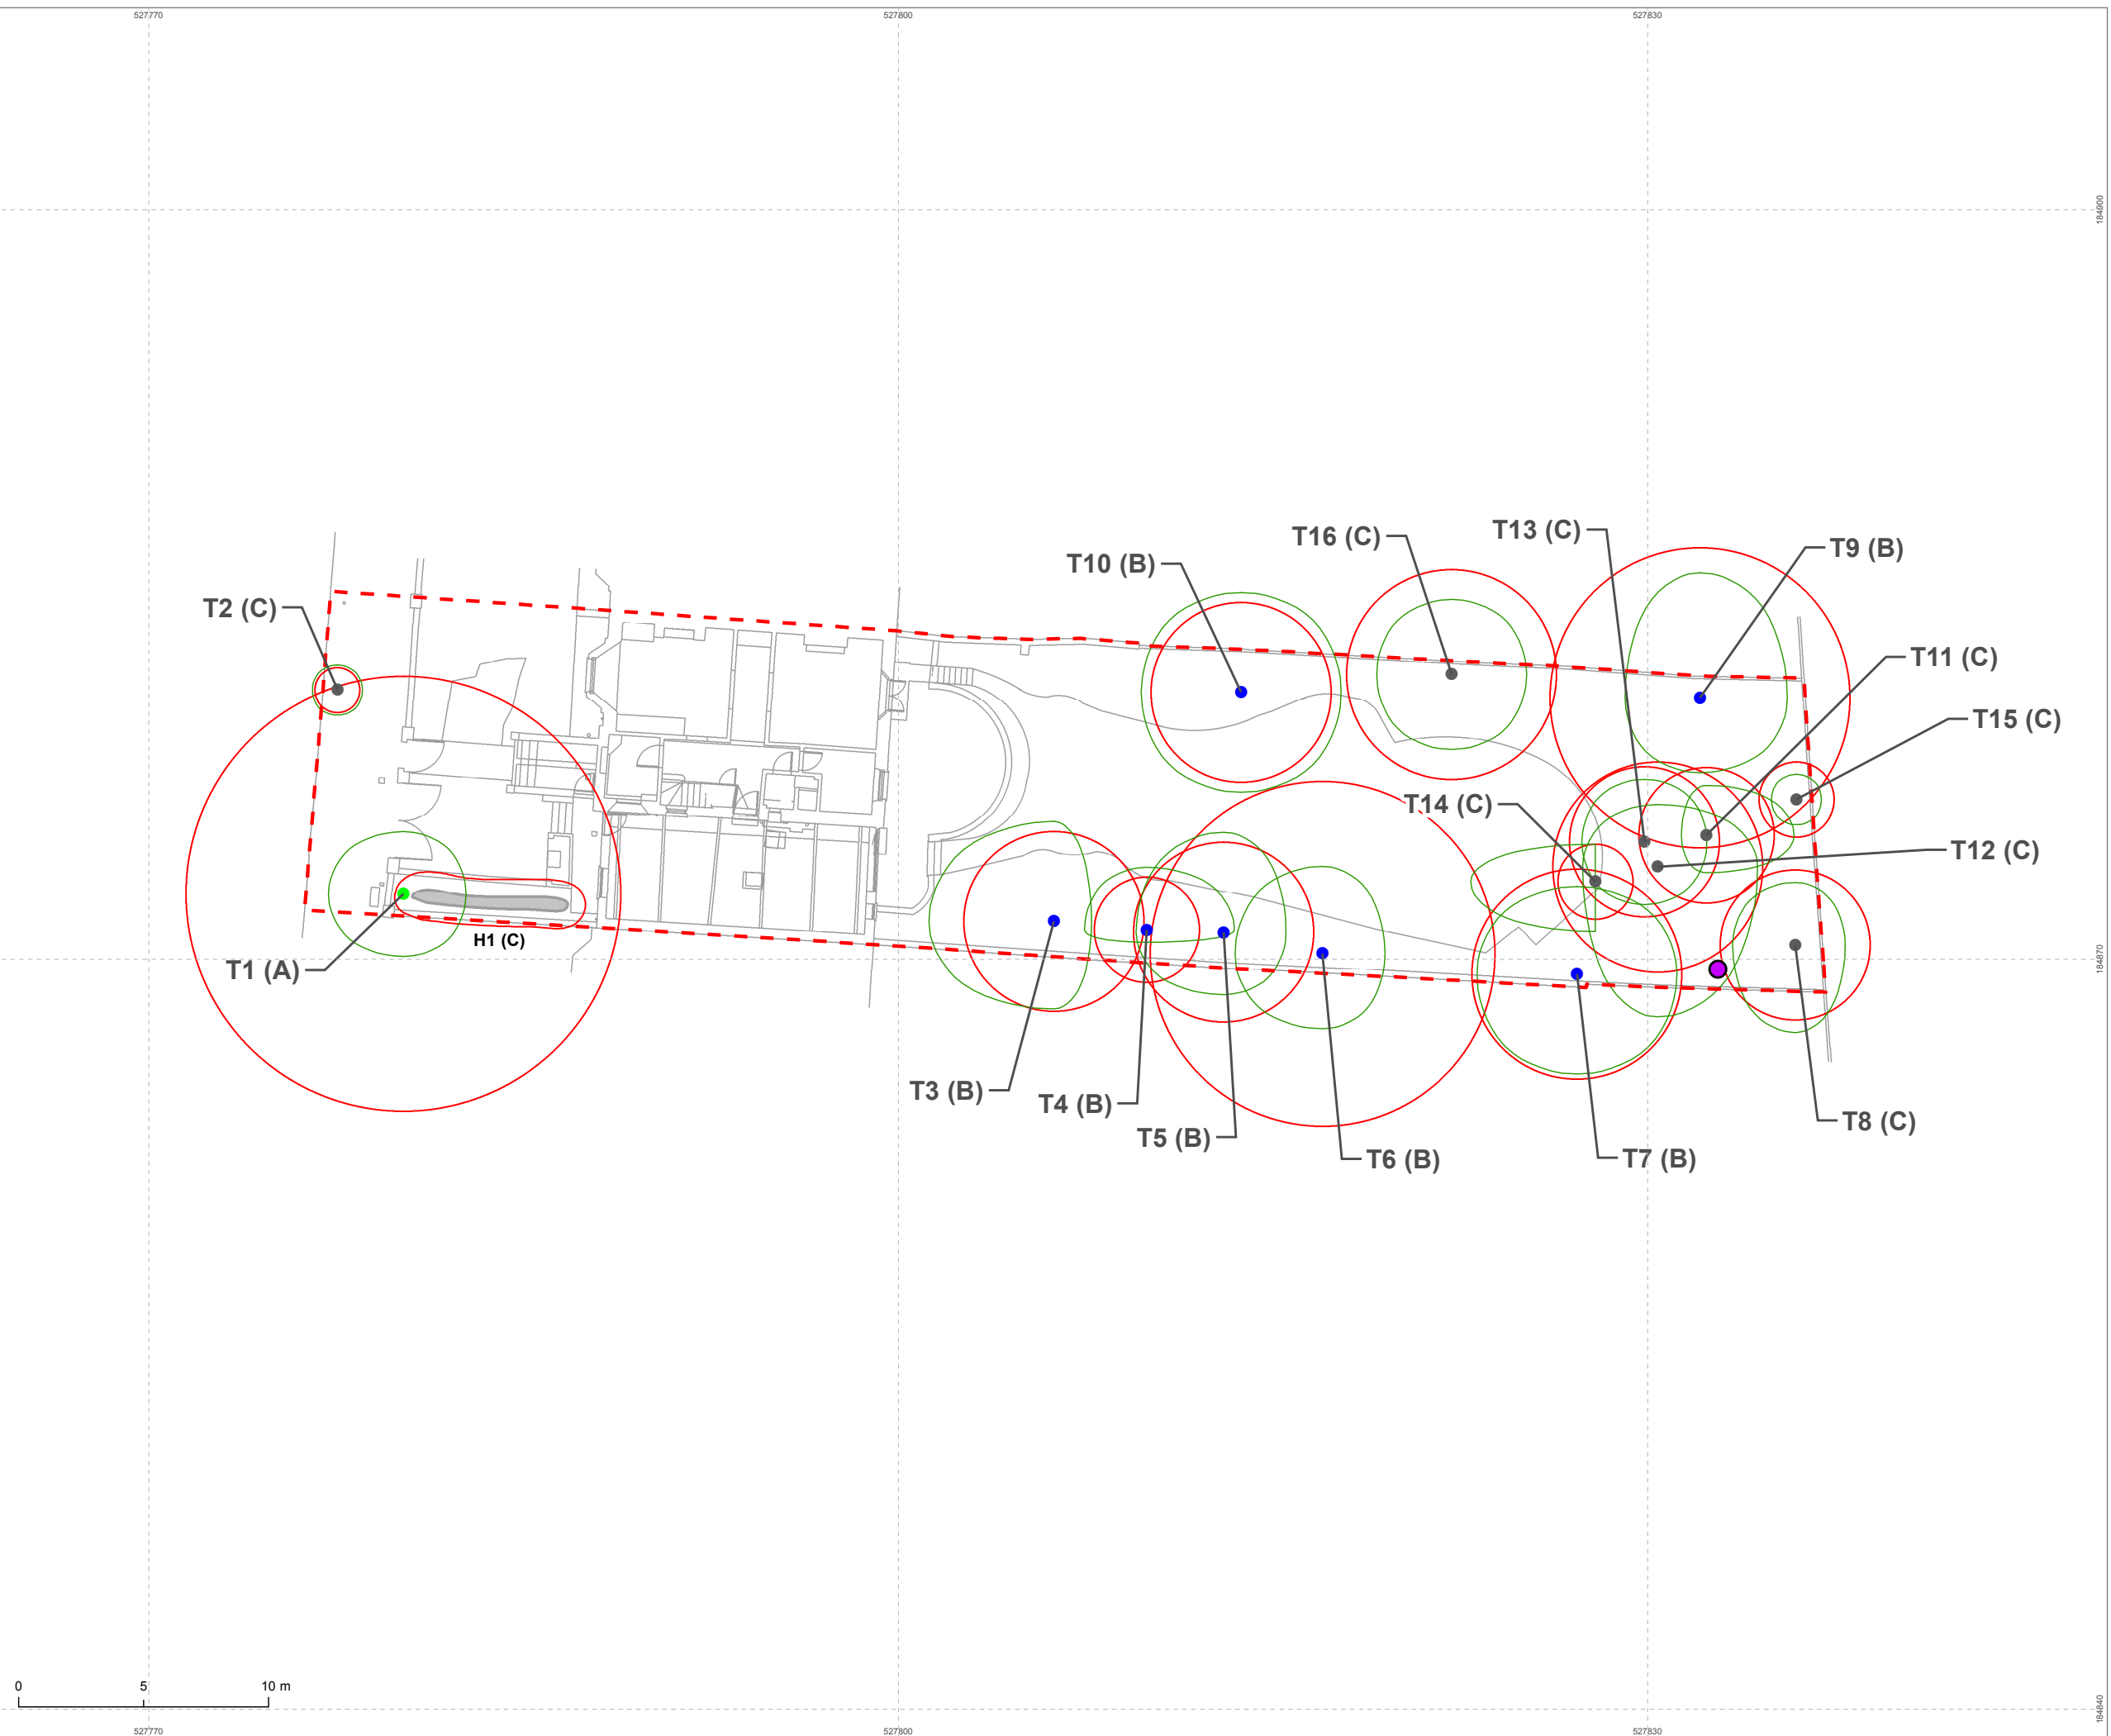
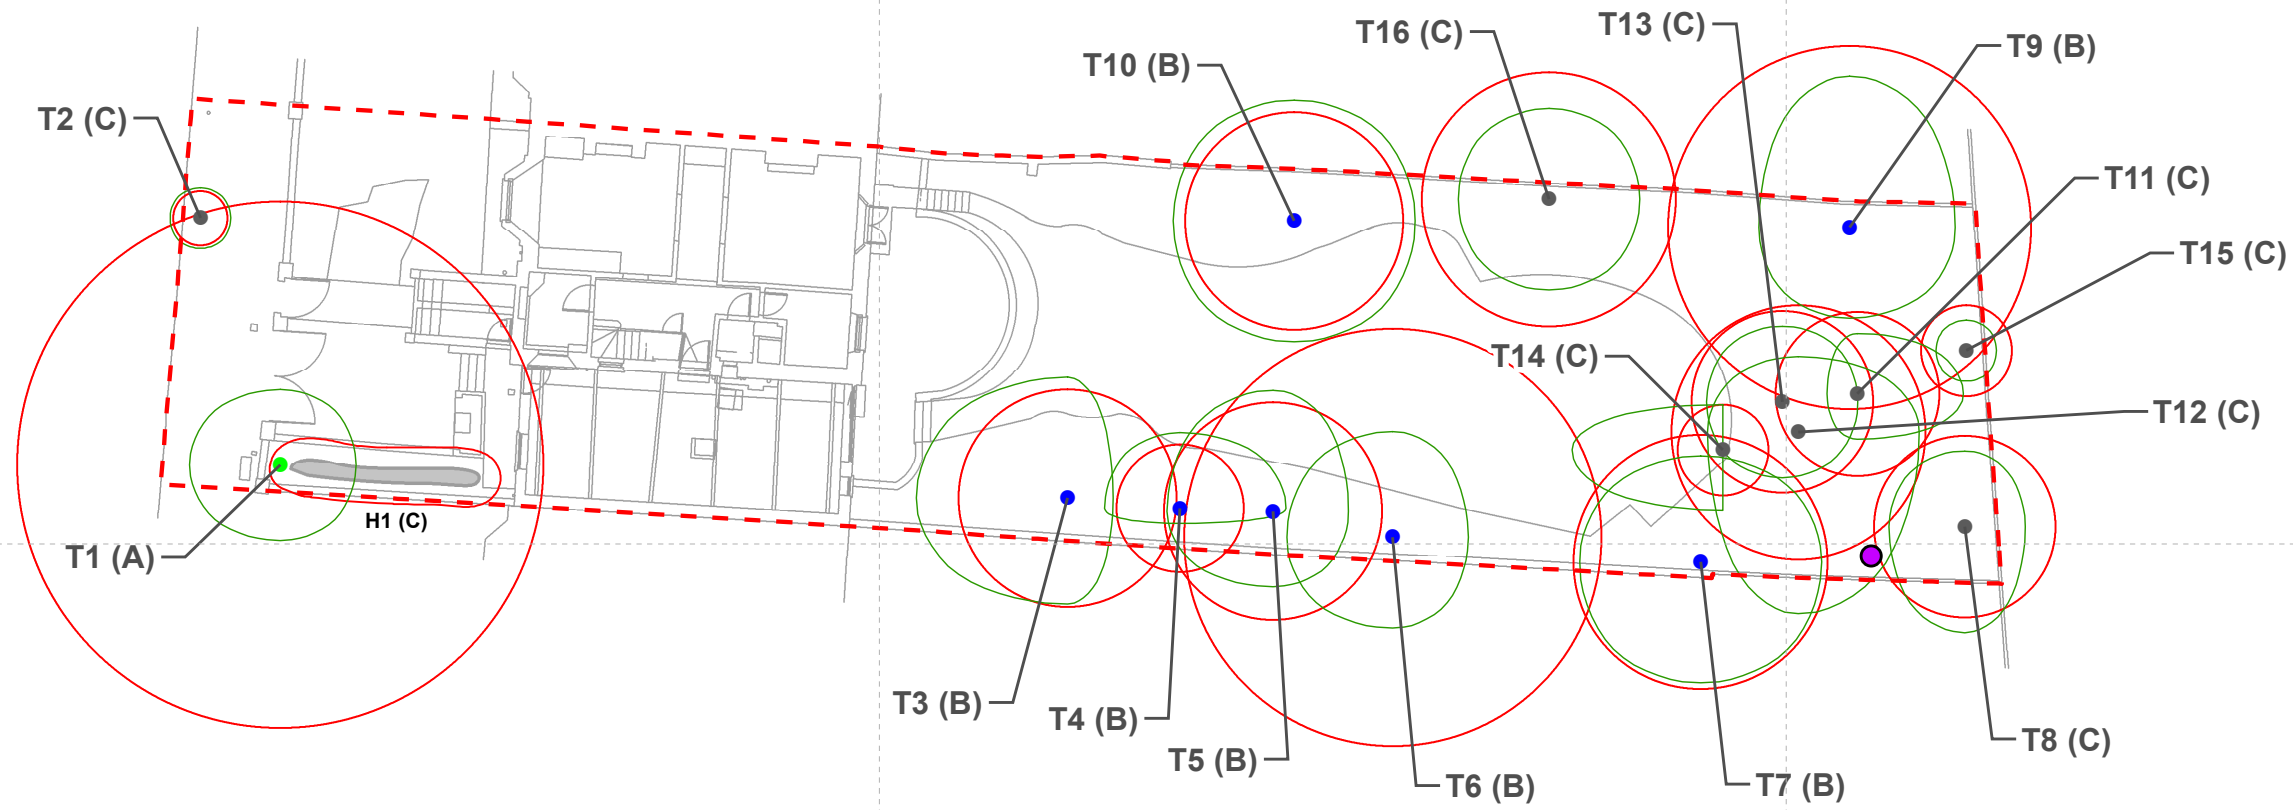
Project		12 Parkhill Road	
Drawing		Tree Constraints Plan	
Client		Sarita Kraljevic	
Drawing Number	C129521-01-01	Revision	00
Scale @ A3	1:250	Date	January 2019
Approved By	DS	Drawn By	GT

The location of the trees surveyed can be found on Middlemarch Environmental Ltd Drawing Number C129521-01 REV A-01, contained within Section 7 of this report.
