**Charlotte Bolland**

Mount Vernon House  
Mount Vernon  
Hampstead  
NW3 6QR

**Date:** 13<sup>th</sup> March 2019

**Trees situated in Conservation area:**

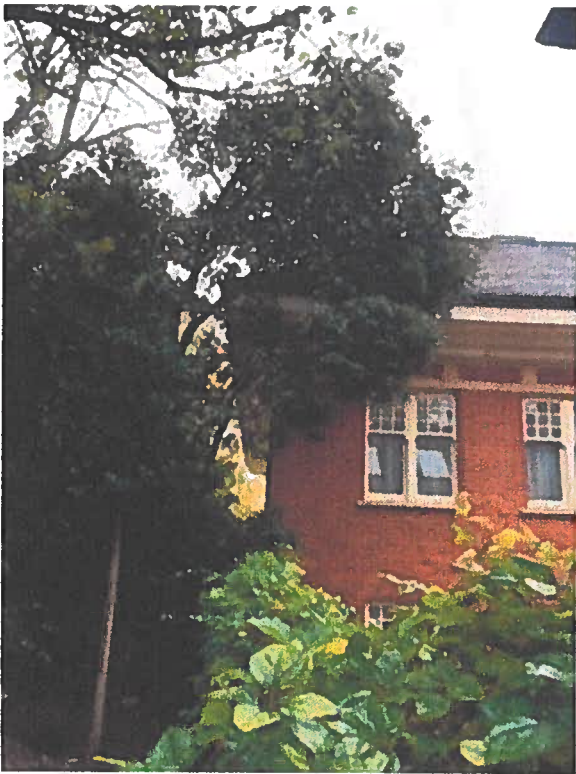
**Photo 4: Holm oak**

**(T7) Holm oak:** This tree is situated in back garden next to boundary fence next to neighbouring property. Looking around the base of this tree there are no signs of any movement or any fungal fruiting bodies at time of site visit.

This tree is causing problems with neighbouring property in relation to branches interfering with the roof and guttering. (picture showing this).

Is to reduce tree in height by approx. 2.5 metres and reduce side branches to blend and maintain trees natural form as per BS3998 – 2010.
