BS5837 Arboricultural Impact Assessment

131 Arlington Road, London, NW1 7ET

Job Reference: 03051R

April 2019

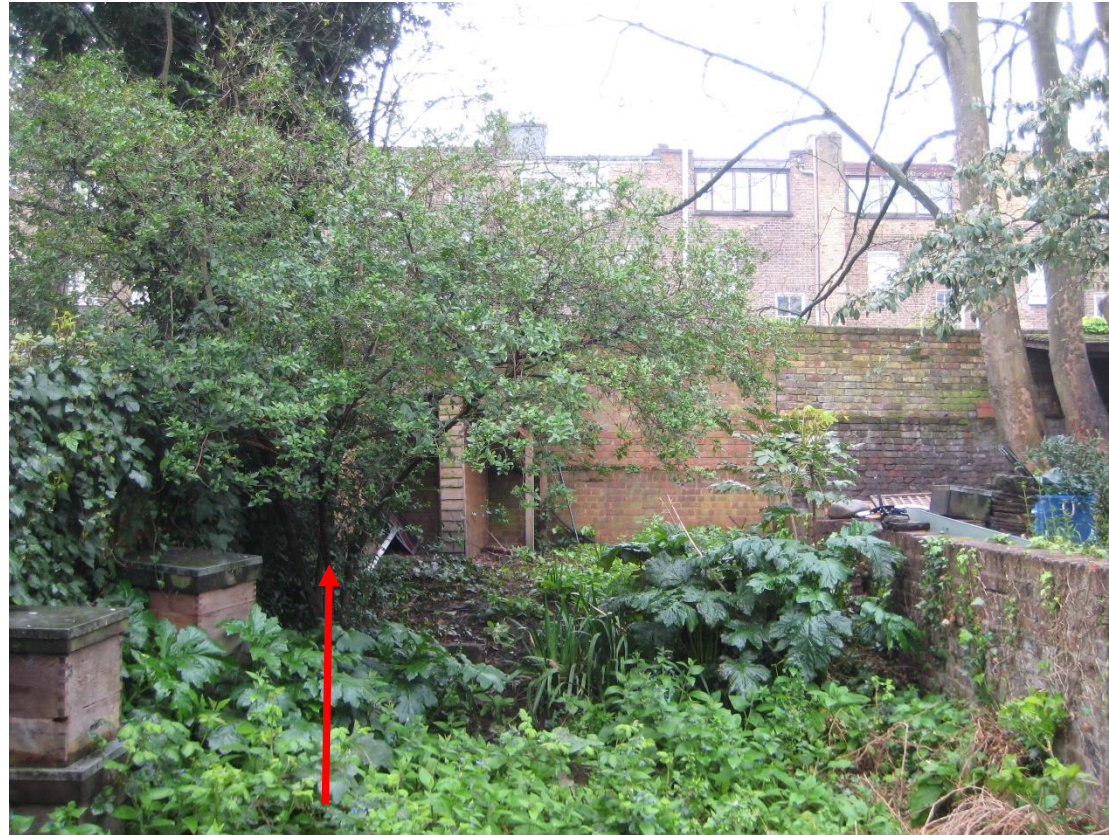
5.3.1 No trees are removed to facilitate the project, but the Privet shrub referenced as S1 will be removed. This is a small and insignificant shrub relative to the local amenity.

Fig 1 – S1 (Privet) above will be removed

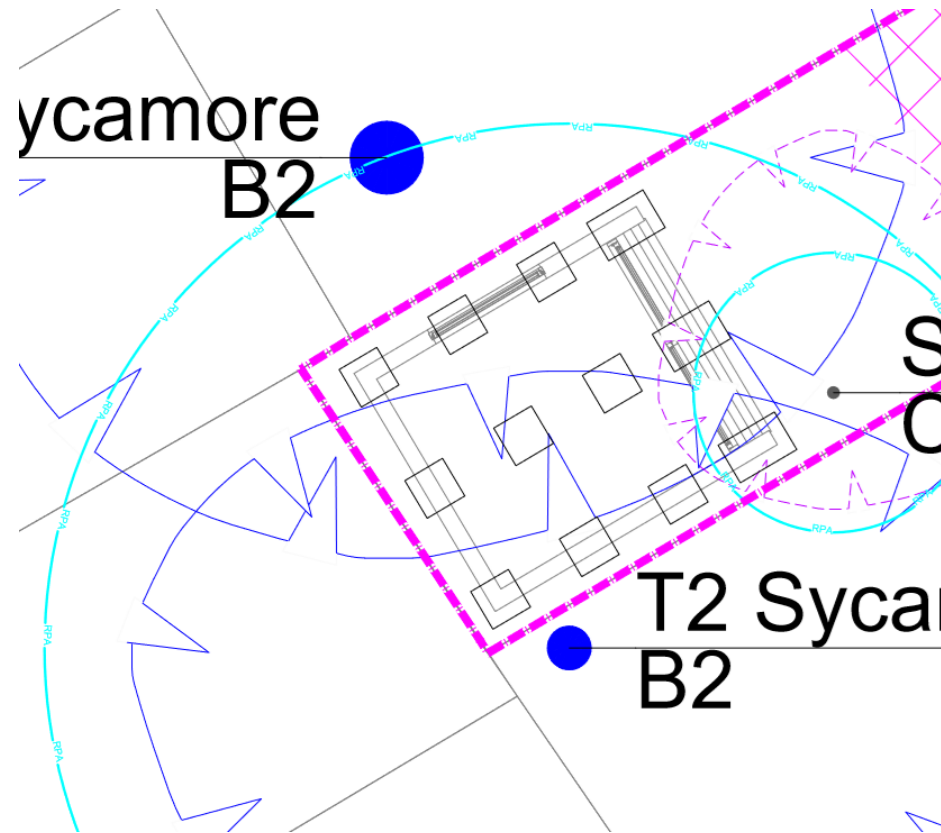
- *Pad footings used to minimise impact.*
- *Hand dug with localised repositioning to avoid roots >25mm.*
- *The level of works is such that no special foundation measures are proposed. In summary at this level and in this location, we believe there will be no discernible impact on the health or stability of T1 or T2.*

Fig 2 – Foundation incursion overview. Note: form and location of pads to be confirmed by structural engineer.

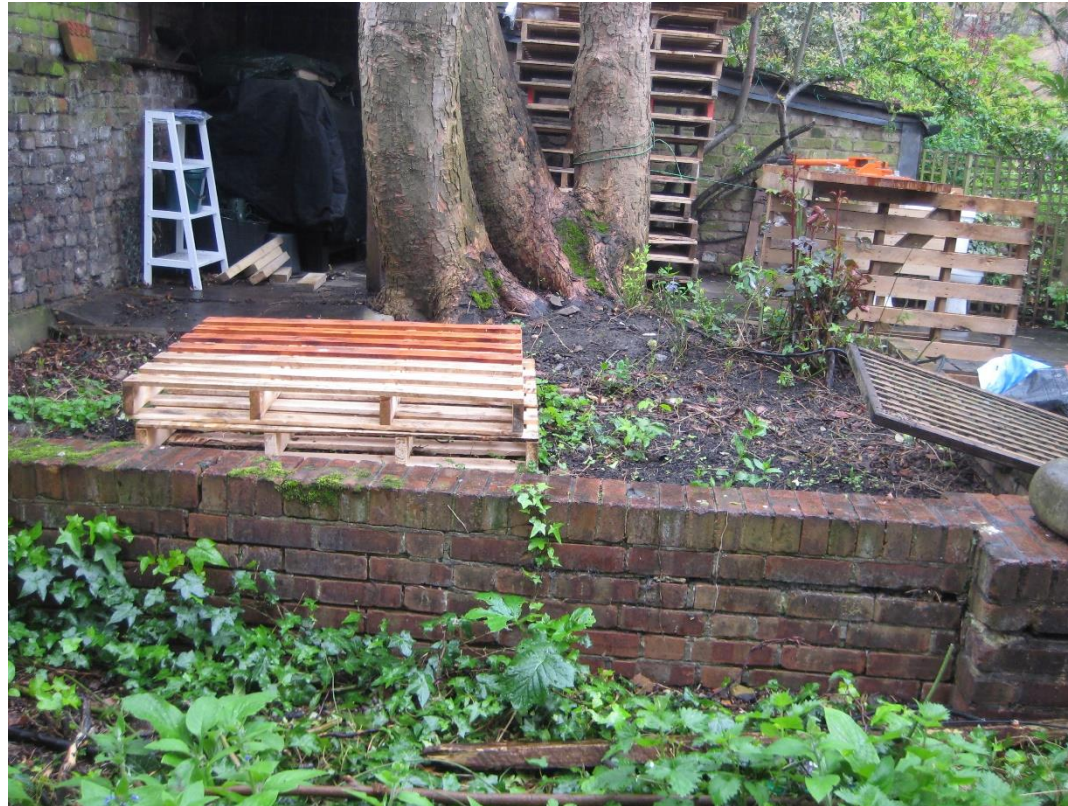
Image 1 – T1 Sycamore is located on 3rd party land

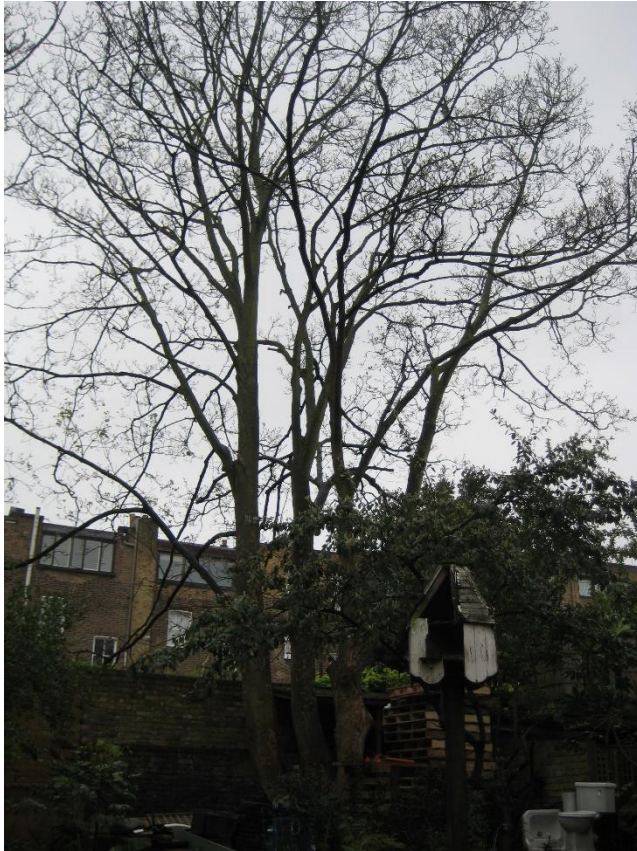
Image 2 – T1 canopy

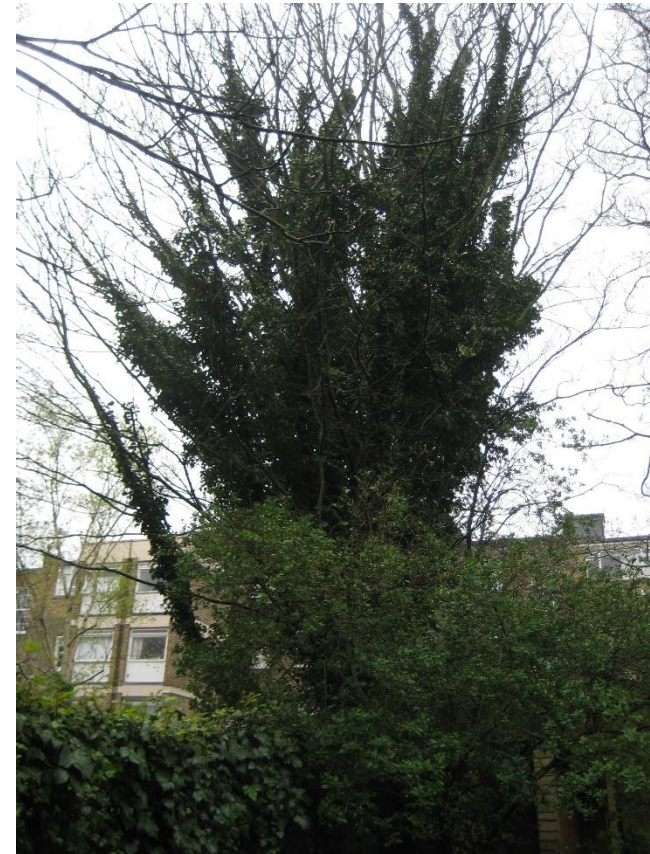
Image 3 – T2 is Ivy covered and on 3rd party land

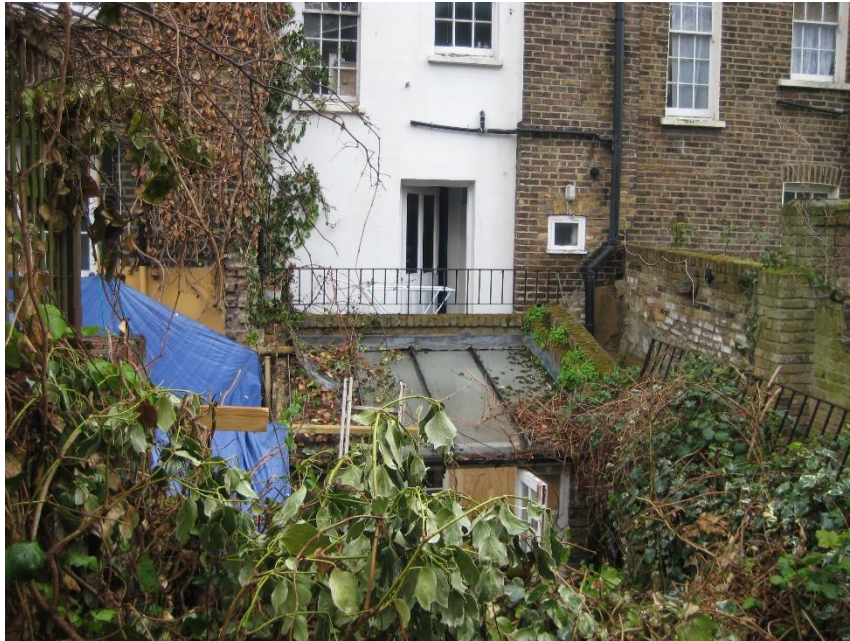
Image 4 – All access is through the house

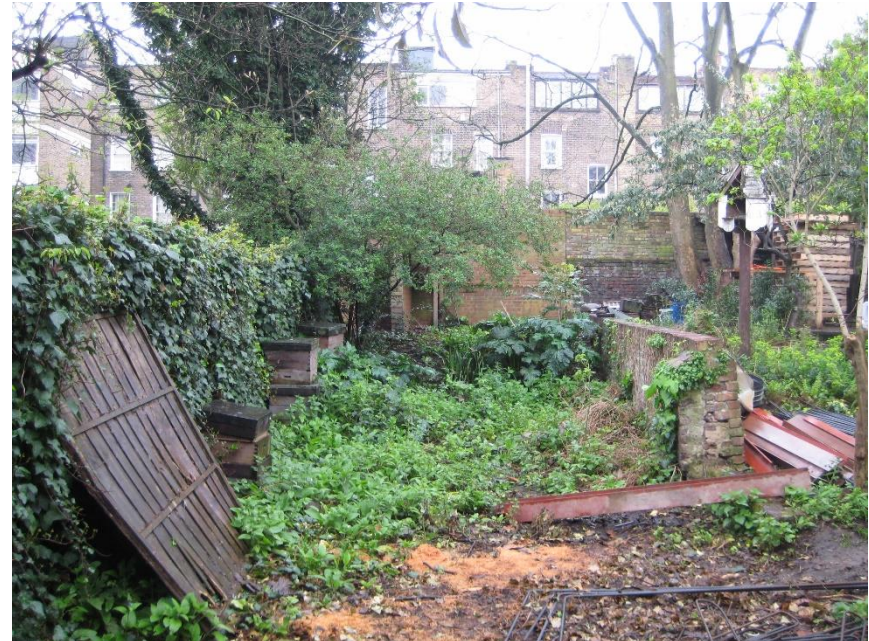
Image 5 –The existing rear garden
