St Giles Circus - 21 Denmark Street Arcade Design Statment

Zone 02 - Arcade Walls

The existing brickwork

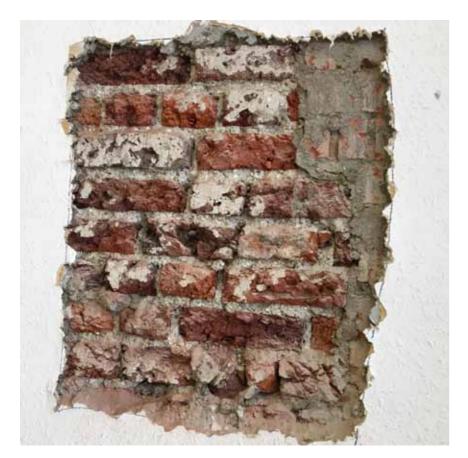
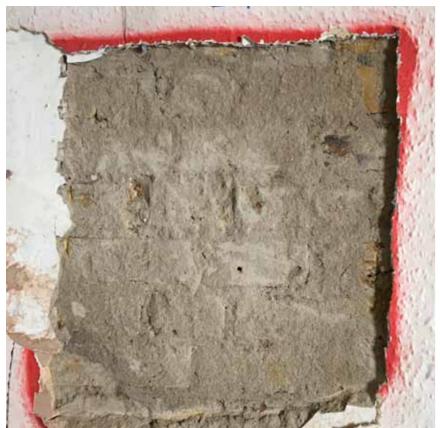
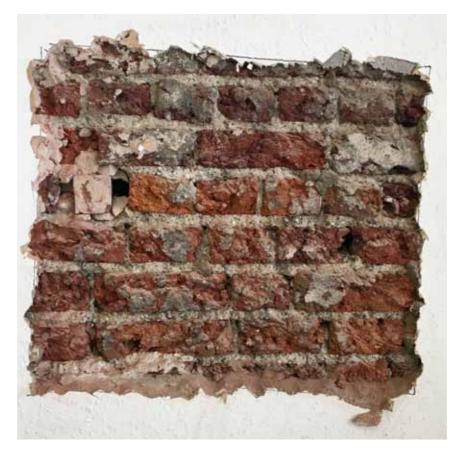
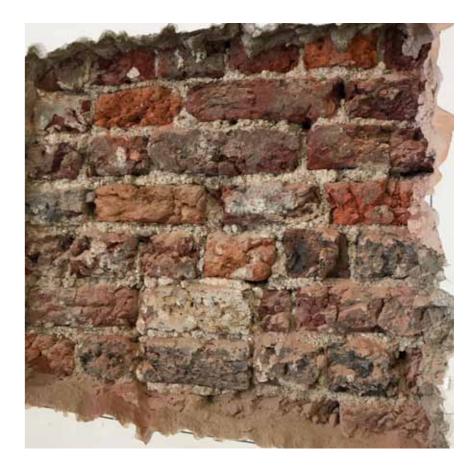
Existing sand cement render has been removed from the existing masonry walls to reveal the existing facing brickwork.

The removal of the render has uncovered several issues with the existing masonry walls.

- Existing masonry is of varying quality
- Existing party wall has different brick types patchworked across the wall due to historic alterations
- Existing masonry has no consistent bonding the bonding is piecemeal and not regonisable as any type

We have reached the conclusion that the existing brickwork cannot be repaired to a level where facing brickwork would provide a positive aesthetic finish.

As a result we propose making the brickwork structurally sound and finishing with a lime render.
