## ARBORICULTURAL IMPACT ASSESSMENT REPORT FOR:

1 Steele's Studio  
Haverstock Hill  
London  
NW3 4RN

**Ref:** JGA/1STS/AIA/01c

**Date:** 16<sup>th</sup> May 2019

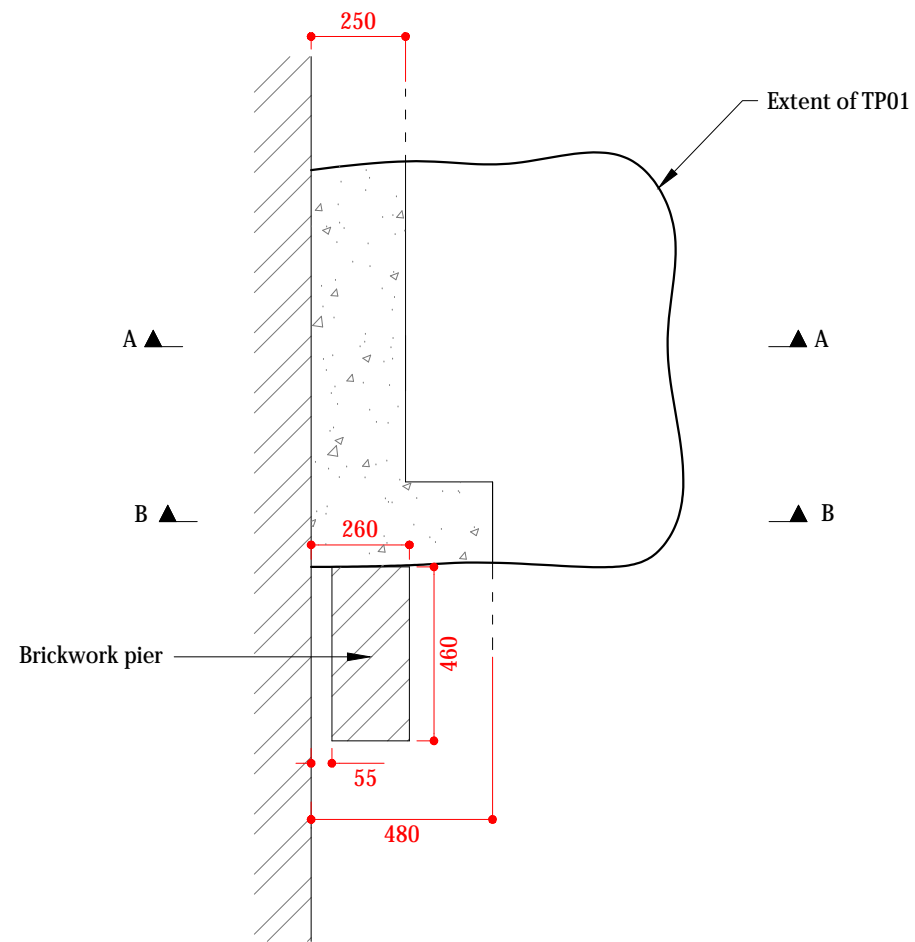
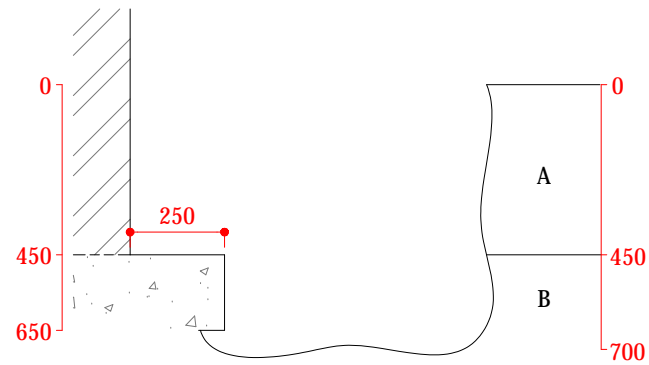
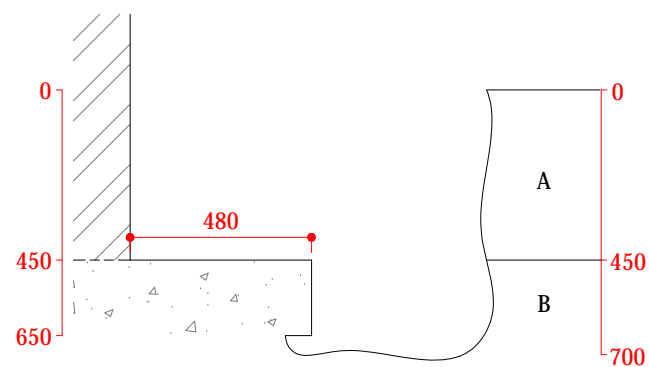
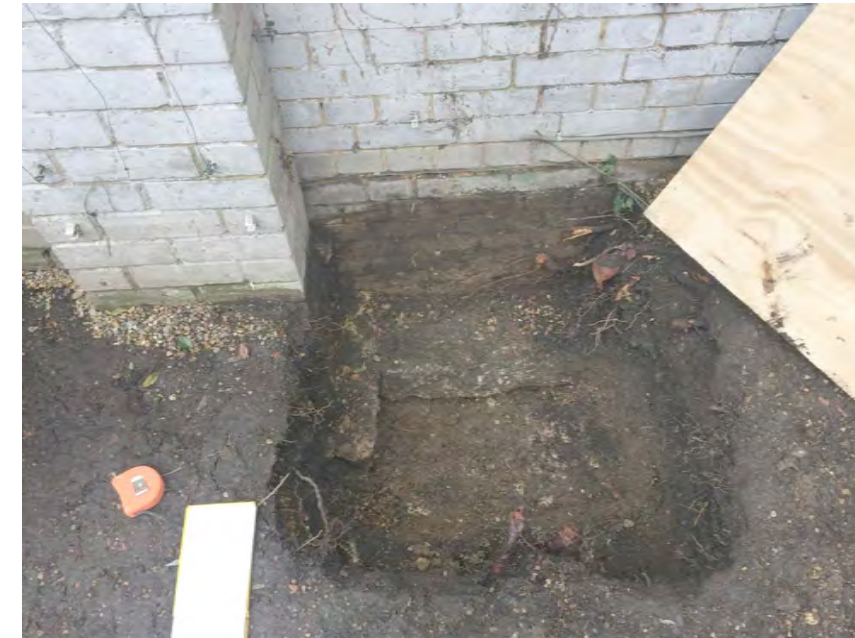
Location reference  
TP01  
Location plan on drawing number  
02  
Appendix  
D

A. Firm dark brown slightly gravelly silty sandy CLAY with frequent rootlets and roots up to 20mm in diameter. Gravel consists of flint, quartz and brick. (MADE GROUND)

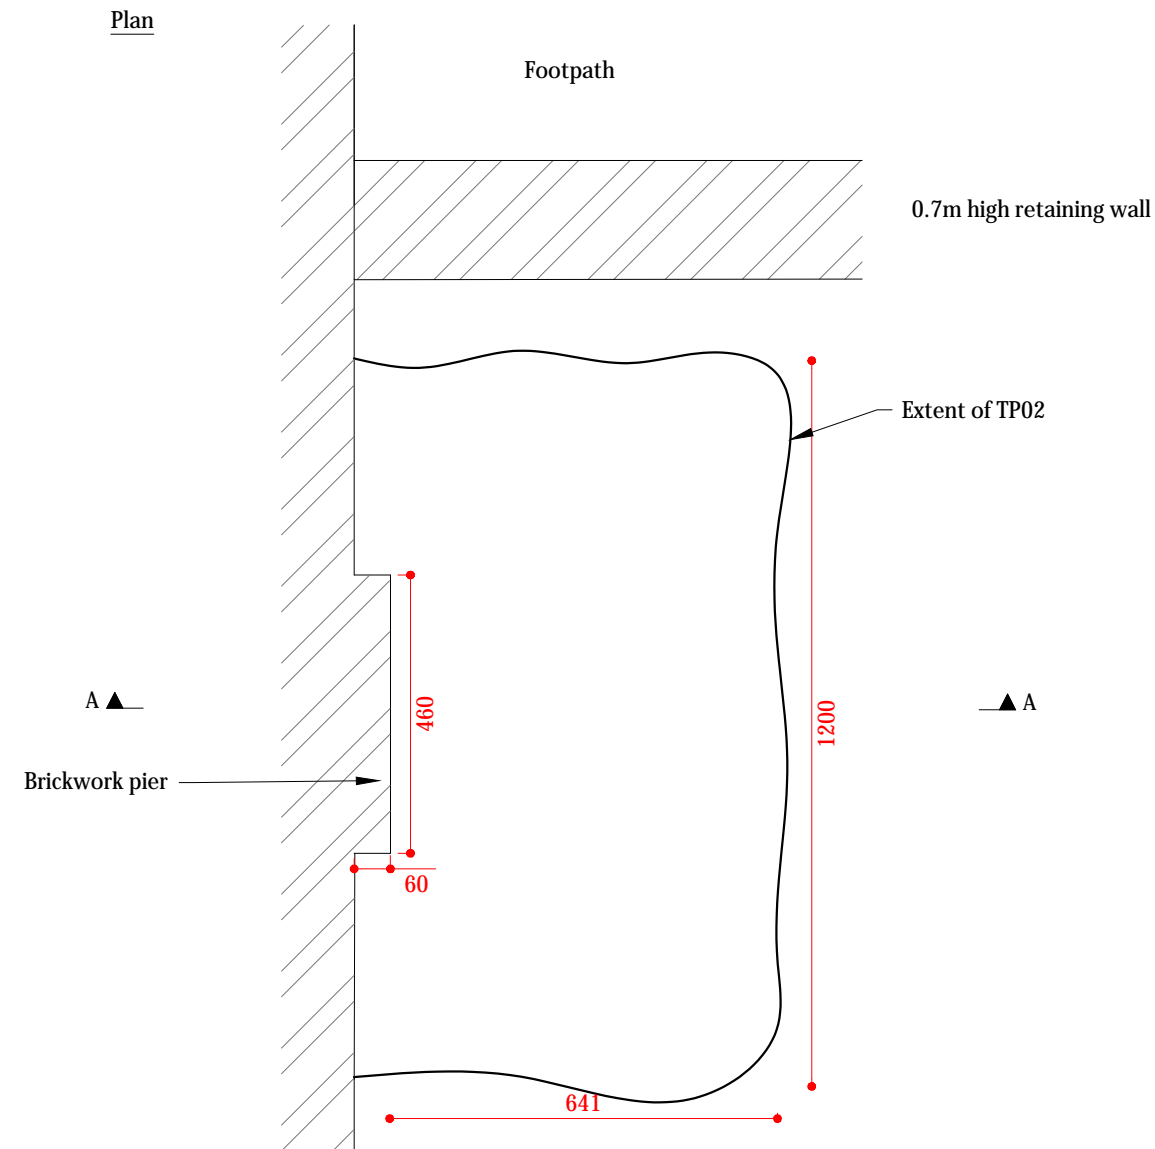
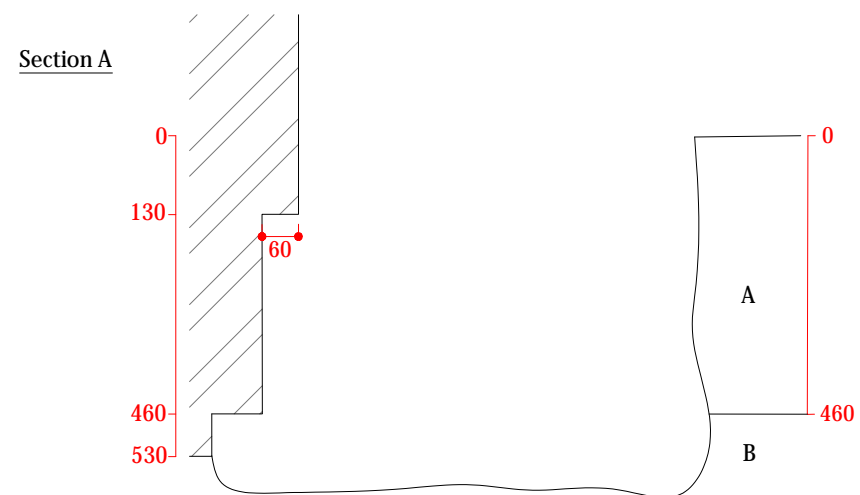
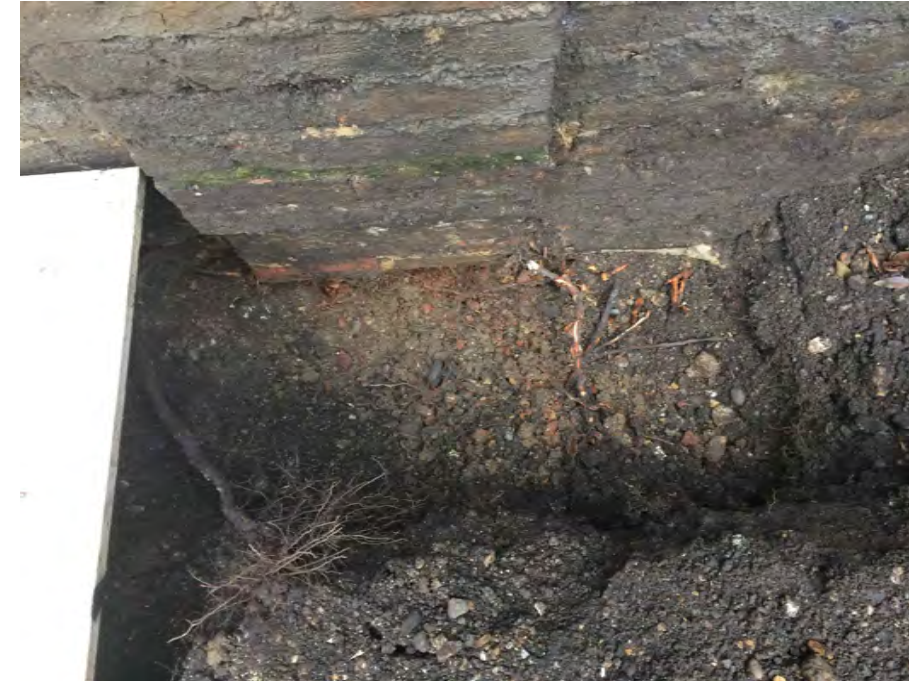
Location reference  
TP02  
Location plan on drawing number  
02  
Appendix  
D

A. Firm dark brown slightly gravelly silty sandy CLAY with frequent rootlets and roots up to 20mm in diameter. Gravel consists of flint, quartz and brick.  
(MADE GROUND)

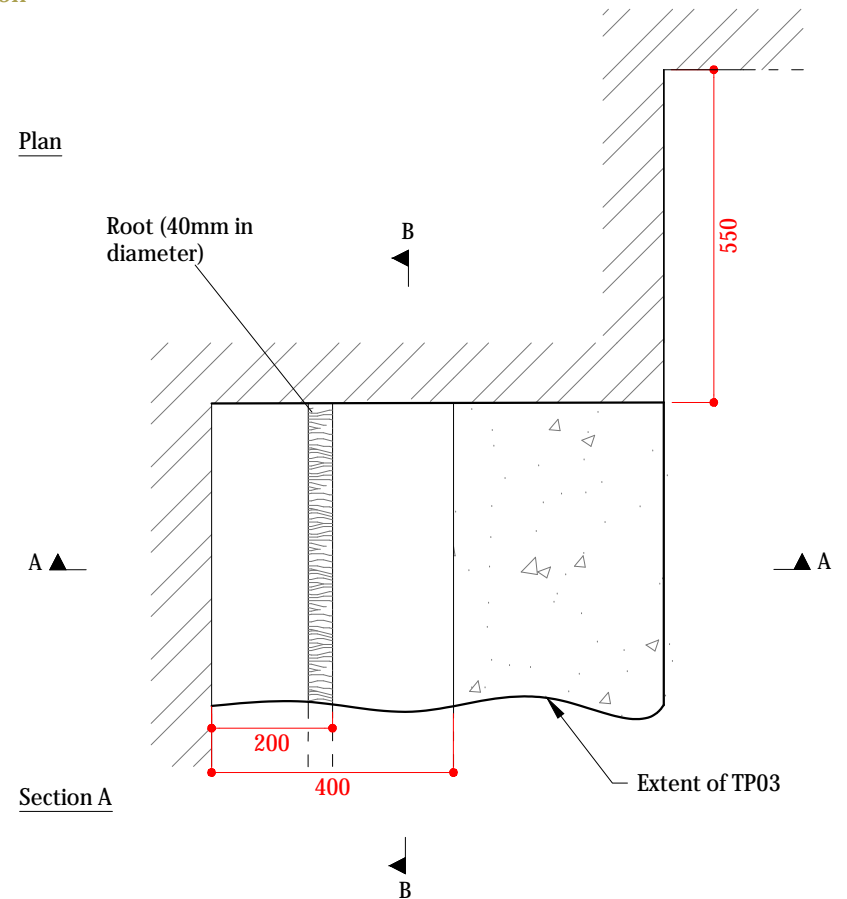
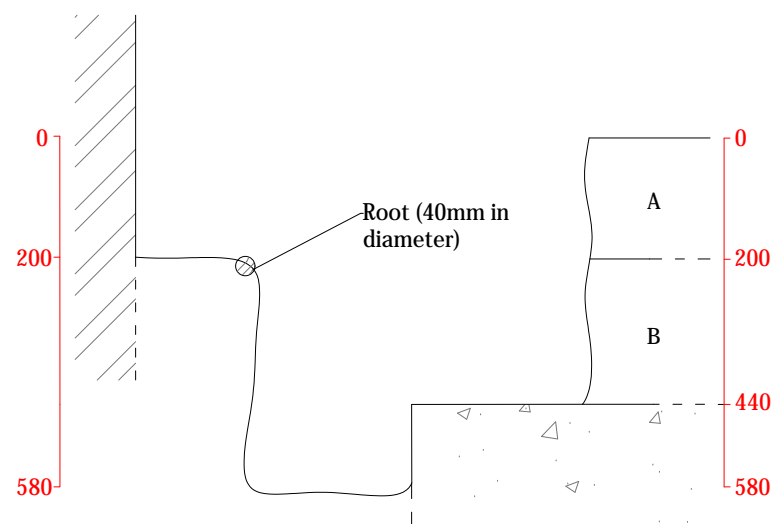
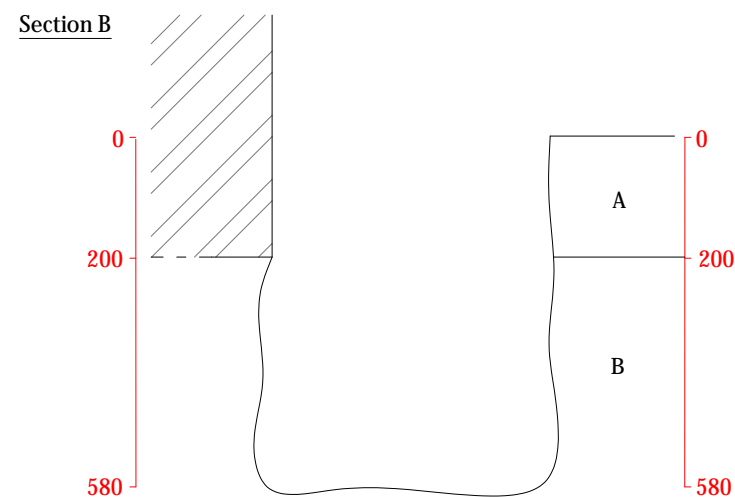
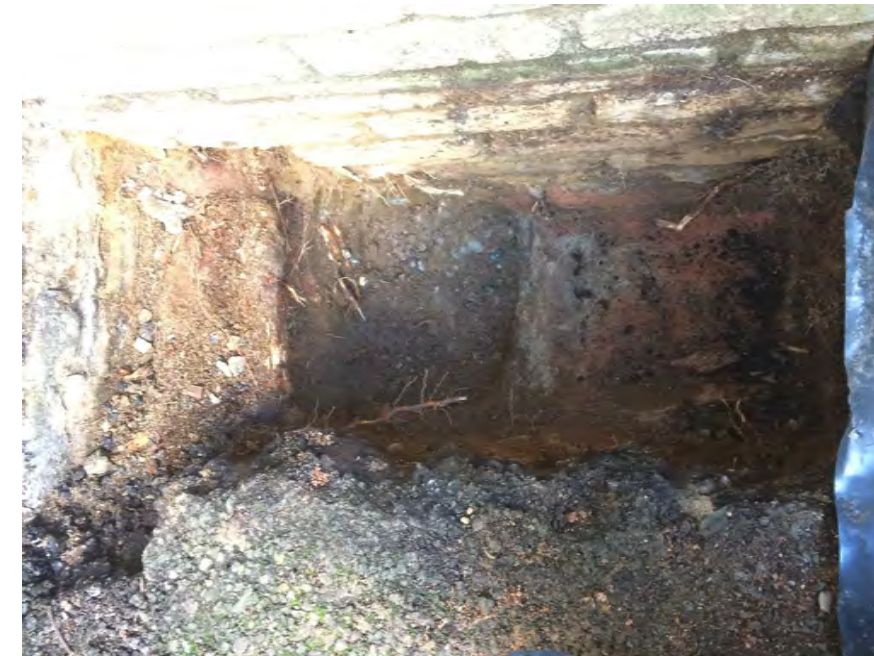
A. Bituminous bound material.  
(MADE GROUND)

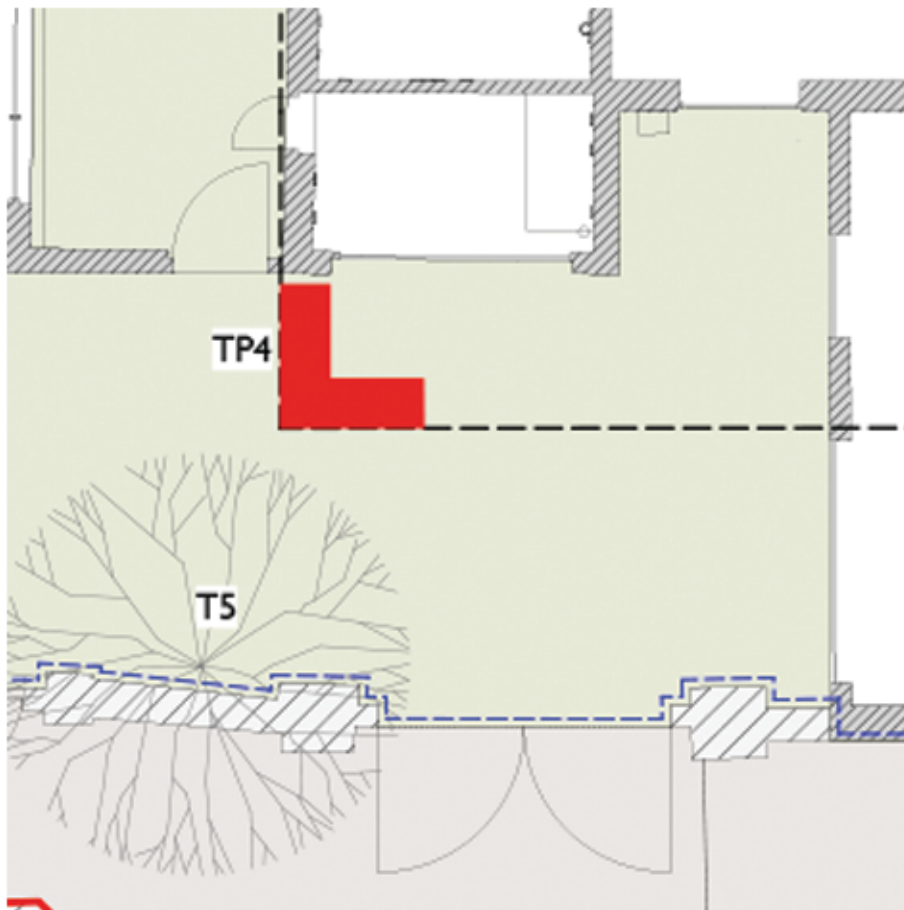
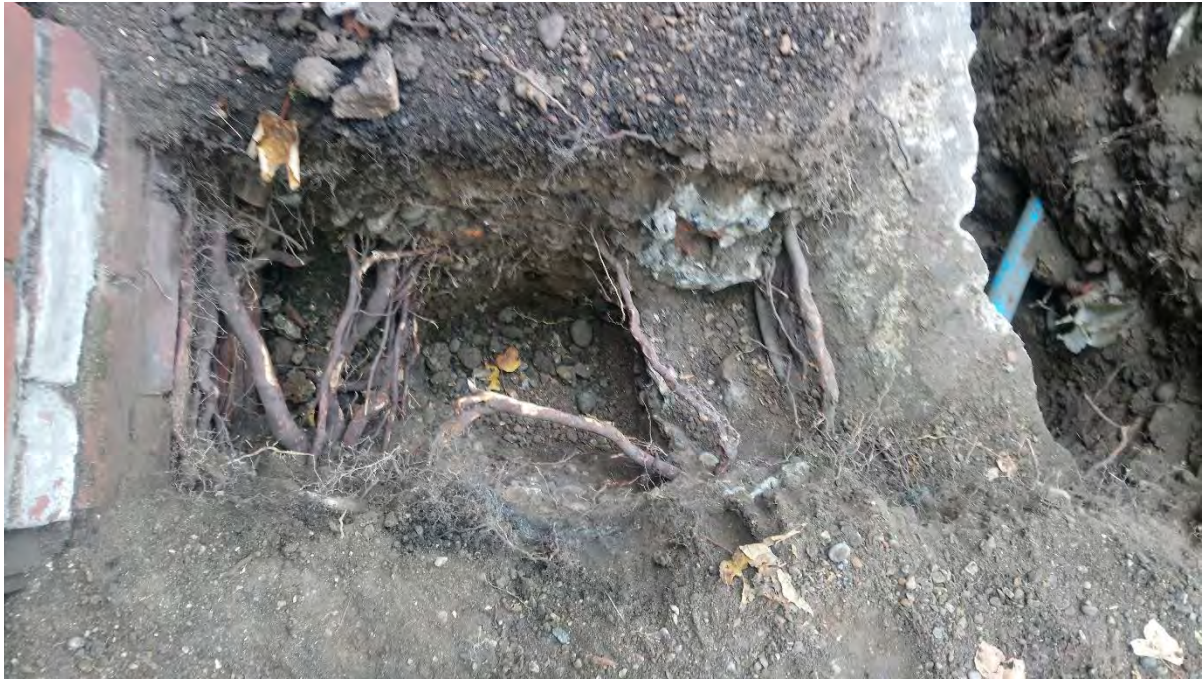
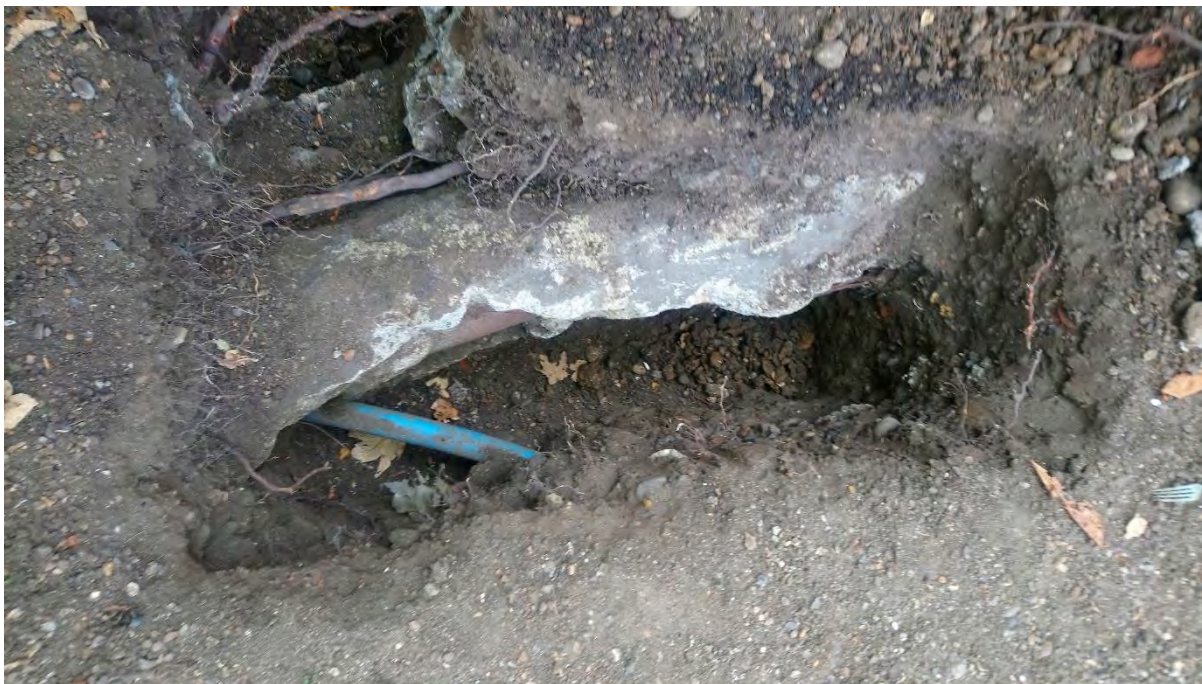
Trial pit 4

The trial pit was extended 100mm away from the building to get around a waste pipe.  
A total of 2 cover boards were left on site.

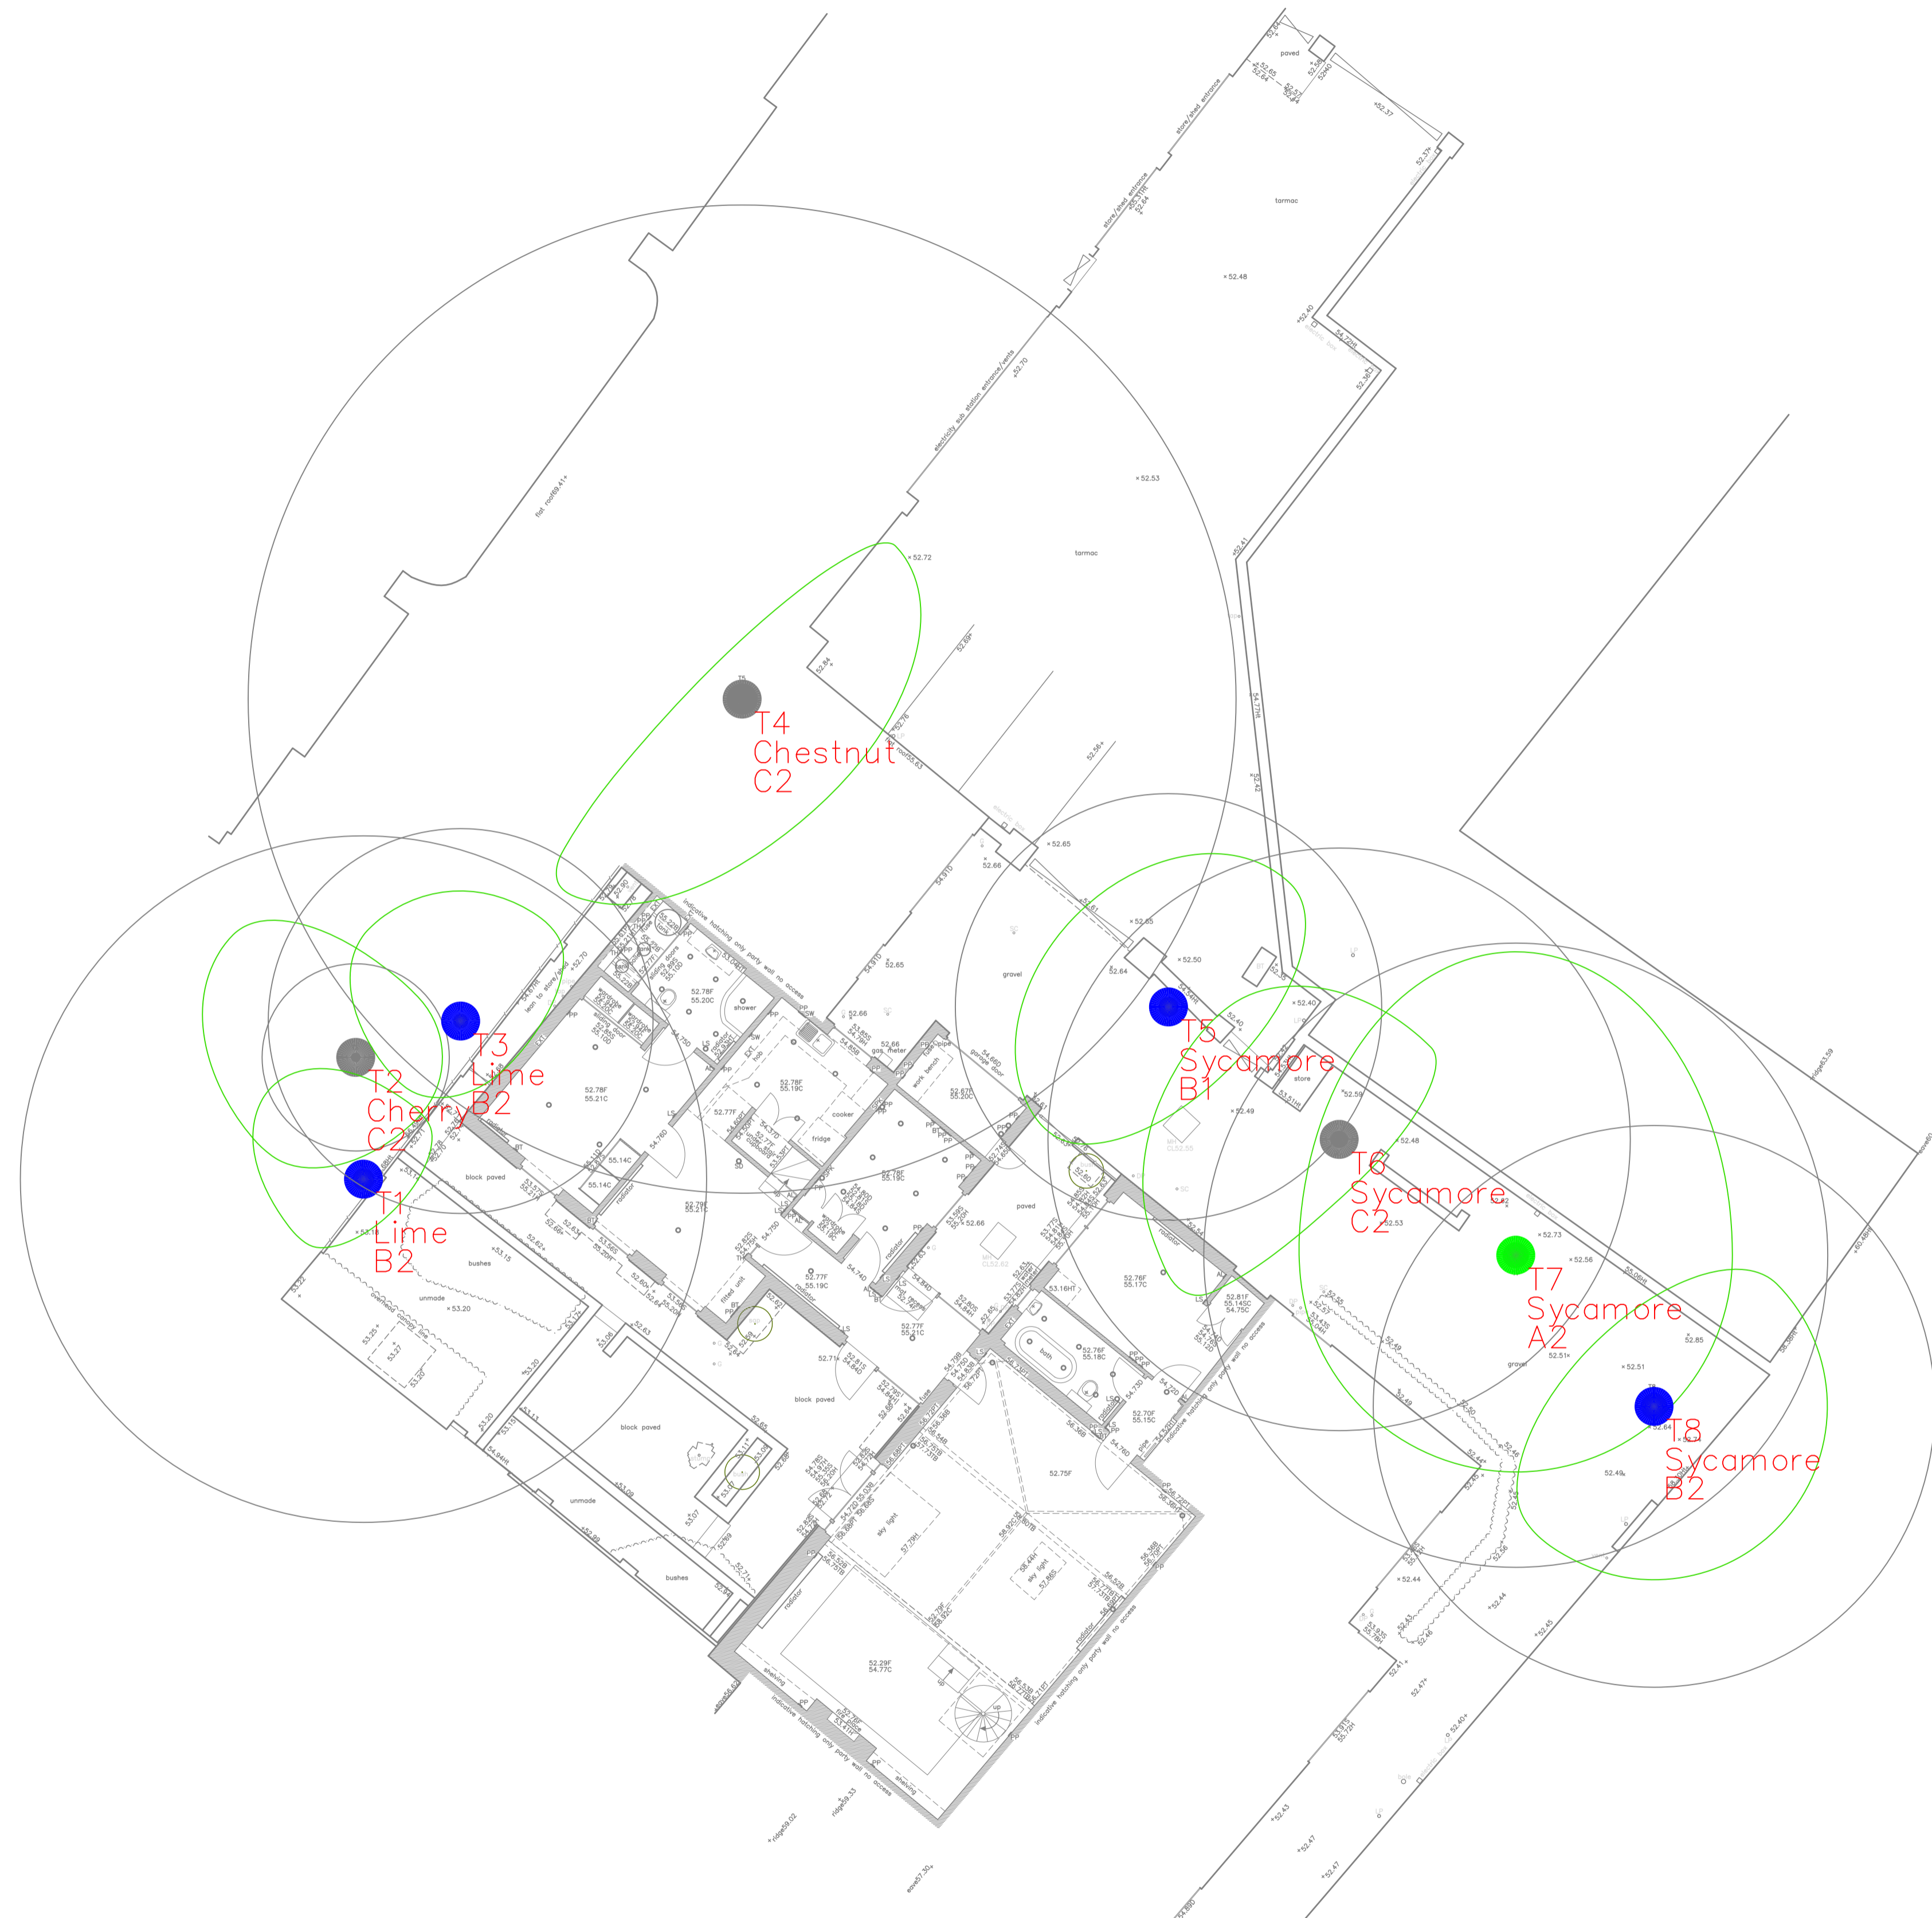
**PLAN 1**

- 3.1.2 The site is relatively level although there is a significant level change to the immediate west with trees T1 – 4 standing 2m above the ground level within the site, beyond a retaining wall.

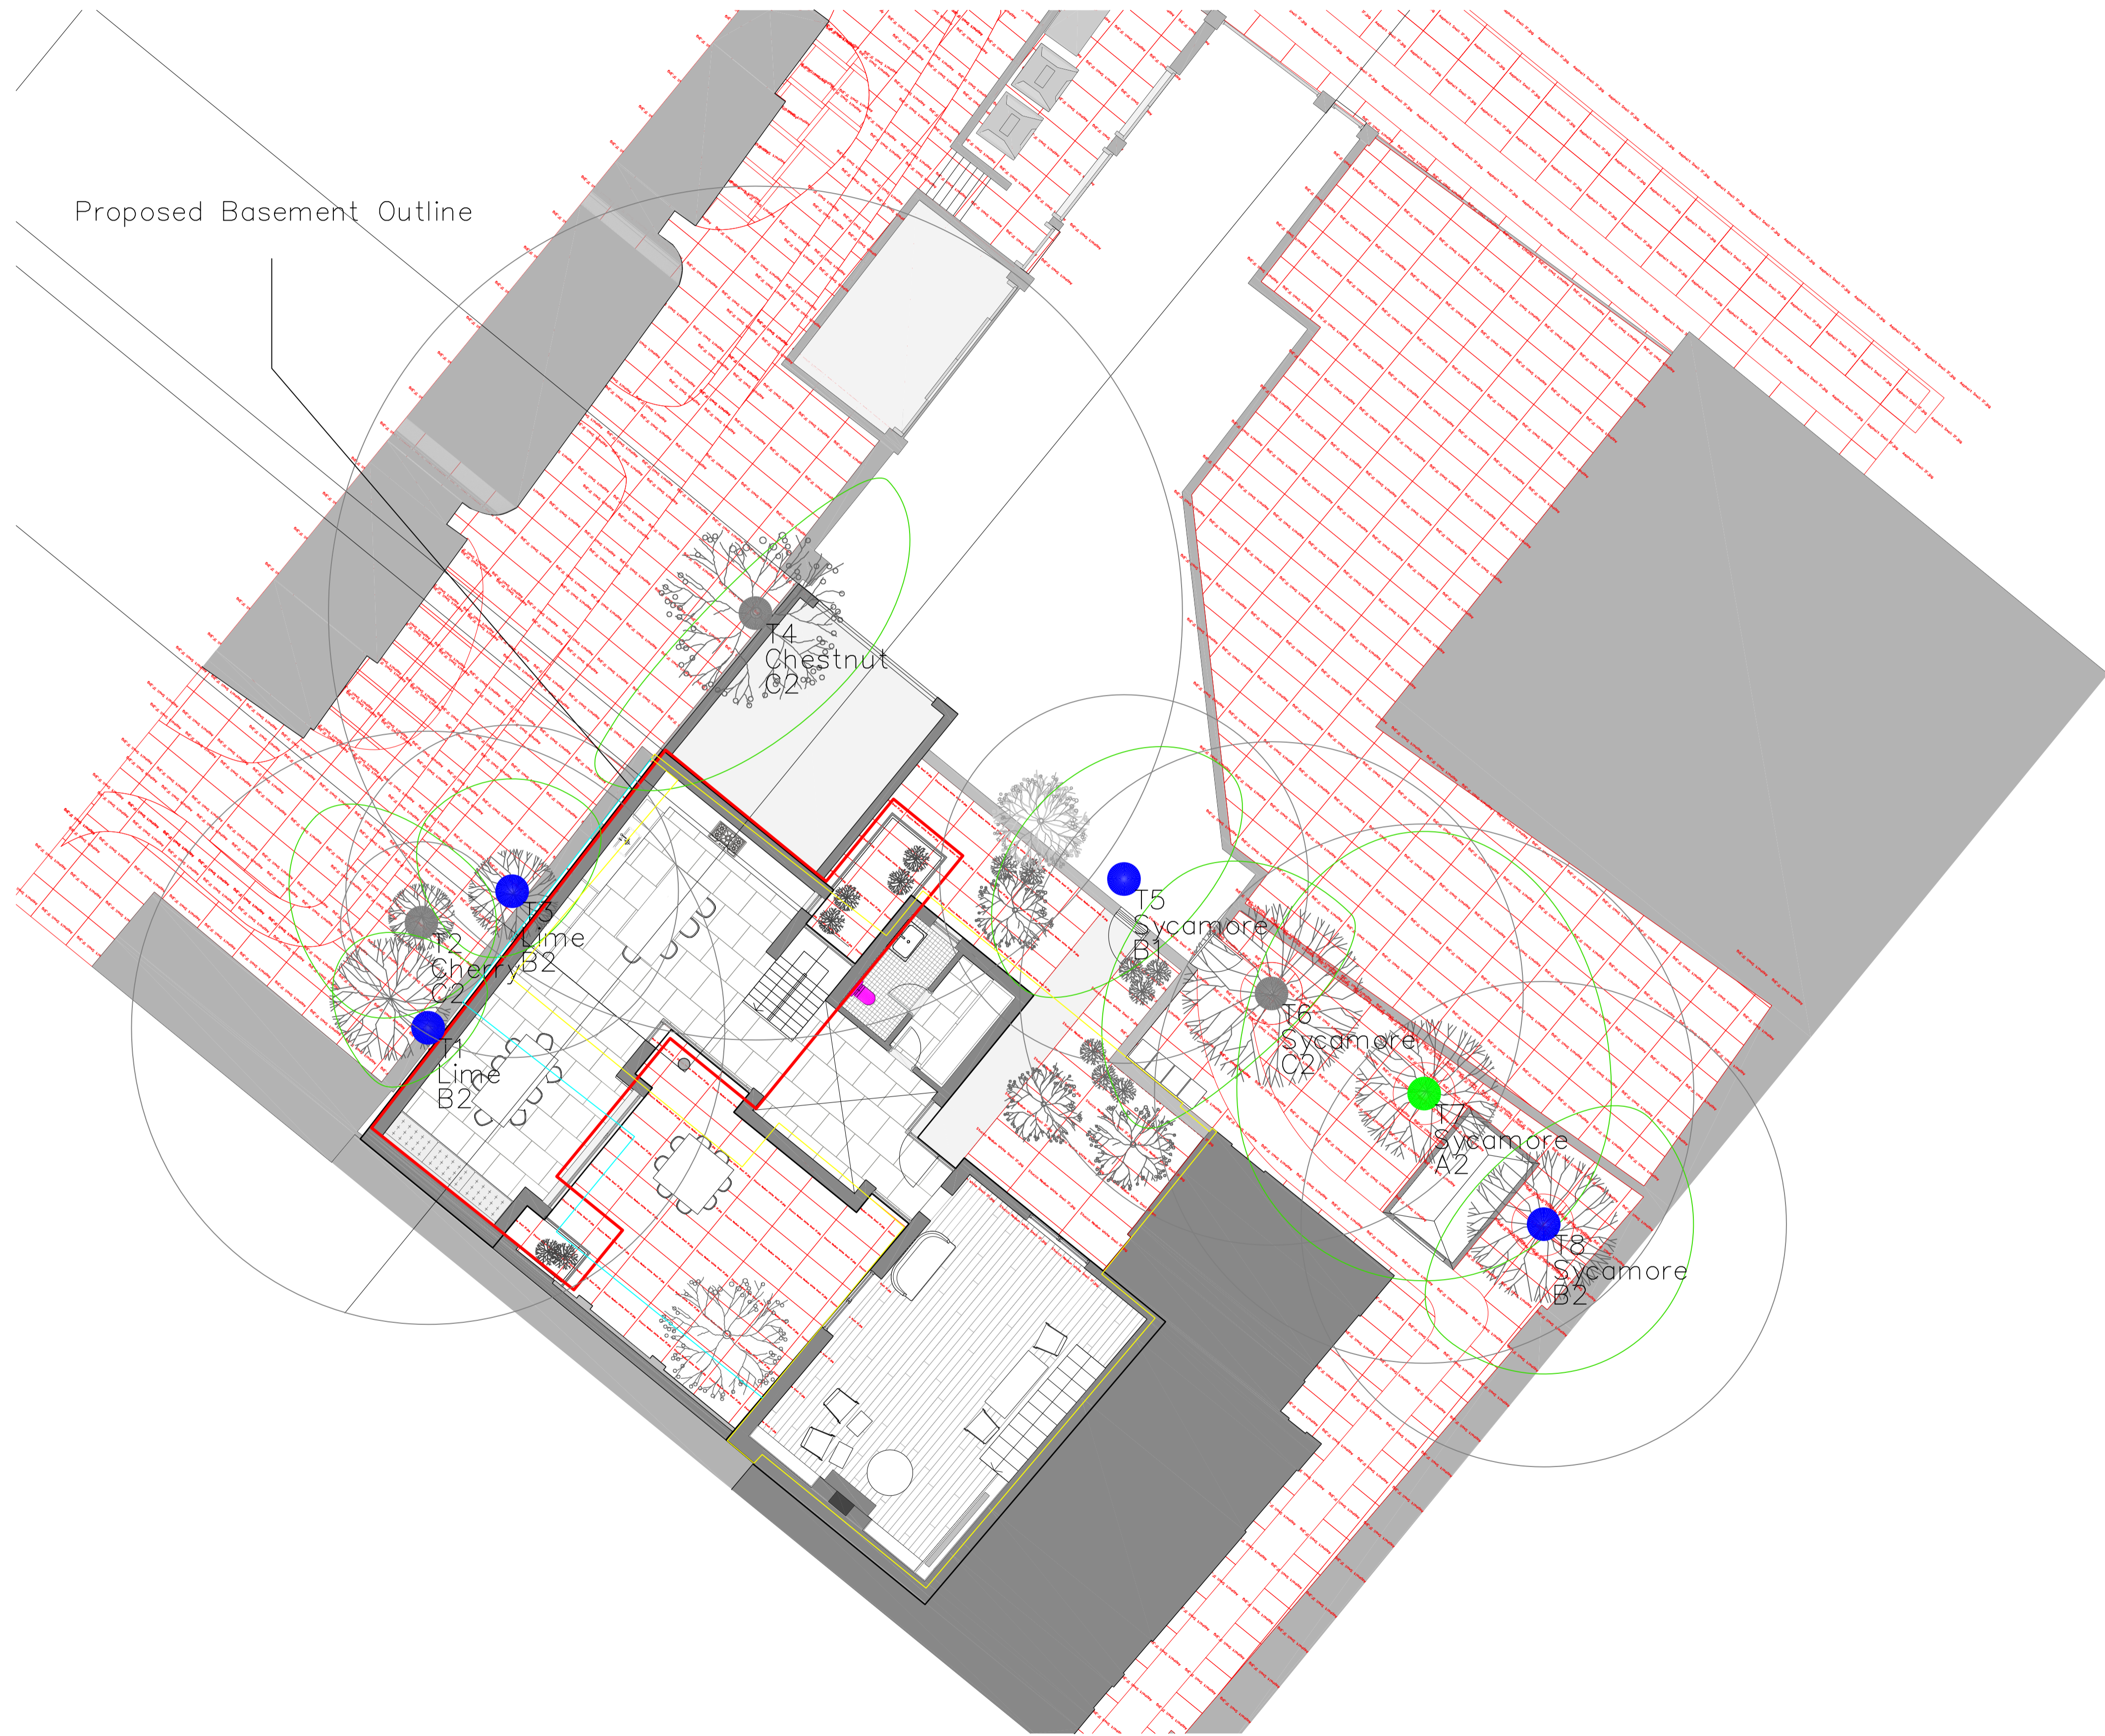
**PLAN 2**

<p>Trial pit evidence shows only minor impacts to T5 from basement level – manual excavation with pre-emptive root pruning and soil remediation proposed as mitigation.</p> <p>Remaining impacts theoretical only (confirmed by trial pit) but comprise the following:</p> <p>Increased footprint of proposed dwelling encroaches within RPA of T1 by 17%, T3 by 2.6% and T4 by 1.7%, assessed as being of low / very low impact – use of low-invasive foundations proposed as mitigation.</p> <p>Basement encroachment of theoretical RPA of T1, T3 &amp; T4 requires precautionary excavation of top 750mm with pre-emptive root pruning.</p>			
<b>Comments</b>			
Recommended works for 3 trees regardless of development, but also pertinent to maintaining a safe work site.			
<b>Recommendations</b>			
1	Proposal will mean the loss of important trees (TPO/CA)		N
2	Proposal has sufficient amelioration for tree loss		Y
3	Proposals provide adequate tree protection measures		Y

- 6.1.6 Whilst the canopies of T1, T3 and T4 do overhang the proposed footprint, there is currently 3.5m clearance to the existing ground floor structure. Whilst there is an increase in the height of the proposed building beneath the canopy of T4, this only amounts to approximately half a storey. Thus, provided due care is taken during the planning and carrying out of lifting operations during construction, no facilitation pruning is required.
- 6.1.7 It will be necessary to demolish the existing building in a controlled manner to avoid incidental damage to retained trees.
- 6.1.8 Any replacement hard surfacing within the RPAs of T4, T5 and T6 will require a no-dig construction methodology.

6.3.2 The building encroachments will require the use of specialised foundation techniques, such as mini-piling or pad and raised beam. The foundation pits within the RPA should be trial-excavated by hand using a double-headed spade (“shove-holer”) or similar to minimise breadth of hole required for inspection.

6.3.3 The path of basement foundations through RPAs will be manually excavated to 750mm depth under arboricultural supervision; any roots encountered within the trenches / pits will be cleanly pruned back to an appropriate junction with a sharp pruning saw or secateurs back to a junction. Roots larger than 25mm diameter may only be cut in consultation with an arboriculturalist.

6.3.4 The replacement paving/hard landscaping will require a no-dig construction technique, either using a cellular confinement system with no fines aggregate for the sub-base or simply building upon the existing sub-base without disturbing the ground below. The degree of encroachment (circa 20% of RPA) means that a permeable paving surface (e.g. gravel or block paving) is required. Choice of construction method will initially depend upon root penetration within the existing sub-grade. The key principle is not to excavate in the presence of roots and to provide a porous surface to promote healthy soil water relations for future root growth. A further consideration in the use of a more expensive cellular confinement system or similar, may be the claimed reduction in risk of possible future slab / surface displacement by roots of trees growing in paved areas.
