ARBORICULTURAL IMPACT ASSESSMENT REPORT FOR:

1 Steele's Studio
Haverstock Hill
London
NW3 4RN

Ref: JGA/1STS/AIA/01c

Date: 20th June 2019

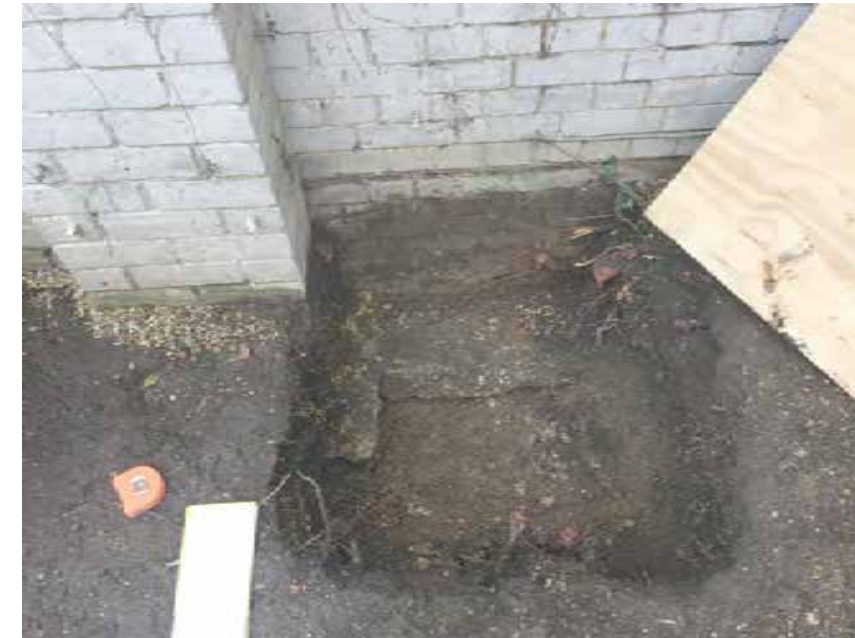
Location reference
TP01
Location plan on drawing number
02
Appendix
D

A. Firm dark brown slightly gravelly silty sandy CLAY with frequent rootlets and roots up to 20mm in diameter. Gravel consists of flint, quartz and brick. (MADE GROUND)

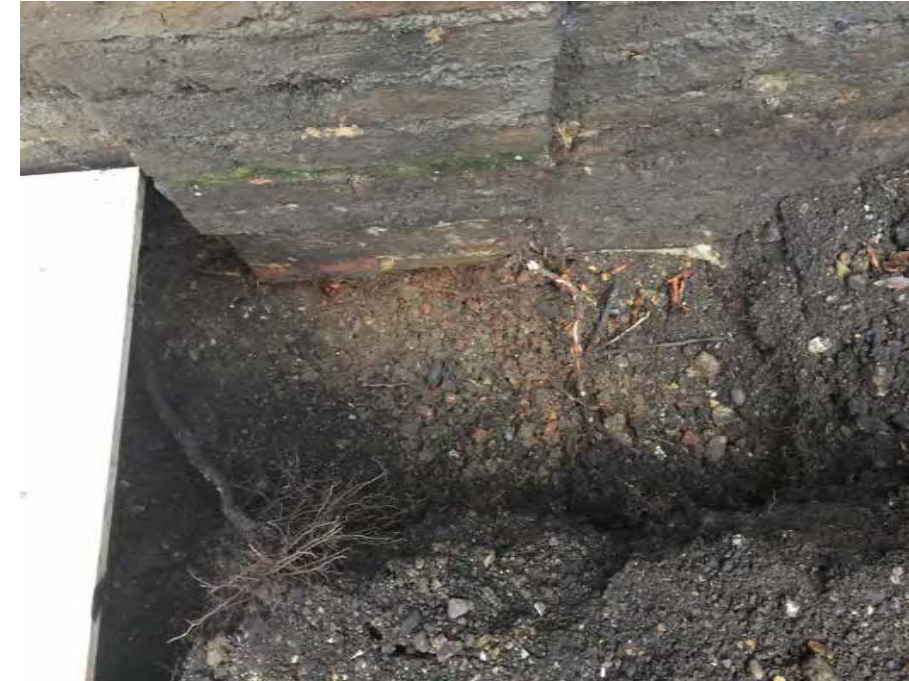
Location reference
TP02
Location plan on drawing number
02
Appendix
D

A. Firm dark brown slightly gravelly silty sandy CLAY with frequent rootlets and roots up to 20mm in diameter. Gravel consists of flint, quartz and brick.
(MADE GROUND)

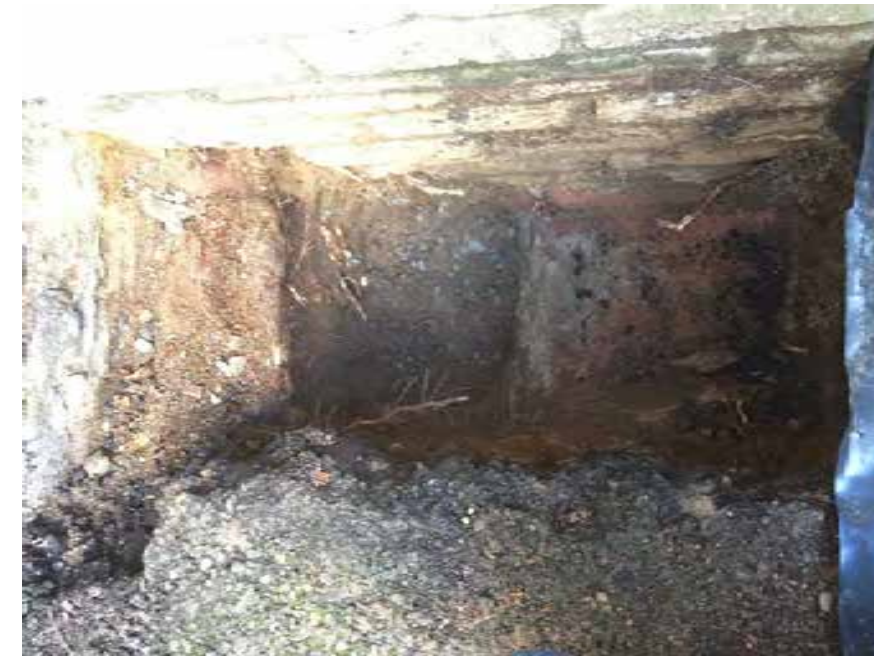
A. Bituminous bound material.
(MADE GROUND)

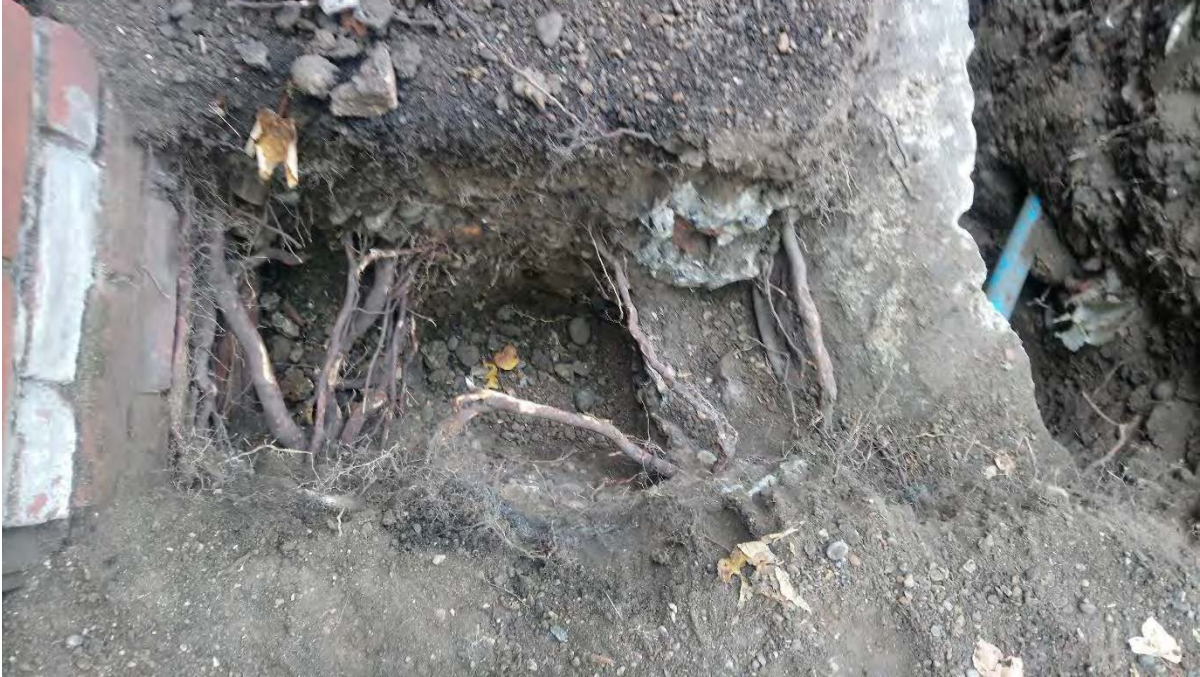
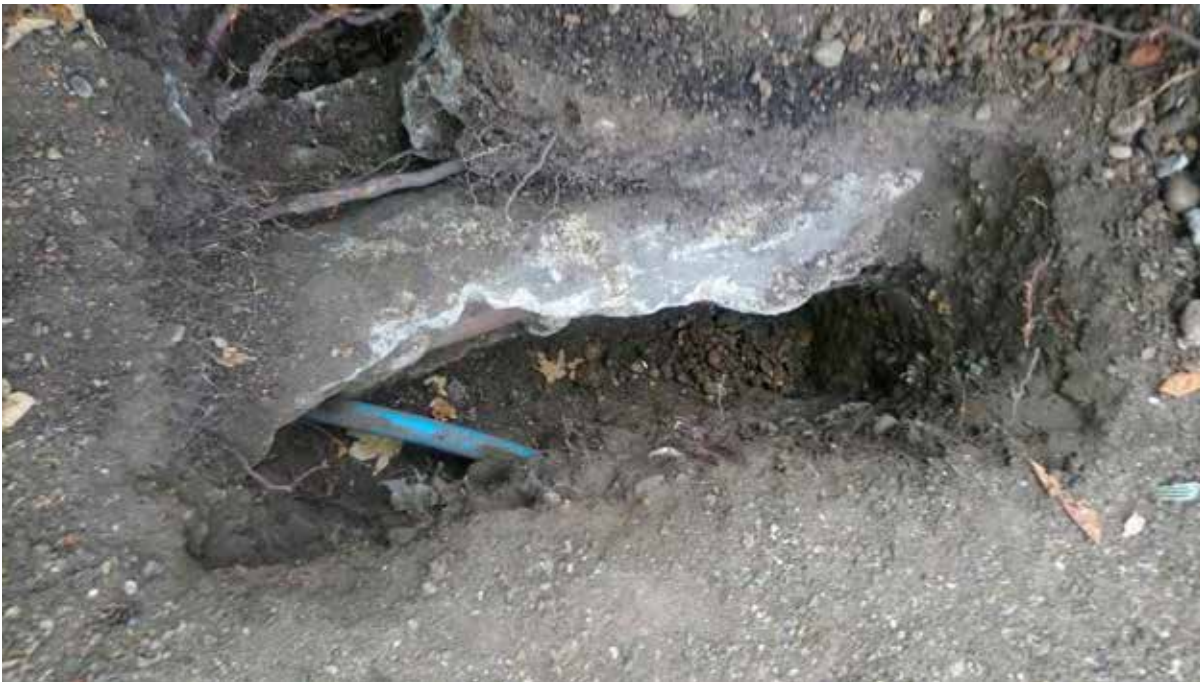
Trial pit 4

The trial pit was extended 100mm away from the building to get around a waste pipe.
A total of 2 cover boards were left on site.

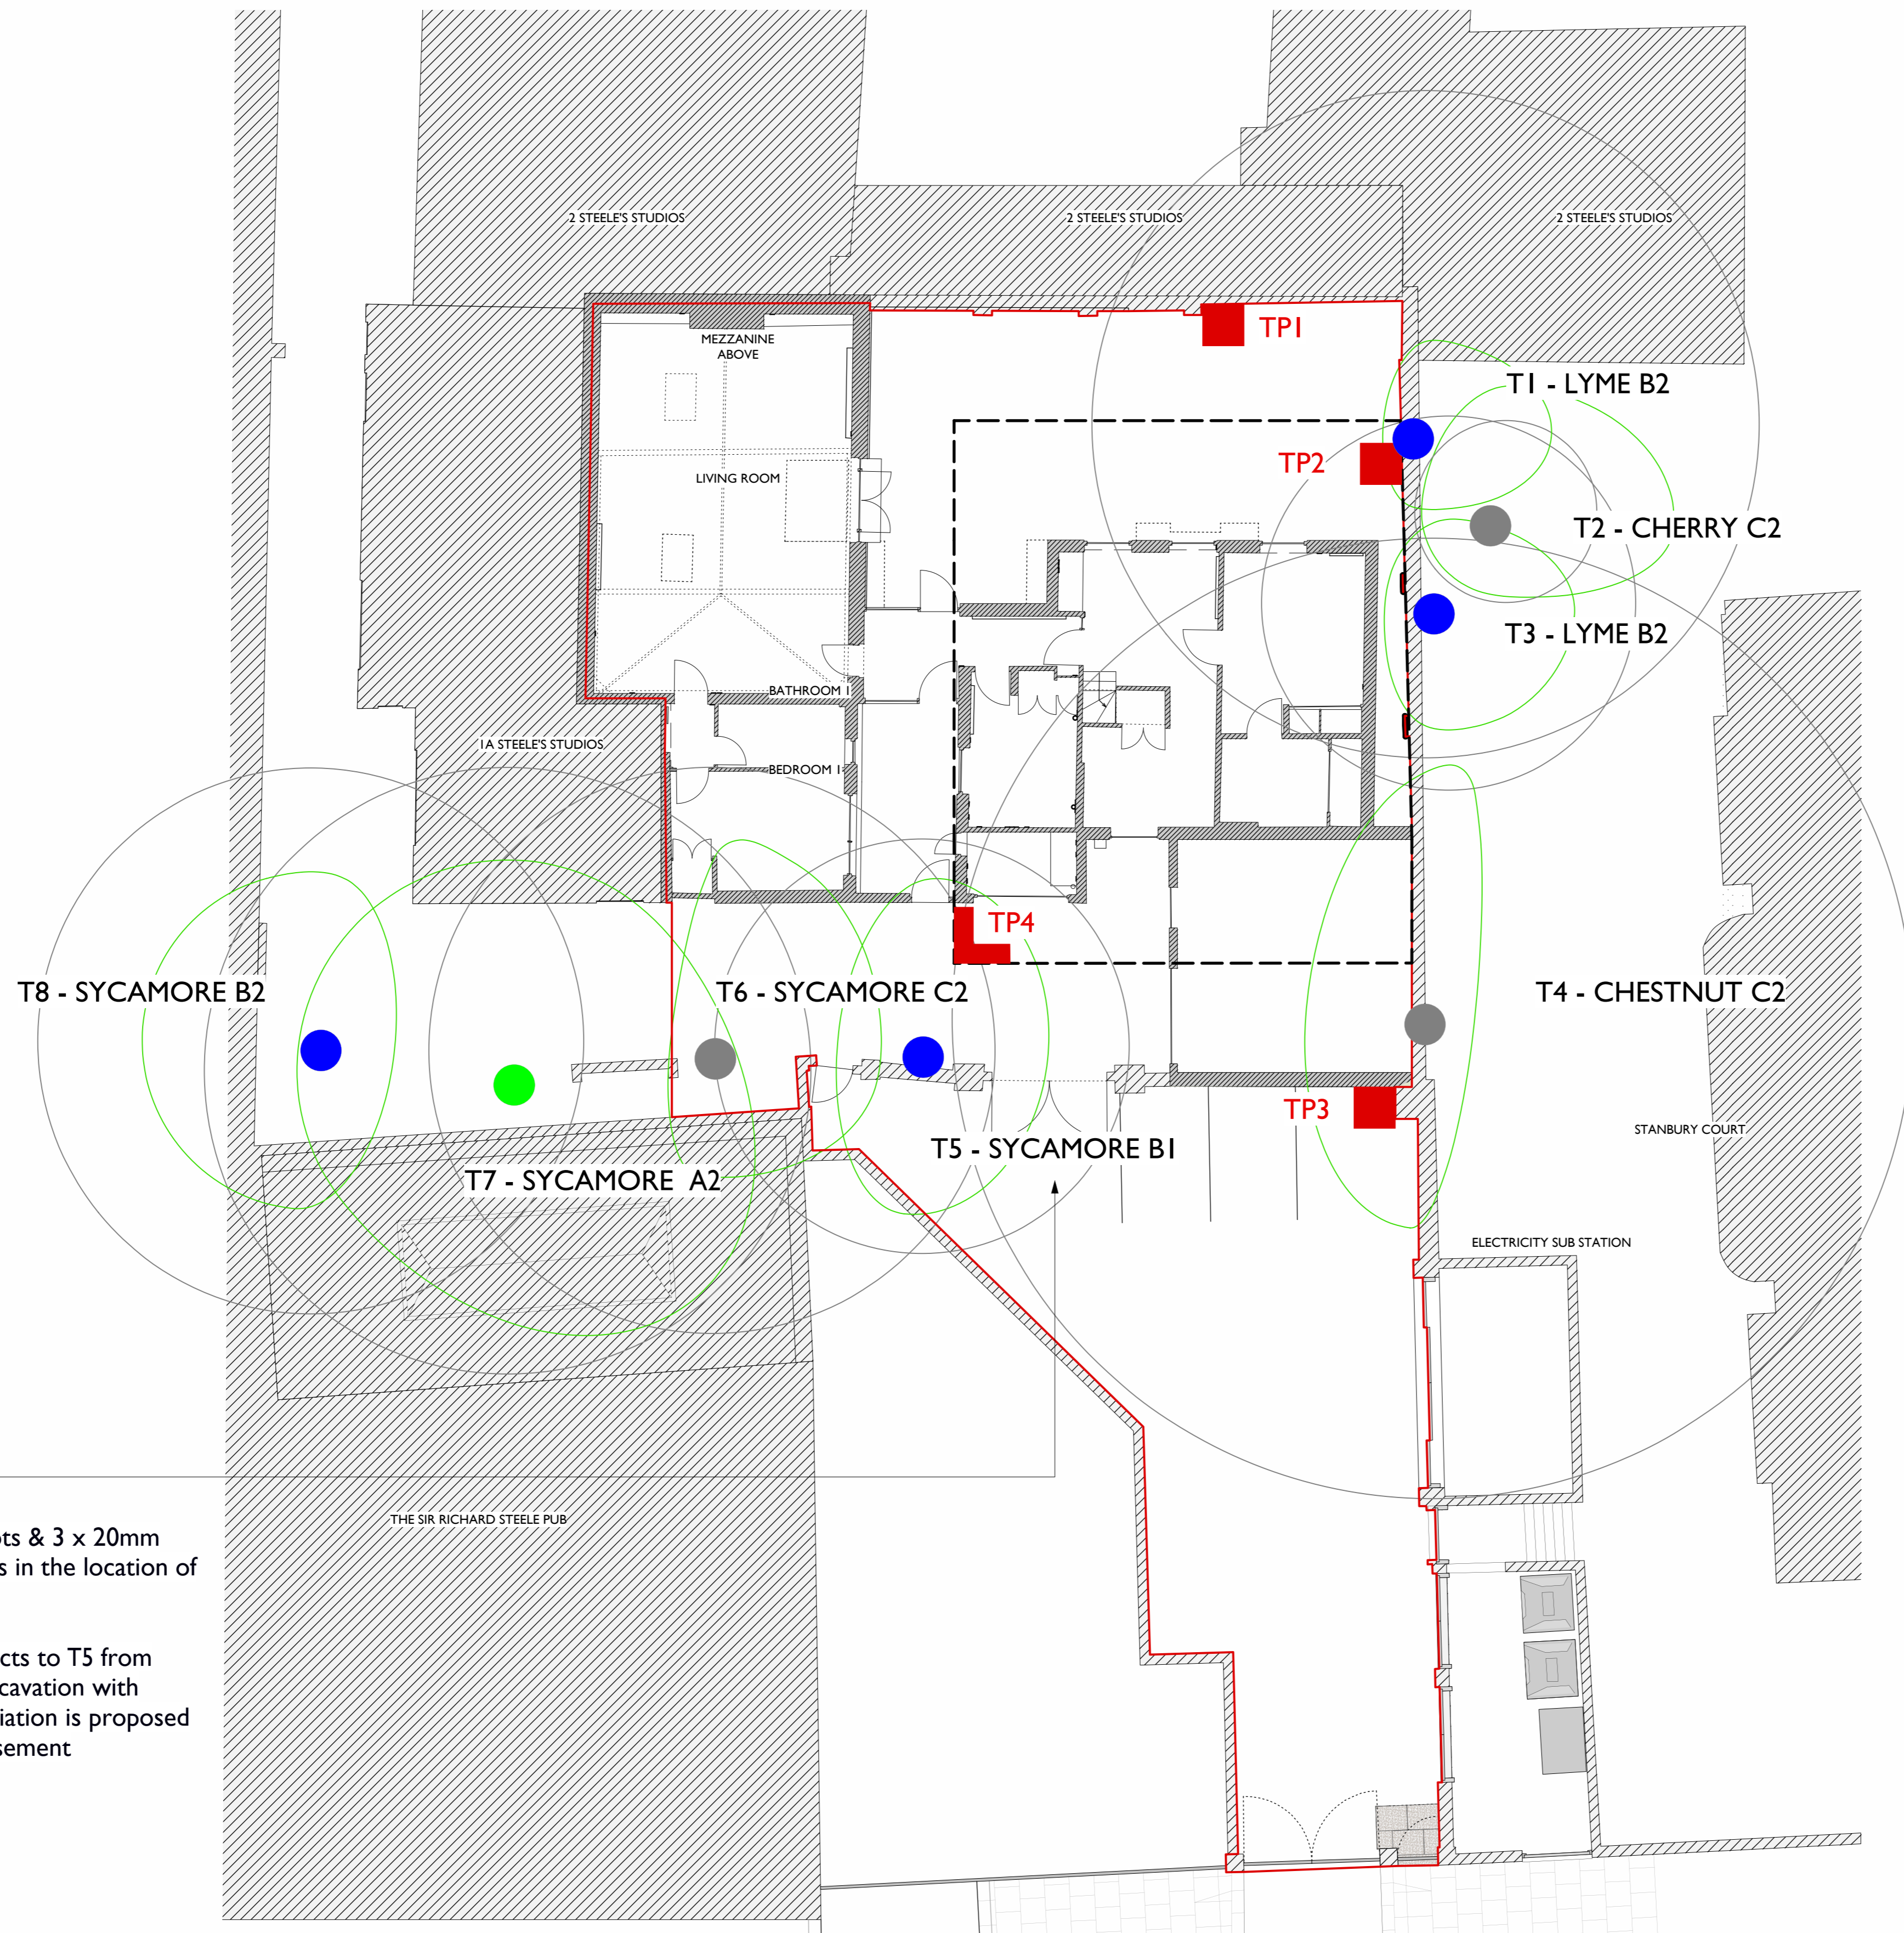
IMPACT ON T5 - SYCAMORE (B1)

TP4 investigation revealed 3 x 30mm roots & 3 x 20mm roots and a small amount of fibrous roots in the location of TP4

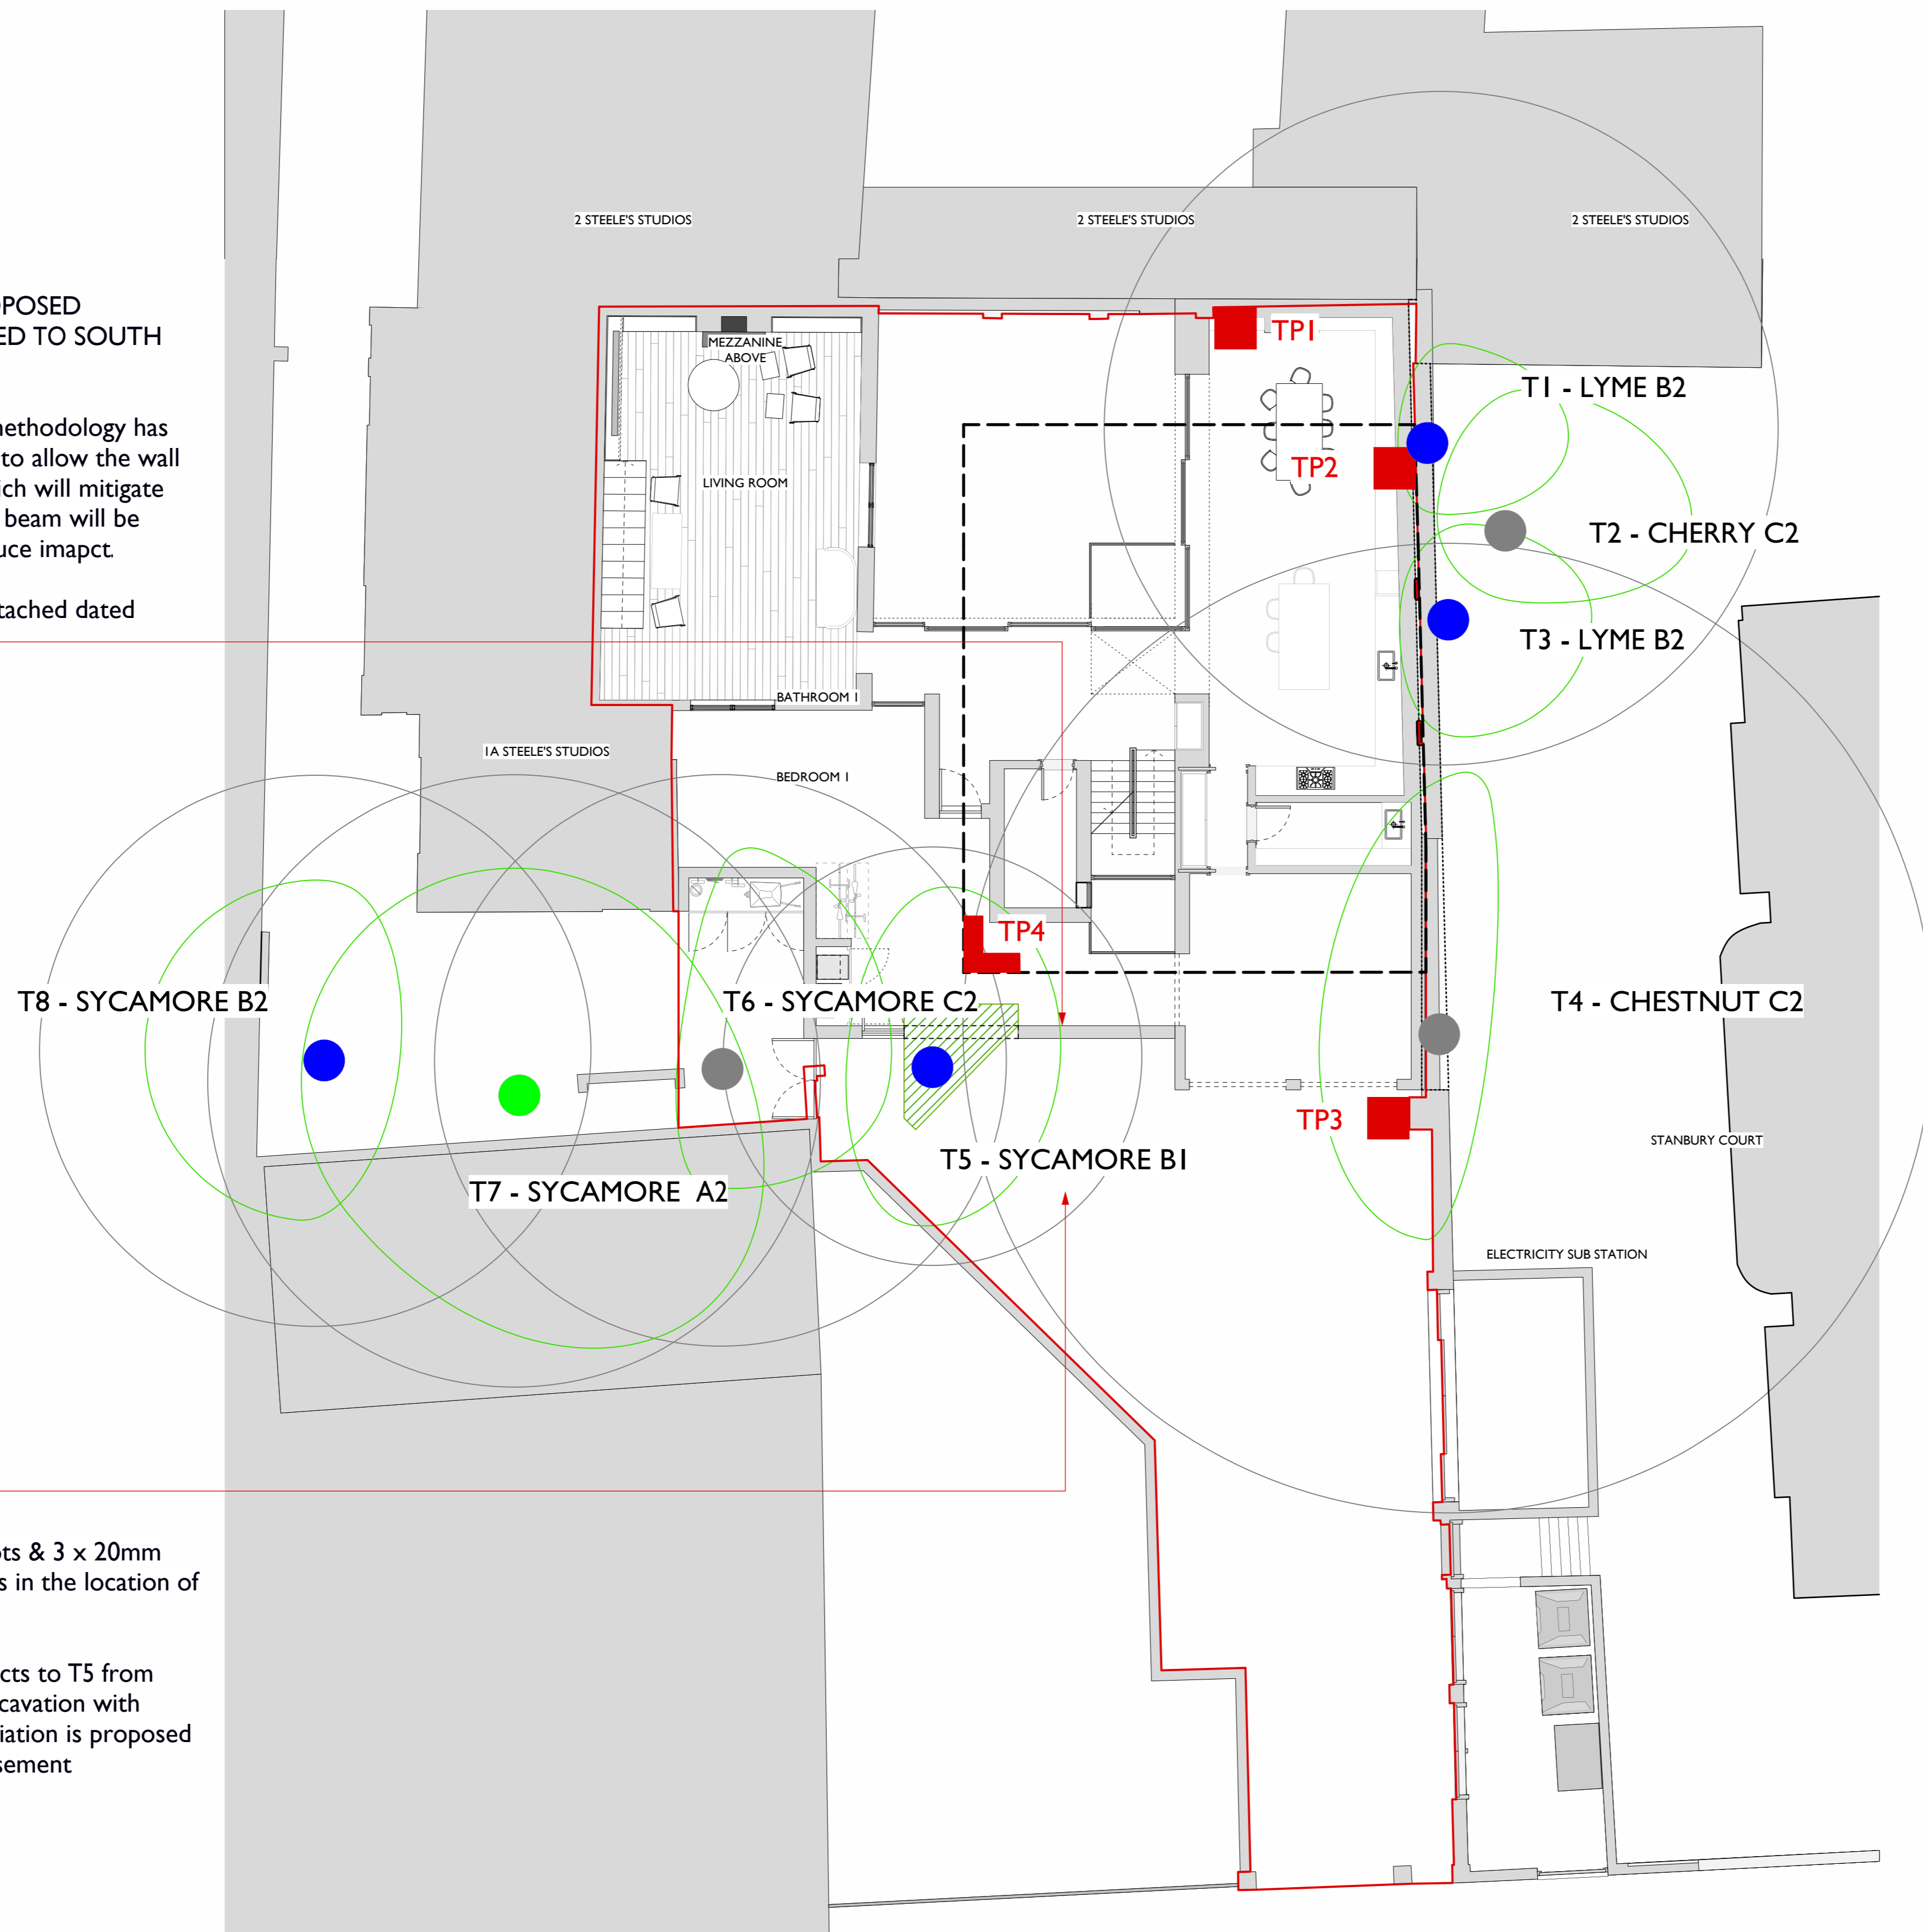
TP4 investigation revealed 3 x 30mm roots & 3 x 20mm roots and a small amount of fibrous roots in the location of TP4

Trial pit evidence shows only minor impacts to T5 from basement level construction – manual excavation with pre-emptive root pruning and soil remediation is proposed as mitigation to the installation of the basement construction in this area.
