## HERITAGE STATEMENT

### 64 Delancy Street

Camden NW1 7RY

February 2019

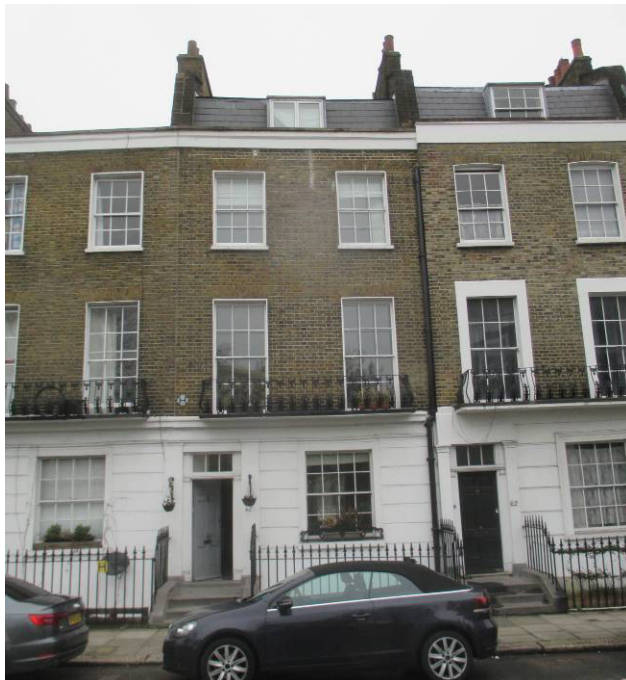
Front view

The current building has been recently refurbished, with a new roof, basement flat, and general refurbishment to all rooms.

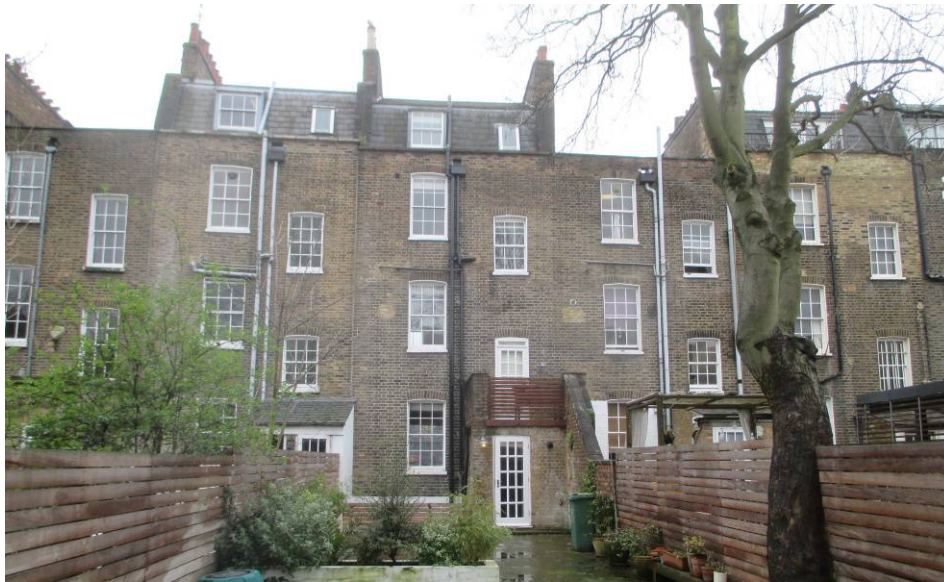
Rear view

A first floor rear terrace has been added. Brickwork needs some repointing and repair, the rear flat roof needs replacing and the render needs some repair and repainting.

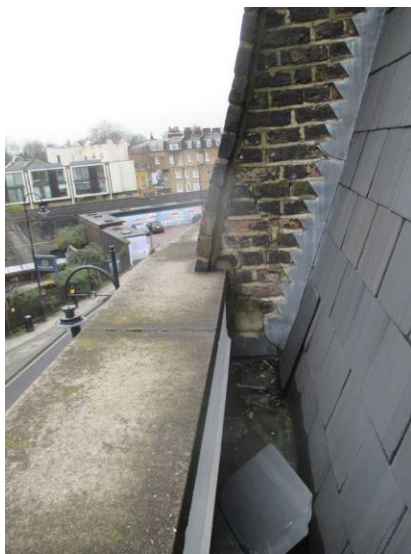
mansard roof front

generally in good condition as it appears to have been completely replaced in the refurbishment.

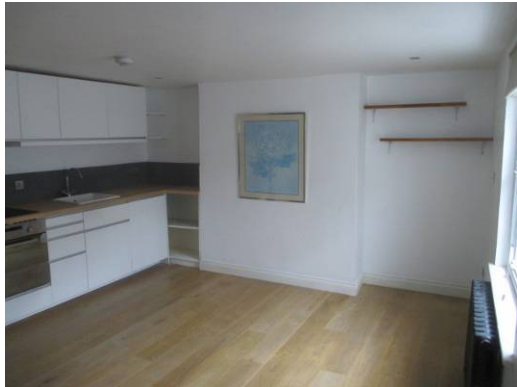
Basement kitchen

The basement has no retained features. The recent refurbishment included new kitchen and bathroom, with door to rear area. The steps from the rear area have been covered over with decking.

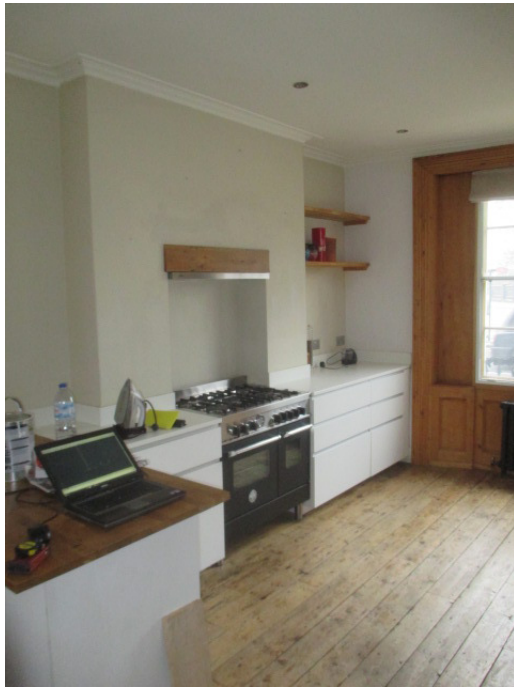
Kitchen/dining

The first floor has been stripped of the fireplaces with new radiators. Original ceiling roses and cornices have been removed with new cornices. Modern downlights have been installed. A new kitchen and joinery has been installed. The windows have modern secondary glazing. Windows and doors have been stripped of paint.

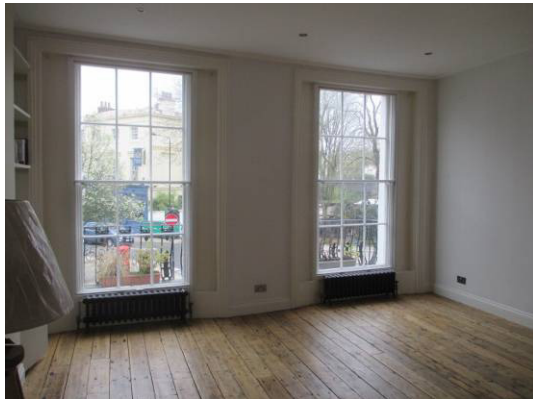
First floor

The first floor has been stripped of the fireplaces with new radiators. Original ceiling roses and cornices have been removed with new cornices. Modern downlights have been installed. The front and rear rooms have been opened up. The windows have modern secondary glazing.
