Arboricultural Impact Assessment BS5837:2012

16 Lyndhurst Gardens, London, NW3 5NR

Apex Environmental Ltd

Ref: AEL-18129-AIA

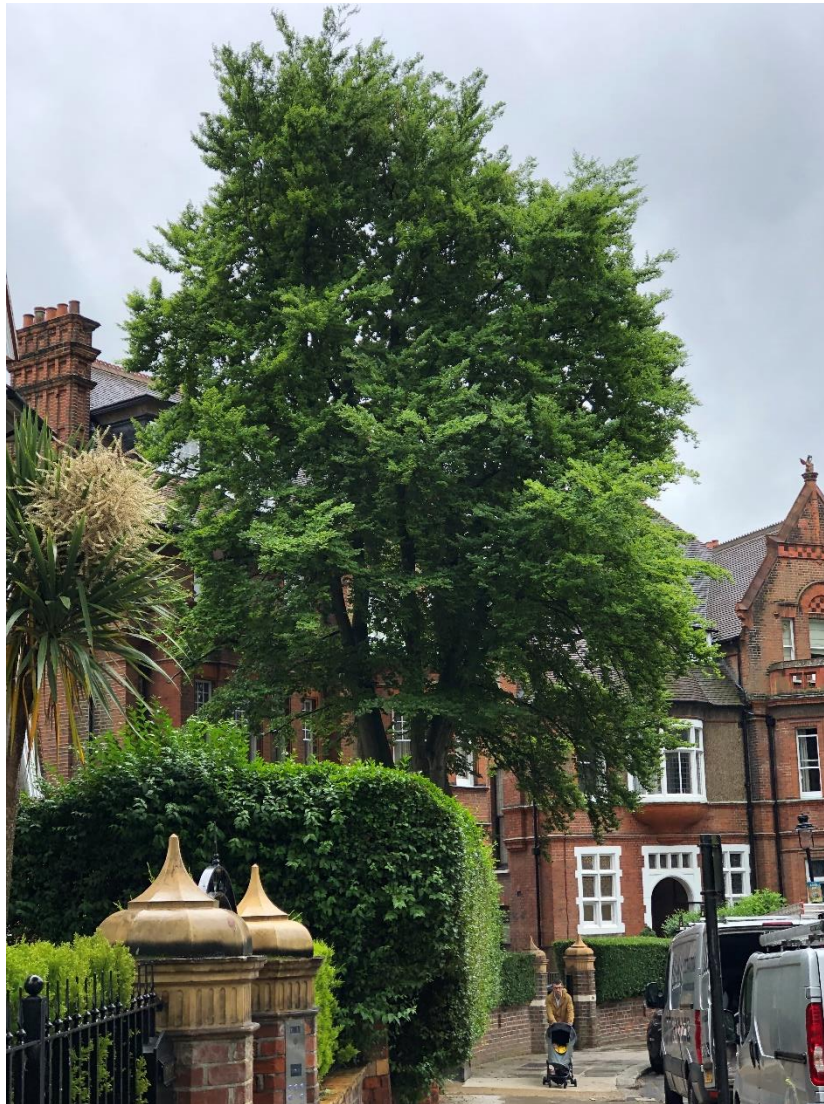
8.8 T.1 – Beech – This is a large mature tree in the front garden of 16. The tree is in good overall condition. The tree is growing within a raised planter which is showing signs of cracking. There are also some cracks to the front boundary wall in the same area. It is possible that this is due to pressure from tree roots. The nearby land is of hardstanding and there are some signs of cracking to the steps, which again could be from tree root damage (although no paving was lifted), and the hardstanding looked to be established and it was seen that the tree had limited sources to moisture. The tree was free from fungus or defects in the lower stem. The tree looks to have been historically pollard at 4m. This has then been allowed to continue to grow to full height maturity. The tree has created a large dense canopy and there are signs of historical works to prune back the canopy (a separate search with London Borough of Camden, confirmed approval for the pruning, back, thinning and crown lifting of this tree). This operation should be carried out again as the canopy is significantly shading the property (although this is not part of this application). This tree has been assessed as [Category B1](#)

AEL-18129-PIC1 – Showing T.1 in front garden

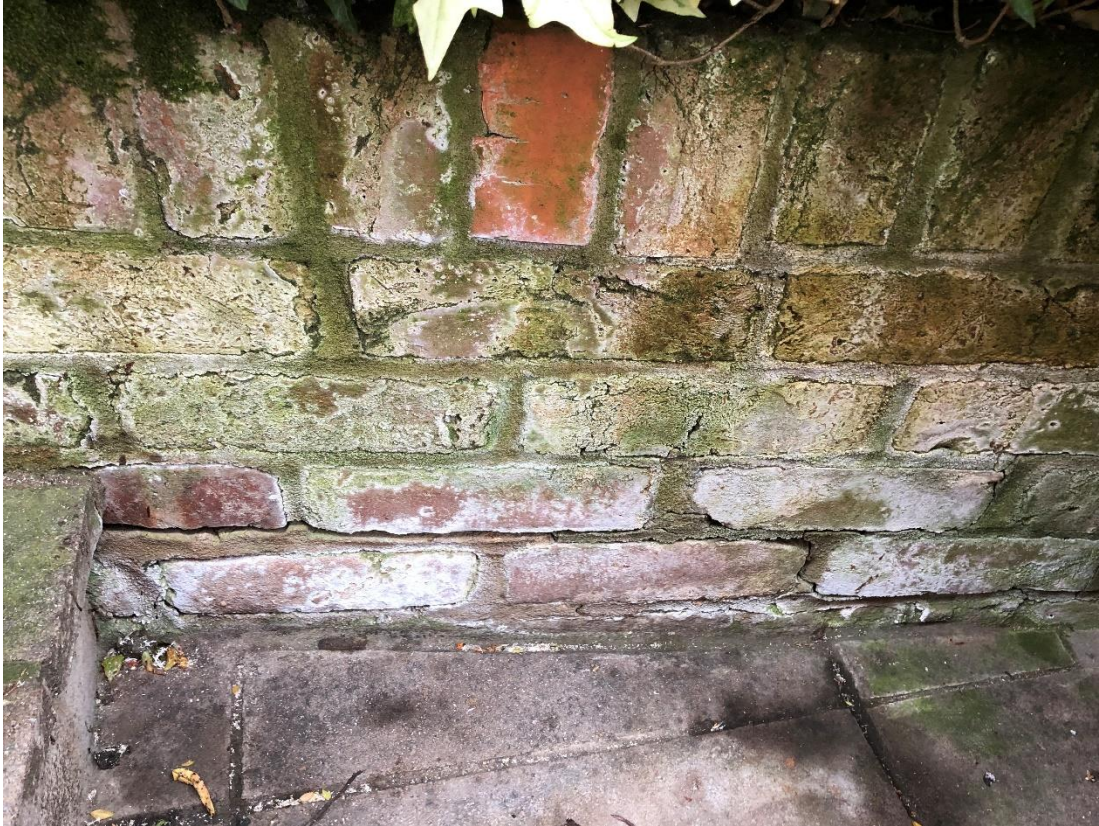
AEL-18129-PIC2 – Showing small crack in wall close to T.1

The brickwork is to be removed and replaced to remove any cracks to the concrete. The area will also change the small area close to the entrance gate, this will be 0.14m² of a total open area of 6m². This would normally be considered as minimal and of little importance. However, given the site and the confined planting area this could have some impact. It will be necessary to include a full Arboricultural Method Statement to detail the size of roots which can be removed, and how to progress if larger roots are found.

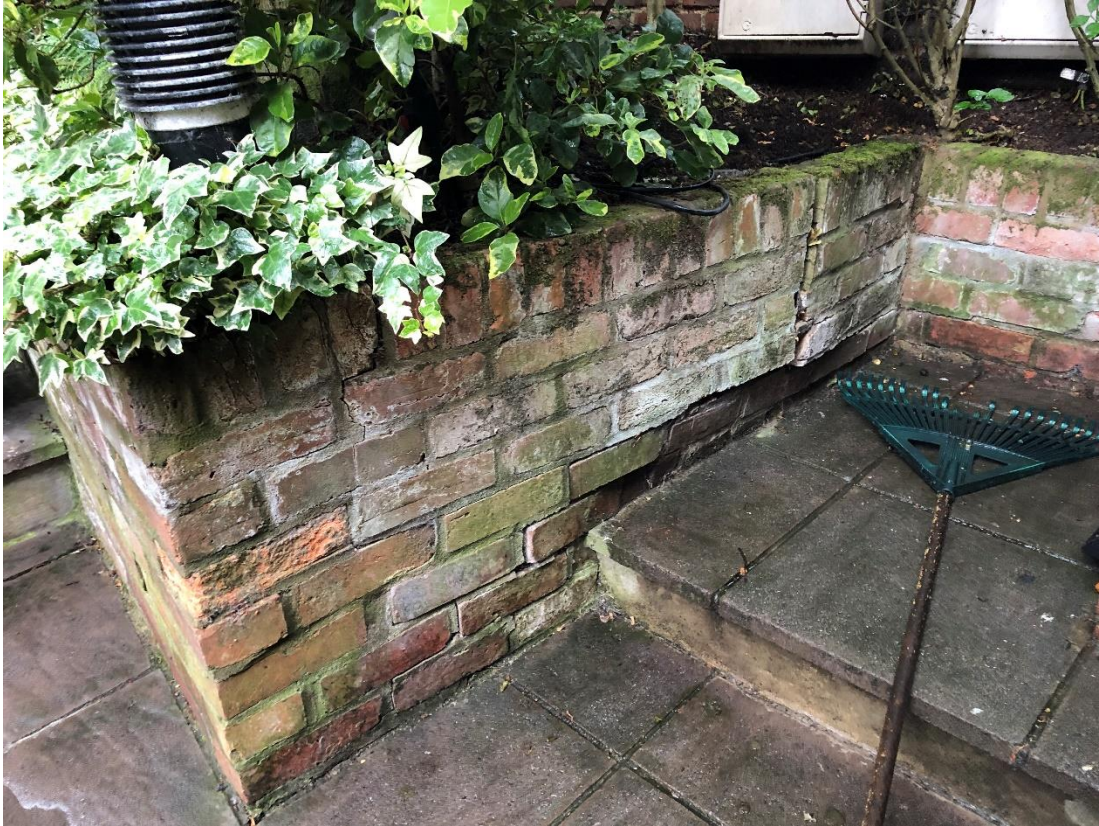
AEL-18129-PIC3 – Showing more significant crack in wall that will require repairing.

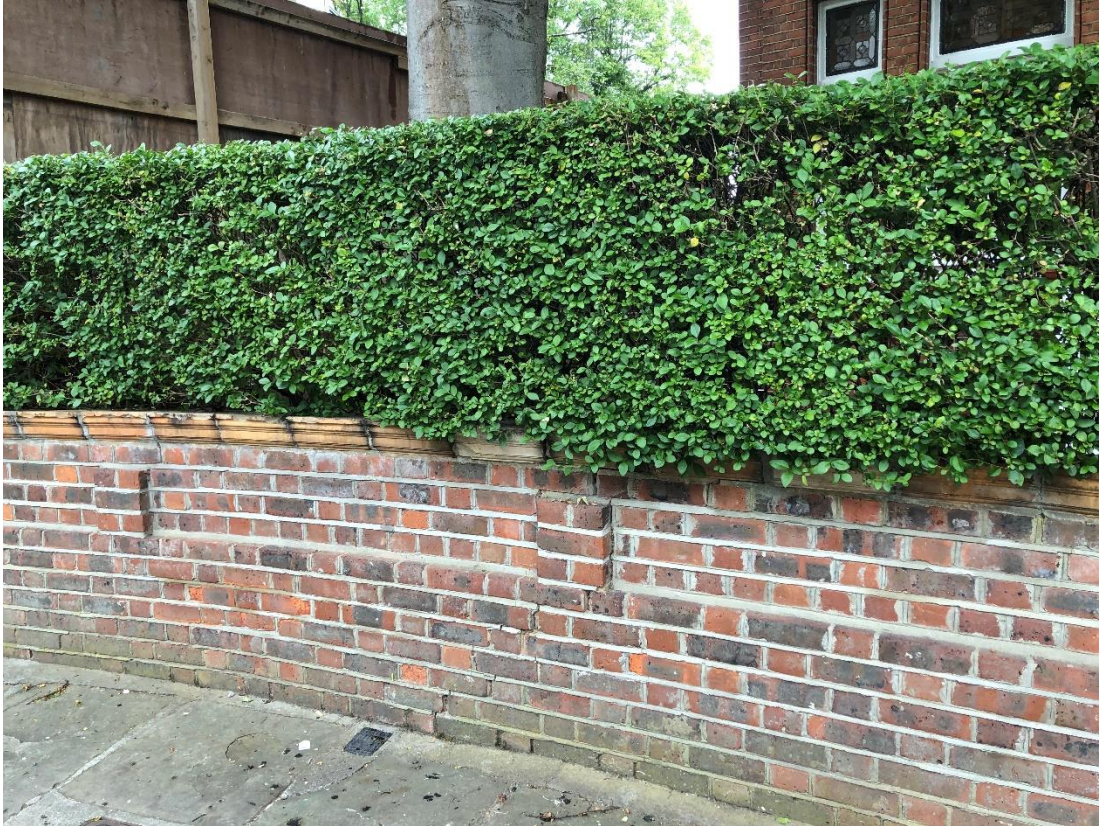
AEL-18129-PIC4 – Showing front boundary wall with crack that will require repair.
