PL01 ISSUED FOR PLANNING ISH CF 22/03/19

PROJECT THE  
**ST GILES CIRCUS,  
 LONDON WC1**

| PROJECT NAME<br><b>No. 20 DMS</b> | DATE<br>28.05.15 |
| PROJECT NUMBER<br><b>029</b> | DRAWING NO.<br><b>ZZ-S-121</b> |

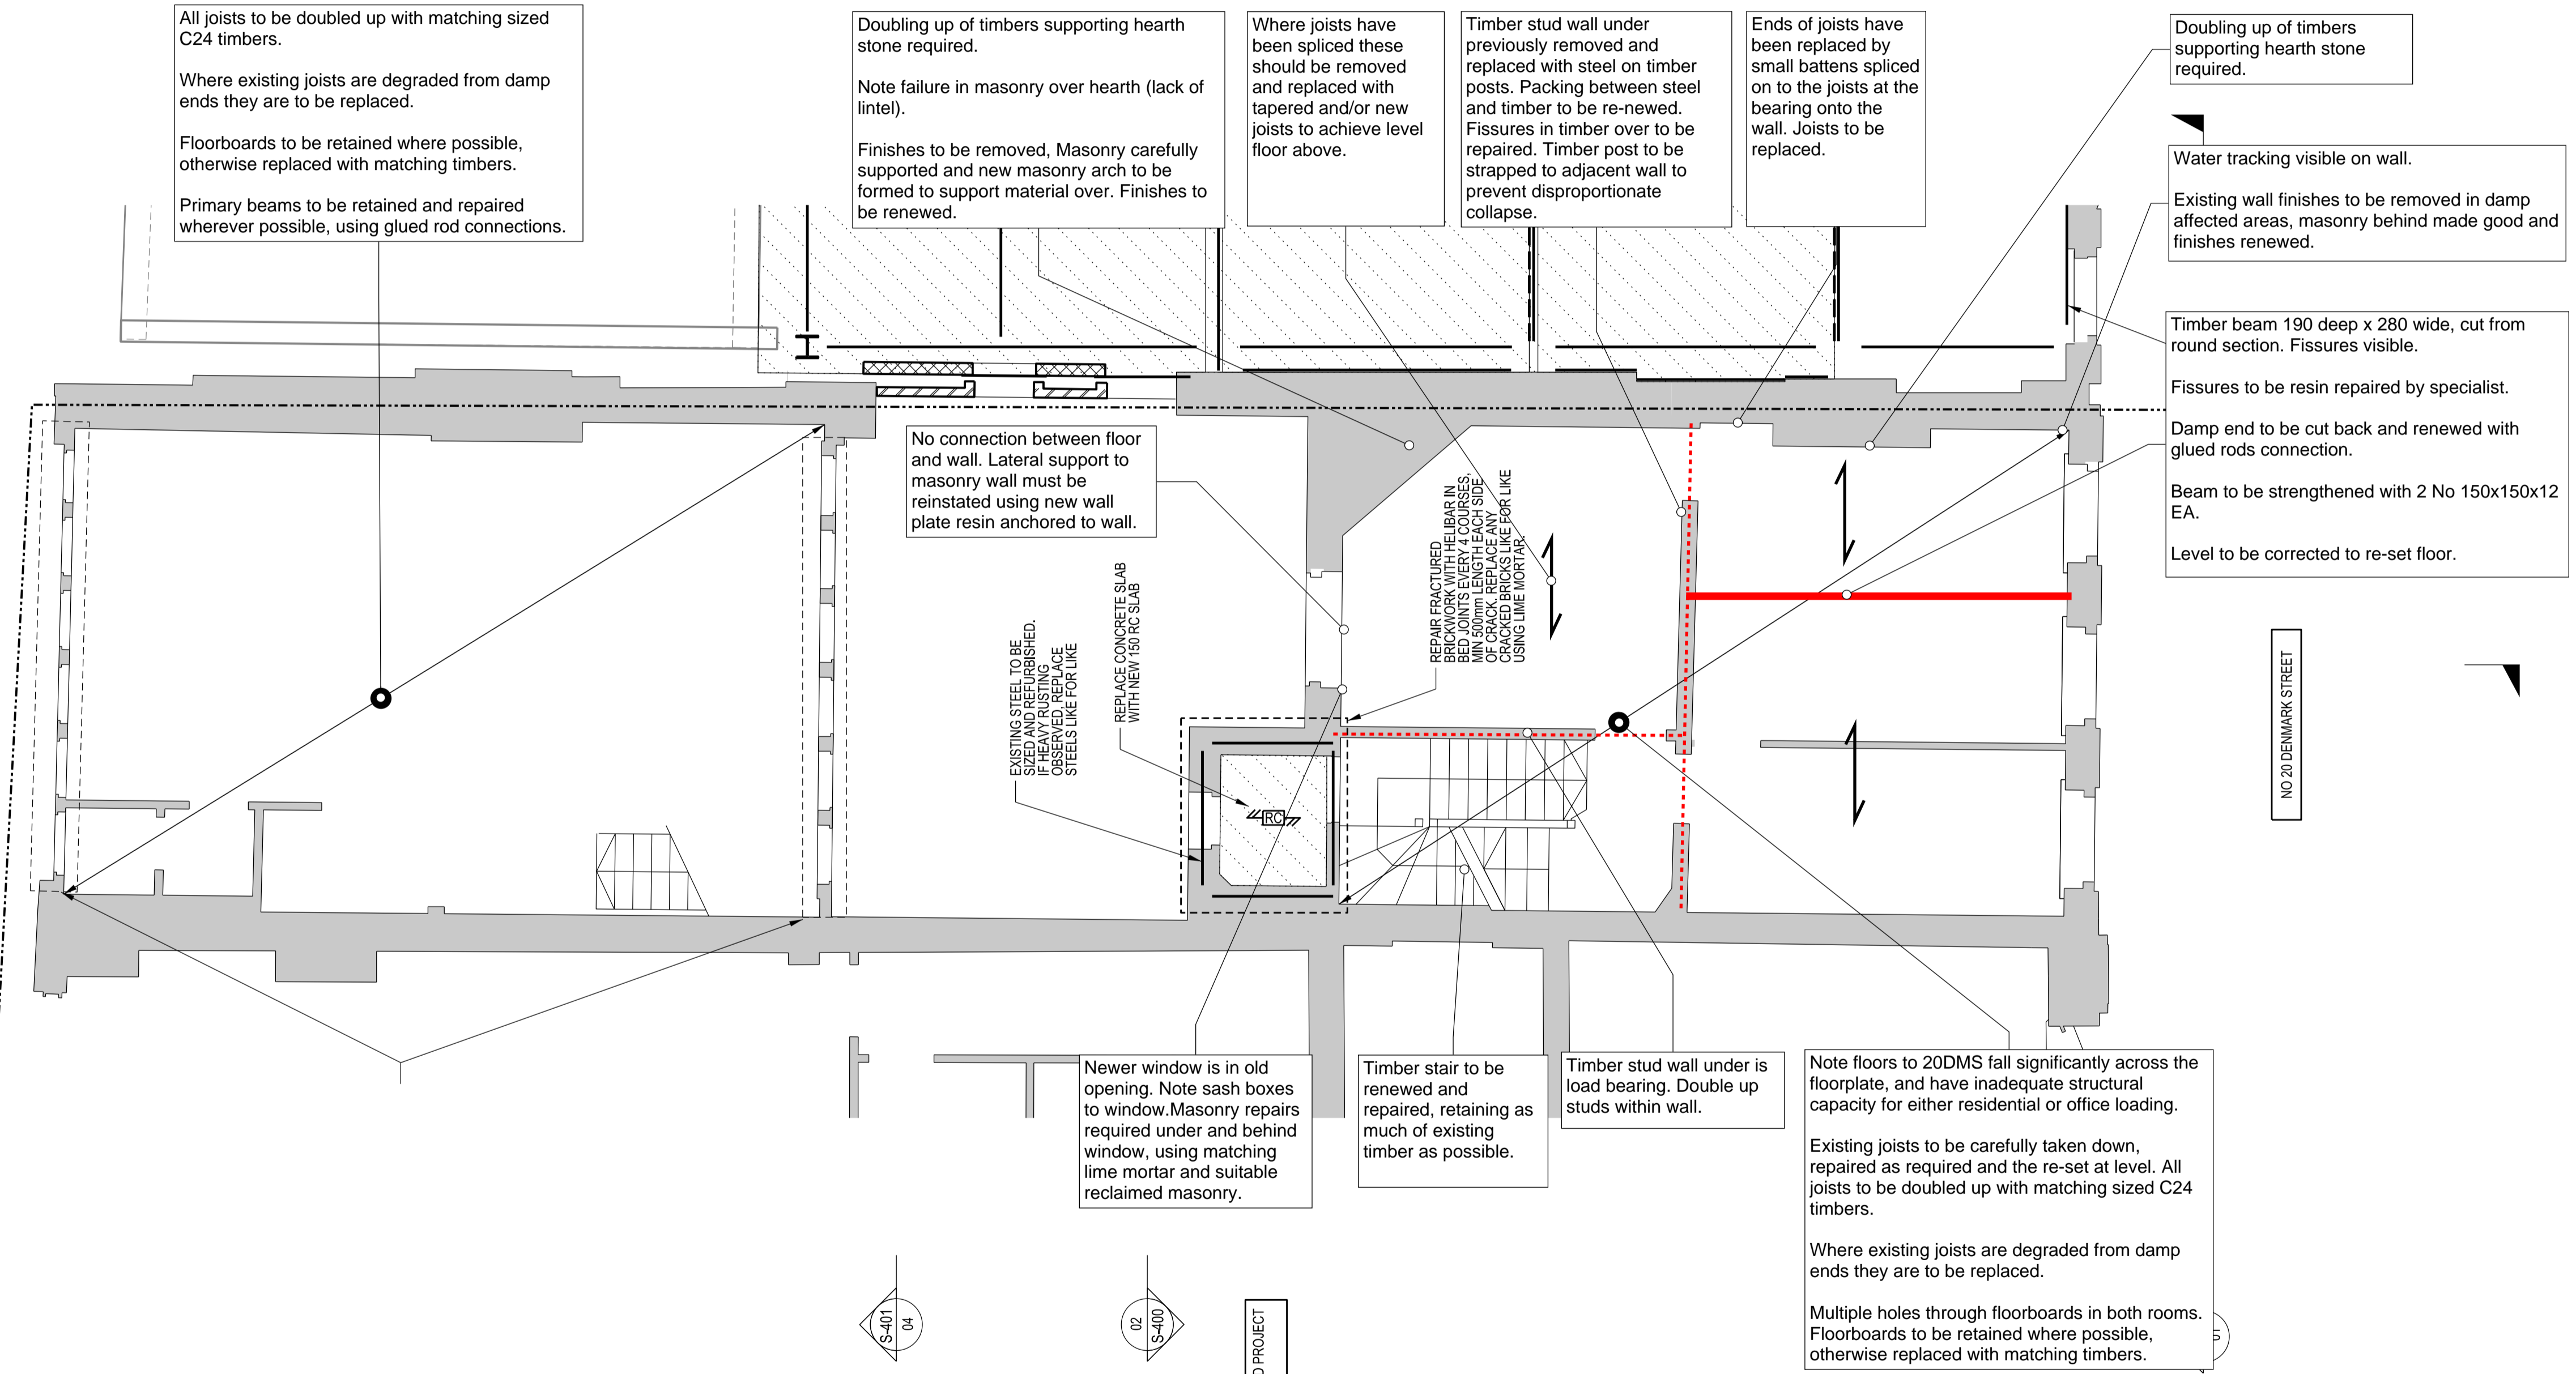
Note failure in masonry over hearth (lack of lintel).

Timber stud wall under previously removed and replaced with steel on timber posts. Packing between steel and timber to be re-newed. Fissures in timber over to be repaired. Timber post to be strapped to adjacent wall to prevent disproportionate collapse.

Ends of joists have been replaced by small battens spliced on to the joists at the bearing onto the wall. Joists to be replaced.

Water tracking visible on wall.

Timber beam 190 deep x 280 wide, cut from round section. Fissures visible.

No connection between floor and wall. Lateral support to masonry wall must be reinstated using new wall plate resin anchored to wall.

Newer window is in old opening. Note sash boxes to window. Masonry repairs required under and behind window, using matching lime mortar and suitable reclaimed masonry.

Note floors to 20DMS fall significantly across the floorplate, and have inadequate structural capacity for either residential or office loading.

Multiple holes through floorboards in both rooms. Floorboards to be retained where possible, otherwise replaced with matching timbers.

All joists to be doubled up with matching sized C24 timbers.

Where existing joists are degraded from damp ends they are to be replaced.

Floorboards to be retained where possible, otherwise replaced with matching timbers.

Primary beams to be retained and repaired wherever possible, using glued rod connections.

Doubling up of timbers supporting hearth stone required.

Finishes to be removed. Masonry carefully supported and new masonry arch to be formed to support material over. Finishes to be renewed.

Where joists have been spliced these should be removed and replaced with tapered and/or new joists to achieve level floor above.

Existing wall finishes to be removed in damp affected areas, masonry behind made good and finishes renewed.

Fissures to be resin repaired by specialist.

Damp end to be cut back and renewed with glued rods connection.

Beam to be strengthened with 2 No 150x150x12 EA.

Level to be corrected to re-set floor.

EXISTING STEEL TO BE REPAIRED AND REFINISHED. OBSERVED. REPLACE STEELS LIKE FOR LIKE.

REPLACE CONCRETE SLAB WITH NEW 150 RC SLAB

REPAIR FRACTURED BRICKWORK WITH BRICKS CUT TO BE MATCHED IN BED JOINTS EVERY 4 COURSES. MIN 50mm LENGTH EACH SIDE. CRACKED BRICKS LIKE FOR LIKE USING LIME MORTAR.

Timber stair to be renewed and repaired, retaining as much of existing timber as possible.

Timber stud wall under is load bearing. Double up studs within wall.

Existing joists to be carefully taken down, repaired as required and the re-set at level. All joists to be doubled up with matching sized C24 timbers.
