59 FLASK WALK, NW3 1EY

Discharge of Conditions: Listed Building Consent

APPLICATION REFERENCE: 2018/6186/L

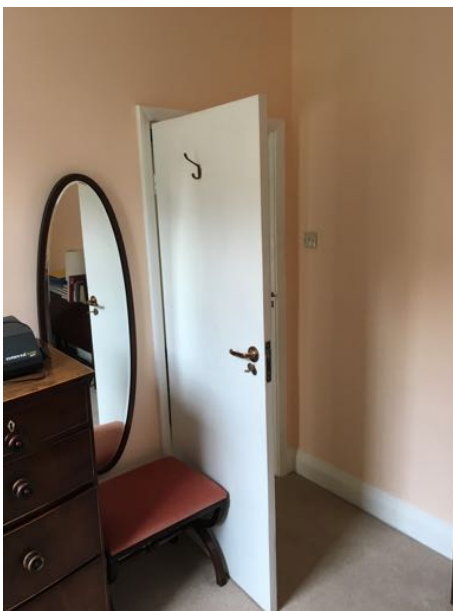
On the First Floor the removal of the lime mortar to the dividing wall between the front and back rooms has revealed London Stock brickwork with timber posts at approximately 620mm centres (refer Photos 1,2 and 3).

PHOTO 1. Back room showing First Floor dividing wall to RHS before mortar removed.

Therefore, we plan to leave the wall intact and instead retain the doorway at the top of the stairs that we had suggested would be blocked up as access to the new Ensuite (refer First Floor Plan, separate attachment).

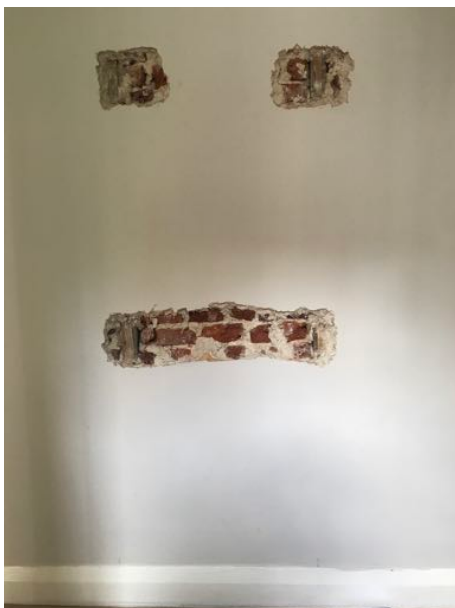
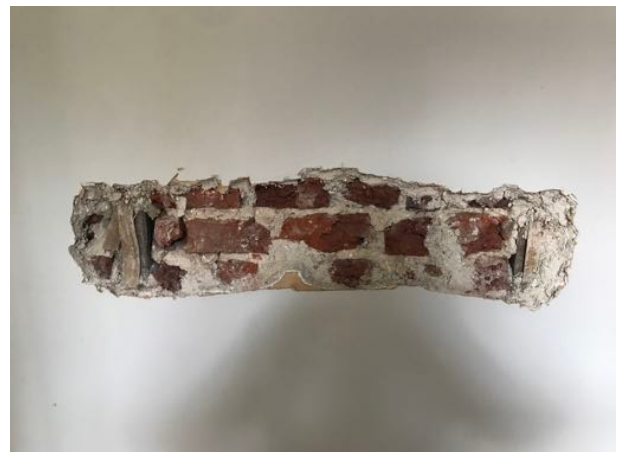
PHOTOS 2 & 3. Wall between front and back rooms on First Floor showing mortar removed, brickwork and timber posts between.

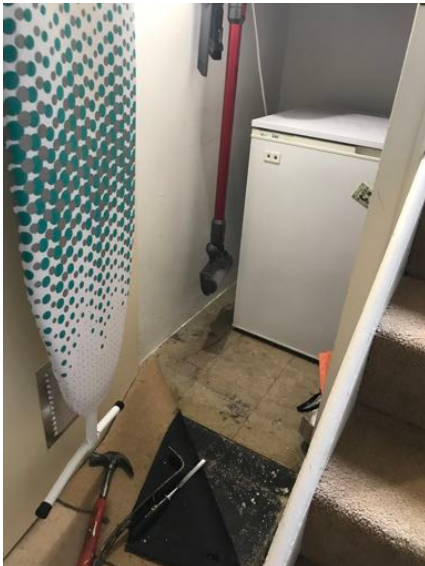
The Lower Ground Floor has a concrete slab floor, while the two upper floors have 150x50mm timber joists @ 400-420mm CTS approximately which run from the front to back of the property (refer Photos 4,5 and 6) (refer floor plans, separate attachment).

PHOTO 4. Lower Ground Floor tiles on slab.

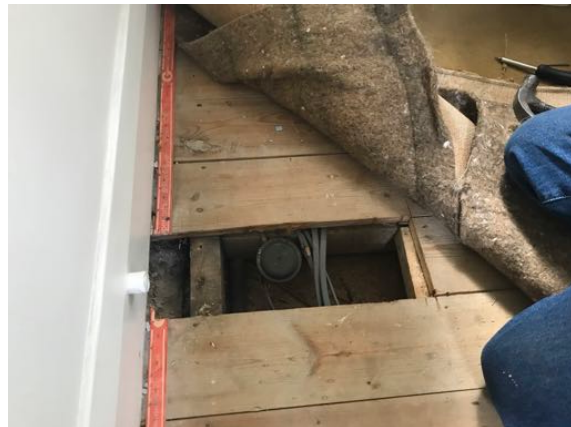
PHOTO 5. Ground Floor timber boards on joists.

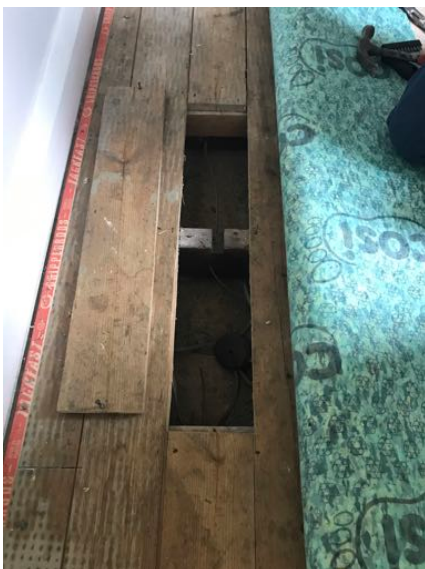
PHOTO 6. First Floor timber boards on joists.

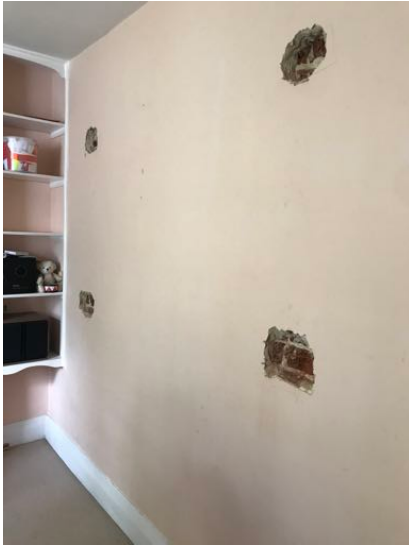
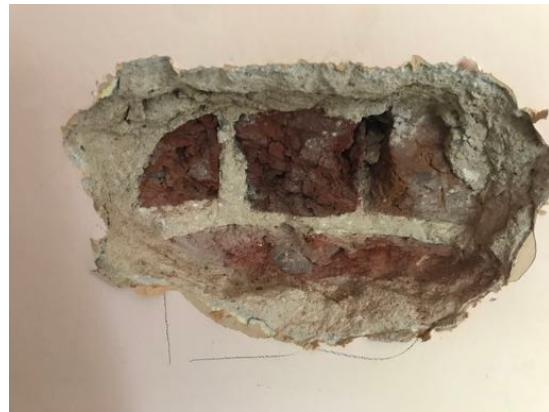
On the Lower Ground Floor the removal of the lime mortar to the dividing wall between the front and back rooms has revealed London Stock brickwork, no timbers (refer Photos 7 and 8).

PHOTOS 7 & 8. Wall between new front and back rooms on Lower Ground Floor showing mortar removed and brickwork.

Therefore, we plan to form the opening shown on the approved plans, taking care to retain the adjacent existing wall linings and repair using like-for-like materials where the new opening is formed (refer Lower Ground Floor Plan attached).
