Re: Replacement of vault roof at 106 Regent's Park Road

Root Excavation Report

106 Regent's Park Road

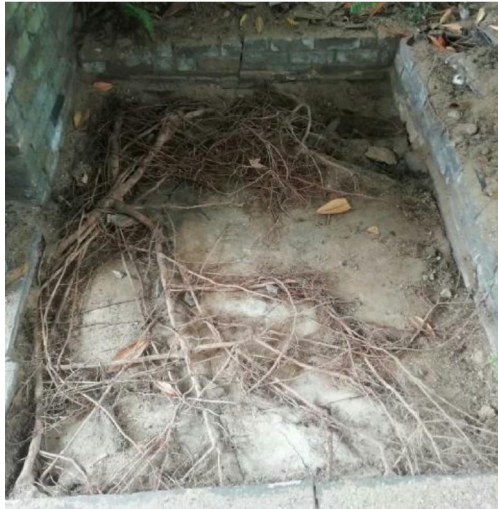
Photograph 1: Roots above vault roof

With regard to the potential for direct damage to the replacement vault roof, I would first comment that roots do not possess the faculty to damage an otherwise undamaged structure, they exploit (and often exacerbate) an existing fault so assuming that the roof construction is of good quality there should be little chance of this occurring. Having said this, installation of a proprietary root barrier such as Terram's Rootguard or GreenBlue Urban's RootStop over the roof would provide a further measure of protection.

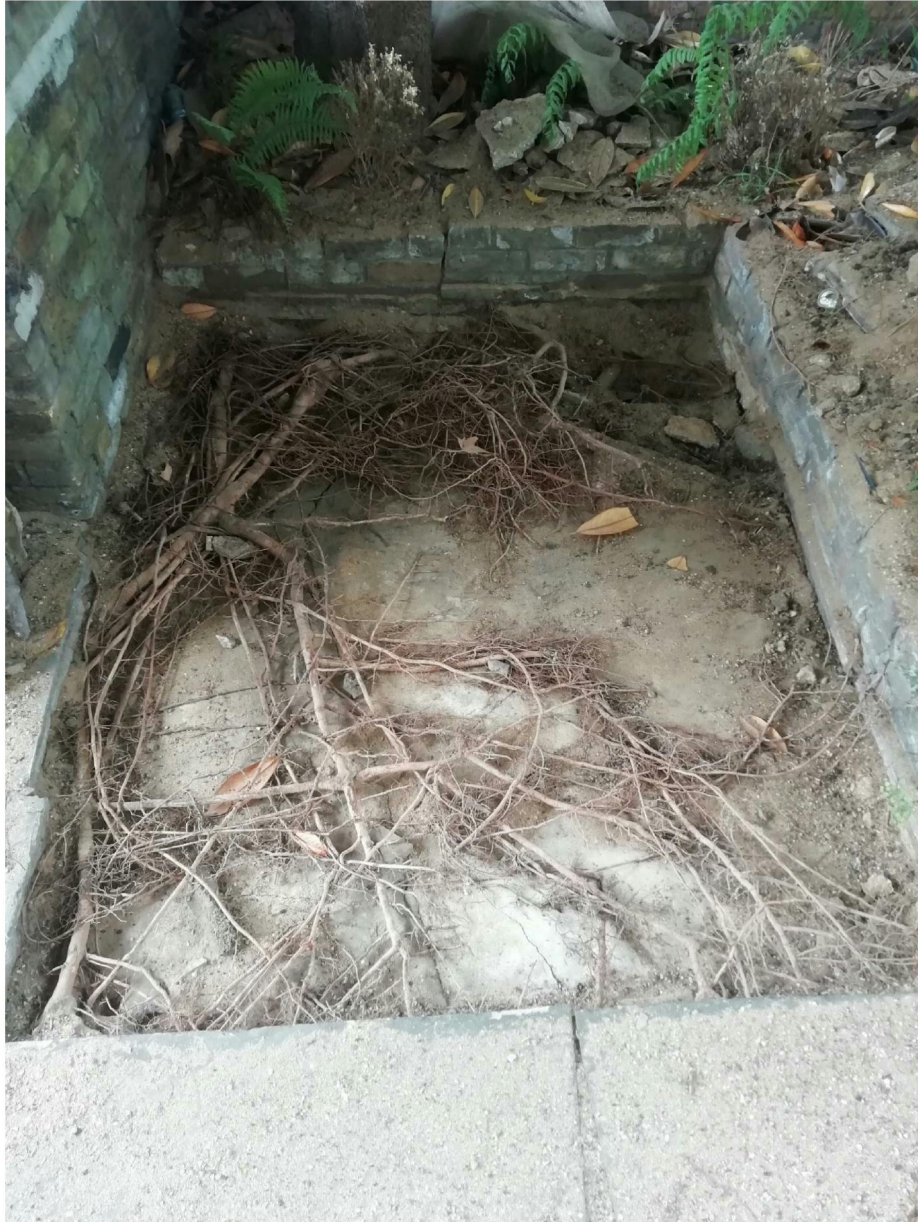
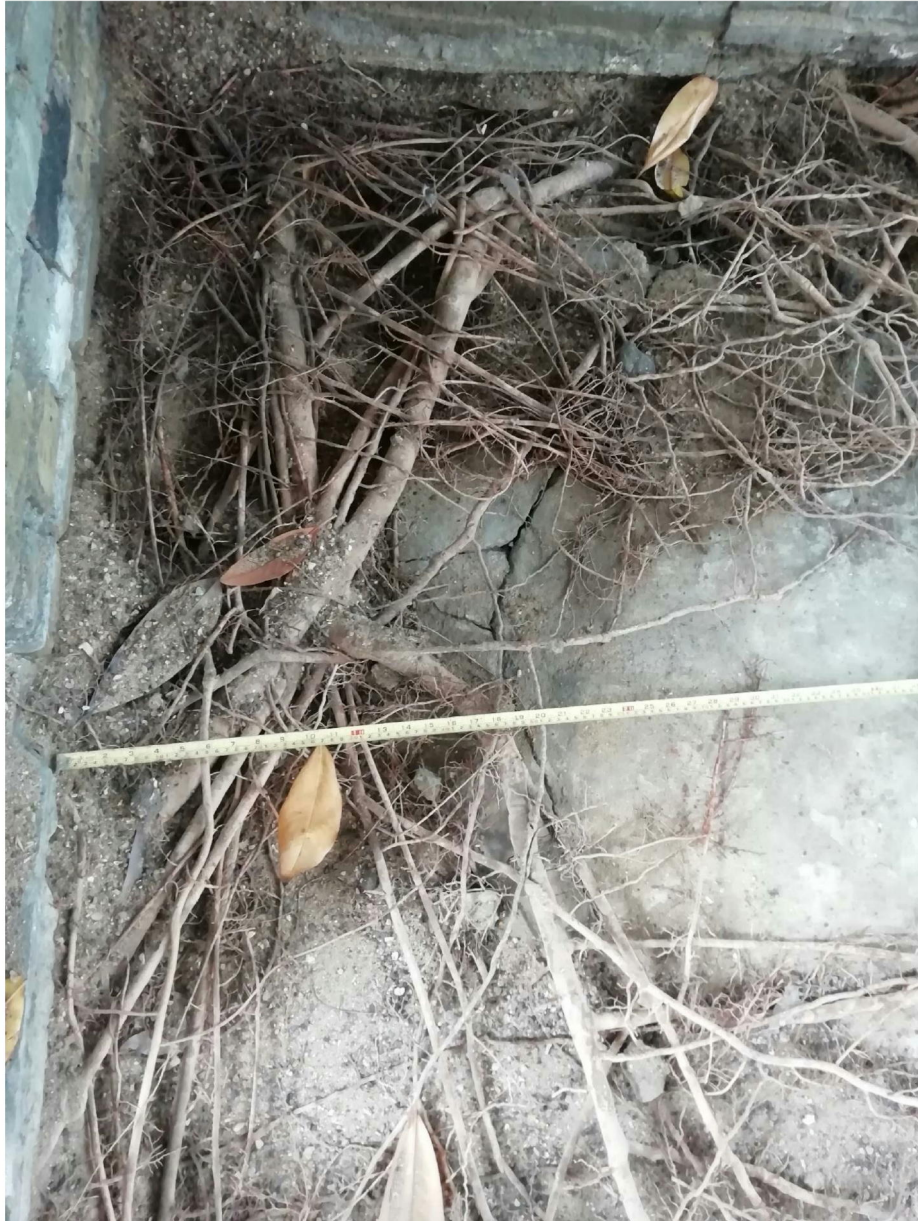
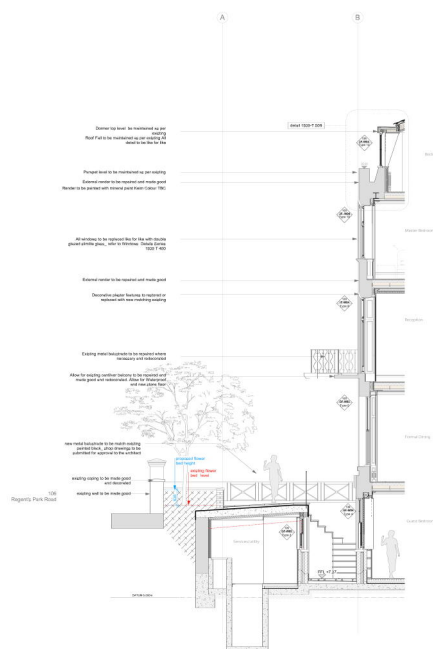
Trial pit 1

Trial Pit 1	<p>1.7m Long x 2.1m Wide x 0.1m Deep</p> <p>Trial pit finishes 1.8m from the edge of the paving</p> <p>1x100mm root</p> <p>3x45mm roots</p> <p>2x30mm roots</p> <p>Small mass of fibrous roots.</p> <p>No roots exceed 25mm at 1.8m from edge of light well</p>
-------------	---
