ARBORICULTURAL IMPACT ASSESSMENT

METHOD STATEMENT

9 THURLOW ROAD

HAMPSTEAD, LONDON

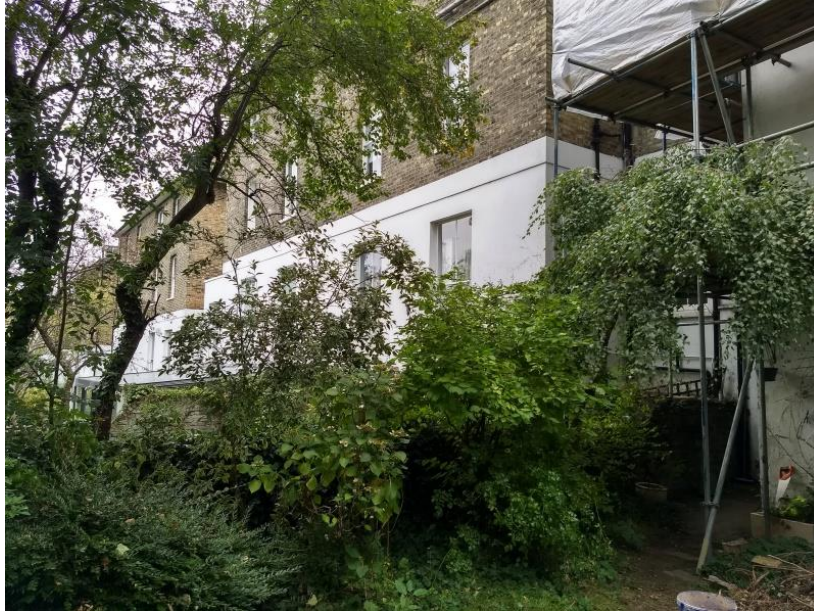
5.5.1. Tree T1 is a weeping silver birch (Youngii) of generally poor form (refer to Appendix A and Photo 1 below). The tree has limited amenity value and does not merit a TPO.

Photograph 1: Tree T1 adjacent to scaffold with trees T2 & T3 to the left.

6.2.1. The proposed design layout requires the removal of trees T1 & T7 for the construction of the single storey rear extension. Tree T7 is shown as 500mm from the rear elevation of the proposed extension and this would require regular management of the crown to clear the building if it could be constructed without damaging any roots that may be present. Tree T10 could be removed to facilitate construction of the annexe as it is of low value. Replacement planting can be carried out following completion of the development if required.

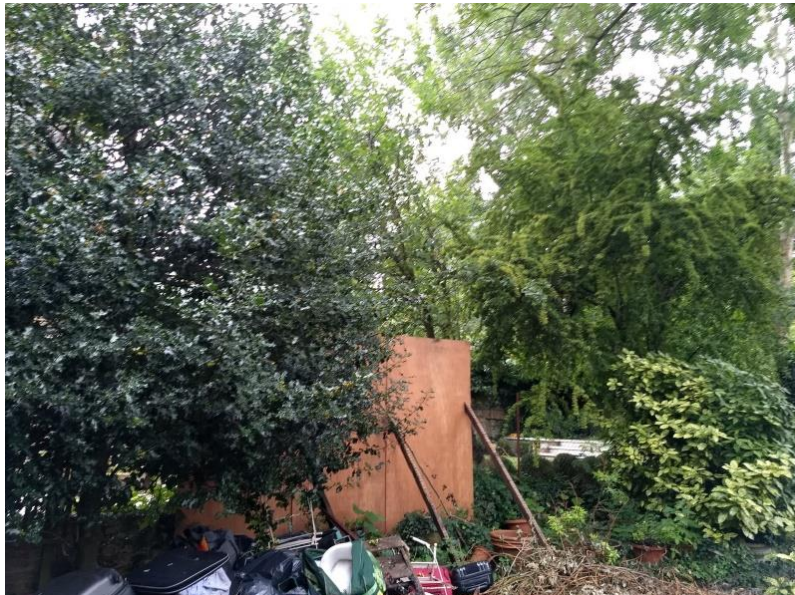
5.5.2. Tree T7 is a holly of generally good condition but currently of limited amenity value; branches are encroaching on the building and the tree would require ongoing management.

Photograph 2: Tree T7 (LHS).

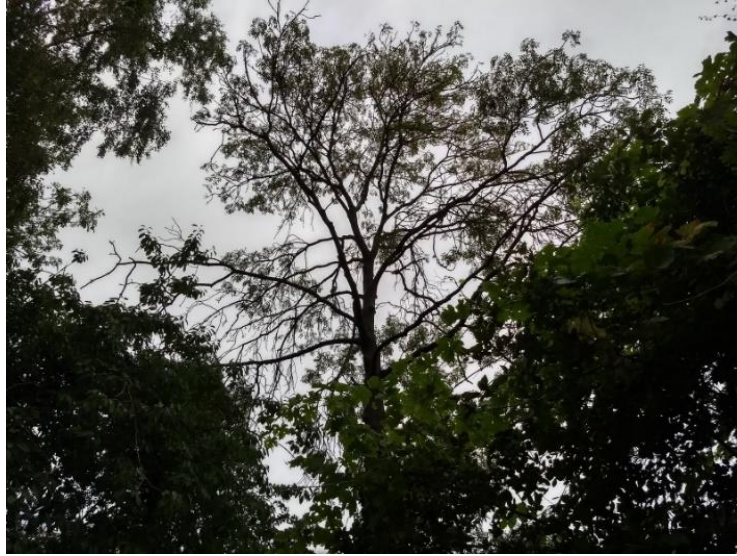
5.2.3. Tree T11 is in poor condition with crown dieback and exudation on the trunk (see Photo's 3 & 4 below) and is recommended for removal irrespective of the development.

Photograph 3: Tree T11 showing sparse crown and dieback.

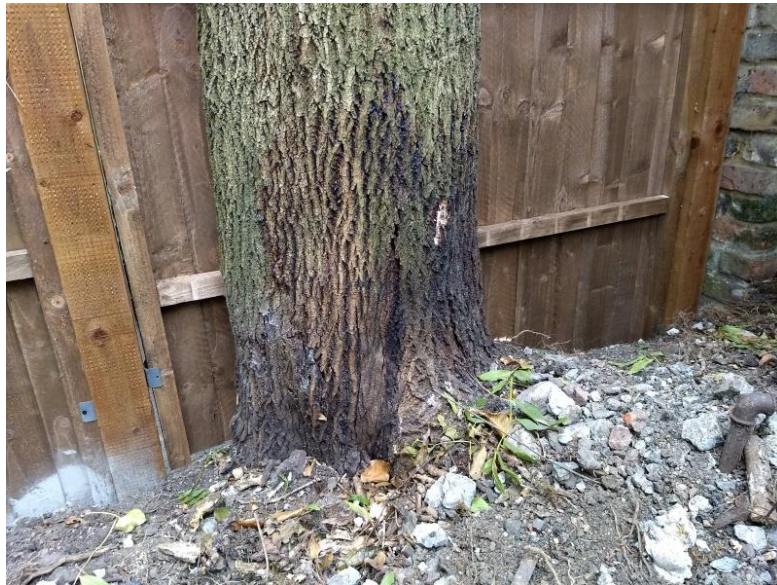
Photograph 4: Tree T11 showing exudation on trunk.

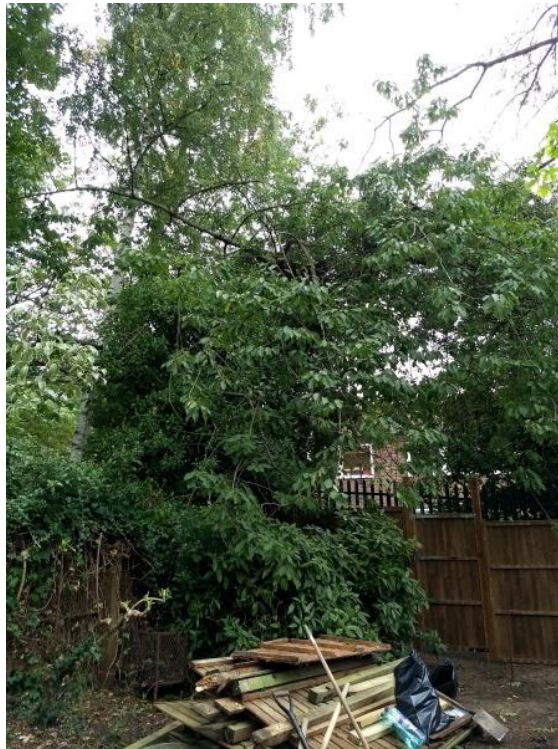
5.5.4. Tree T12 is a wild cherry growing in adjacent property (shown as in the garden on the topographic survey (see photo 5 below). The RPA of this tree extends into the garden and development area. There is dense ivy suppressing the crown.

Photograph 5: Tree T12, trunk originates in neighbouring property.

8.5.2. There are existing sections of concrete within the RPA of tree T12 that will require the recommended procedures noted above.

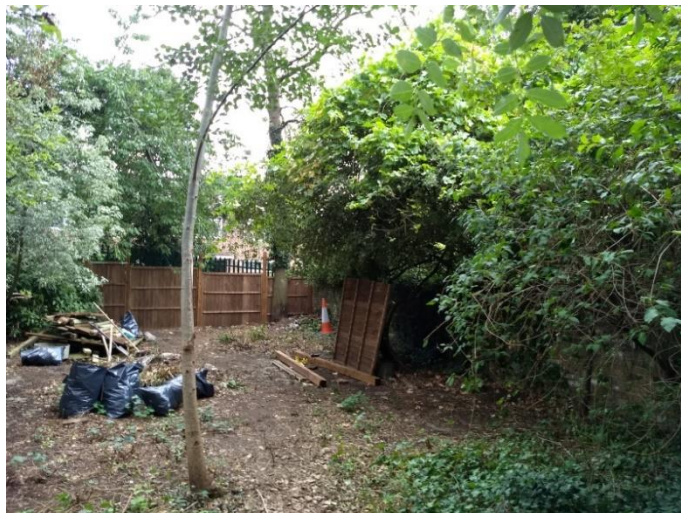
5.5.5. Trees T9 & T10 are close to the development but are of low value. The trees could be removed if required (particularly T10) as they would not merit a TPO (see photo 6 below).

Photograph 6: Tree T9 in the foreground with tree T10 to the RHS (with fence panel).
