Arboricultural Report

Site: Mount Cottage

47d Netherhall Gardens, London NW3 5RJ

*Survey undertaken: Trees in relation to design, demolition and construction –
Recommendations.*

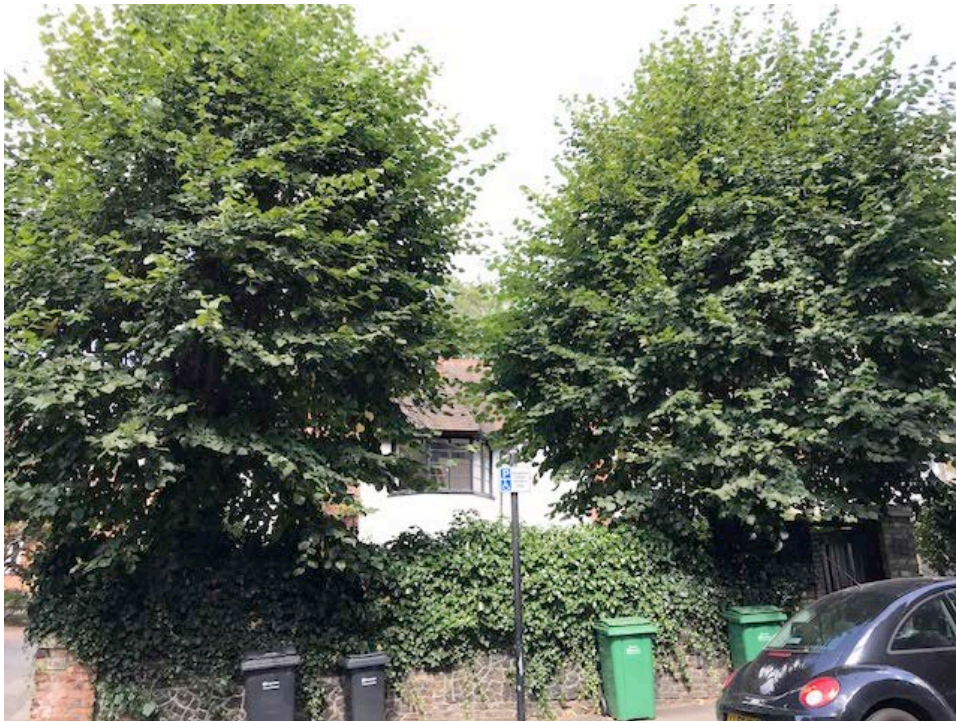
Photo 1: T1 on the right of picture adjacent to pedestrian entrance (site access) and T2 on the left of photo. Both trees were reduced to approximately 6m in height 3 years ago and now have re formed canopies via epicormic growth. Front elevation of Mount cottage can be seen through the canopies.

Canopy reductions of T1 & T2 are recommended prior to work commencing to ensure no mechanical damage to the canopies occur when installing the proposed basement soil extracting conveyor belt. The trees are due to be reduced regardless as part of a cyclical pruning management plan. The dormant season of 2019/2020 would be an ideal time in terms of tree health, to carry out the tree surgery.

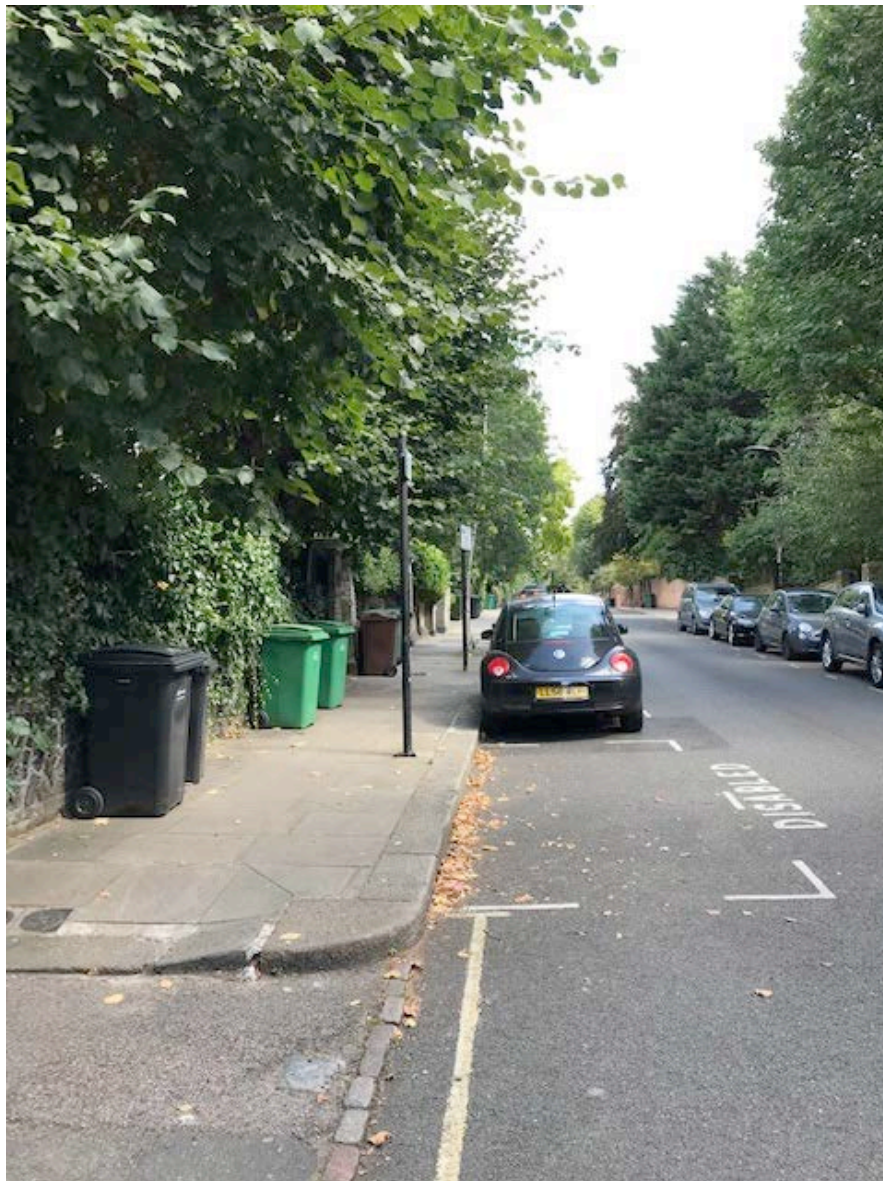
Photo 2: Taken from Netherhall Gardens facing east up the hill with T2 and T1 on the left of picture. The trees are now beginning to encroach into the highway and are due to be reduced as part of cyclical tree pruning management. The street has an abundance of privately owned trees in front gardens of property, which contributes to the high amenity value of the area.

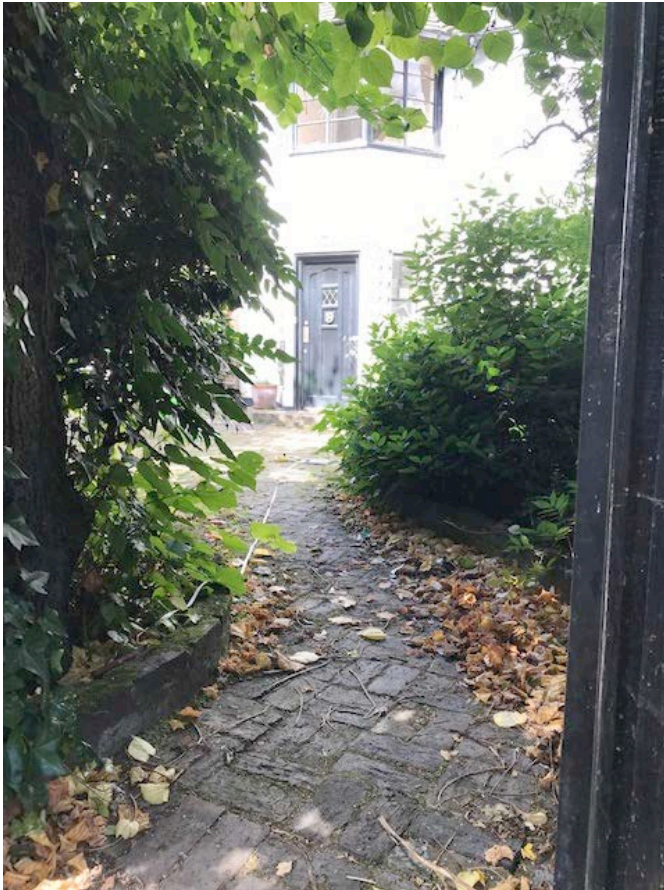
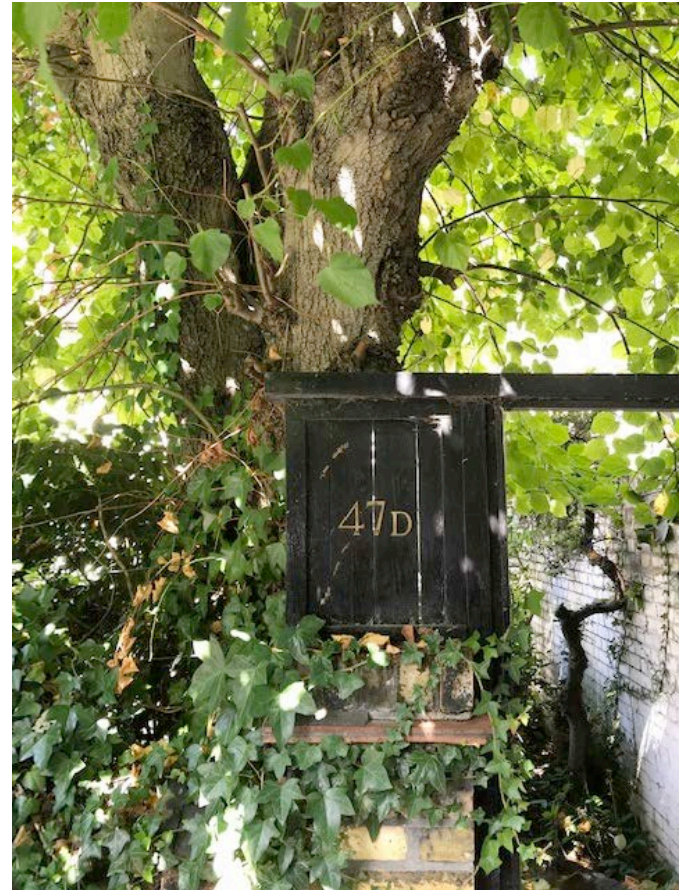
Photo 3 & 4: Site entrance adjacent to the stem of T1. Brick planter boundary surrounds both tree stems and planting beds around the garden. There is a small step down onto rear garden surface and step up to front door level. There is no plan to develop or alter the front gateway or front boundary walls therefore demolition and construction would be confined to the house only.

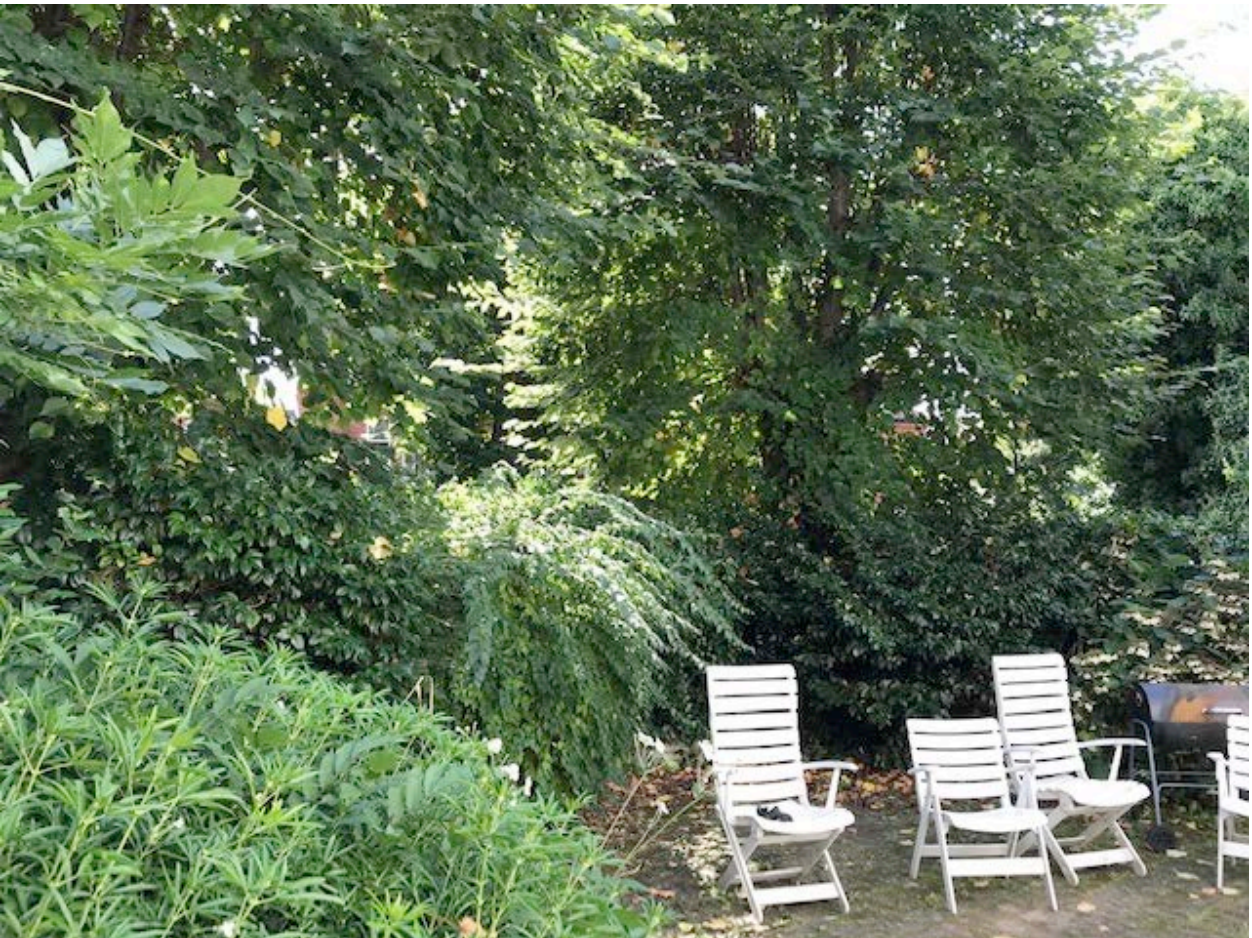
Photo 5: View of T1 and T2 from inside the front garden of Mount cottage with access on the left. Camellias grow underneath the canopies, which will be retained (stem diameters under 75mm at 1.5m from ground level). There is a clear gap in between the tree canopies T1 & T2 for a soil and rubble extracting conveyor belt.

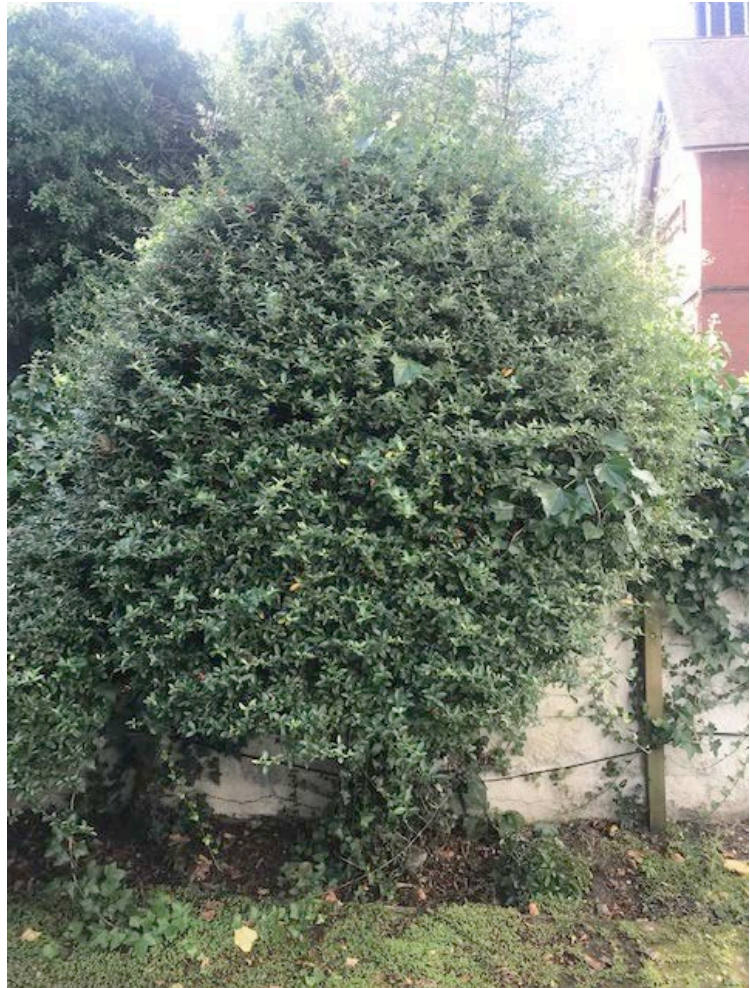
Photo 6: T3 - *Pyrocantha* to be removed as part of the proposed development. Half of the shaped canopy is visible from neighbouring driveway, apart from that this tree is not visible from the road and in my opinion would not cause irreparable loss of landscape.

T3 – Pyrocantha: Fell to ground level and remove stump to provide uninhibited access along west boundary (service runs etc.).
