# Arboricultural Impact Assessment and Method Statement

**Report Reference: 3BACON001/09/19**

3 Bacon Lane, Camden, London

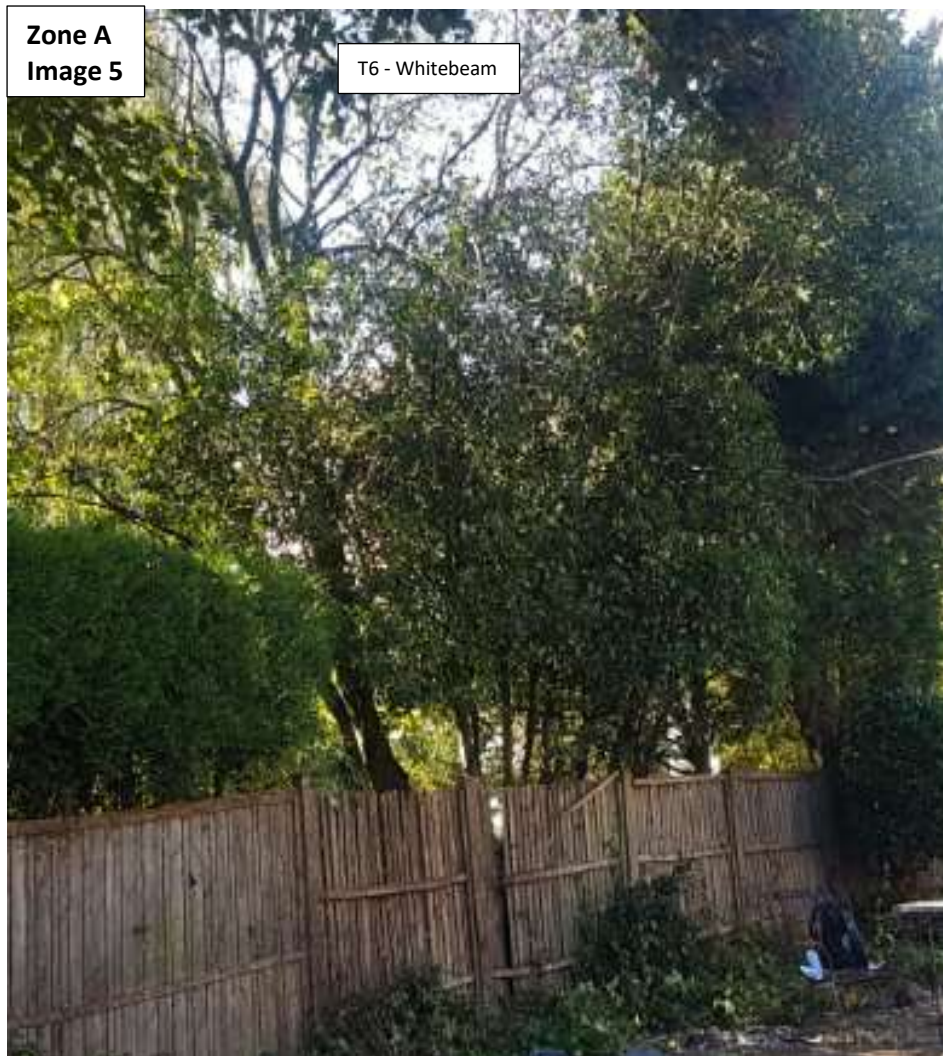
Zone A  
Image 5

T6 - Whitebeam

| | Tree Ref | Species | Height (M) | Crown-Spread<br>N/E/S/W | | | | Age | DBH (mm) | Condition | BS:5837 CAT | RPA (m) | Construction<br>works within<br>RPA | Observed Bird<br>activity | Bat roost<br>potential | Proposal |
|---|---|---|---|---|---|---|---|---|---|---|---|---|---|---|---|---|
| Zone A | T6 | <i>Sorbus aria</i> | 13 | 5 | 5 | 5 | 5 | M | 380 | Poor | U | 4.56 | N | N | N | Advise<br>owner of<br>potential<br>for<br>structural<br>failure |

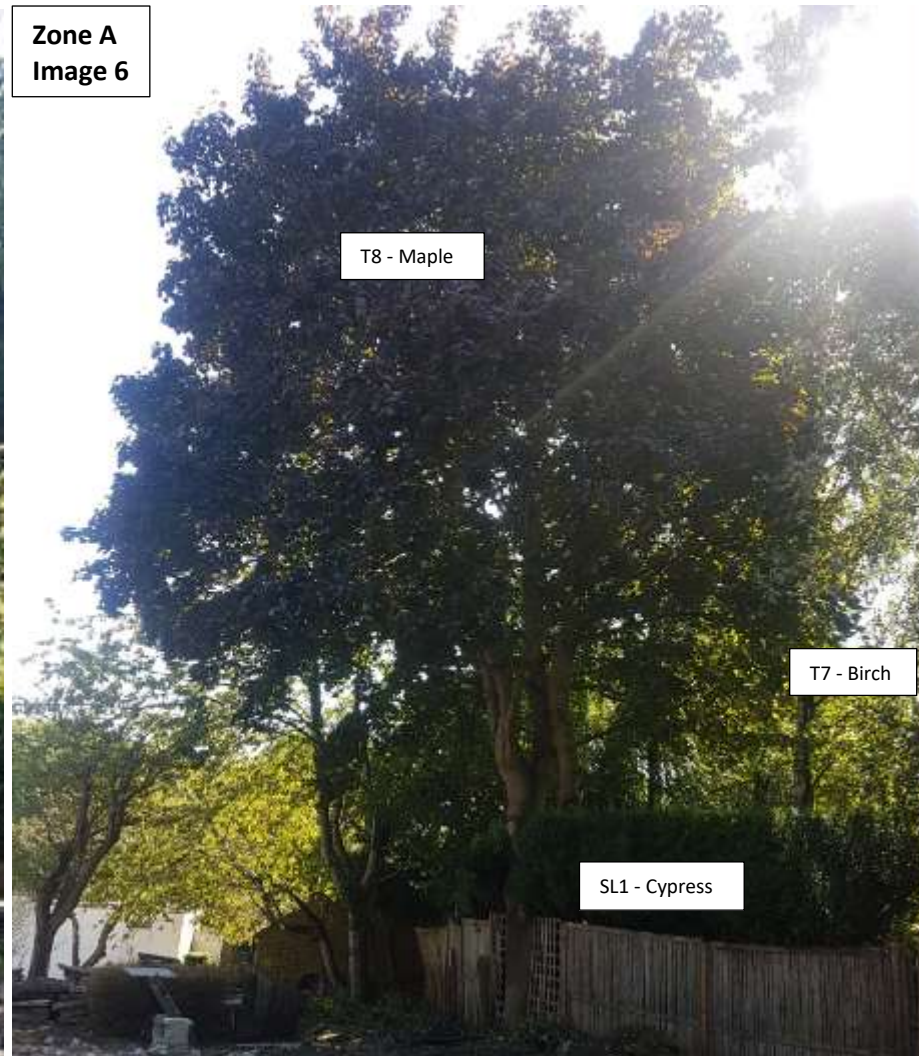
Zone A  
Image 6

T8 - Maple

T7 - Birch

SL1 - Cypress

| | Tree Ref | Species | Height (M) | Crown-Spread<br>N/E/S/W | | | | Age | DBH (mm) | Condition | BS:5837 CAT | RPA (m) | Construction<br>works within<br>RPA | Observed Bird<br>activity | Bat roost<br>potential | Proposal |
|---|---|---|---|---|---|---|---|---|---|---|---|---|---|---|---|---|
| Zone A | T8 | <i>Acer<br/>plataniodes</i> | 15 | 4 | 4 | 4 | 4 | M | 610 | Good | A | 7.2 | Y | N | N | Retain<br>and<br>protect |

- 7.1 Hand-dig methodology under arboriculture supervision should be employed for patio excavation into the RPA of T8 (SEE APPENDIX A).
- 7.2 Landscaping should be agreed to off-set tree loss within the rear garden of the property.
- 7.3 Lift T8 to 5m over property boundary to minimize potential for construction plant conflict.
- 7.4 Follow aftercare programme for T8 rhizome (SEE APPENDIX B)
- 7.5 Follow Tree Protection Plan ((TPP) SEE APPENDIX C)

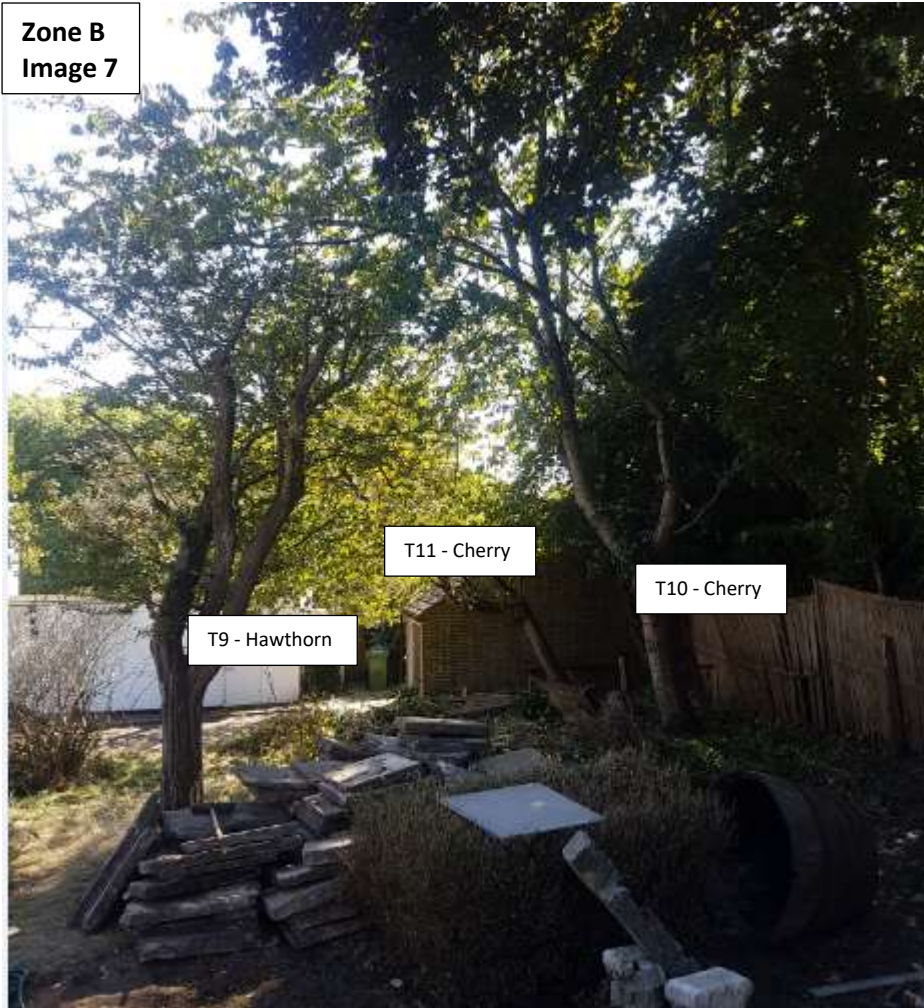
Zone B  
Image 7

T11 - Cherry

T10 - Cherry

T9 - Hawthorn

| Zone B | T9 | <i>Crataegus monogyna</i> | 6 | 1 | 1 | 1 | 1 | SM | 260 | Poor | C | 3.12 | N | N | N | Remove |
| Zone B | T10 | <i>Prunus avium</i> | 9.5 | 3 | 3 | 3 | 3 | M | 330 | Average | B | 4 | N | N | Y | Remove |
| Zone B | T11 | <i>Prunus avium</i> | 11 | 2 | 2 | 2 | 2 | SM | 250 | Average | C | 3 | N | N | N | Remove |

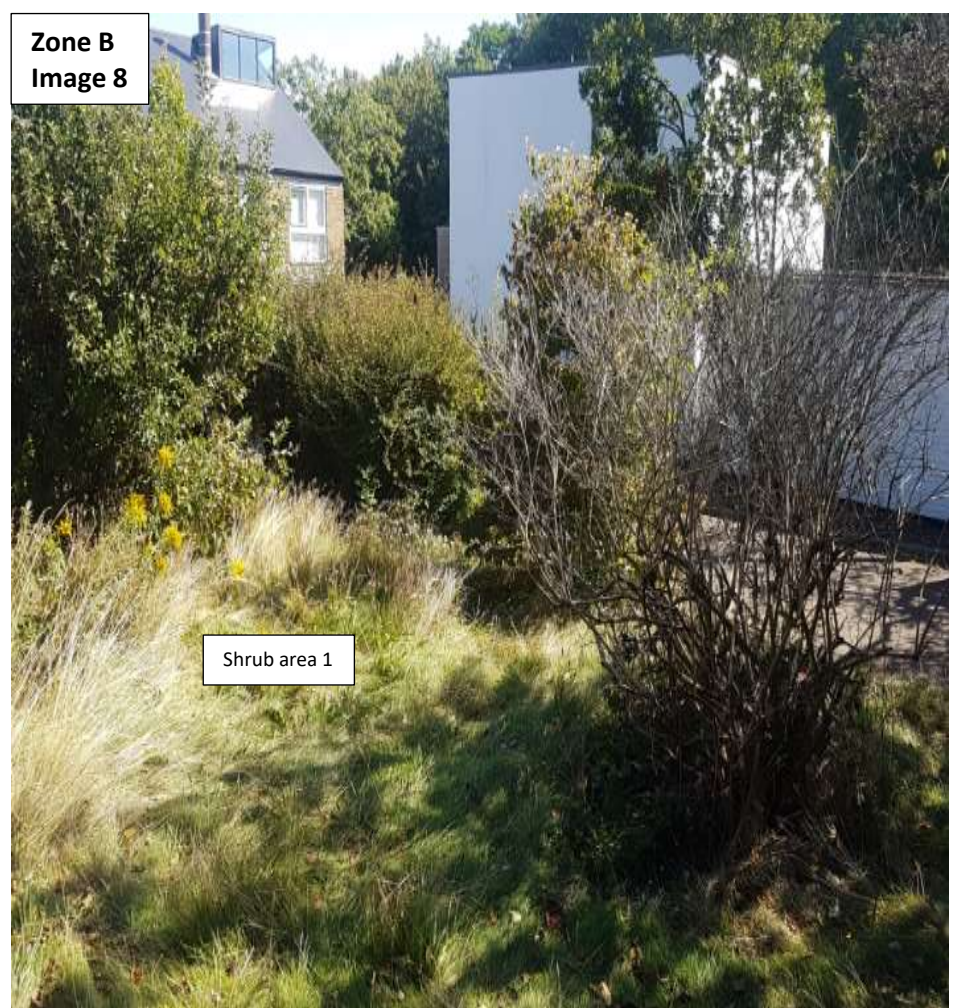
Zone B  
Image 8

Shrub area 1

| Zone B | SA1 | <i>Mixed</i> | N/S | N/A | | | | N/A | 190 | N/A | N/A | 2.3 | N | N | N | Remove |
