ARBORICULTURAL IMPACT ASSESSMENT REPORT

& OUTLINE METHOD STATEMENT:

12 Park Village West London NW1 4AE

Ref: CZL/12PVW/AIM/03a

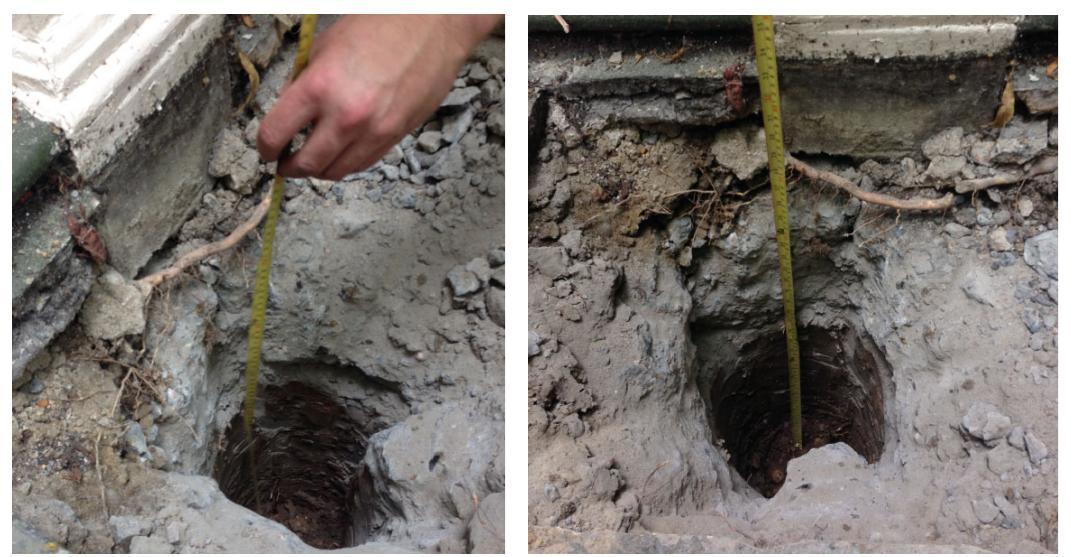
4.1.5 The most recent photographic trial pit evidence for trial pit 8 (see Appendix 2) has been viewed by the Tree Officer Nick Bell on the 12th August 2015. At the site meeting on the 5th of August 2015 and in a subsequent email, there is agreement between the parties that the excavations appear to be free of significant roots; the Tree Officer also noted that some of the excavations (TP8) would be best described as a holes as opposed to pits i.e. trenches. This was due to the existence of a 600mm concrete apron.

Photographs A4.1 - A4.4: Results from Trial Pit 8 showing one root in the paving slabs only

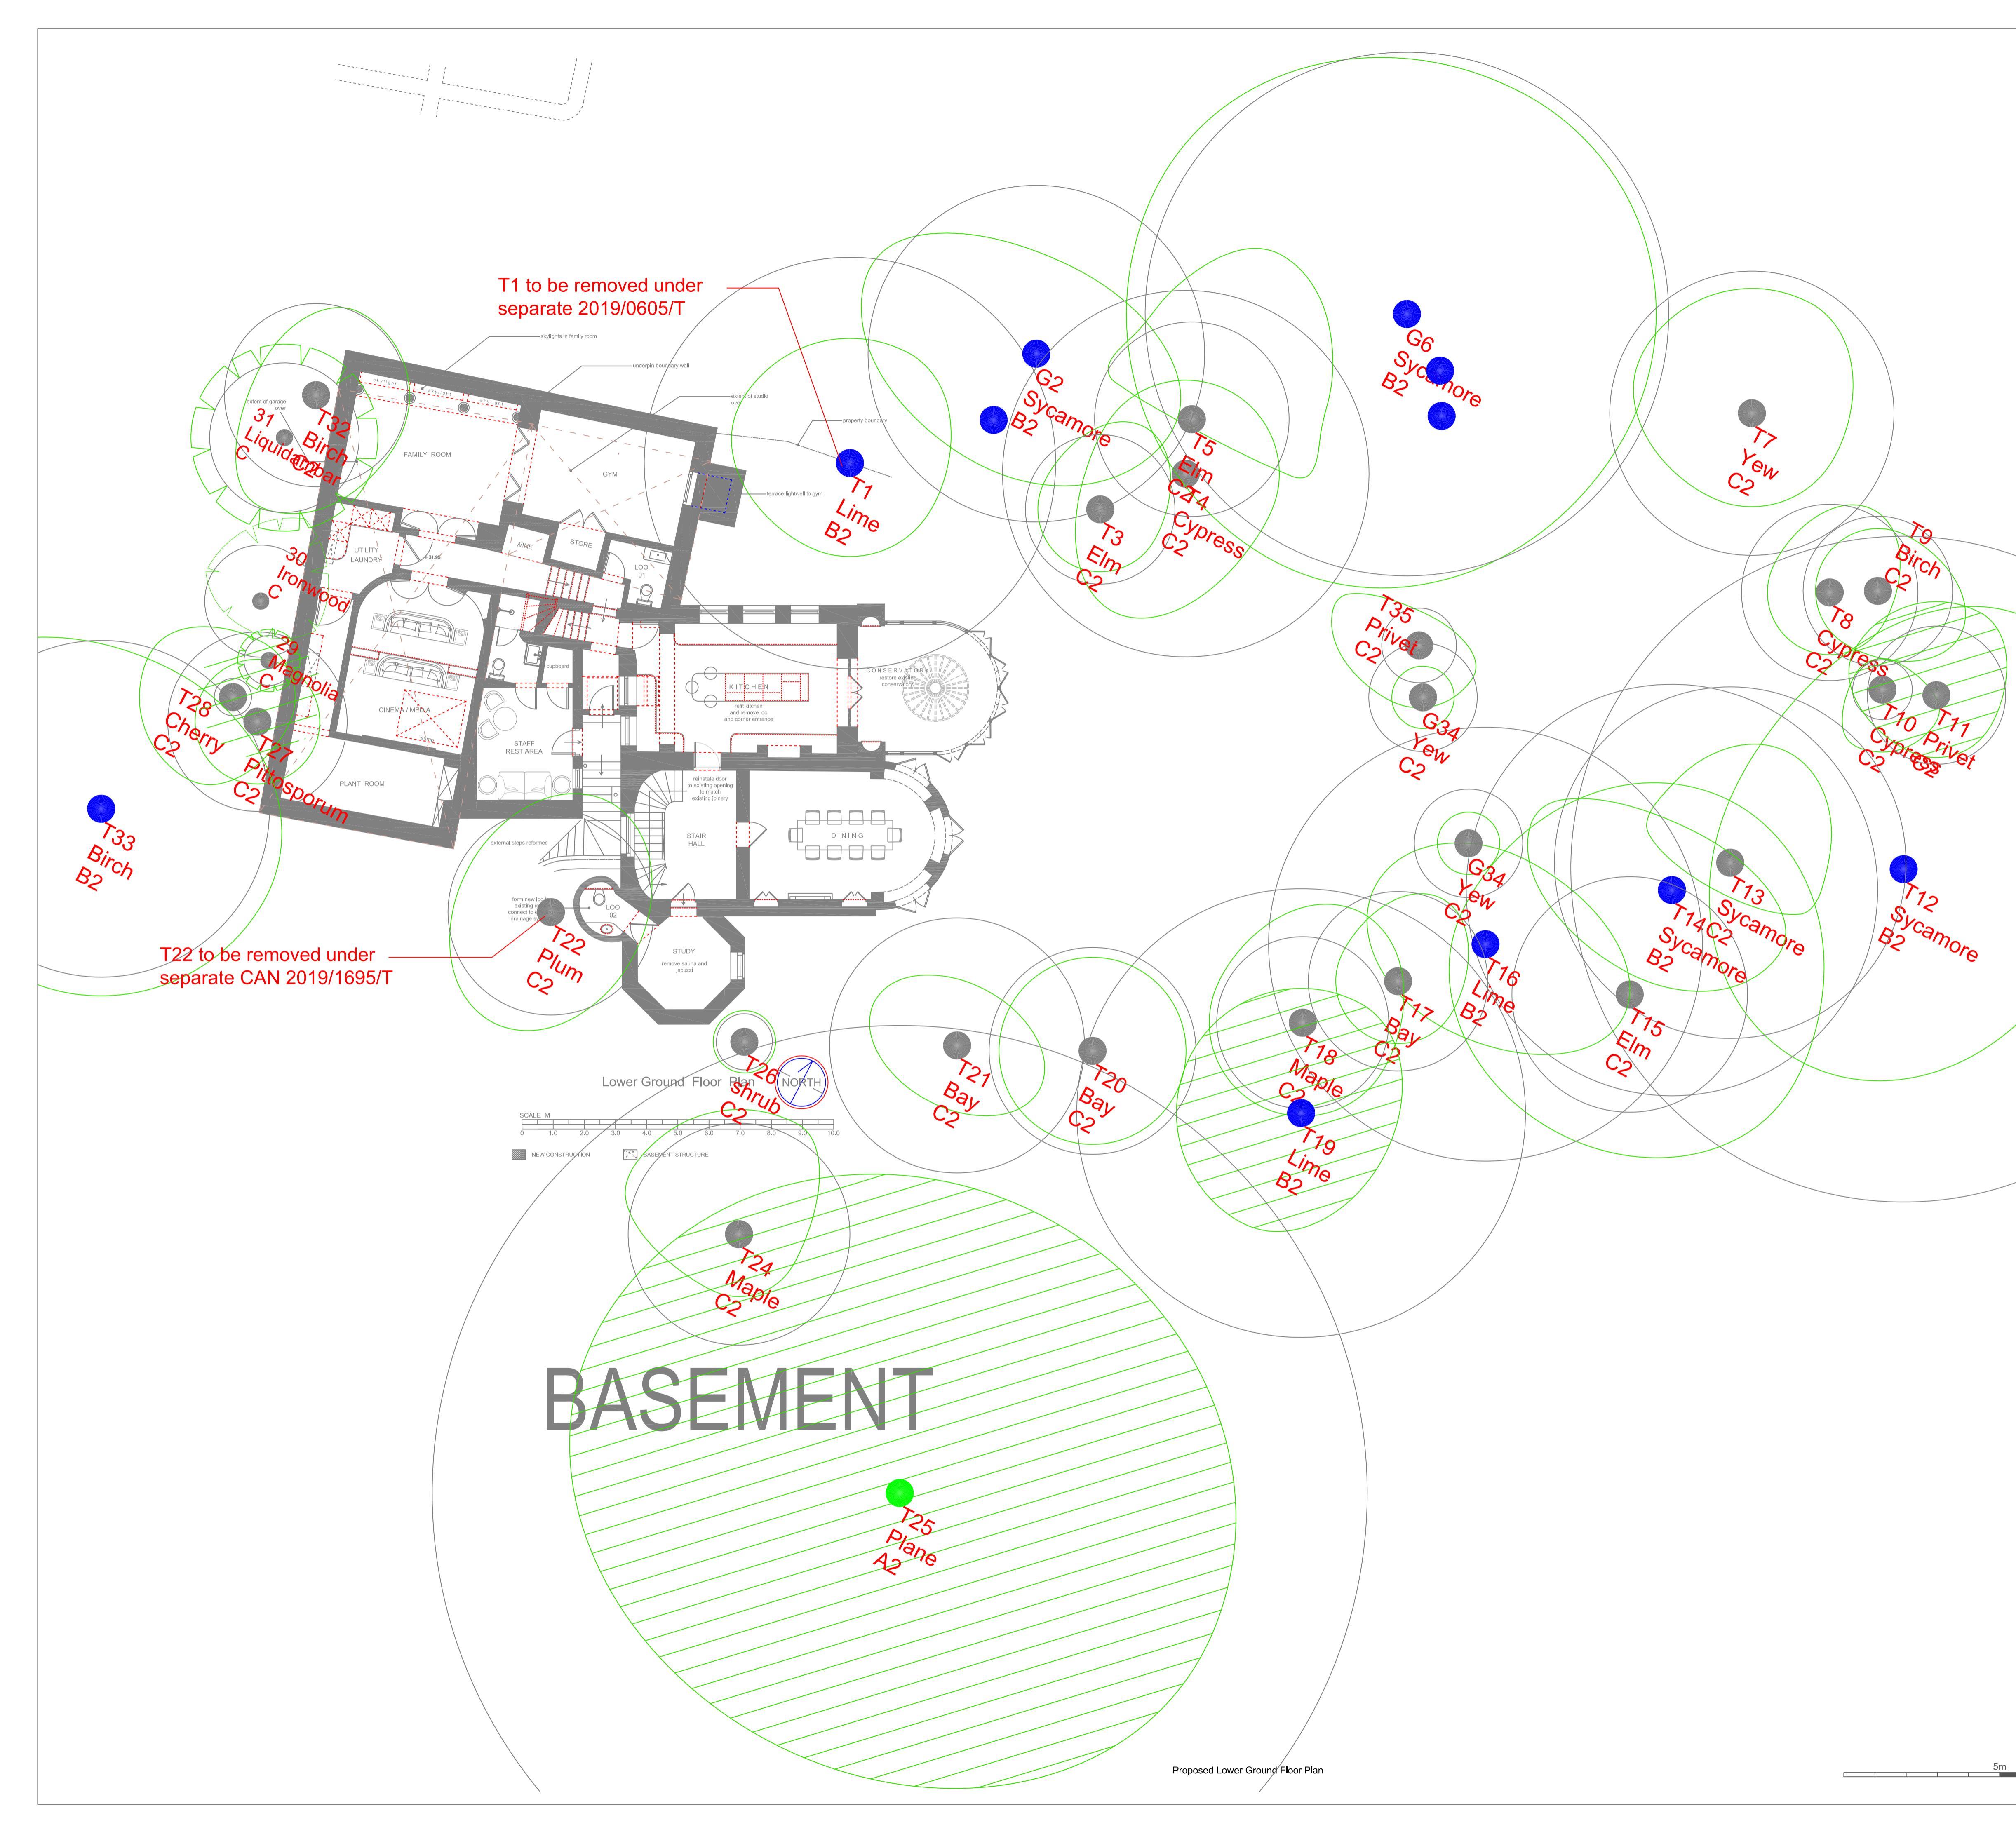
ARBORICULTURAL IMPACT ASSESSMENT PLAN

B.S. Cat.	Tree No.	Species	Impact	Tree / RPA Affected	Age	Growth Vitality	Species Tolerance	Impact on Tree Rating	Impact on Site Rating	Mitigation
С	27	Pittosporum	Basement Construction within RPA	9.9 m ² 37.99 %	Early Mature	Normal	Moderate	Very Low	Very Low	Hand dig top 750mm of basement line thro' RPA
			All beneath existing structure / hardstanding with supporting trial pit evidence							
	29	Magnolia, Southern	Basement Construction within RPA	0.2 m ² ? %			Moderate	Very Low	Very Low	Hand dig top 750mm of basement line thro' RPA
			All beneath existing structure / hardstanding with supporting trial pit evidence							
	30	Ironwood, Persian	Basement Construction within RPA	1.0 m ² ? %			Moderate	Very Low	Very Low	Hand dig top 750mm of basement line thro' RPA
			All beneath existing structure / hardstanding with supporting trial pit evidence							
	31	Liquid Amber	Basement Construction within RPA	2.6 m ² ? %			Moderate	Very Low	Very Low	Hand dig top 750mm of basement line thro' RPA

All beneath existing structure / hardstanding with supporting trial pit evidence							
С	32	Birch, Silver	Basement Construction within RPA	8.0 m ² 29.46 %	Early Mature	Normal	Moderate	Very Low	Very Low	Hand dig top 750mm of basement line thro' RPA
			All beneath existing structure / hardstanding with supporting trial pit evidence							
В	33	Birch, Silver	Basement Construction within RPA	0.2 m ² .22 %	Mature	Normal	Moderate	Very Low	Very Low	Hand dig top 750mm of basement line thro' RPA
			All beneath existing structure / hardstanding with supporting trial pit evidence

- 8.2.4 Where the basement line/wall underpinning line lies within the RPA of T's 27 33, the foundations should be hand excavated to 750mm with pre-emptive root pruning under arboricultural supervision if required.
- 8.2.5 Where levels of dust build-up on trees are likely, it may be necessary to seek the advice of Landmark Trees on remedial measures, e.g. hose down the tree(s) immediately following any significant accumulation of dust.
