Tree report in accordance with BS 5837:2012

Site Address: 18a Frogna Gardens, London, NW3 6XA
Ref: 031682

Demolition of existing structure and construction of a new 4-storey dwelling in its place

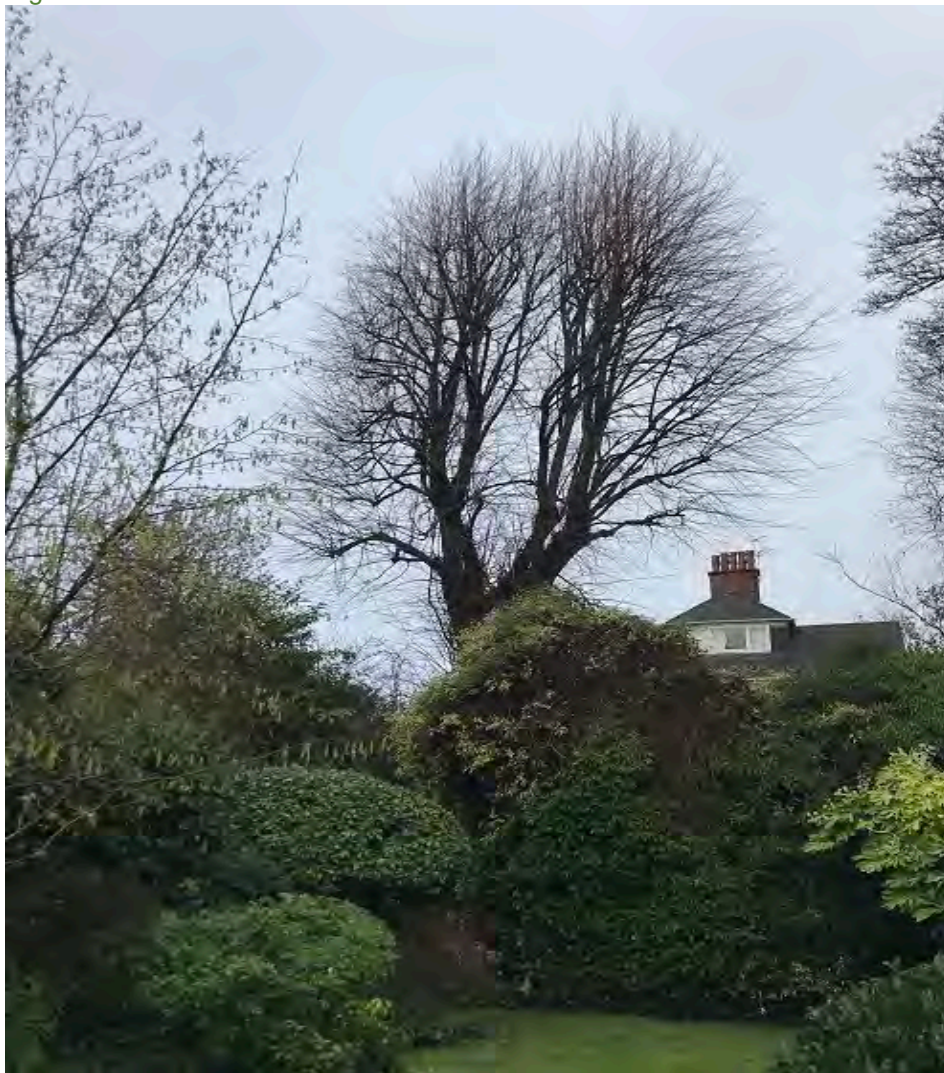
Figure 1 T10

2.2.4 The most significant tree with respect to the proposal is a lime (T10) [Figure 1] located towards the rear boundary of 18a Frognal Gardens' rear garden. No works are planned to occur within the RPA of this tree.

Excavation works to accommodate the basement level will occur outside the RPA of T10 as drawn as a nominal circle. There is no reason to deviate from a nominal circle. From that point of view, there is no incompatibility between T10 and the new structure. New decking will be laid to the rear of the proposed dwelling that will exist very slightly in the southern portion of T10's RPA. This will not involve extensive ground excavation and will be done by hand-only. Measures laid out within the AMS will be followed should roots from this tree be encountered.

There is a proposal to remove and rebuild the retaining wall directly adjacent to T10. The demolition will be done by hand only and arboricultural advice will be sought should any significant roots impede the rebuilding of this wall. The existing paving slabs directly to the south of T10 will be lifted by hand and replaced with mulch. This will be of benefit to T10 providing an improved rooting environment.

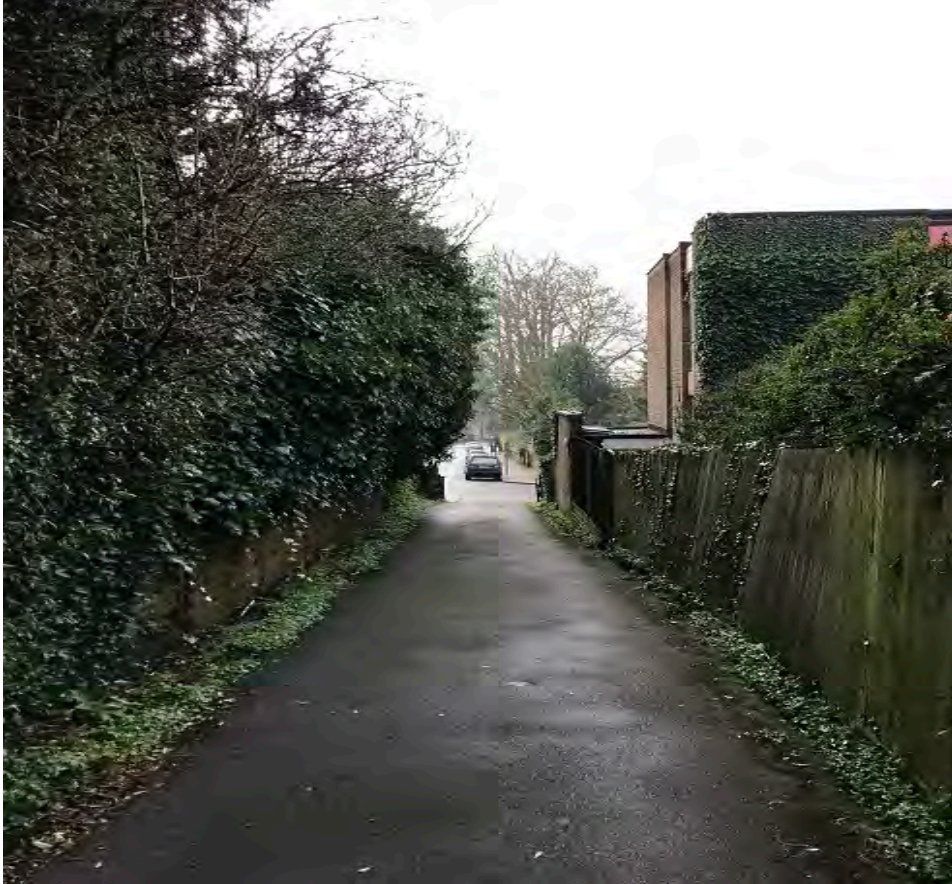
T4, T5 and T6 are 3rd party trees whose RPA clips the north-eastern corner of the site. Similar to T1, there is not an anticipation that significant roots will be found in this portion of the garden given the presence of a boundary wall and an established tarmac driveway [Figure 2] between the two.

Figure 2 Established driveway between 18a and 3rd party trees to the east
