TREE PROTECTION PLAN

ARBORICULTURAL REPORT

**12 Keats Grove
Hampstead
London**

7th October 2019

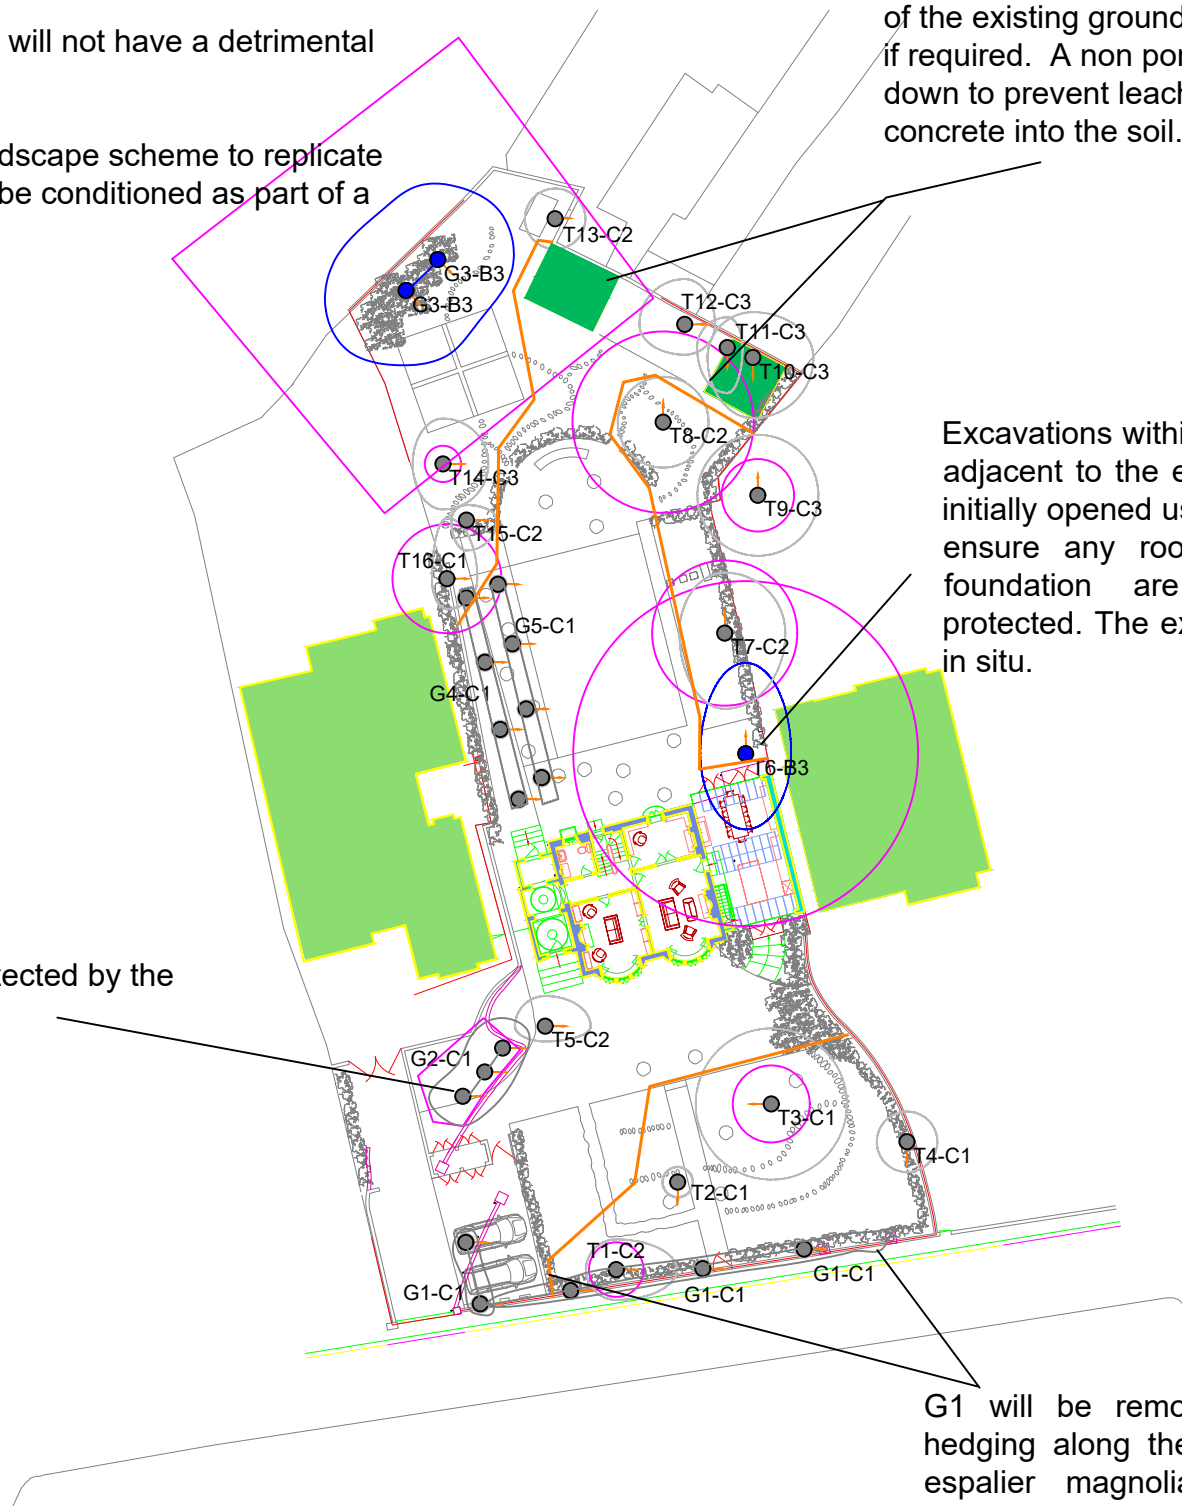
Trees to be removed to implement layout and landscaping:

G1, G4, G5, T2, T4, T5, T10, T11, T12, T13 & T15.

All low quality trees whose removal will not have a detrimental impact on the wider public amenity.

G2 retained and protected by the existing wall.

New planting is proposed in the landscape scheme to replicate and enhance the site, and this can be conditioned as part of a planning consent.

Base of garden room in this location to be on top of the existing ground level, with minimal leveling if required. A non porous membrane will be laid down to prevent leaching of toxins from the concrete into the soil.

Excavations within the footprint of the building adjacent to the existing foundation line to be initially opened using hand tools to 600mm, to ensure any roots growing parallel to the foundation are recorded and suitably protected. The existing foundation will remain in situ.

G1 will be removed and replaced with Yew hedging along the boundary with the road and espalier magnolia grandiflora on the return around the bin store in the property and protected, which will screen the property and not change the perspective from the street scene. See soft lanscape plan for details.

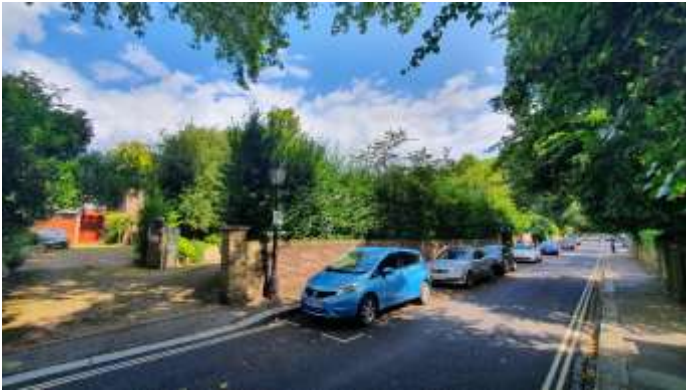
Showing G1 from outside of the site. The part to be removed is not visible

G1 will be removed and replicated with Yew hedging along the front boundary, with espalier magnolia grandiflora by the bin store to offer screening to the property, and not affect the street scene perspective.

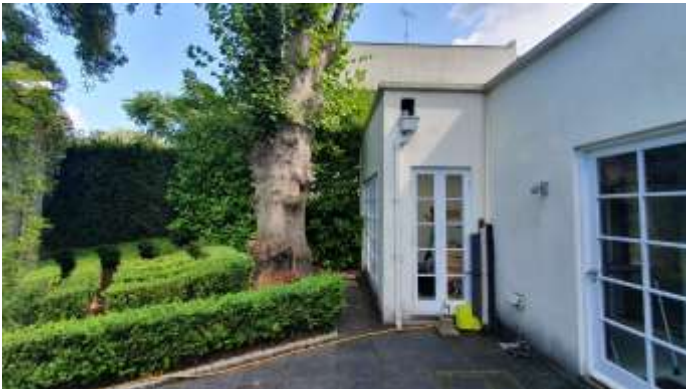
The main aspect in relation to this development in relation to tree protection and retention will be for the basement construction adjacent to T6. The plan shows the footprint of the building and the basement, which is to sit under the existing building, set back further from the original foundation line. Given the age of the building and the tree I believe it is likely that the roots from this tree have developed in a more parallel fashion with the existing foundation, rather than deeper and under the building. Therefore, it is less likely that the excavation works to install the new basement will impact on the tree. The project engineer has said that the existing foundations which are set closer to the tree can be retained and there is no reason for them to be removed, this will then mean the foundation that is acting as a barrier can be maintained and it is unlikely that significant roots will have developed beyond this and be affected by the new basement which is set back further. When undertaking the excavation works it will be better to start excavating from the rear to the front, so that if any roots are present, they can be suitably pruned clear and covered to prevent conflict. Limes are tolerant of root pruning, so its feasible if roots have extended below the existing foundation, they will be fibrous or minor roots. In my opinion I consider it feasible to implement the proposed layout and suitably protect and retain this Lime tree. Hoarding may provide better protection around the tree compared to heras fencing, because this will provide a solid barrier to protect from any debris that may accidentally fall during demolition. However, extreme care will be taken when demolishing the building in this location using a method to pull its down and away from the tree. The demolition contractor can provide further details as to how this will be achieved taking into account the protection of this tree and others on site. Arboricultural supervision will be important as well to ensure on hand advice is available during works to demolish and excavate the existing structure in this location. To ensure every effort to take steps to ensure roots do not get damaged unnecessarily the existing hard surface will be removed using hand tools where possible, or a pneumatic head on a digger under the supervision of an arborist. All debris will be removed by hand working back across the area from the furthest point, so that the ground in the RPA is protected by the hard surface as its removed. Where possible the hand dig method statement provided in **Appendix 3**, Will be followed when working in the RPA.

- Part of the RPA of T6 will need to be excavated to achieve the redesign of the building in this location, including the basement construction. Because the existing building is set closer to the tree and has likely been present for the same time the tree has been there, it is feasible that roots have grown in a more parallel fashion and the foundation line has acted as a root barrier.

Showing T6 and proximity to the existing building line with hard surfaces

Where the RPA of T6 will be compromised by the footprint of the redevelopment of this part of the building and the basement, it is feasible that significant roots will not be affected, for the reasons explained above. Any excavation works will be initially undertaken using hand tools with the supervising arborist present to undertake any root pruning.

- The existing foundations will be left in situ with the excavation for the basement being undertaken further back, where it is unlikely that roots from this tree will be impacted. Specific care and arboricultural supervision will be in place when undertaking the works to ensure the tree is suitably protected.

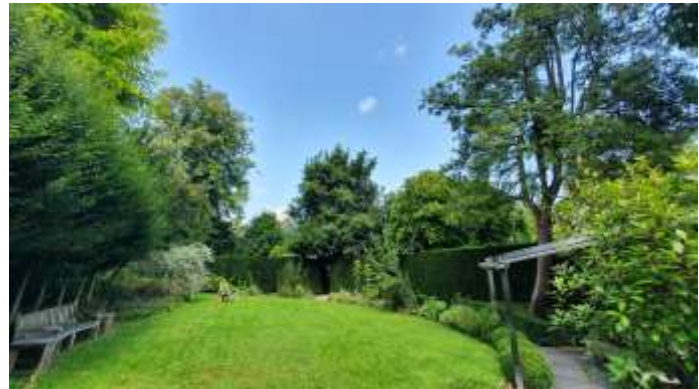
One of the garden rooms will partially encroach into the RPA of T8, this is a bay and would likely tolerate root pruning to clear when installing the base for this structure. BS5837:2012 allows provision for such hard surfaces to be accommodated in the RPA, as long as it doesn't compromise more than 20% of the total RPA. In this case it is under this amount for the total amount of RPA. However, minimal excavation for the base should be administered to level for the base, and a non-porous membrane laid down to prevent toxins from the cement leaching into the soil. This way the best protection as can be possibly afforded can be implemented.

A view down the garden showing T7 – T9, part of G3 & G5

Where the garden room partially extends into the RPA of T8, it is possible that no significant roots will be present, or none that cannot be pruned clear. BS5837:2012 does make provision for hard surfacing such as this to be located within the RPA, as long as it does not exceed 20% of the total area. Given the fact the amount of RPA crossed is less than this 20% value the tree is unlikely to be impacted. Again, measures can be put in place to afford this tree as much protection as possible to achieve the build and retain it.

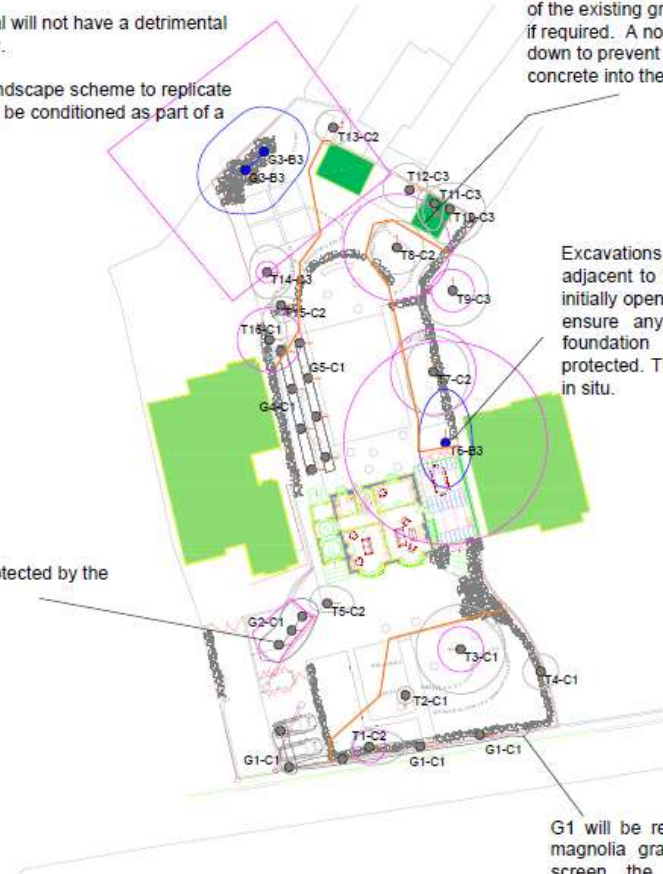
G2 retained and protected by the existing wall.

New planting is proposed in the landscape scheme to replicate and enhance the site, and this can be conditioned as part of a planning consent.

Excavations within the footprint of the building adjacent to the existing foundation line to be initially opened using hand tools to 600mm, to ensure any roots growing parallel to the foundation are recorded and suitably protected. The existing foundation will remain in situ.

G1 will be removed and replaced with espalier magnolia grandiflora and protected, which will screen the property and not change the perspective from the street scene.
