SITE RECORD DETAILS

INSURED: London Borough Of Camden

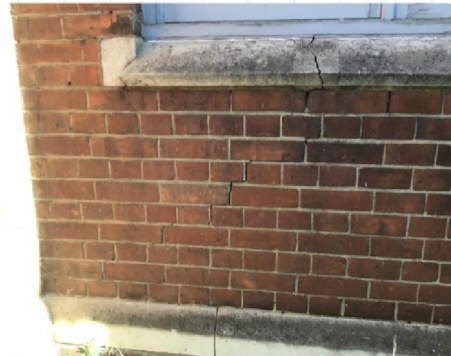
Crack To Left Flank Below Front Window

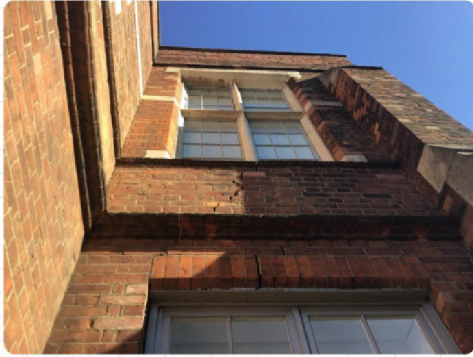
Crack To Left Flank Above Front Window

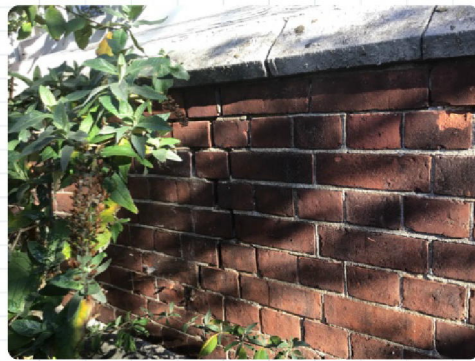
Crack To Left Flank Below First Bay Window

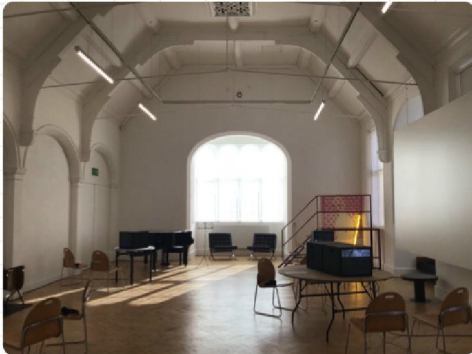
General View Of First Floor Gallery 3

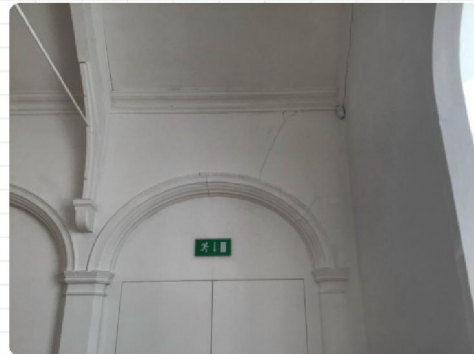
Crack Above Left Flank Internal Door In Gallery 3

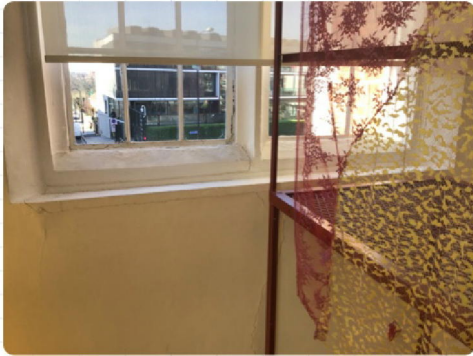
Crack Below RH Flank Window In
Gallery 3

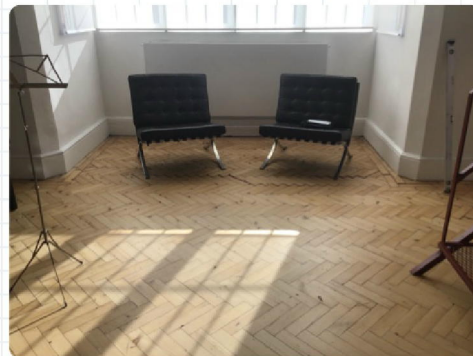
General View Of Crack To Floor To
Front Section Of Gallery 3

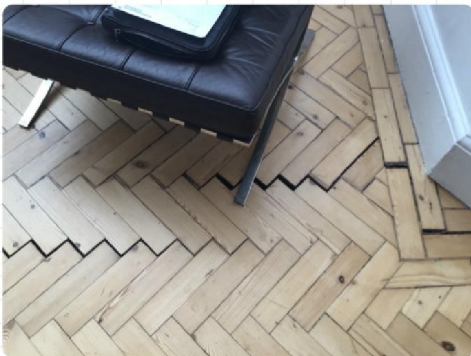
Close Up Of Cracking To Floor To
Front Of Gallery 3

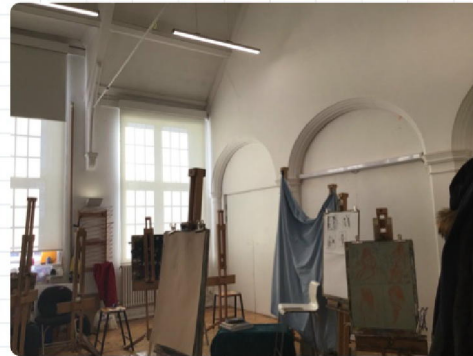
Crack Above Right Hand Door To
Flank Wall Of Drawing Room

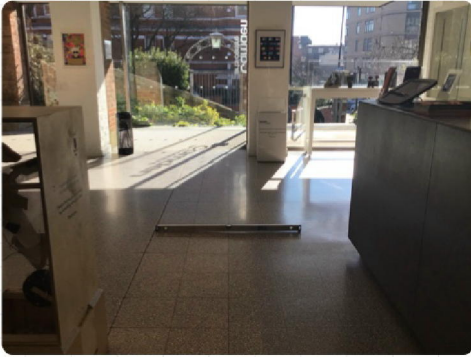
General View Of Movement Of Ground Floor In Front Entrance

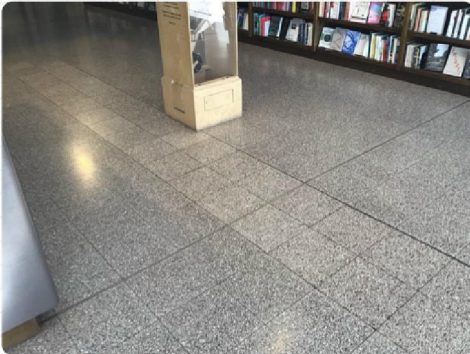
Previous Repair To Ground Front Entrance Floor In Same Area As Current Movement

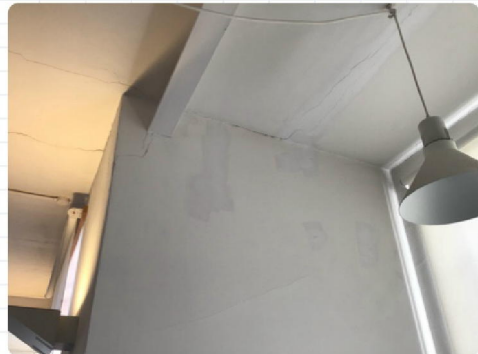
Cracking To LH Flank In Ground Floor Office

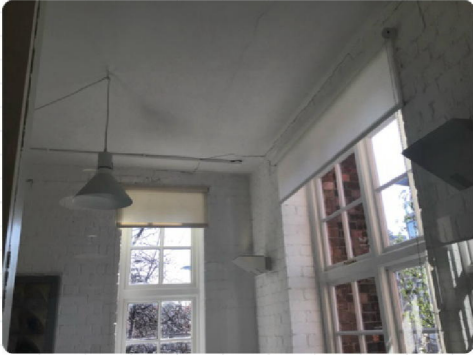
Cracking To Front Section Of Ground Floor Office

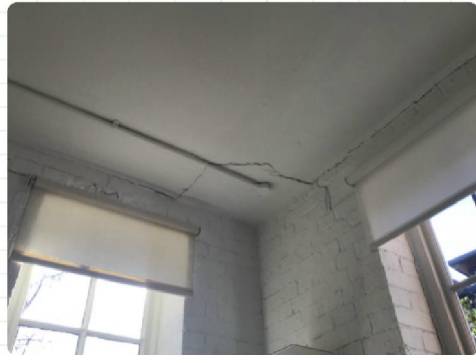
Cracking To Front Section Of Ground Floor Office

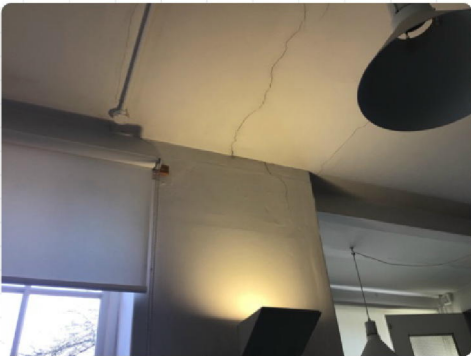
Cracking To Left Flank In Rear Main Ground Floor Office

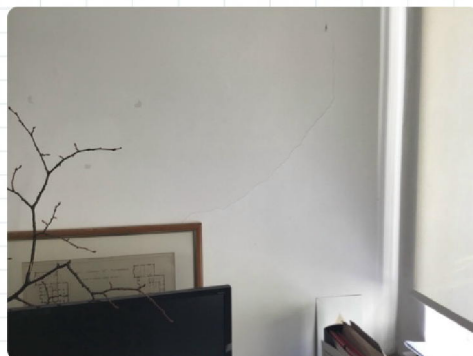
Cracking To Rear Section O& Left Flank Wall In Ground Floor Main Office
