DESIGN & ACCESS STATEMENT

**Proposed Repair of Part of the boundary Wall
To St Giles-in-the-fields Churchyard
at
45 New Compton Street,
Camden, London.
WC2H 8DF**

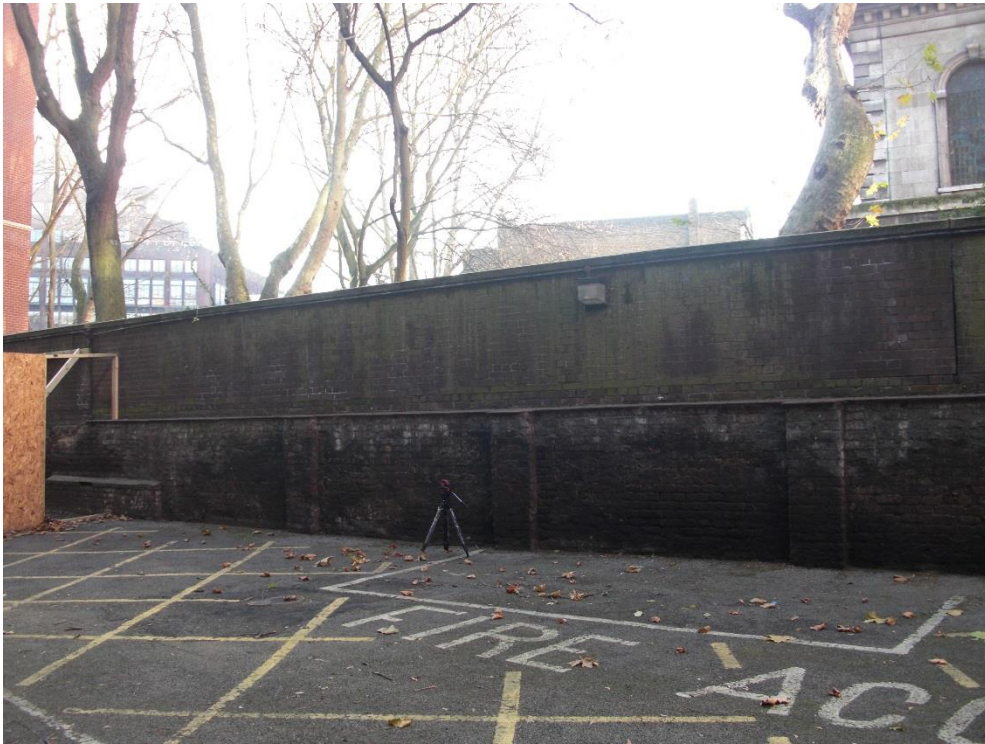
- 2.3 The existing wall is of mixed age and construction. The lower part, approximately 1.5m height, is a retaining wall and in poor repair. Above this is a C20 brickwork wall approximately 1.5m in height. This is divided into three panels with movement joints between each.

- 2.4 The southern end panel has moved significantly, leaning out approximately 150mm from vertical. The remaining parts also lean out by lesser amounts.

Wall from Car Park Side 45 New Compton Street

- 2.8 This proposal was dealt with by the Church under ecclesiastical exemption rules and a Faculty was granted for this work.
- 2.9 This current proposal is to construct 6 new buttressing piers to the failed length of wall to avoid the drilling of cores through the historic structure

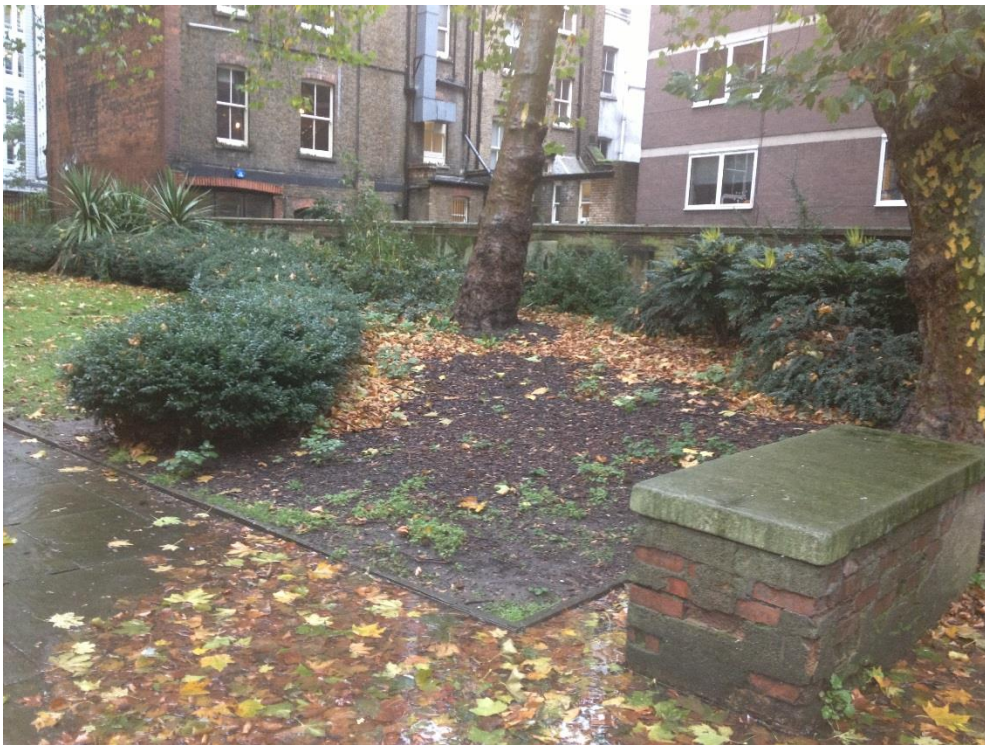
Wall from St Giles In The Fields Churchyard
