DR WILLIAMS'S LIBRARY- 14 Gordon Square, London WC1H 0AR

HERITAGE STATEMENT | NOVEMBER 2019

8555-CPM- ZZ-ZZ-RP-A-10001

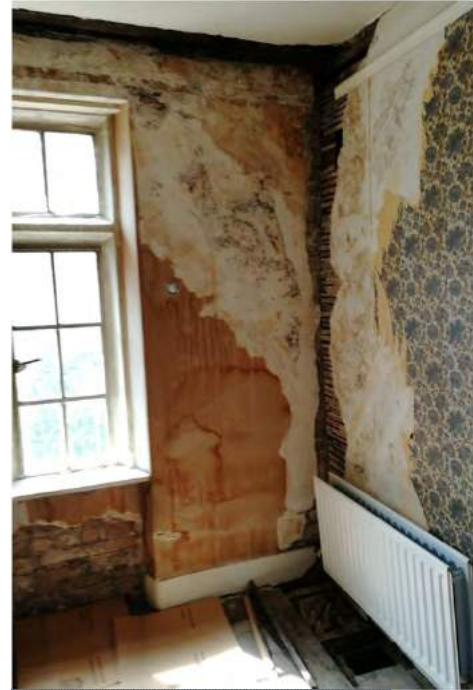
CONDITION SURVEY:
Plaster damage and structural failings on level 7

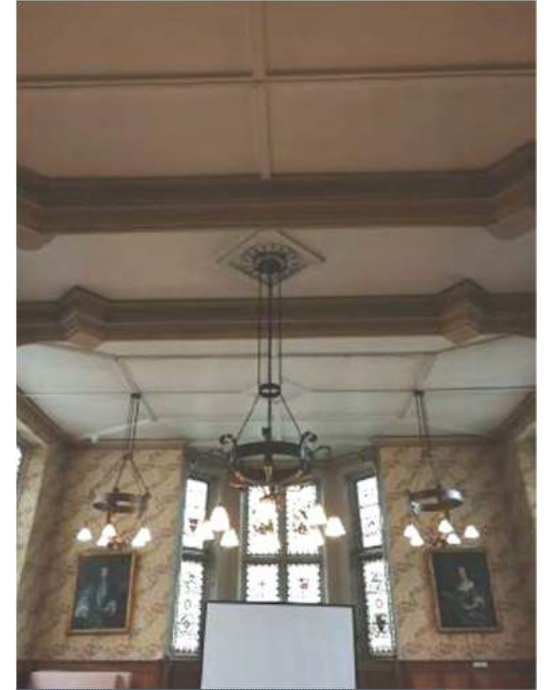
CONDITION SURVEY:
Lecture Hall- level 2, considered in very good condition

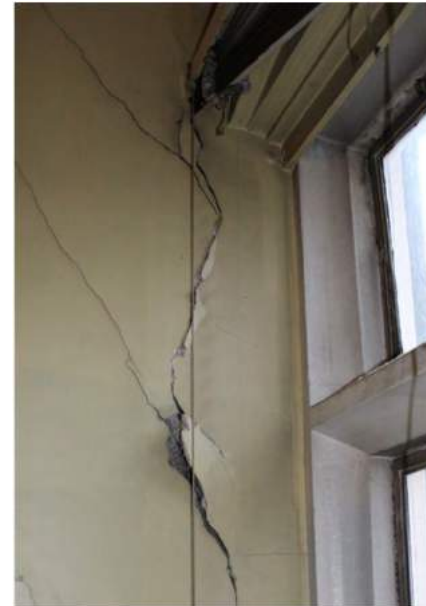
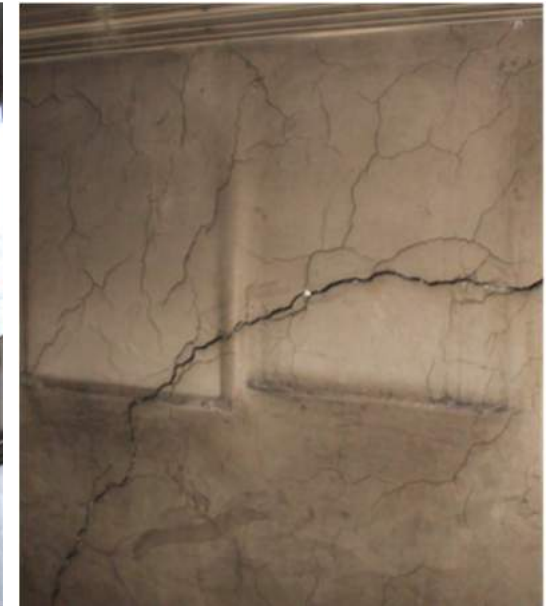
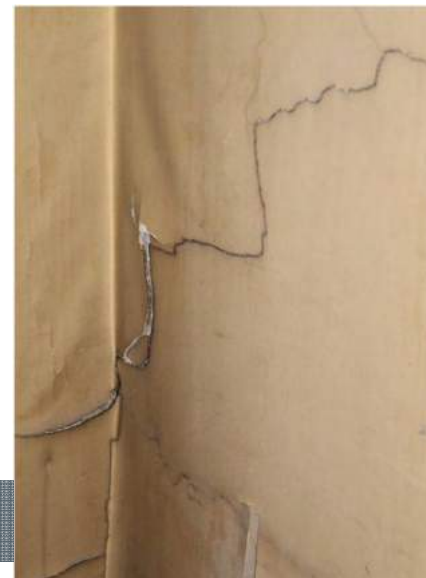
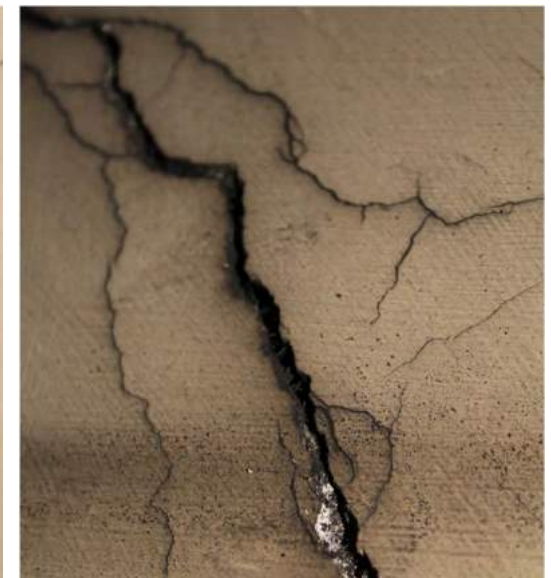
CONDITION SURVEY:
Structural cracking noted in various locations throughout the building.

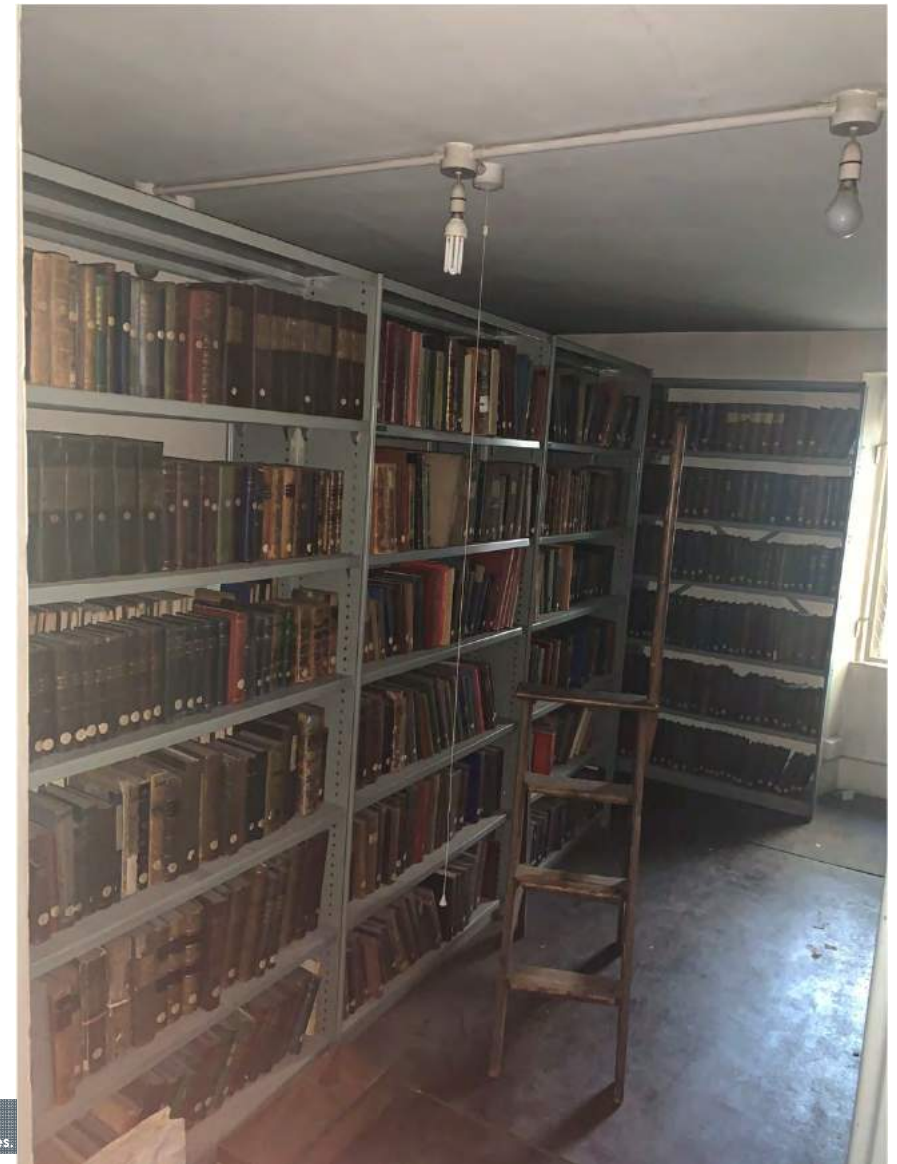
CONDITION SURVEY:
Example of current storage facilities.

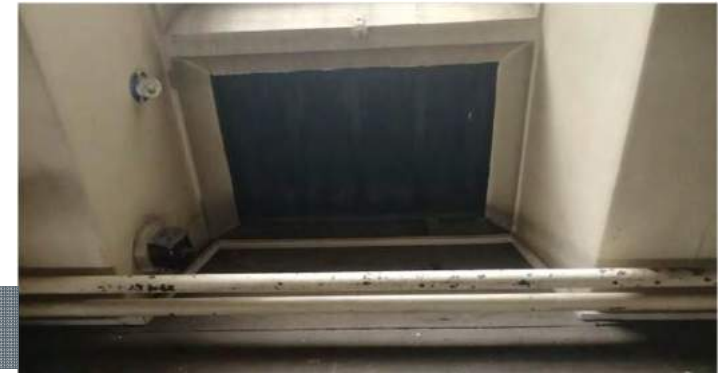
CONDITION SURVEY:
Pipes running in front of window recess.

It is proposed to achieve these ends by using new dedicated risers that will be incorporated in fire rated service routes. The routes will be designed to pass through the building in a sympathetic way requiring minimum intervention. The removal of the existing pipework distribution will return the existing staircases in particular to their original condition.

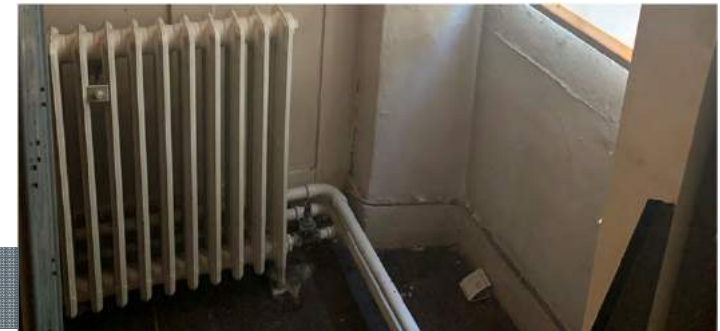
CONDITION SURVEY:
Pipes running in front of window recess.

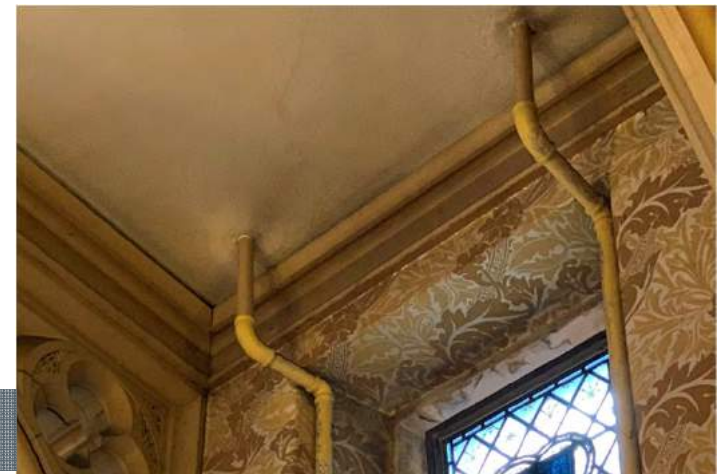
CONDITION SURVEY:
Pipes running within stained glass window recess within Lecture Hall.

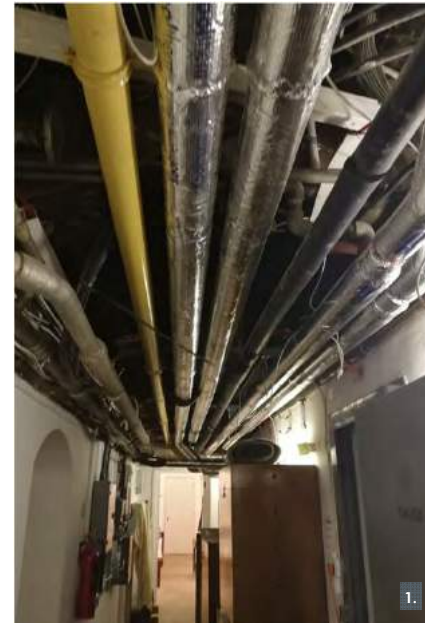
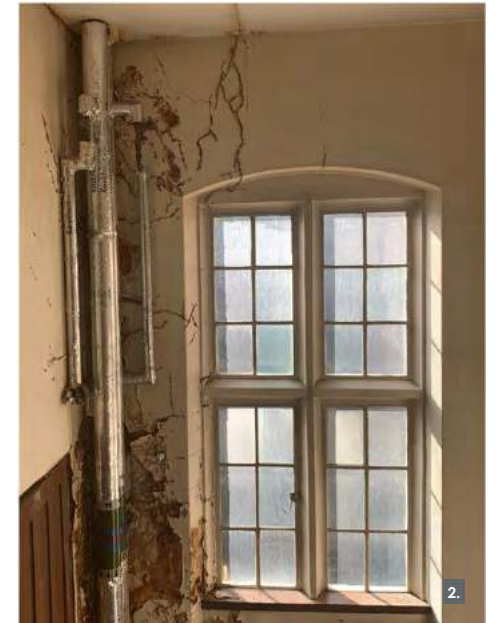
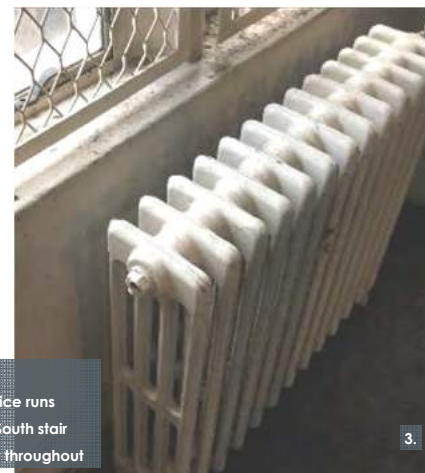
CONDITION SURVEY:
1- Existing exposed service runs
2- Heating pipes within South stair
3- Existing radiators vary throughout

New radiators will be provided throughout. The existing radiators vary in type and age and will be replaced with modern efficient column radiators. Technical specifications for the new radiators can be provided on request.

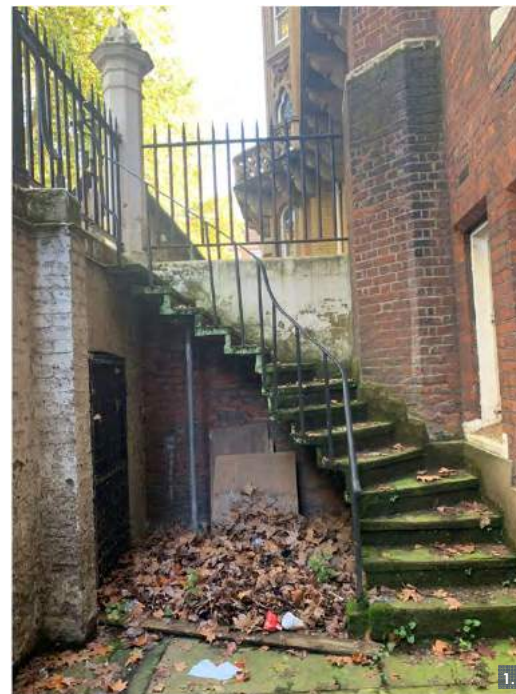
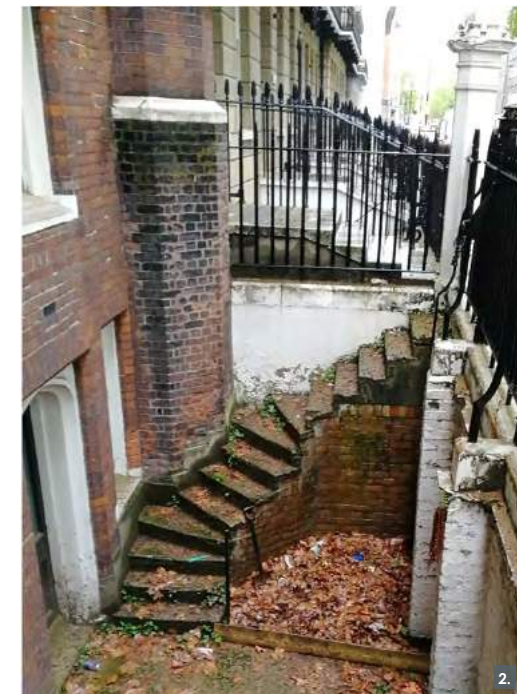
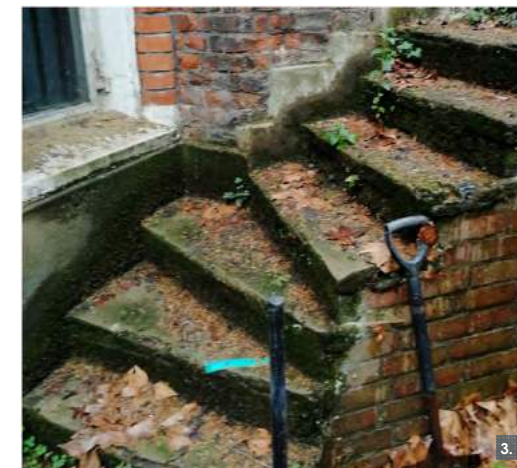
The two external stone staircases to the front of the building have now been deemed unsafe and unusable. Reference should be made to Appendix B, for the associated Structural Engineer's summary report. This highlights the core structural concerns with these stairs.

It will readily be seen from the associated photograph that the South Wing stair is currently propped due to concerns that it may collapse. The level of dampness is also clear through the level of moss growing against the building. This dampness is penetrating into the interior of the building and over time has caused harm to the original fabric. This is the case with both the North and South stair.

CONDITION SURVEY:
1- South Wing- Stair propped to avoid collapse.
2- North Wing- Stair supported by brickwork, cracking evident
3- Close up of damp penetration into Historic Asset

While both stairs are believed to be original to the building, they are in need of complete replacement. The trust wish to replace both sets of stairs with modern metal staircases. These will be designed to reflect the historic railing pattern

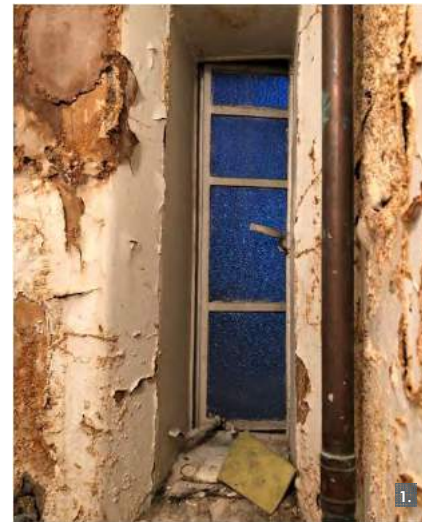
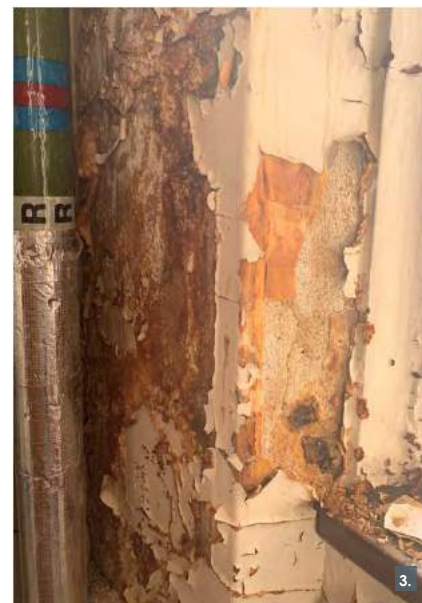
1- Plaster damage to window reveal (water ingress)
3- Plaster damage due to water ingress

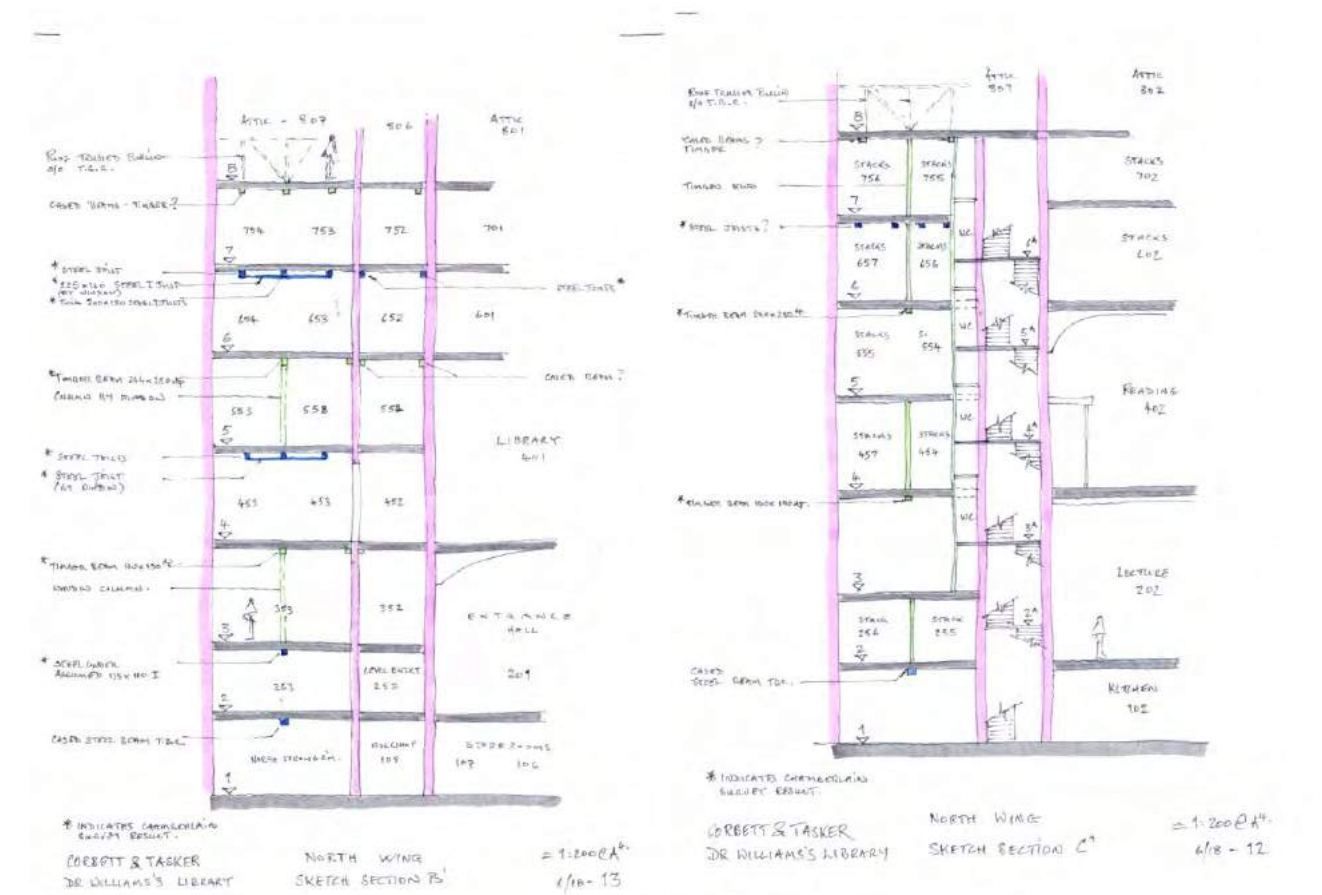
The north part of the building was previously structurally surveyed and assessed with recommendations for additional supporting beams and restrictions in loading. It appears from an initial study that some of these recommendations have not been executed and excessive deflections were recorded in some rooms. This is probably due to the loads from the book stacks exceeding the 'design' loads and in part due to the previous recommendations not being carried out. This is particularly critical in the rooms on the west side where loads from the upper levels are supported on a relatively small cased ceiling beams, which may be causing the excessive deflections in the upper rooms.

Figure 3: Sections showing existing observed structure at north wing. Left: section in east bay, looking east. Right: section in west bay, looking east.

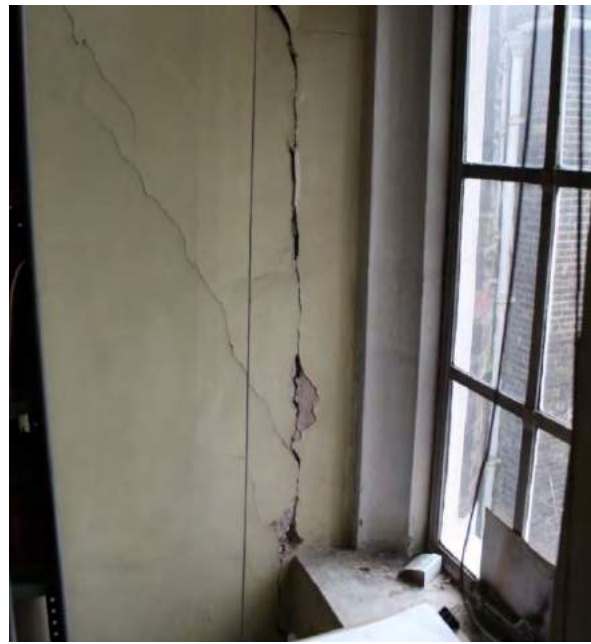
Excessive floor deflections were noted in levels 5 to 8 of the south wing, which are probably caused in part by excessive floor loading and insufficient support along the stud partition walls running east to west. The deflections on the west side may have been partly caused during building works for the WC's at level 4, although it is also possible that there was excessive deflection of the small landing WC rooms before the new beam was inserted. The floor deflections in the south wing have caused cracking in the associated timber stud walls.

Figure 4: Cracking at internal partition walls (assumed loadbearing) where large floor deflections were observed

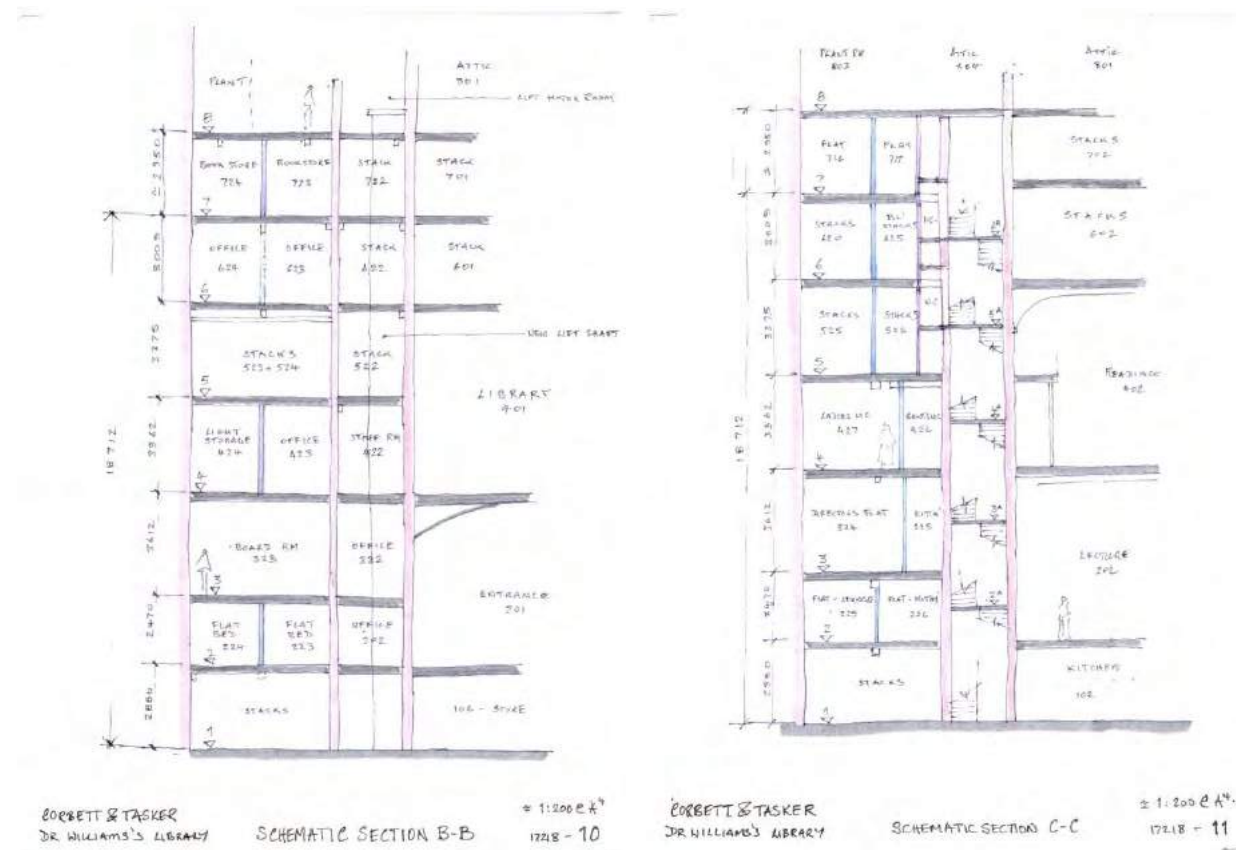
A section drawing of the south wing west side (see Figure 5, right) clearly shows the critical nature of the ceiling beam which effectively supports levels 5 to 7 together with added roof load including plant room and water tanks. A similar situation exists on the east side (see Figure 5, left), exacerbated by the significant book storage on level 7 and the book stacks on level 5.

Figure 5: Sections showing existing observed structure at south wing. Left: section in east bay, looking west. Right: section in west bay, looking west.

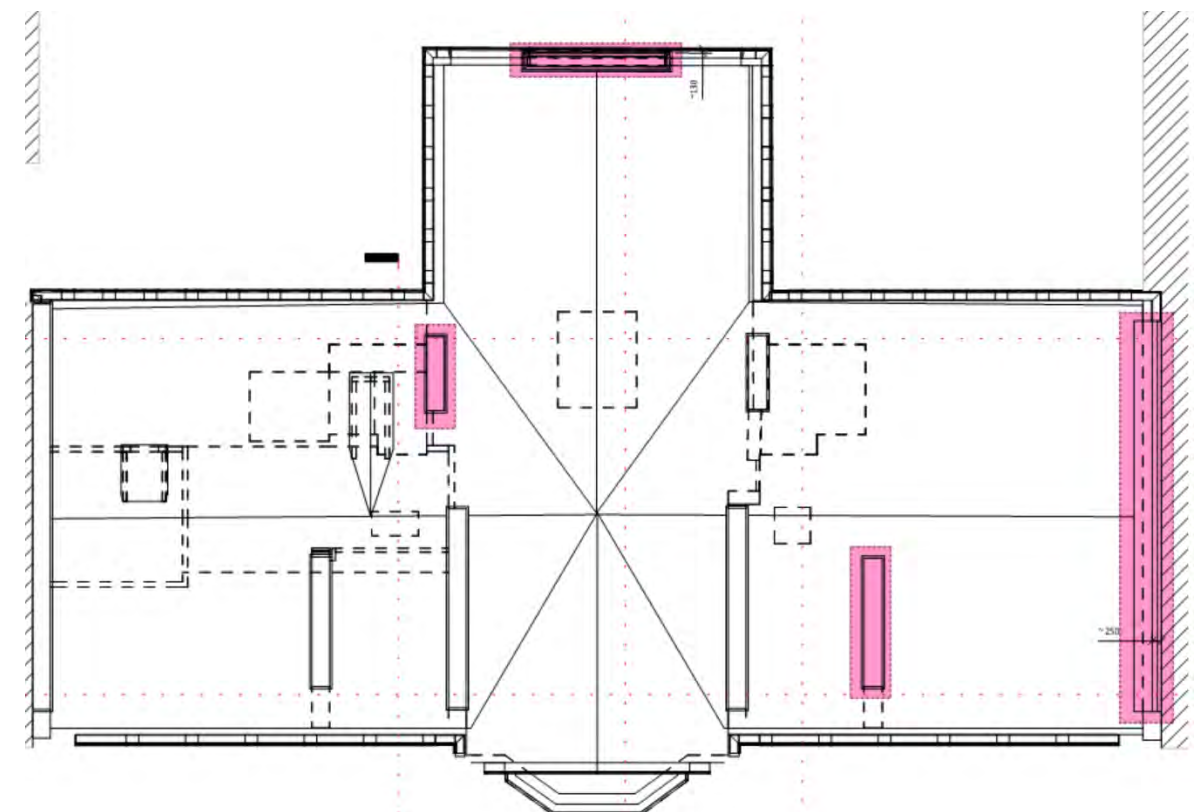
Some of the chimney stacks have laterally deflected; the main stack to the north gable wall is severely out of plumb, plus others have been noted. The chimneys of the north and south gable walls cantilever up from the existing roof level, at the front and back this is a large cantilever as the roof is at its lowest point at these locations.

Figure 9: Roof plan with Chimneys thought to be deflection excessively highlighted in pink

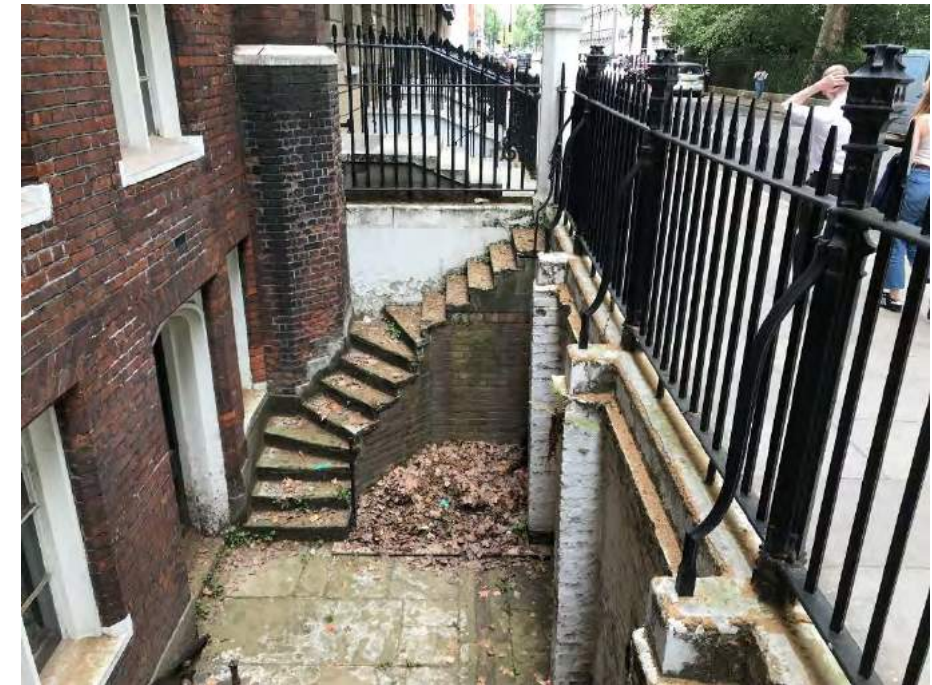
Figure 13: North external staircase

This is constructed with stone treads and risers built into the side walls and east wall of the library and supported on a masonry wall to the inside edge. The current opinion is that this 'inside' wall is not from the original build and was built as a repair and strengthening to the original 'cantilevered' stone stairs. The treads and risers are in poor condition (probably accounting for the need to repair) and need to be replaced. There are numerous cracks between the stone treads and the brickwork below which may indicate some subsidence of the wall. The balustrade uprights and handrail have been removed due to inadequate connection to the treads.

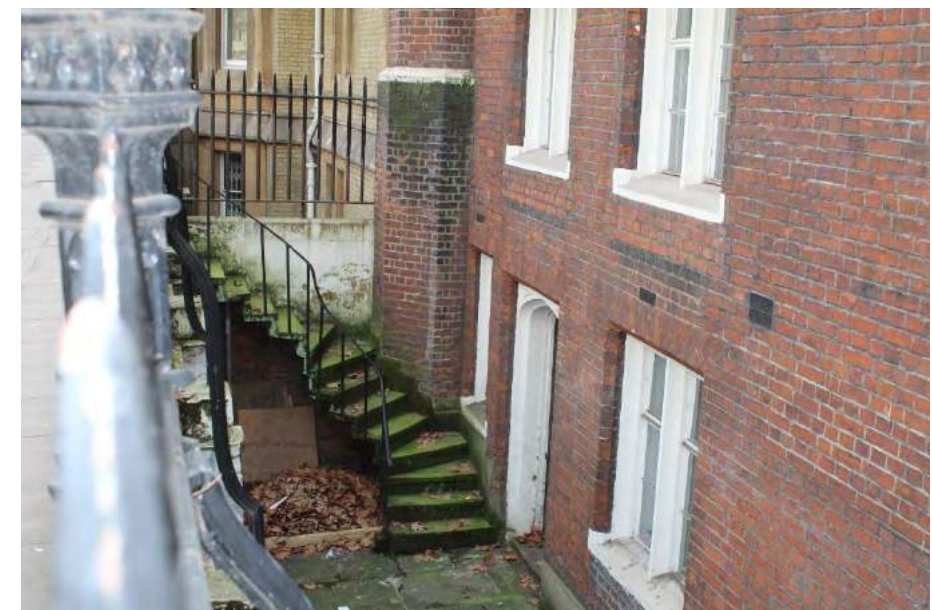
Figure 14: South external staircase

Corbett and Tasker's opinion is that this is the original 1840's staircase design using cantilever-shell structural principles. The risers and treads are supported on one side by the adjacent party wall and the external east wall of the library. Unlike the north staircase, the 'free edge' is unsupported and relies on a continuous shell action to transmit loads to the base. Unfortunately many of the treads and risers are in very poor condition with the result that the structural integrity is severely compromised. This has resulted in a temporary prop being used to prevent a collapse. The original balustrade and handrail are in place although an upright has been removed due to excessive degradation of the stone. The stairs are structurally unsafe and require replacement.
