# *The Heath & Hampstead Society*

**Planning Ref:** 2019/5710/T  
**Address:** Camden Arts Centre  
**Case Officer:** Tom Little  
**Date:** 5th December 2019

This is an objection to this Notice of Intent to fell trees here.

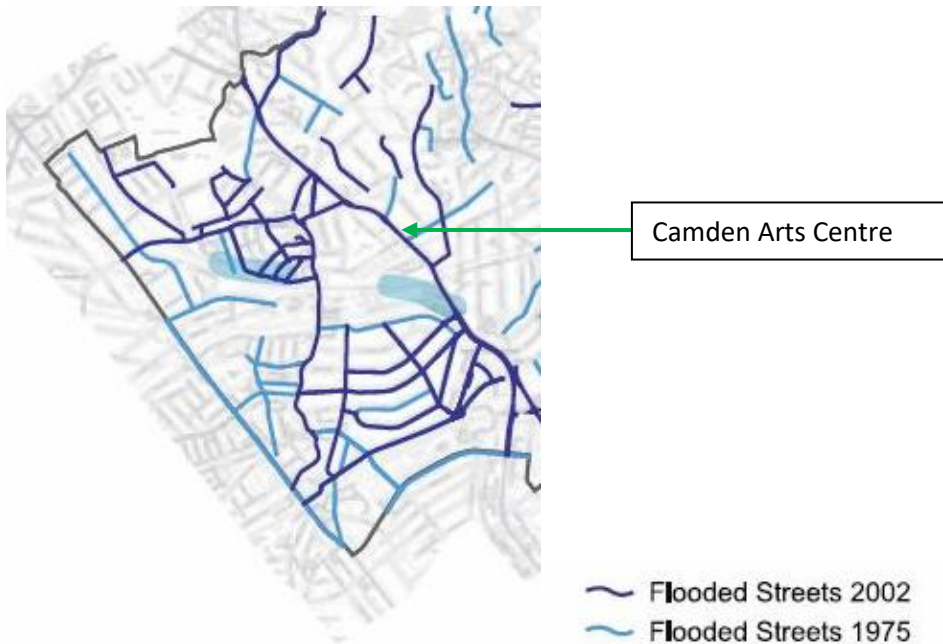
From 'Flood Map' Figure 15 of ARUP's Camden Geological, Hydrogeological and Hydrological Study.

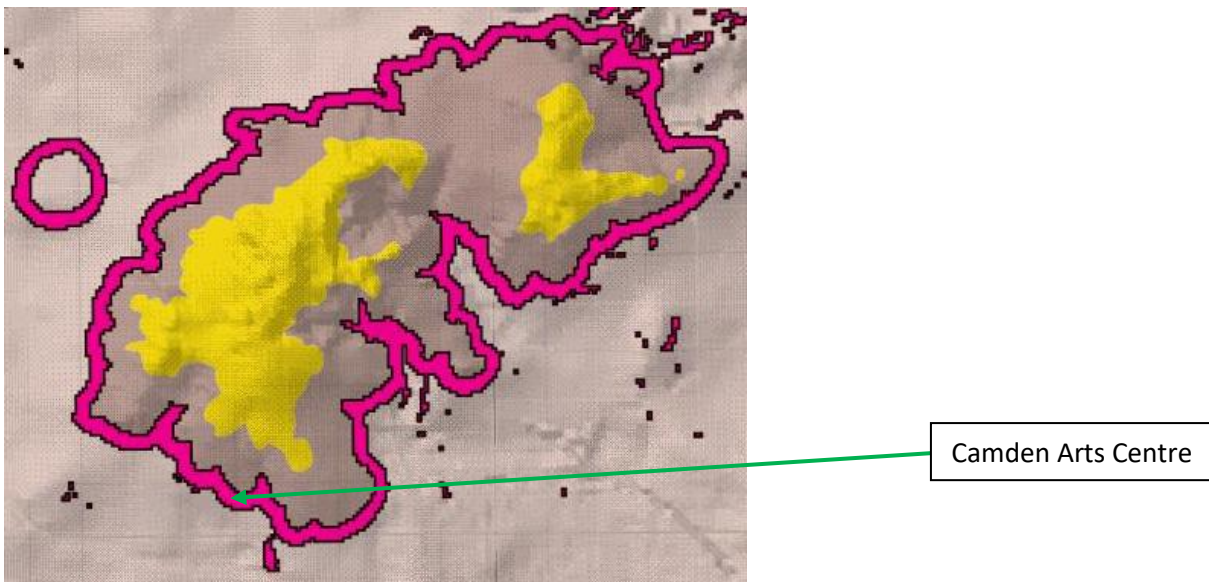
Another factors again here is that of landslip and the steepness of the slope as Arkwright Road joins the Finchley Road. It can be seen (below) that CAC is right on an area of greatest potential for slope instability, just at the point where there is a considerable amount of slip-lubricating groundwater. The history of this site indicates that landslip is likely to be occurring.

**Areas of greatest potential for slope instability**, from BGS North London Sheet 256

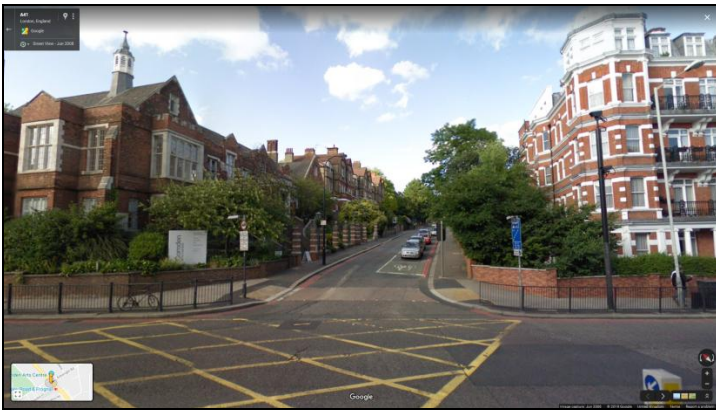
May 2008 Poor roadway state at junction with frequent patching, some due to water mains leaking & bursts

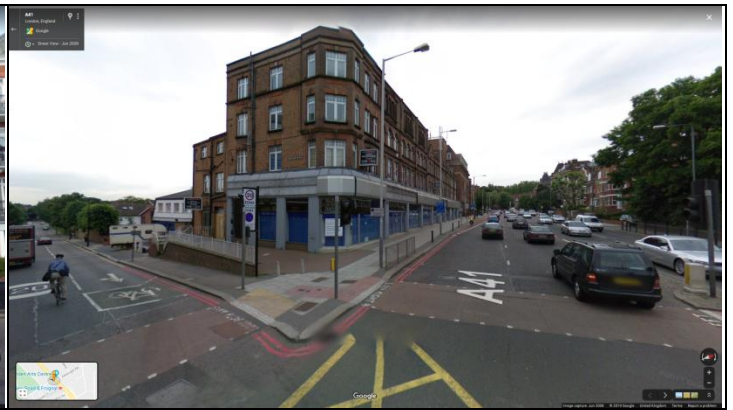
June 2008 Subsidence pre-JW3 corner opposite

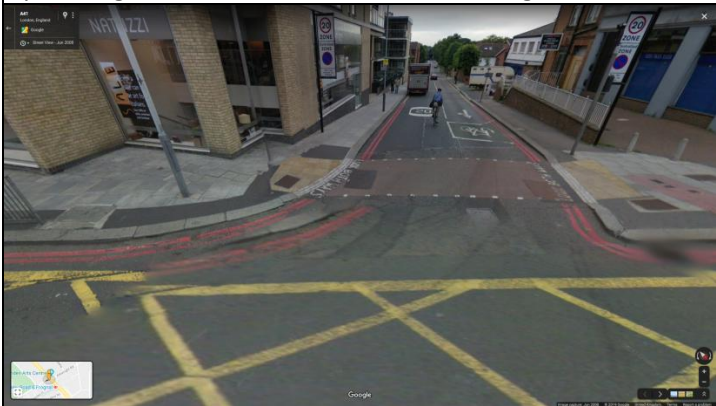
June 2008 Subsidence junction outside Natuzzi opposite

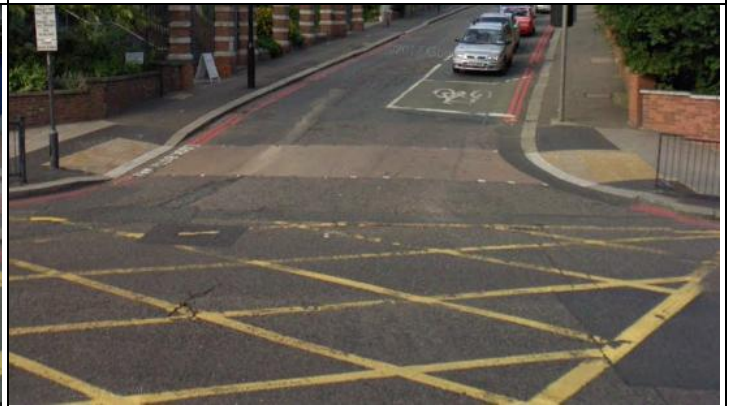
June 2008 Poor junction state, subsidence & frequent patching, some due to water mains leaking & bursts

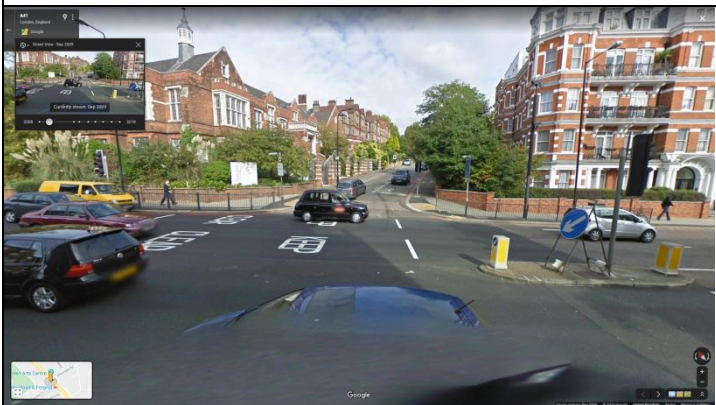
Sept 2009 new tarmac Finchley Road junction

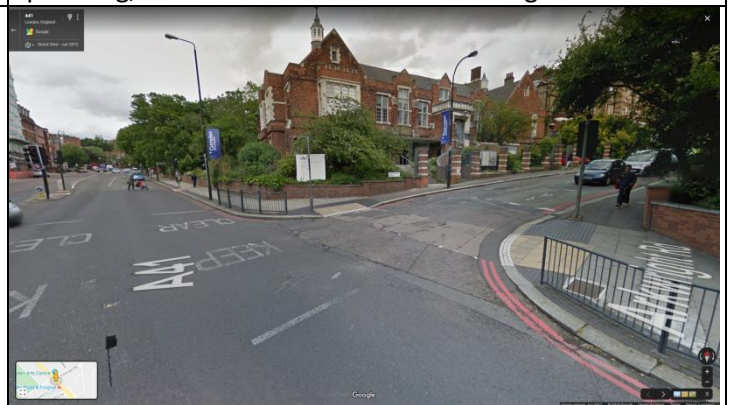
June 2012 patched junction but dip - exhaust scrapes - adding to vibration

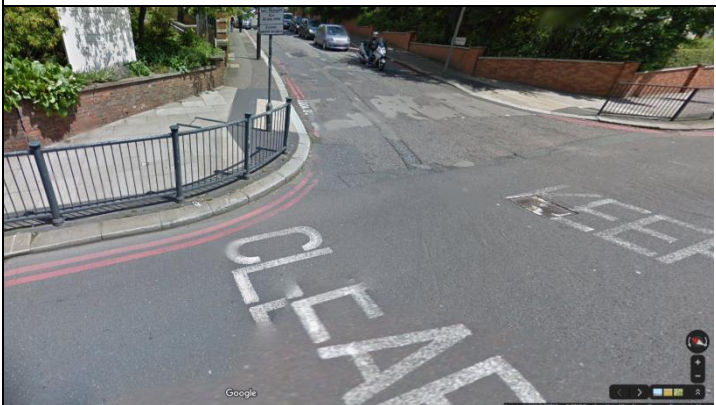
July 2012 Dip at junction - exhaust scrapes increasing

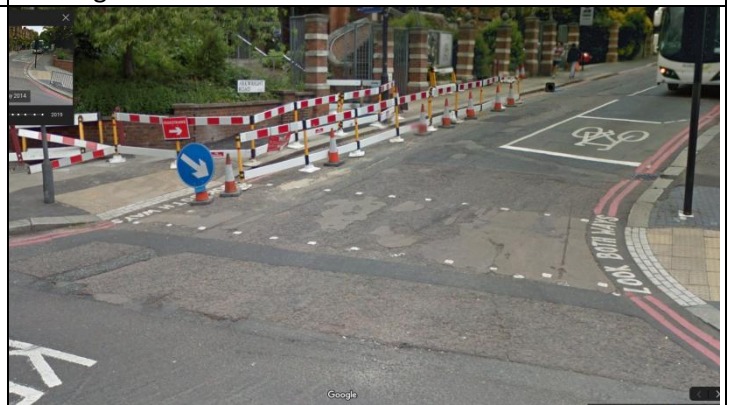
May 2014 Dip at junction deteriorating

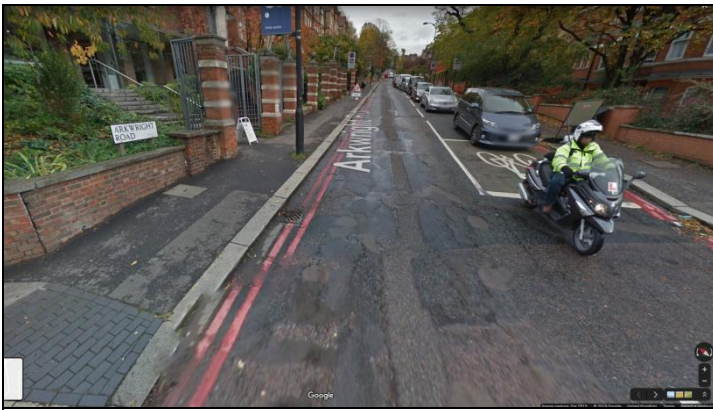
Oct 2015 surface water run-off down Arkwright Rd into drains with silt

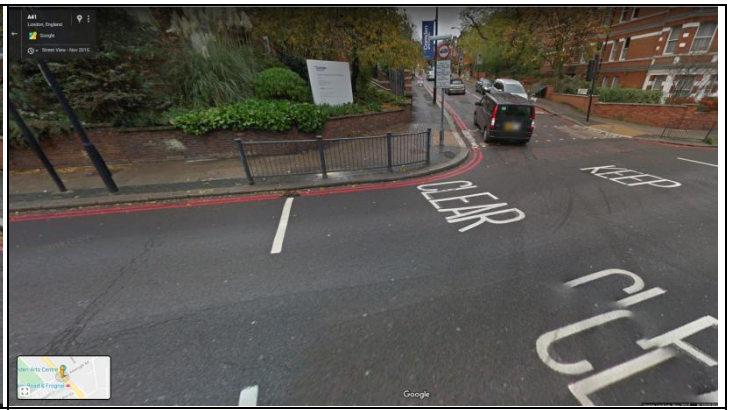
Nov 2015 Cracking across Finchley Road's new tarmac suggesting on-going erosion and subsidence of the area

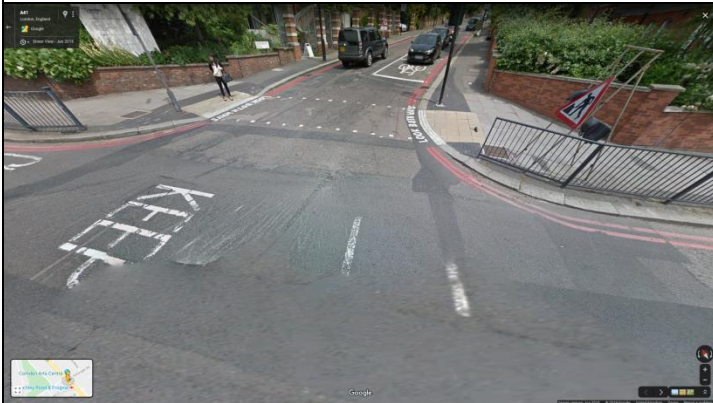
June 2016 Continuing subsidence + service repairs

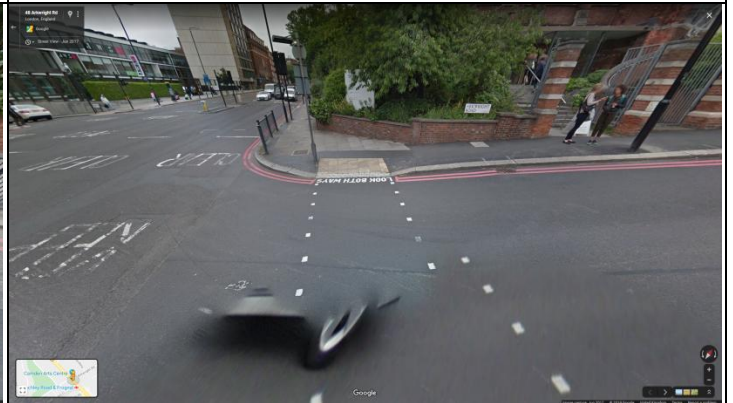
June 2017 Dip filled & new tarmac bottom of Arkwright Rd

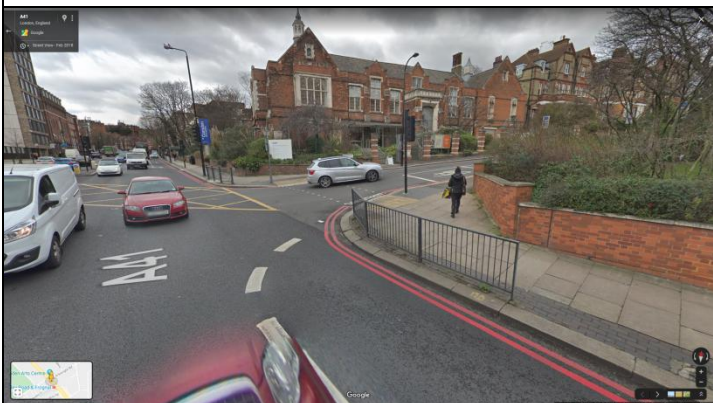
Feb 2018 New tarmac Finchley Road

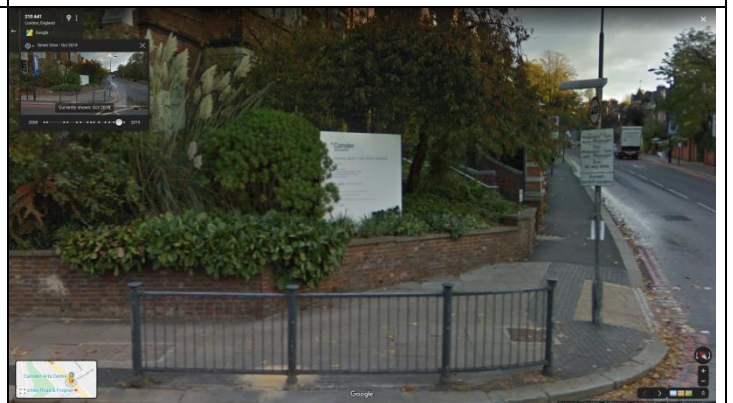
Oct 2018 Pavement and roadway water

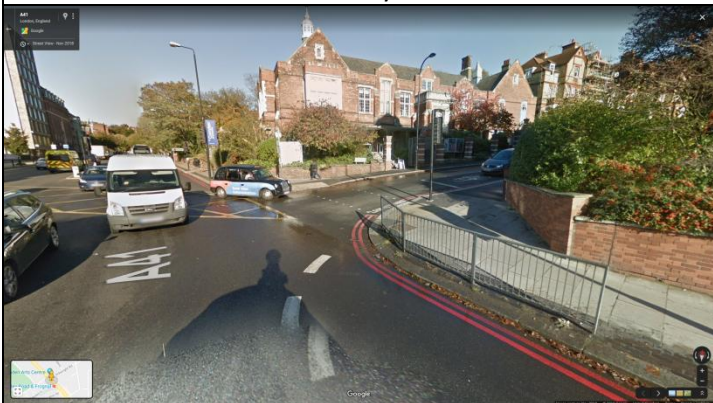
Nov 2018 Burst water main - many occur here and at other places along this section of Finchley Road, not picked up by snap-shot Street View

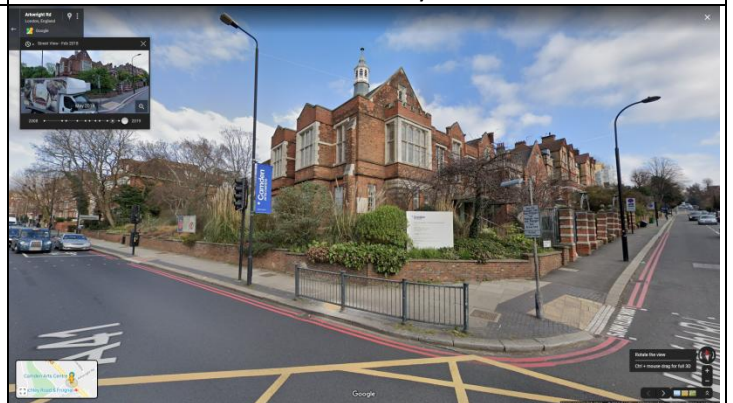
May 2019 Road mended, water still appearing on pavement

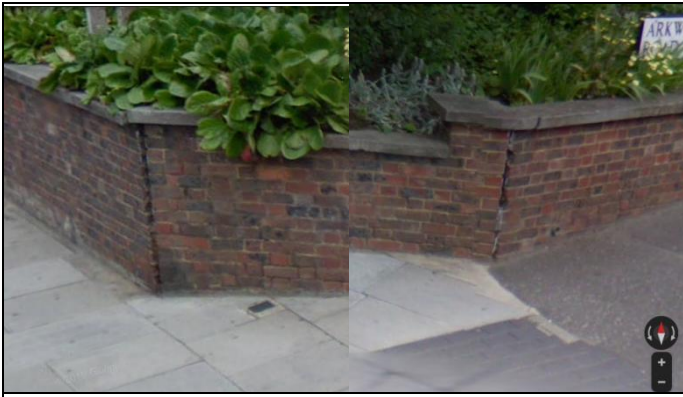
June 2008

I think all this is reflected in Historical Street View of the junction here that demonstrates on-going subsidence of the roadway junction at the bottom of Arkwright Road and Finchley Road in places. Unfortunately with only 1-2 snap-shots taken each year, the months and months of leaking water down Arkwright Road and at the junction that occurred in many years are not always shown. Movement of the front garden down the hill with dropping of boundary wall sections and opening out of cracks and of joints in that direction can be seen.

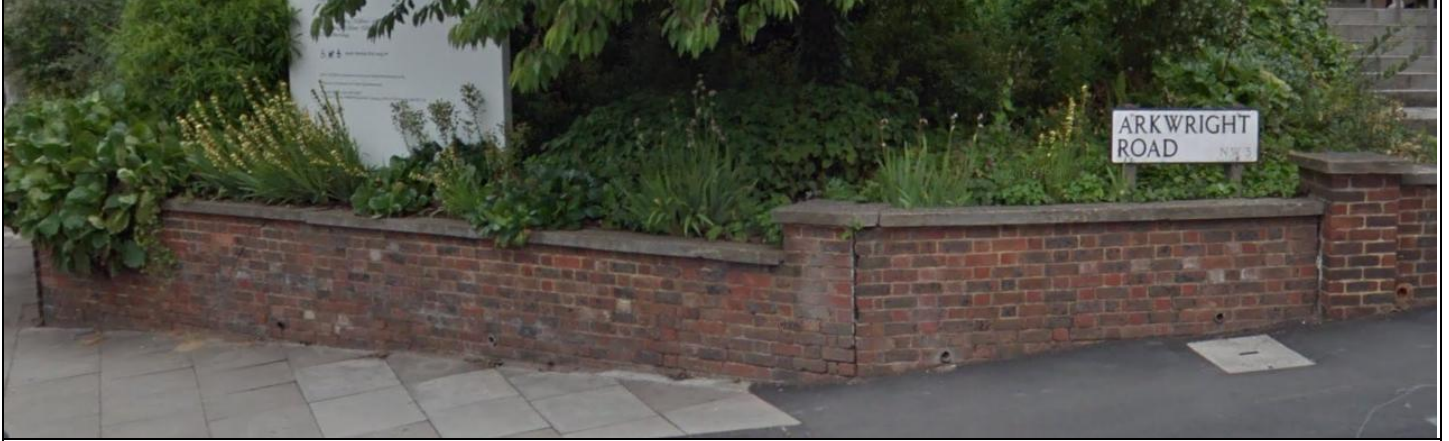
It would seem to provide support for the theory that the groundwater known to flow down here has washed out the foundations below both roadways, water mains, drains and the CAC, has lubricating some landslip and been fracturing further mains and drains for years. CAC itself has some drains fractures probably emanating from landslip. From the drains report: 'MH1 upstream to RWP1 Run 1: Condition B - cracks and fractures observed at 1.3m, 2m and 2.1m; unserviceable.' The water mains problems just by the steep drop in Arkwright Road would seem to coincide with cracks evident under the first floor window of the Finchley Road flank wall in Sept 2017 onwards, that seem not to be there in July 2016 though the Street View shot is unclear.
