Tree report in accordance with BS 5837:2012

Site Address: 18a Frogna Gardens, London, NW3 6XA
Ref: 031682

Report Date: 28th August 2019

Demolition of existing structure and construction of a new 4-storey dwelling in its place

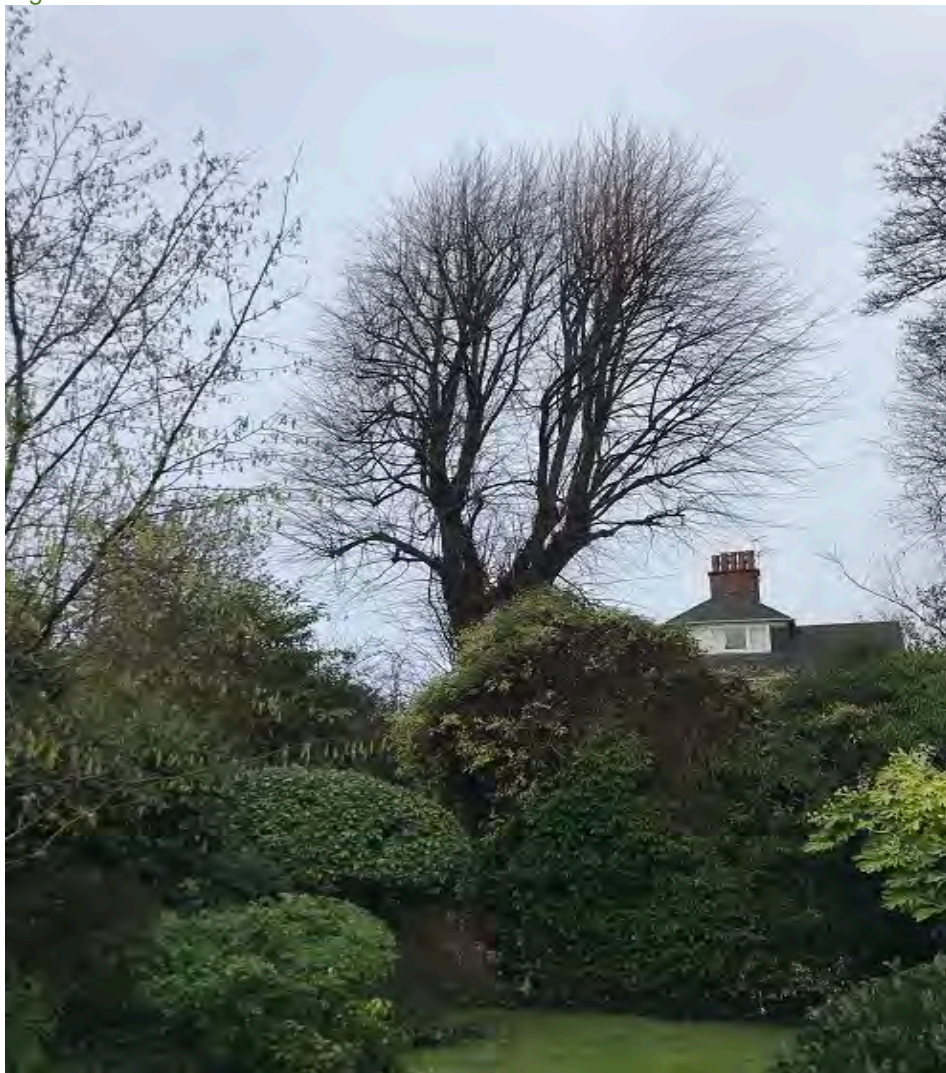
Figure 1 T10

2.2.4 The most significant tree with respect to the proposal is a lime (T10) [Figure 1] located towards the rear boundary of 18a Frognal Gardens' rear garden. No works are planned to occur within the RPA of this tree.

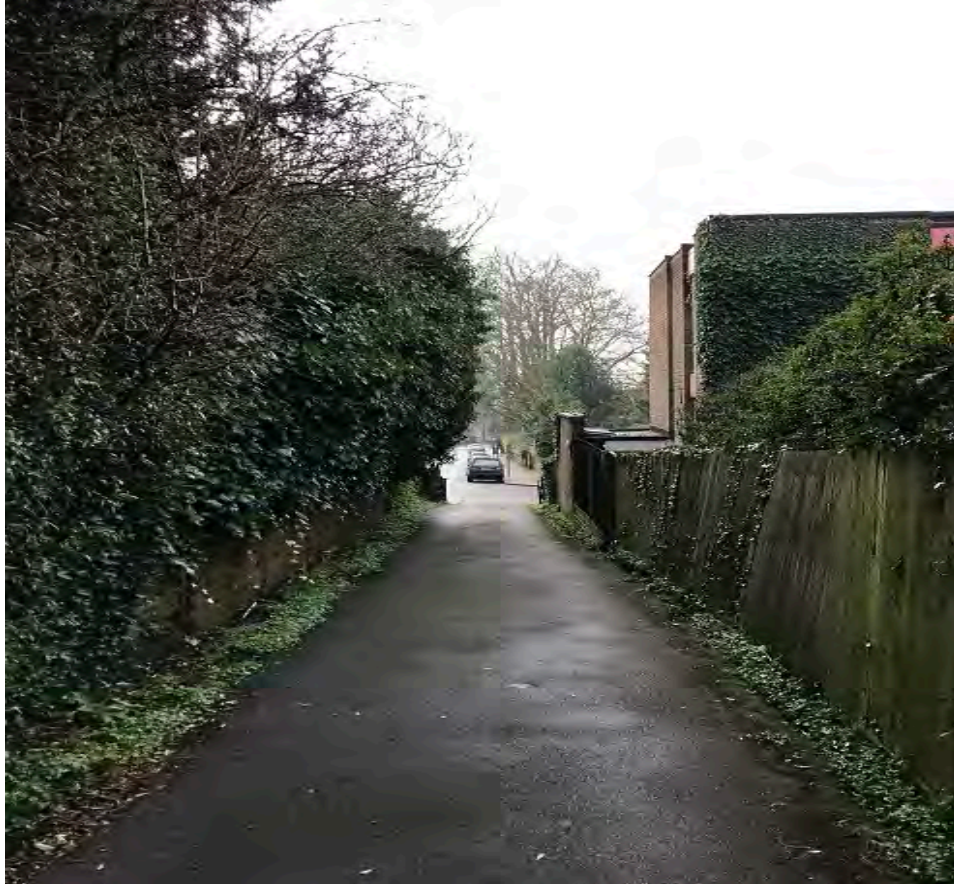
Figure 2 Established driveway between 18a and 3rd party trees to the east

T4, T5 and T6 are 3rd party trees whose RPA clips the north-eastern corner of the site. Similar to T1, there is not an anticipation that significant roots will be found in this portion of the garden given the presence of a boundary wall and an established tarmac driveway [Figure 2] between the two.
