# 1EW02 Enabling Works – Area South

## Heritage Agreement Method Statement

### Alteration and Temporary Protection Methods for Party Wall between Royal College of General Practitioner’s Building and Walkden House

Document number: 1EW02-CSJ-HS-MST-S003-000625

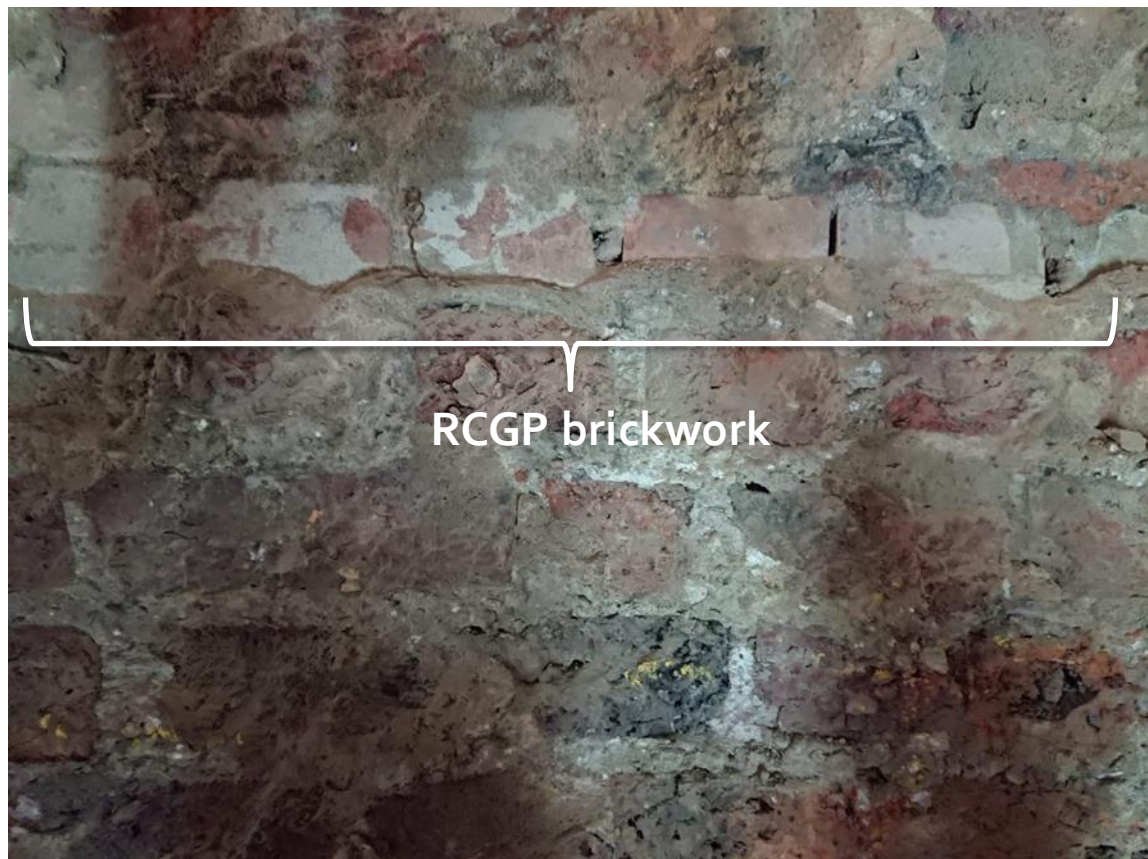
*Figure 6. Early 19th century brick scabbled back during the construction of Walkden House, revealing the RCGP northern elevation in the top of the photo (Mott MacDonald, 2019)*

- 2.2.15 As per Figure 6, looking at party wall face from within Walkden House (Level 1) this shows the fragmentary remains of the pre-existing early 19<sup>th</sup> century brickwork (up to c.50mm in depth), which had been dressed back when the RCGP extension was built. This 19th century brickwork covers the later RCGP brickwork, visible as a single course in the photo. The RCGP wall was apparently built flush against the retained, scabbled 19th brickwork - the brickwork and the remains are quite well bonded to the RCGP wall.

- 3.3.2 The remains of earlier brickwork (thought to belong to the 19<sup>th</sup> century terrace) overlying the RCGP wall face (in a thin layer) will be carefully removed by hand by a mason suitably experienced and skilled in historic brickwork. Removal will permit inspection of the underlying RCGP brickwork, to verify brick bond and condition and to facilitate installation of protection to the exposed RCGP party wall.

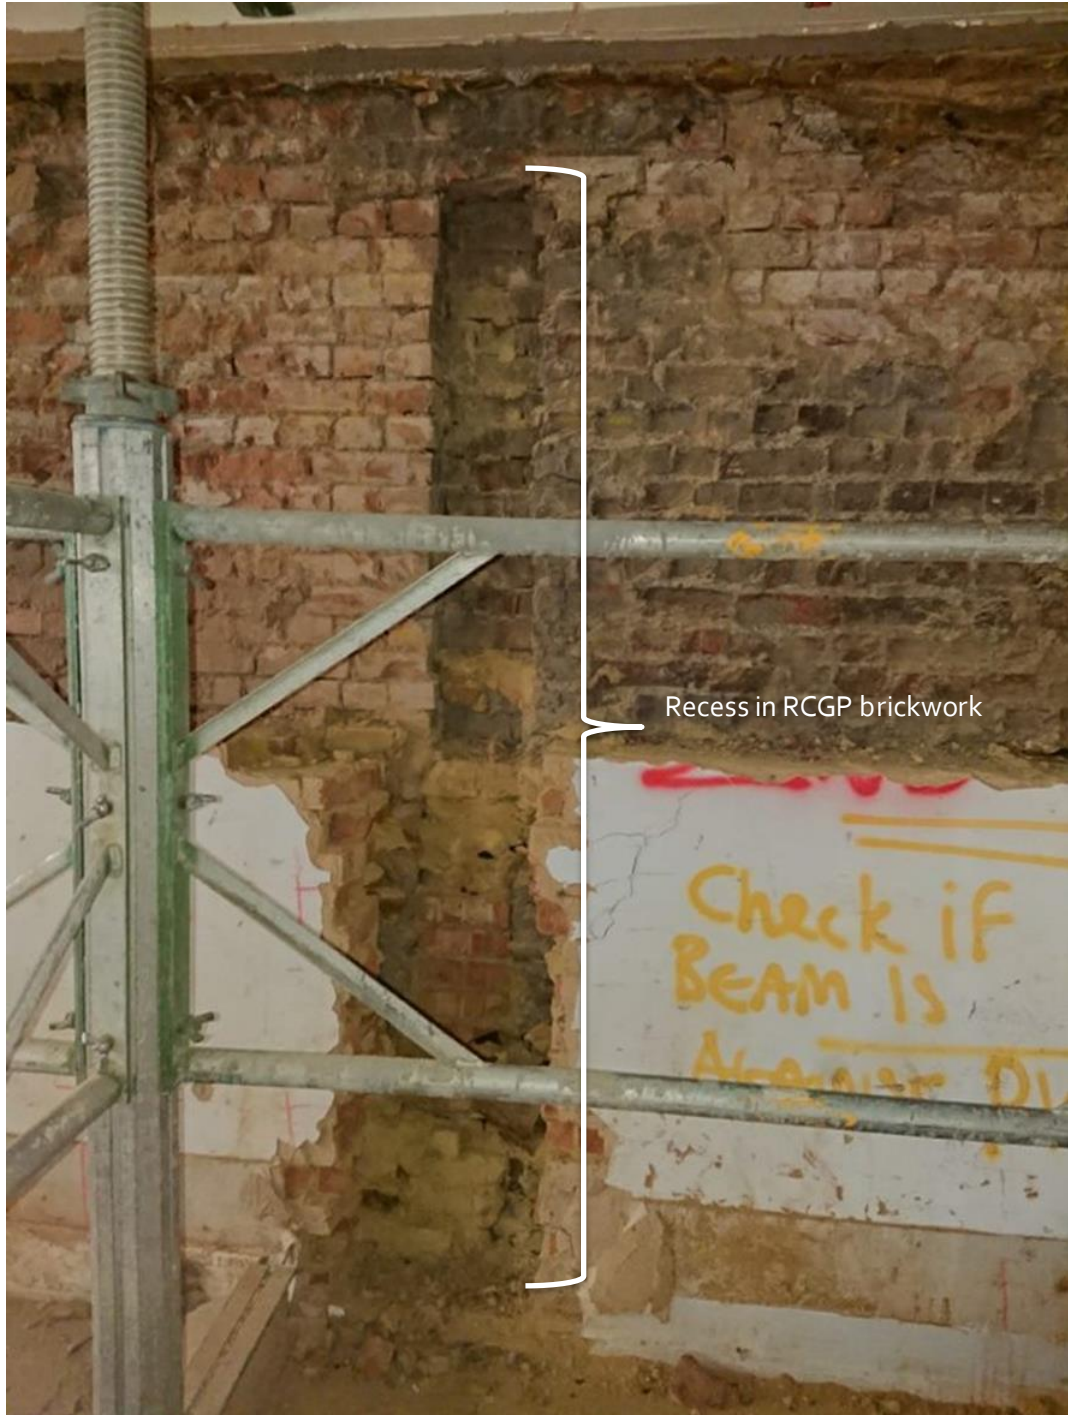
Recess in RCGP brickwork

Figure 9. Recess in the RCGP northern elevation (Walkden House second storey) in line with the ridge of former 19th century terraces (Mott MacDonald, 2019)

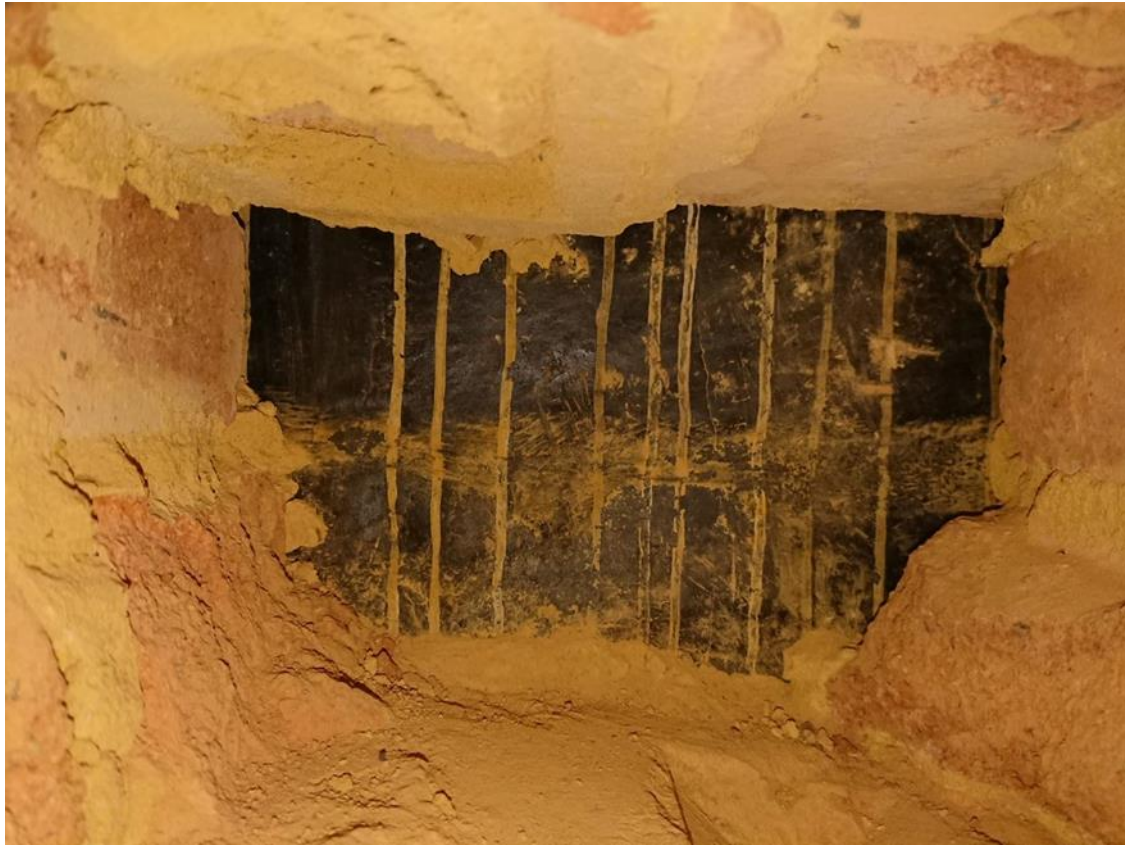
4. Basement level – a solid relatively thick coating / layer (hard, black) has been applied, apparently over brickwork. This appears to be some sort of “tanking” or waterproofing. Visual inspection was made through a small ‘window’ made through the Walkden House brickwork (Figure 11)

*Figure 11 A 'window' in the basement party wall of Walkden House - brick infill removed revealing RCGP brick covered in bitumen (Mott Macdonald, 2019)*

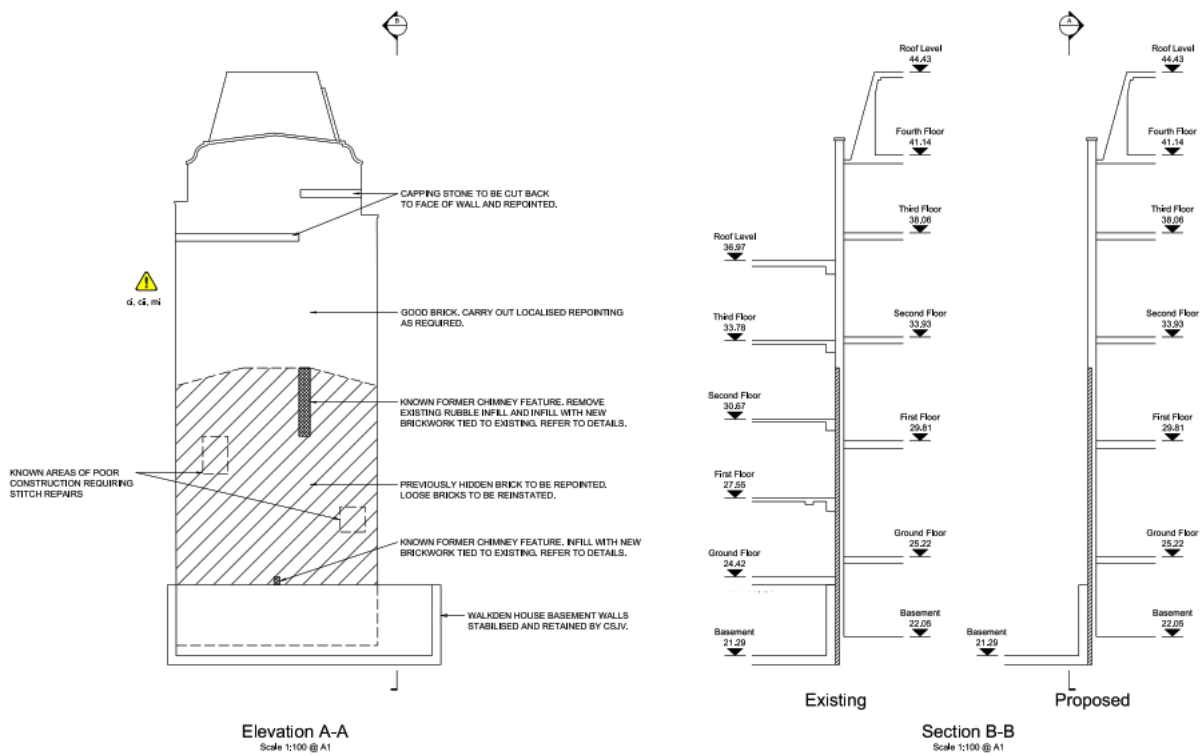
Figure 12. RCGP northern elevation and sections (Not to scale)

- 2.4.3 The condition of the RCGP northern elevation below the ridge height of 19th century terraces is generally assessed as poor.
- 2.4.4 Areas of red brick and yellow stock above the ridge height of 19th century terraces and above the roof height of Walkden House, have been assessed as of good quality. The same blackening from air pollution is apparent on both.

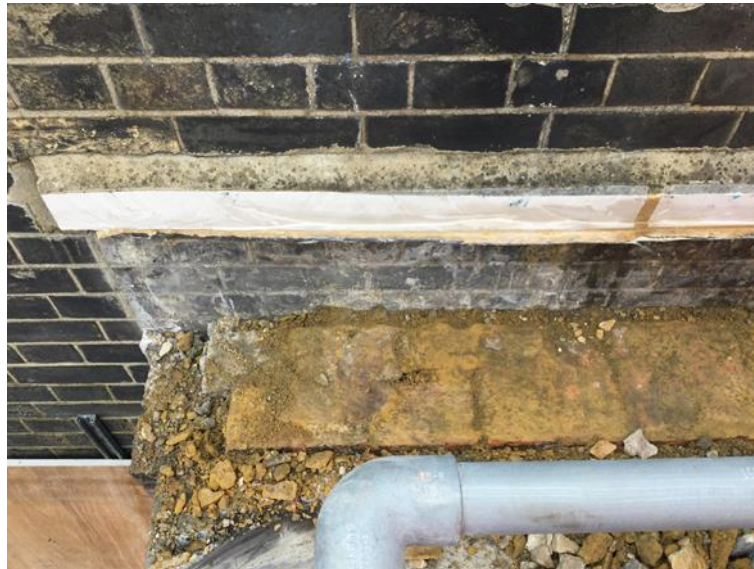
Figure 14. Walkden House coping stones embedded into the RCGP northern elevation

Embedded coping stones to which flashings for Walkden House were connected shall be cut back so that c.20mm projects from the elevation of the RCGP brickwork. This is to avoid cutting against the RCGP wall. Joints will be repointed flush with brick faces (respecting the original joint widths and brick arises) and to match existing, adjacent joints. The stones shall be pointed where required.

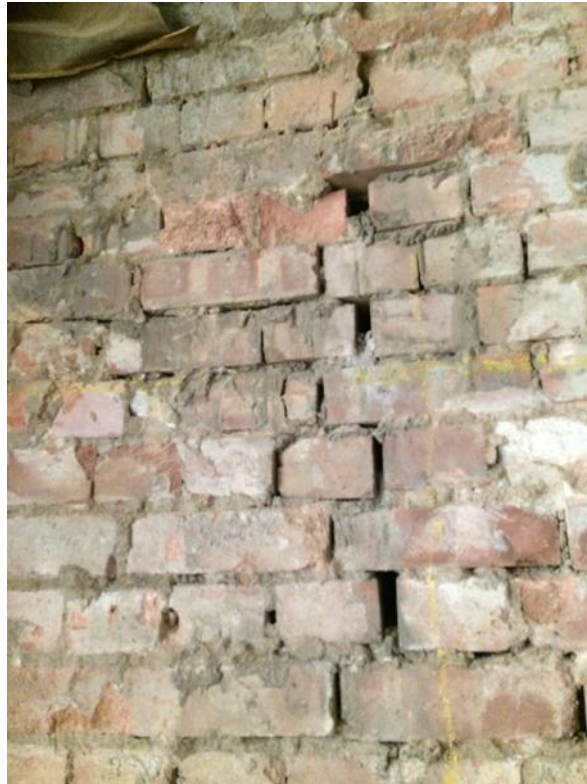
- 3.3.15 Particularly poor-quality brick work has been observed at ground floor and at first floor (Walkden House levels) (See Helibar Stitch Repair Detail, in Appendix D – Remedial Detail Figure). These areas comprise of brickwork with large gaps (approximately 20mm) between bricks and non-standard bond patterns, forming notional vertical cracks (Figure 15).

*Figure 15. RCGP elevation at first floor (Walkden floor levels) showing brickwork needing repair (Mott MacDonald, 2019)*

- 3.3.16 In order to ensure the wall's integrity, Helibar stitches are to be installed along with Helifix remedial wall ties. The area will be repointed as per the rest of the wall.
- 3.3.17 Proprietary 6mm diameter Helibar stainless steel bars shall be installed as per the Helibar Stitch Repair Detail, in Appendix D – Remedial Detail Figure
- 3.3.18 Helibars shall be installed at the top, bottom and at every four intermediary courses and shall extend a minimum of 500mm either side of the notional vertical crack.
- 3.3.19 Repointing shall be carried out as per the rest of the wall.

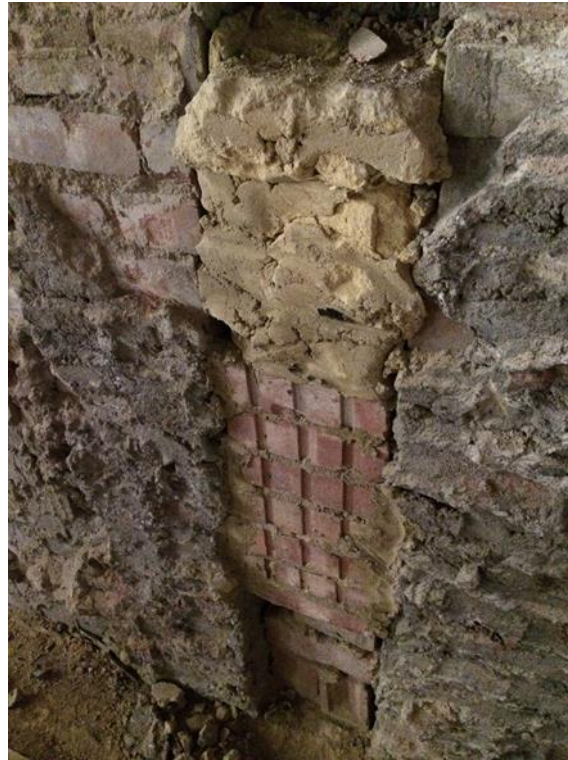
- 3.3.20 There are two known void features in the RCGP northern elevation (See Brick Infill Repair, in Appendix D – Remedial Detail Figure). These are located at ground and second floor (Walkden House levels). The largest is located at second floor.
- 3.3.21 At second floor level (Walkden House), void feature is partly infilled with rubble, approximately 1300mm high, as shown in Figure 16. This shall be removed. A single skin of new brickwork shall be installed within the void, where available, existing phorpres bricks will be re-used.

*Figure 16. Close up of void Feature at second floor level (Walkden floor levels) of the RCGP (Mott MacDonald, 2019)*

3.3.22 The approximate dimensions of the void are 250mm wide x 100mm deep. Existing defective brickwork will be removed without compromising the structure. The brick face will be repaired using bricks of matching type and dimensions, maintaining existing construction details including coursing, brick bond (English), and joint widths. Any voids behind the brick face and in the wall core will be filled with a mixture of bedding mortar and suitably sized clean aggregate to be approved by the project’s built heritage advisor. All joints will be filled to full depth and mortars will be protected as required (depending on environmental conditions) until fully cured / set.
