Tree report in accordance with BS 5837:2012 – Rev A

Site Address: 18a Frognal Gardens, London, NW3 6XA
Ref: 031682

Demolition of existing structure and construction of a new 4-storey dwelling in its place

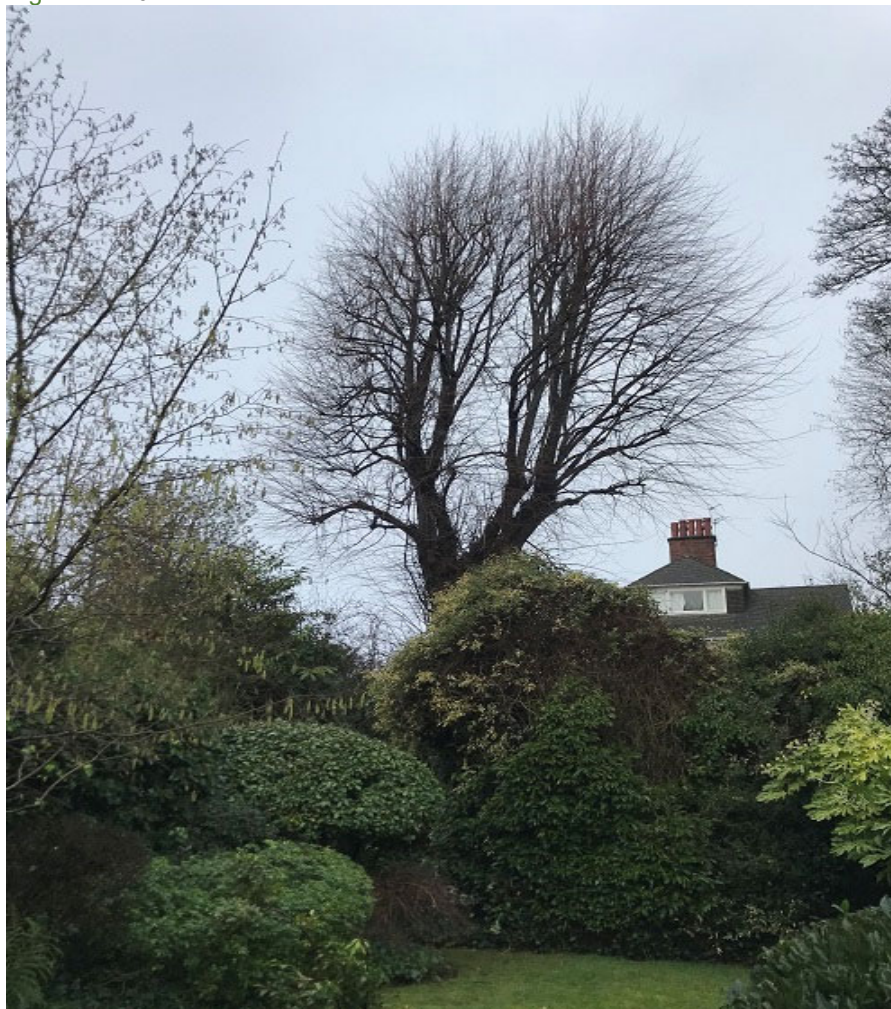
Figure 1 T10

2.2.4 The most significant tree with respect to the proposal is a lime (T10) [Figure 1] located towards the rear boundary of 18a Frognal Gardens' rear garden. No works are planned to occur within the RPA of this tree.

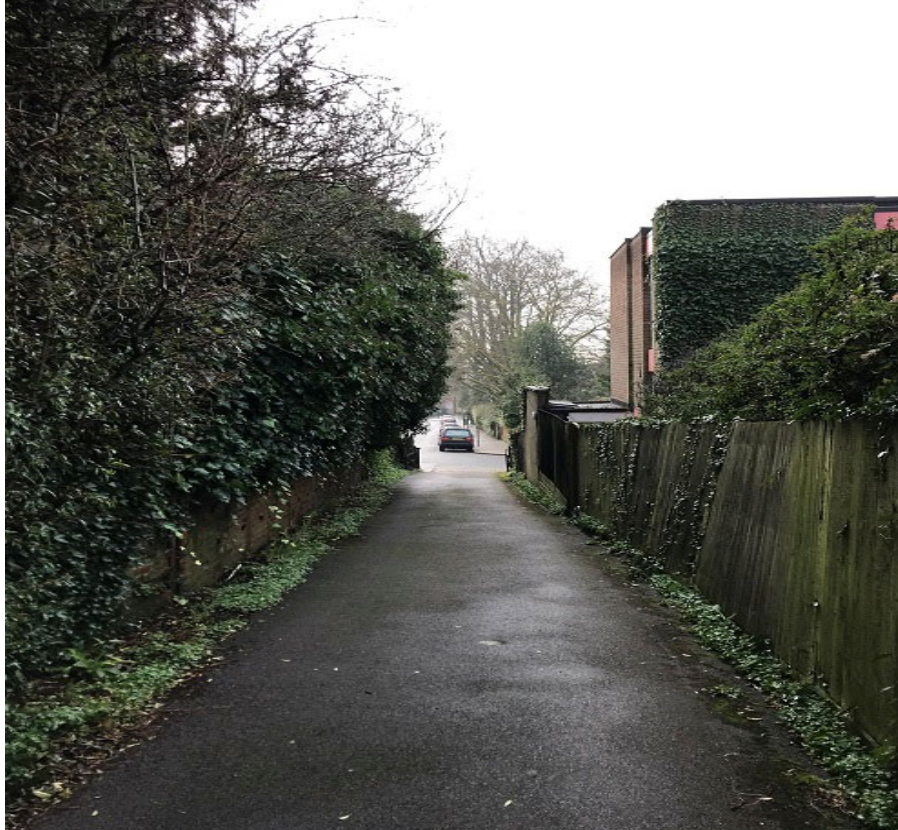
T4, T5 and T6 are 3rd party trees whose RPA clips the north-eastern corner of the site. Similar to T1, there is not an anticipation that significant roots will be found in this portion of the garden given the presence of a boundary wall and an established tarmac driveway [Figure 2] between the two.

Figure 2 Established driveway between 18a and 3rd party trees to the east
