DRIVING STATUS	PLANNING
DRIVING TITLE	UNDERPINNING SEQUENCE AND SECTIONS A_A & B_B THROUGH BUILDING AND ADJOINING PROPERTIES
PROJECT	20A FERNCROFT AVENUE, LONDON, NW3 7PH,
Project Number	P19-461
3, Dufferin Avenue London EC1Y 8PQ T.020 7253 2626	
Drawn	Checked
GB	NTS
Purpose of Issue	29.10.19
BASEMENT IMPACT ASSESSMENT	
Drawing Number	Revision
P19-461_SK08

## **BS 5837:2012 Tree Survey Arboricultural Impact Assessment**

20A Ferncroft Avenue, Hampstead, London, NW3 7PH

**November 2019**

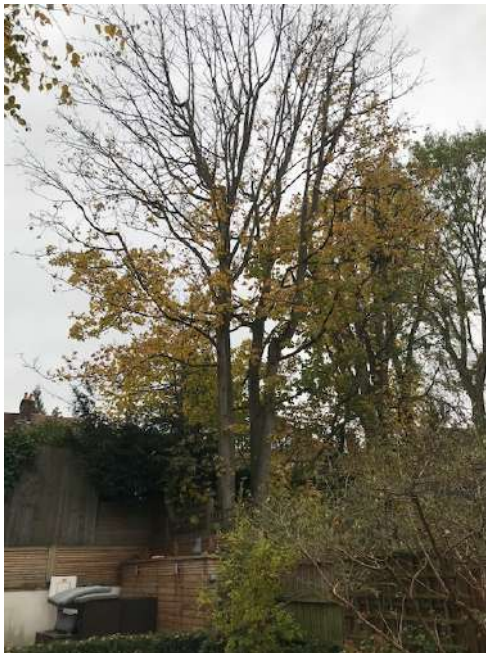
The only medium quality tree in the survey is the mature sycamore at the rear of the garden, this tree is multi-stem and has an extensive canopy but has been subject to tree work in the past. This tree is not located near the construction and will not be impacted.

T4 sycamore – located in neighbours garden with extensive canopy

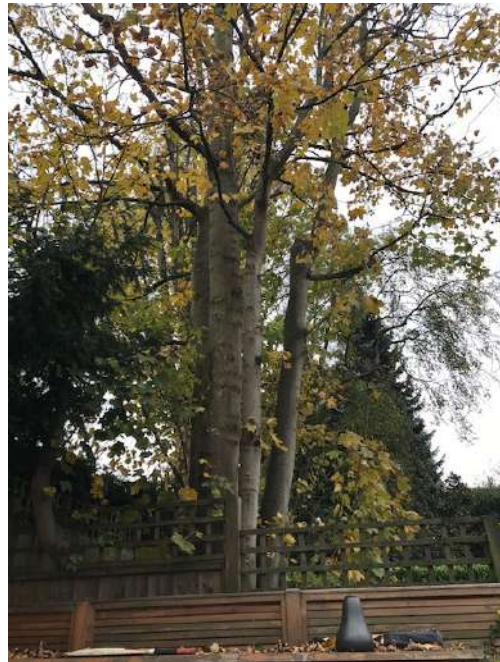
T4 tree is a large multi-stem mature tree which has been subject to tree work

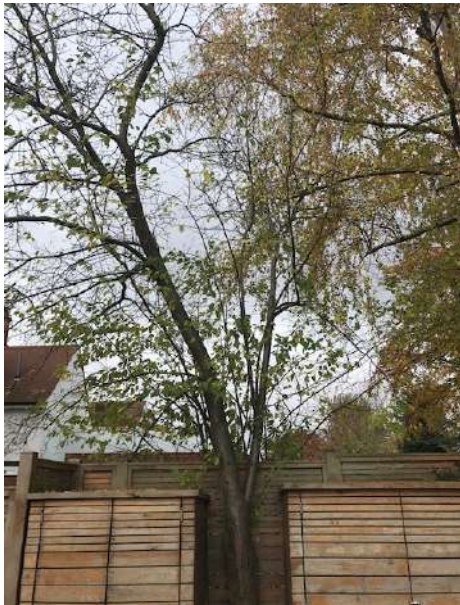
T1 Cherry with pronounced leaning stem due to proximity to T2 birch

This Category 'C' cherry (T1) is the owners tree, it suffers from having both a constricted canopy and also from its compromised planting position. The tree is out-competed by the adjacent and dominant T2 silver birch which has an extensive canopy. T1 can be shown to be leaning to the south to gain canopy space. The stem of T1 is also positioned between 2 storage sheds meaning that its planting area and drainage is not ideal. This tree is to be removed and a replacement tree further down the garden is proposed.

- 7.5 The proposed basement will extend further into the garden and will directly affect the T1 Cherry as its canopy and RPA are inside the intended basement area. It has been noted however that this tree is poorly positioned and struggles for canopy space as it being out competed by the nearby T2 birch. It is proposed that this tree be removed and for a replacement tree to be planted towards the rear of the garden.

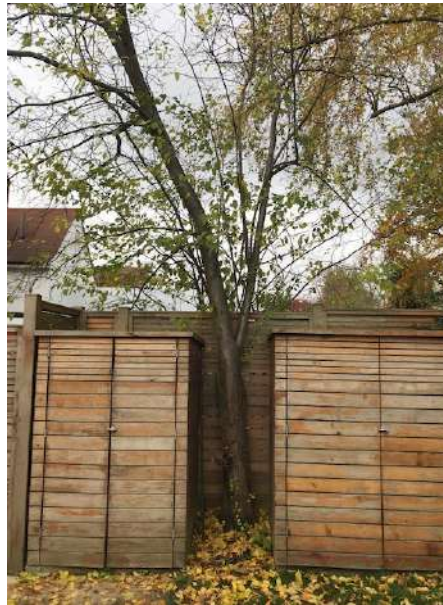
T1 Cherry is positioned close to fence and between 2 garden storage sheds

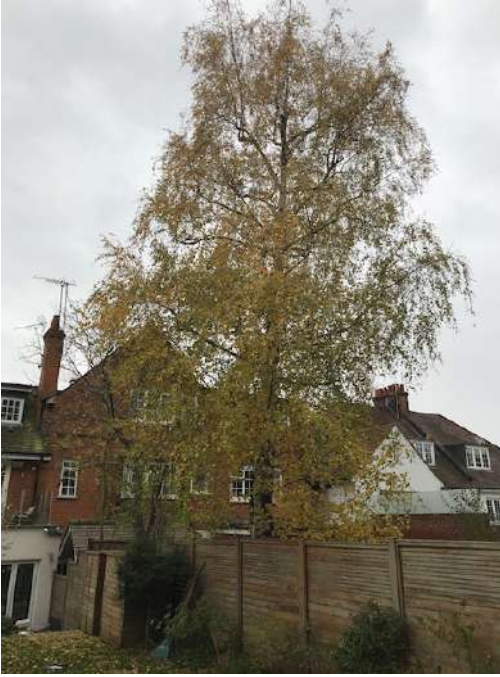
T2 Silver birch with extensive canopy – this is the neighbours tree (No. 20 Ferncroft)

- 7.6 The T2 silver birch is owned by neighbours of 20 Ferncroft and as demonstrated in **Appendix 3**, there will be no disturbance to its RPA through the demolition, excavation or new basement construction. There is a risk soil compaction to RPA of T2 however this is being addressed by the installation of tree protection fencing. T3 and T4 will similarly be set behind tree protection fencing to avoid root damage and soil compaction.

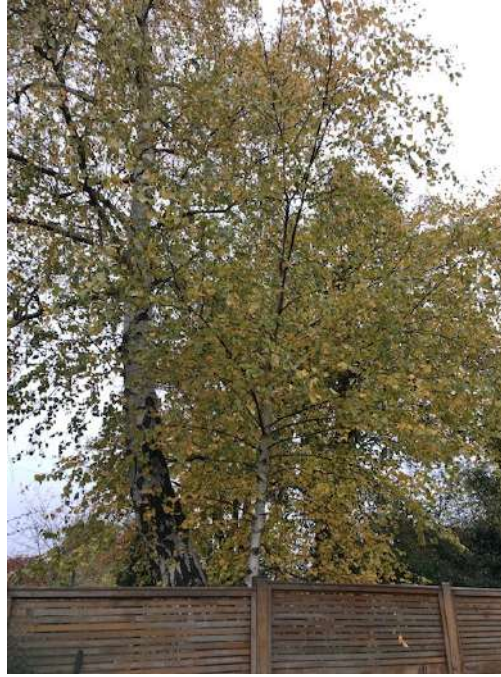
T2 Silver birch with slightly leaning stem and additional leader now developing

The above Category 'C' T2 silver birch is the neighbours tree (20 Ferncroft) and this tree was noted to have a slightly leaning form stem until 2m which then straightens. The stem has also developed a new small "leader" which is gaining dominance and is growing a new secondary canopy from this leader. T2 has an extensive canopy and provides good screening, privacy and seasonal interest.

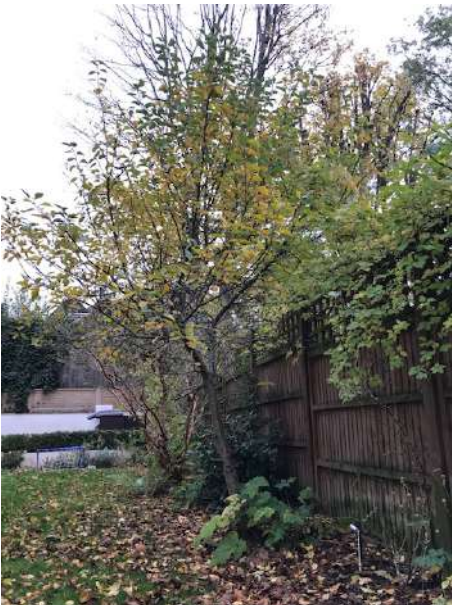
T3 Cherry is a small decorative tree located close to opposite fence – the tree has slight leaning form – leans to north.
