ARBORICULTURAL IMPACT ASSESSMENT REPORT  
BS 5837:2012 'Trees in relation to design, demolition and construction. Recommendations'

SITE

Branch Hill,

**DATE: 6 December 2019**

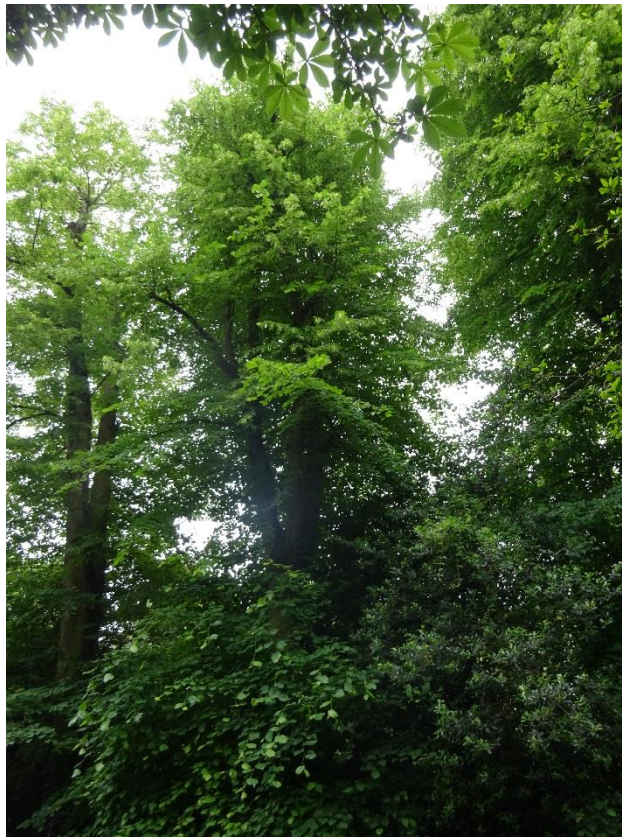
- 6.5.1 This line of trees, in particular trees T2 – T9 and T11 – T13 (excluding stump T8) are mature and approximately 18m high. Collectively they form a dense screen between the allotment site, in which they grow, and the site. The limes have been reduced in the past and have regrown vigorously. A full inspection could not be made as the trees are offsite and clothed in epicormic growth and ivy, but the crowns appear to be in good health. They also provide a linear habitat. The cluster of trees T16 – T23 are growing close together resulting in asymmetric crown spreads and poor stem taper. Never the less they provide collective landscape and habitat value.

*Photo 1 of T3 in centre looking south*

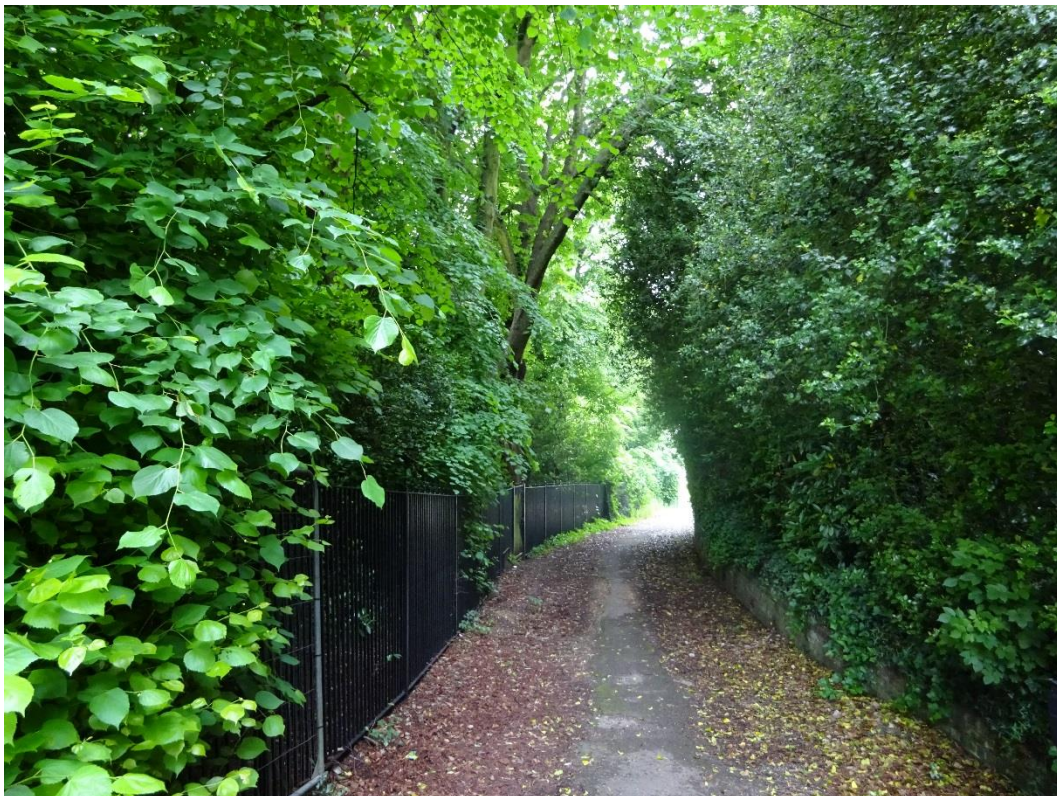
*Photo 2 of off the offsite limes on the left and hollies on the right (from T4)*

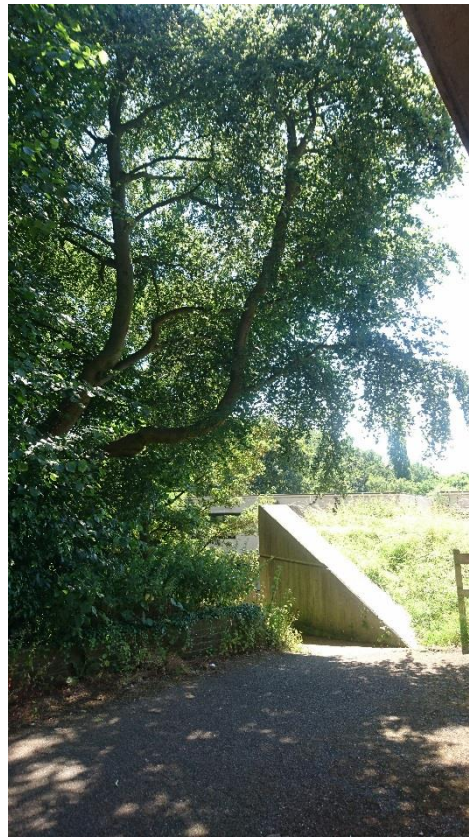
*Photo 3 showing ungainly form of T14 to be removed*

6.5.3 The trees will be retained, except T10 and T14 (if in site ownership) which are low quality sycamore and beech respectively. T15, a spindly leaning sycamore, is also recommended for removal due to its condition.

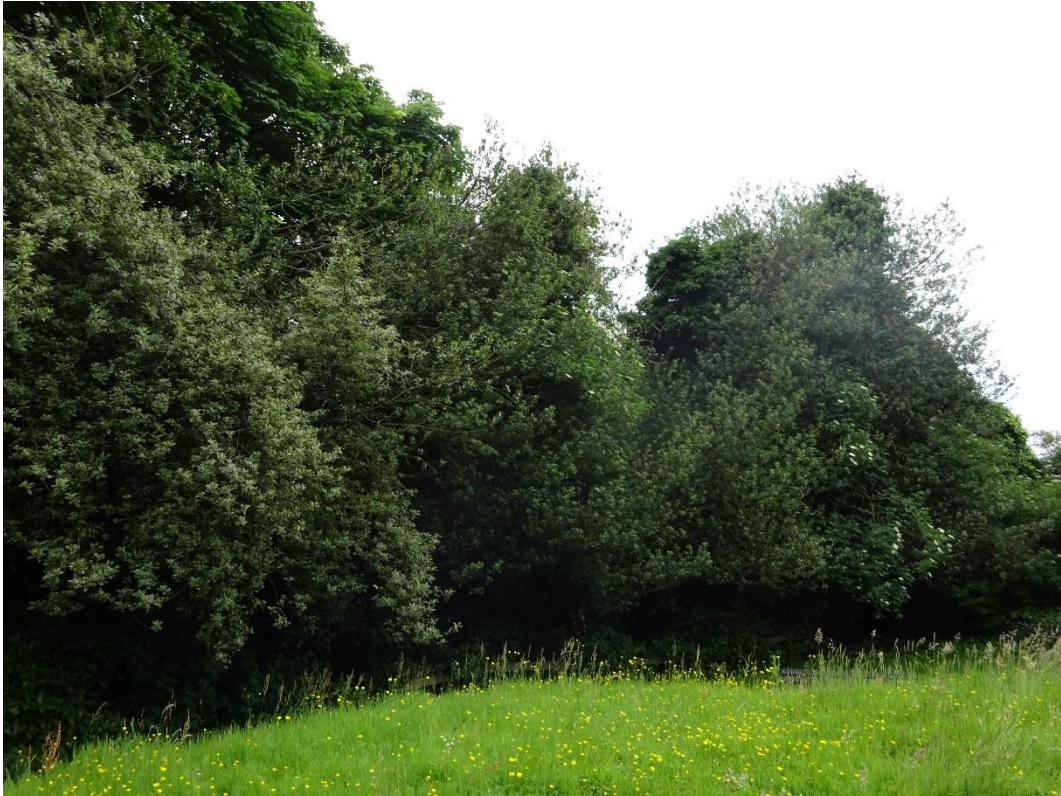
6.6.1 The holly trees are growing in a tight group to the immediate north of a low retaining wall. They are mature and as they are growing so close together, they have asymmetric crowns and lean out towards the light. Some have ivy growing up the stems and pockets of decay on stems and main branches. T35 is identified in the Ecological Impact Assessment by Hybrid Ecology as having a potential bat roost feature. The trees are internal to the site and screened from the south by the lime trees, to the east from the woodland area and to the north by the existing building. The yucca's are planted very close to the building and are of very low arboricultural and landscape value.

*Photo 4 of T30 – T39 left to right, looking south west*

6.6.2 All will be felled to facilitate construction. There will be little visual impact from their removal. T35 will be inspected by a licensed bat ecologist prior to removal. The trees will be replaced by a holly hedge along this boundary and by trees throughout the development. A feature tree will be planted on the eastern end of this current group to act as a focal point.

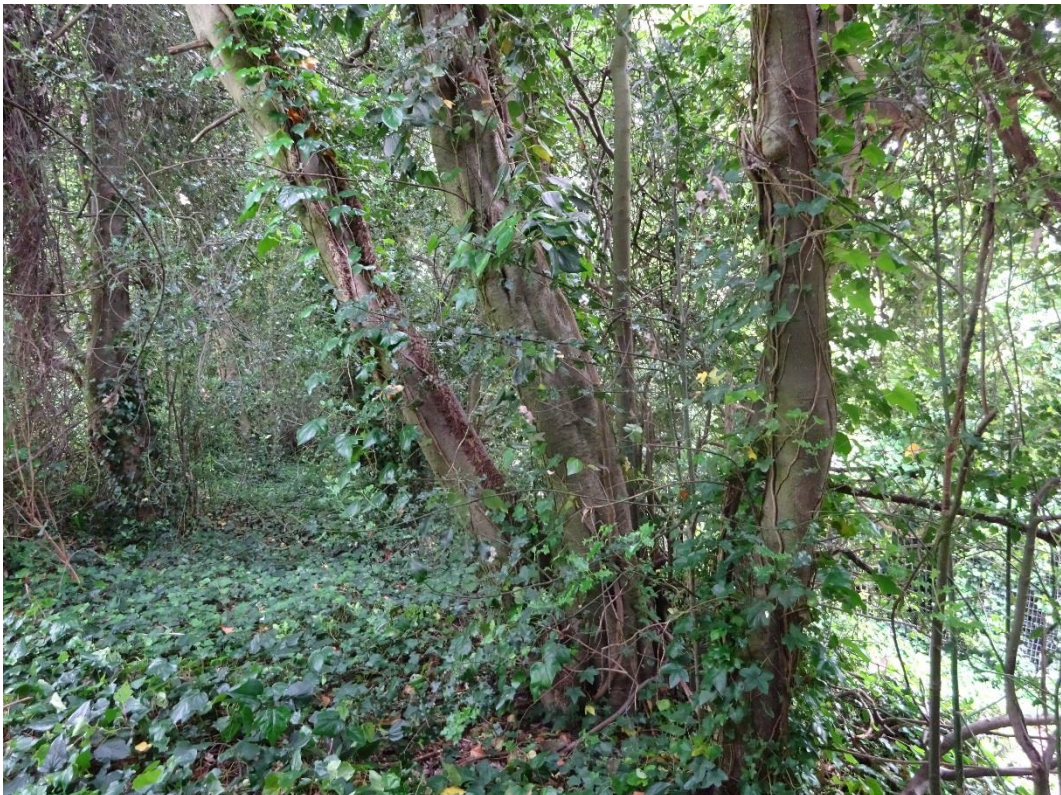
*Photo 5 of typical interior of the group of hollies with T36 in foreground*

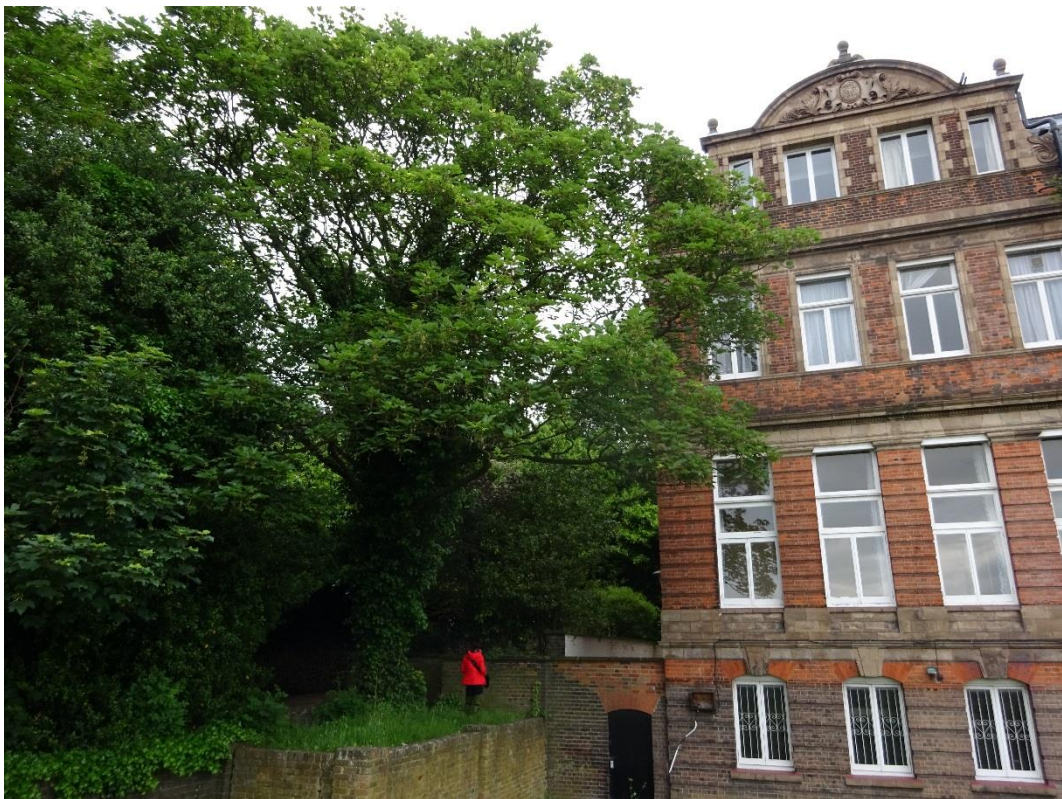
6.7.1 The cotoneaster is a low quality small tree which has been coppared in the past and regrown. T50 is a mature sycamore growing on a raised area enclosed by the brick wall which acts as a root barrier. It is in a reasonable form and condition with a large crown (c.16m diameter). It is recommended to sever the ivy so that a full inspection can be made of the tree's condition.

*Photo 6 of T50 sycamore showing how the tree is elevated*

6.7.2 The cotoneaster will be removed due to its condition and to enable new landscaping. The sycamore will be retained. There will be no works near the crown or roots of this tree and it is protected as it is elevated on the raised area from all activity. Therefore there is no impact from the proposed sub station as the existing raised walls act as a root barrier.

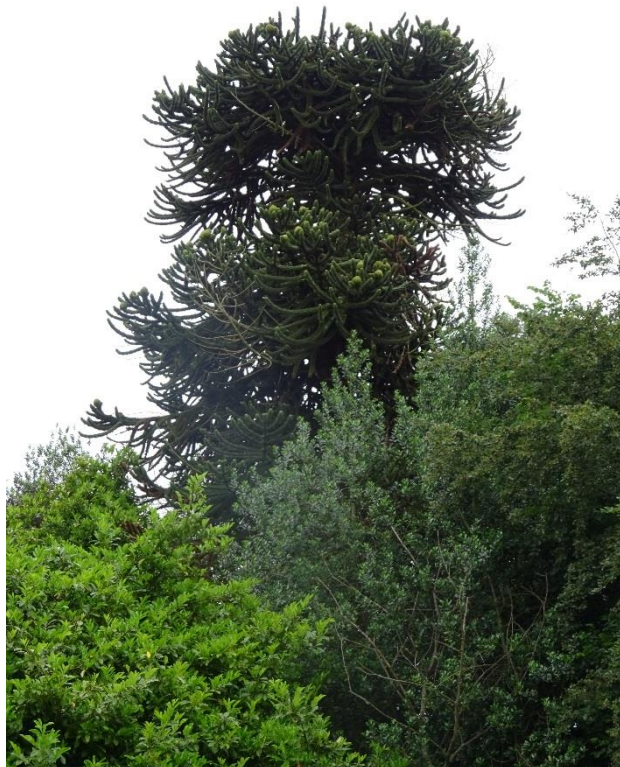
*Photo 7 showing the prominence of T52 monkey puzzle above the tree line*

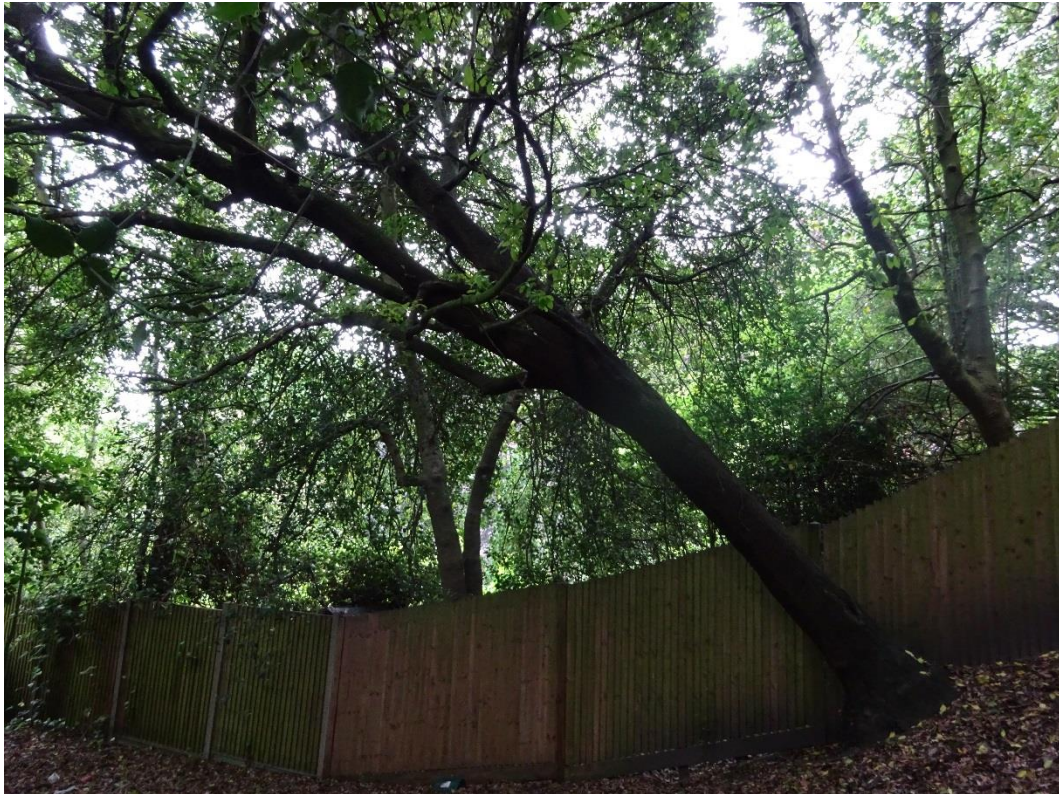
*Photo 8 showing the pronounced lean of T55 holm oak*

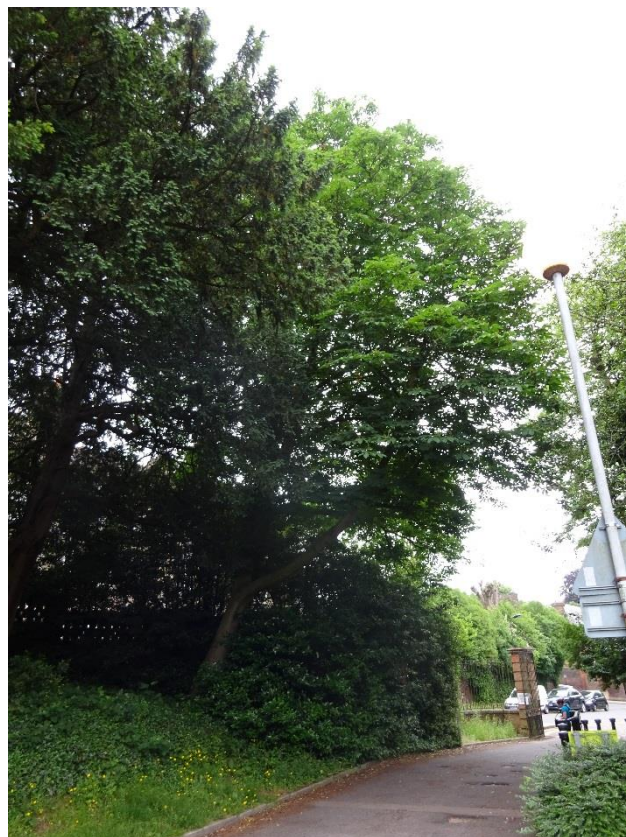
*Photo 9 of T63 horse chestnut looking south east towards the entrance*

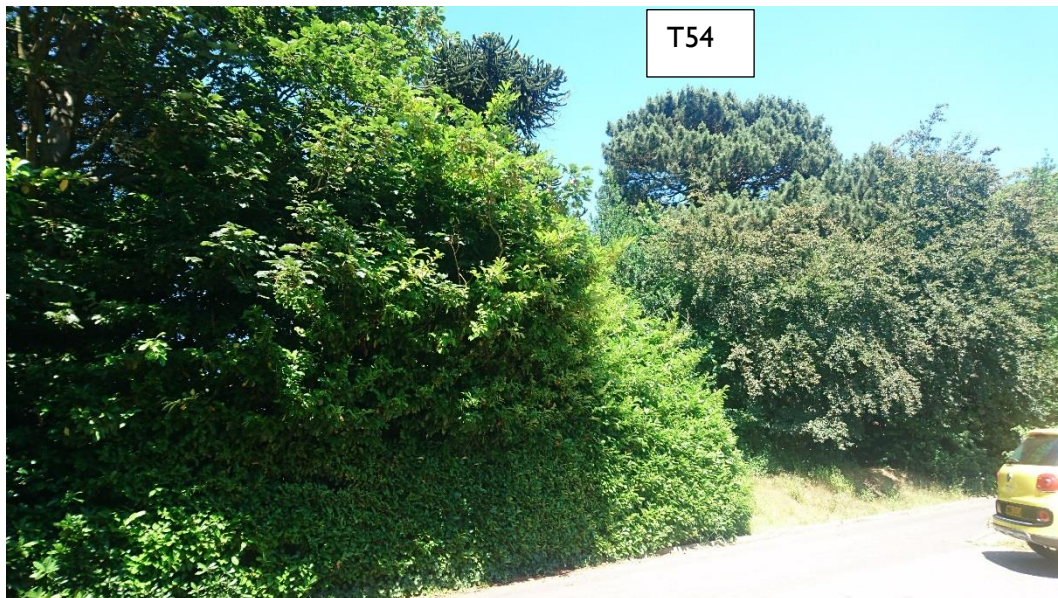
6.8.1 The triangular woodland slopes up to the north-eastern corner. It is approximately 0.3 hectares and contains sycamore, laurel, rhododendron, a single monkey puzzle, a single holm oak, Norway maple and birch. The holm oak is leaning very heavily west and is recommended for removal for safety reasons. T53 beech leans very heavily south and should also be removed for safety reasons. The low quality group G65 comprises holly, laurel and rhododendron. Rhododendron and laurel are spreading throughout the woodland, and if left unmanaged, the rhododendron would dominate by creating toxicity in the soil to prevent the growth of other species (allelopathy). The woodland has high landscape value collectively, but many of the trees are poor quality. There is very little understory and the woodland requires holistic management to restore its value as a SINC.

*Photo 10 general view of the south-western end of the woodland*

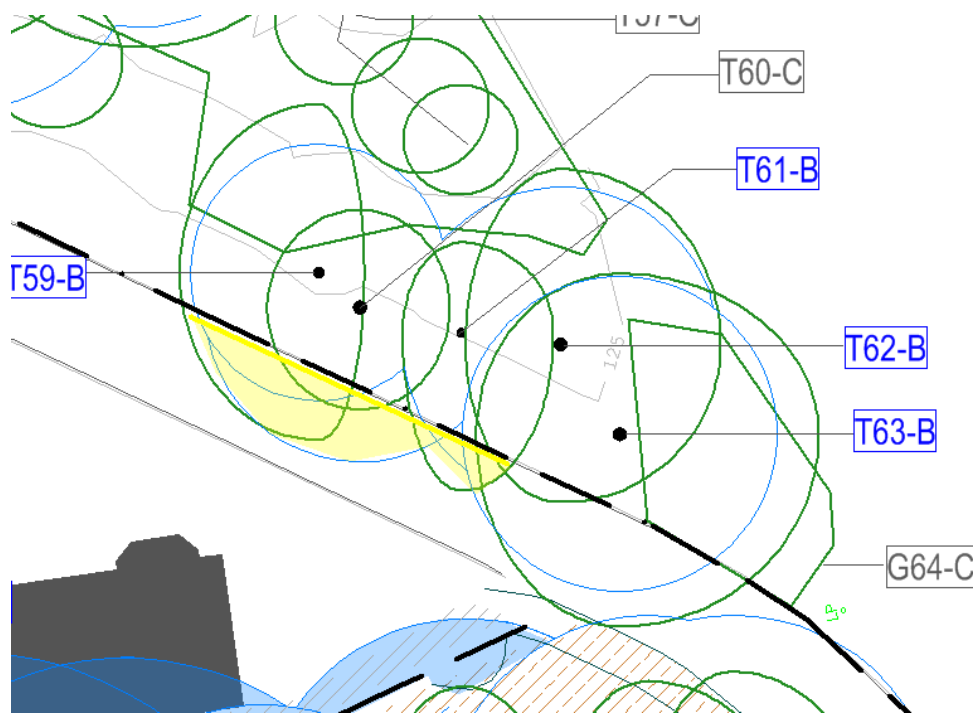
6.8.5 Spedan Close will need to be lowered within the root protection area of T59 - T61 yew.

A TreeRadar survey was conducted by TreeRadar UK in September 2019. The results showed that *'Roots are found in very low rooting densities throughout the scan lines, with the majority of the roots found in an unevenly distributed band between 35-50cm deep and few deeper. This shallow rooting pattern indicates adventitious roots, growing to exploit the condensation layer beneath the surface, rather than larger structural roots. Again a very large number of non-root reflectors and services were found within the data.'*

Given the data, I am content the impact on the trees structure and vitality will be negligible. A full method statement for the root pruning will be produced post planning, but the principle is one of root pruning and facing back with plastic sheeting and hessian. The edge of the drive would need to be retained to prevent the bank from slipping, and the detail of this will also form part of the method statement.

*Plan 6 – extract from SHA 681 TPP2 – yellow area is the area for root pruning by the arboriculturist to allow for the excavation for a sloping level including the construction make up of the road. Do not scale. North is vertical.*
