Report on Existing Roof Timbers

22 Keats Grove

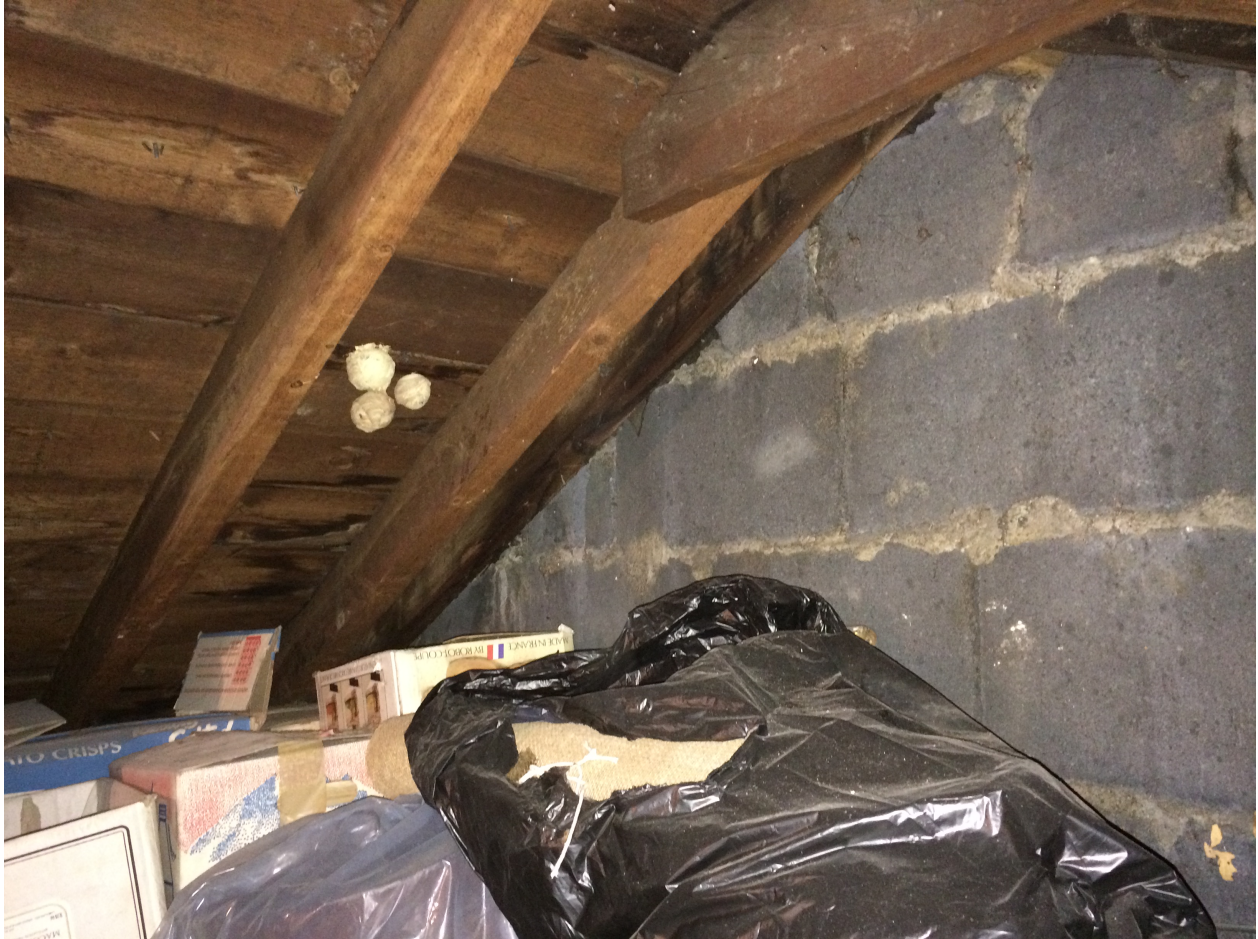
view of rafters at party wall to 21 Keats Grove. Note: party wall rebuilt with concrete blocks confirming repair works have been carried out at roof level in the relatively recent past

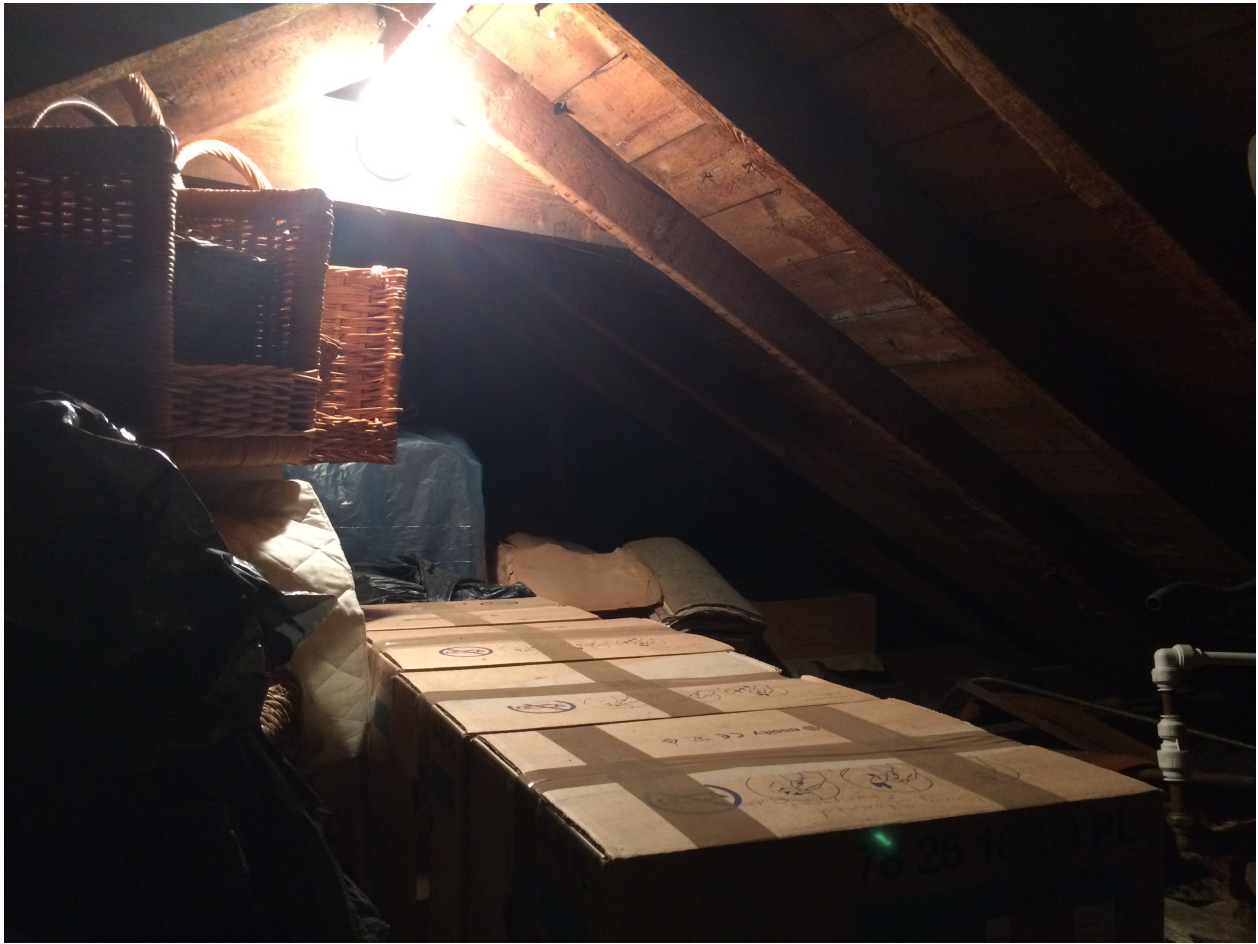
general view of roof space

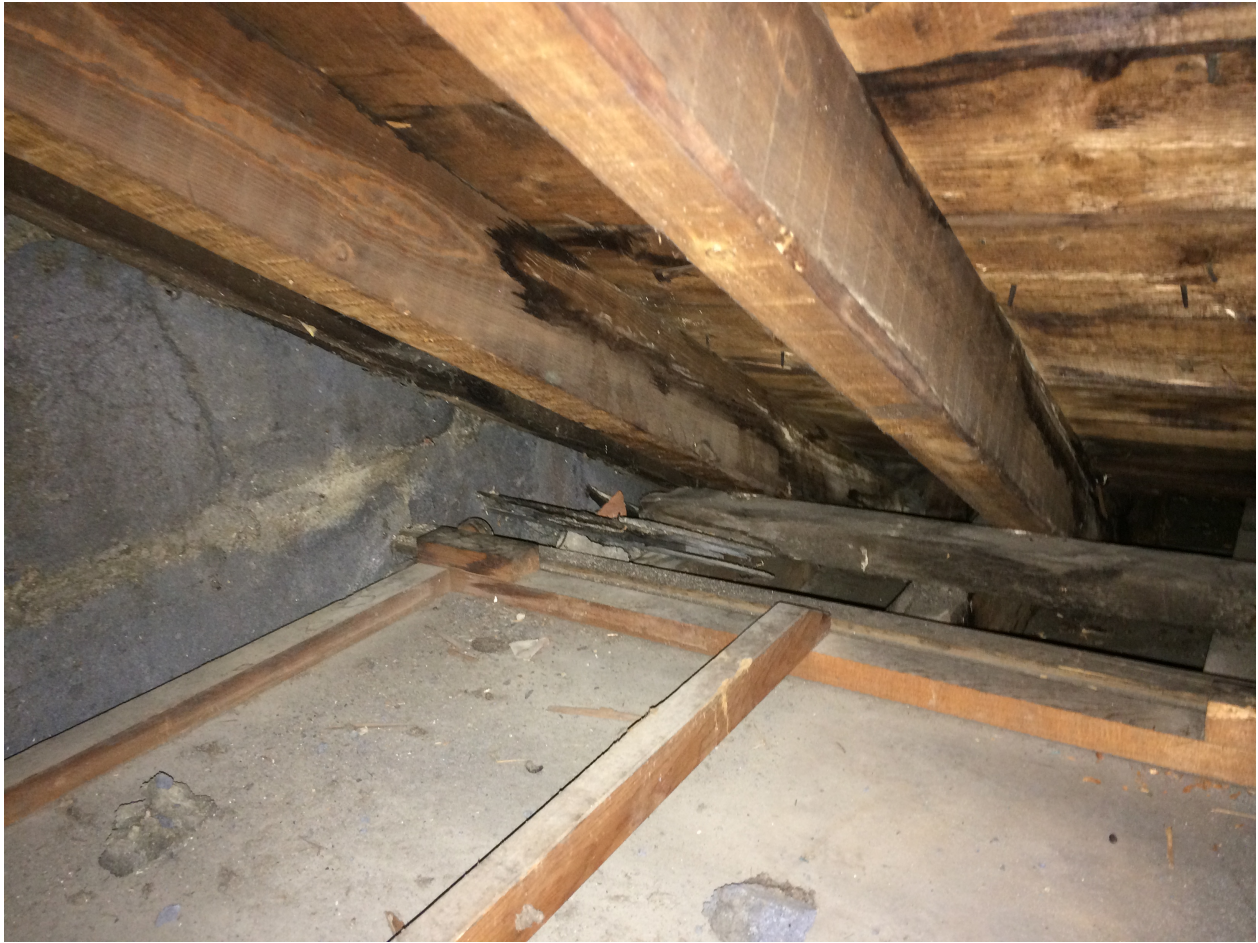
view of rafters at valley gutter showing signs of water staining; note also bandsaw marks on r.h timber.
