**BS5837 ARBORICULTURAL REPORT,
ARBORICULTURAL IMPACT ASSESSMENT
& METHOD STATEMENT**

OUR REFERENCE	AC.2020.105
CLIENT	Mr Hugh Tuffley
SITE	134 Haverstock Hill, Camden, London, NW3 2AY
REPORT BY	I S Thompson (known as Tom) M. Arbor. A., BSc. (Hons) Arb, MSc. eFor
DATE	24th January 2020
DATE OF SITE VISIT	21st January 2020

134 Haverstock Hill, Camden, London, NW3 2AY

**Construction of a rear extension with a green roof and
some paving**

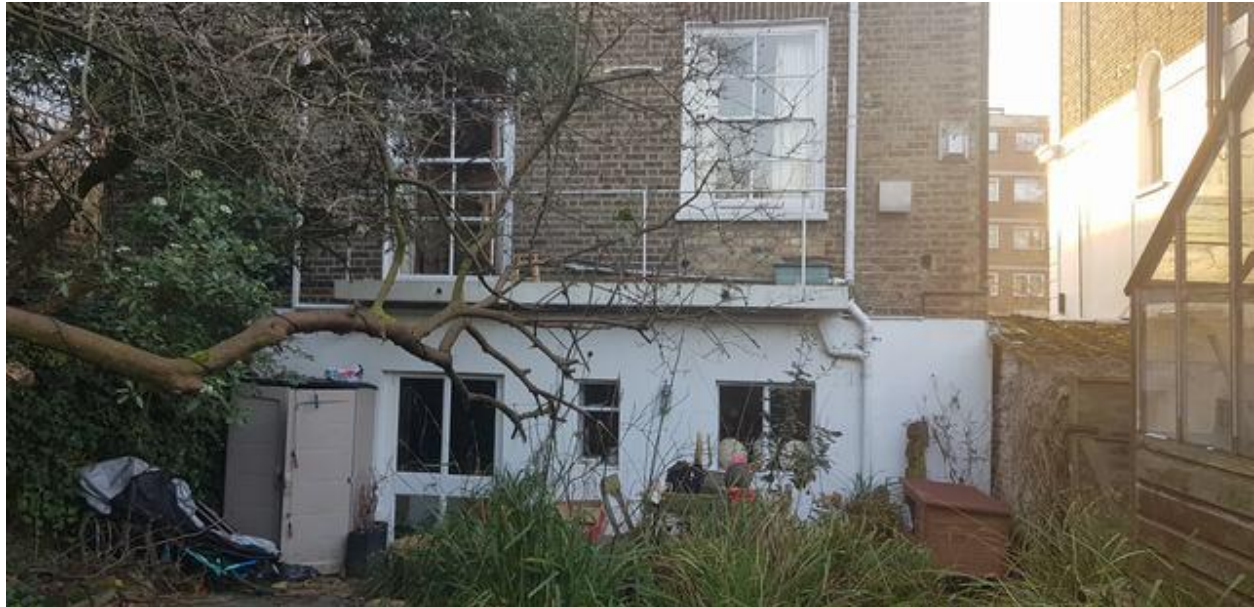
- 12.2** There are only two shrubs that are proposed for removal as part of this applications. These are S1 and S2 on the eastern side of the garden, consisting of a small dogwood and a small poor condition guelder rose with poor form dieback and a cavity as well as being propped up.

Image 1 S1 and S2 on the left of the picture

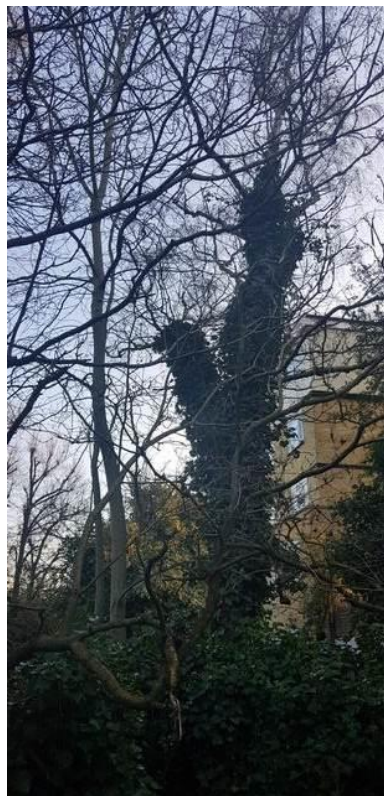
Image 6 Ivy covered trunk of T4 a birch tree

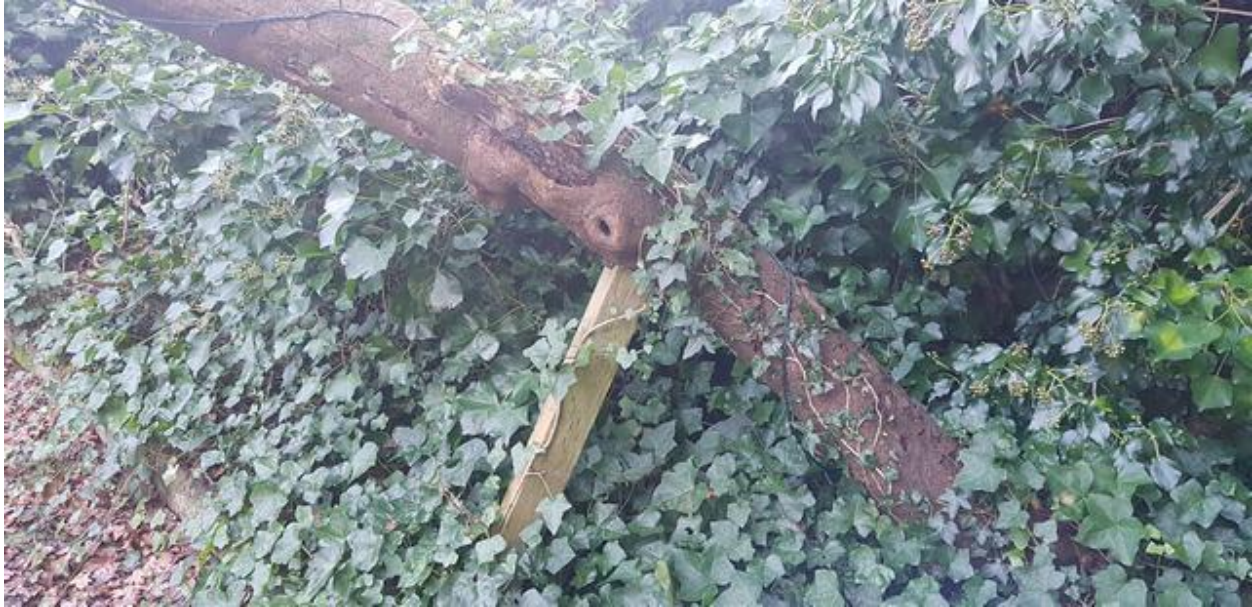
Image 7 Trunk of S2 with cavity and being propped up.

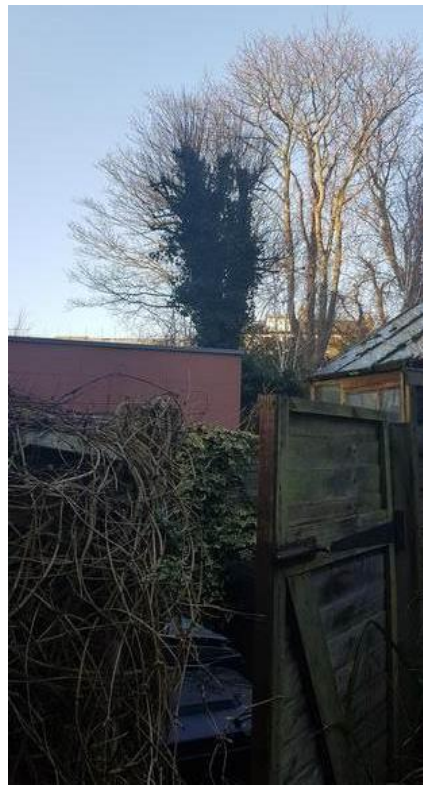
Image 11 Pollarded lime tree in adjacent property
