**Planning Application 2020/0344/T**

**Notification of Intended Works to Tree(s) in a Conservation Area**

**Outside 59 Hillway London N6 6AD**

**To prepare an arboricultural report on a mature lime tree in relation to subsidence damage at 59 Hillway**

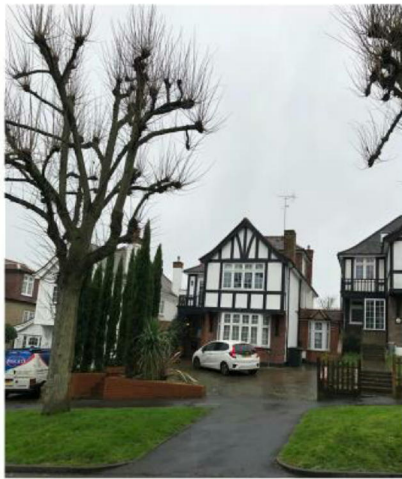
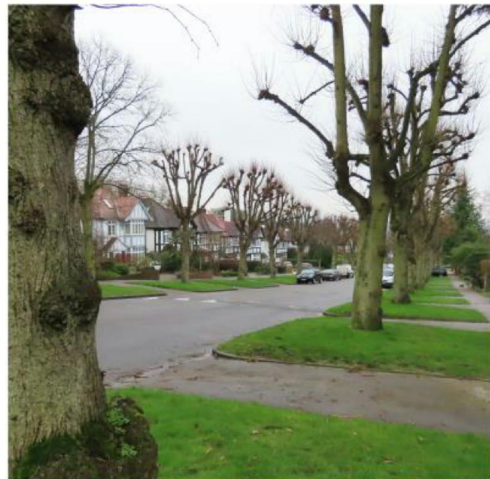
**Front aspect of 59 Hillway and the avenue of limes lining the entire length of Hillway .**

Note the row of cypress along the left margin of no 59, the hard standing sloping away from the front of no 59

and the pollarded lime standing in the wide grass verge

The image shows the lime tree and row of cypress. The lime is some 10m from the front of no 59 and the cypresses are much closer, Whilst almost all the front garden of no 59 is given over to hard standing the lime stands in the middle of a broad grass verge outside the property.
