# Heritage Statement

34 Christchurch Hill, NW3 1JL, London

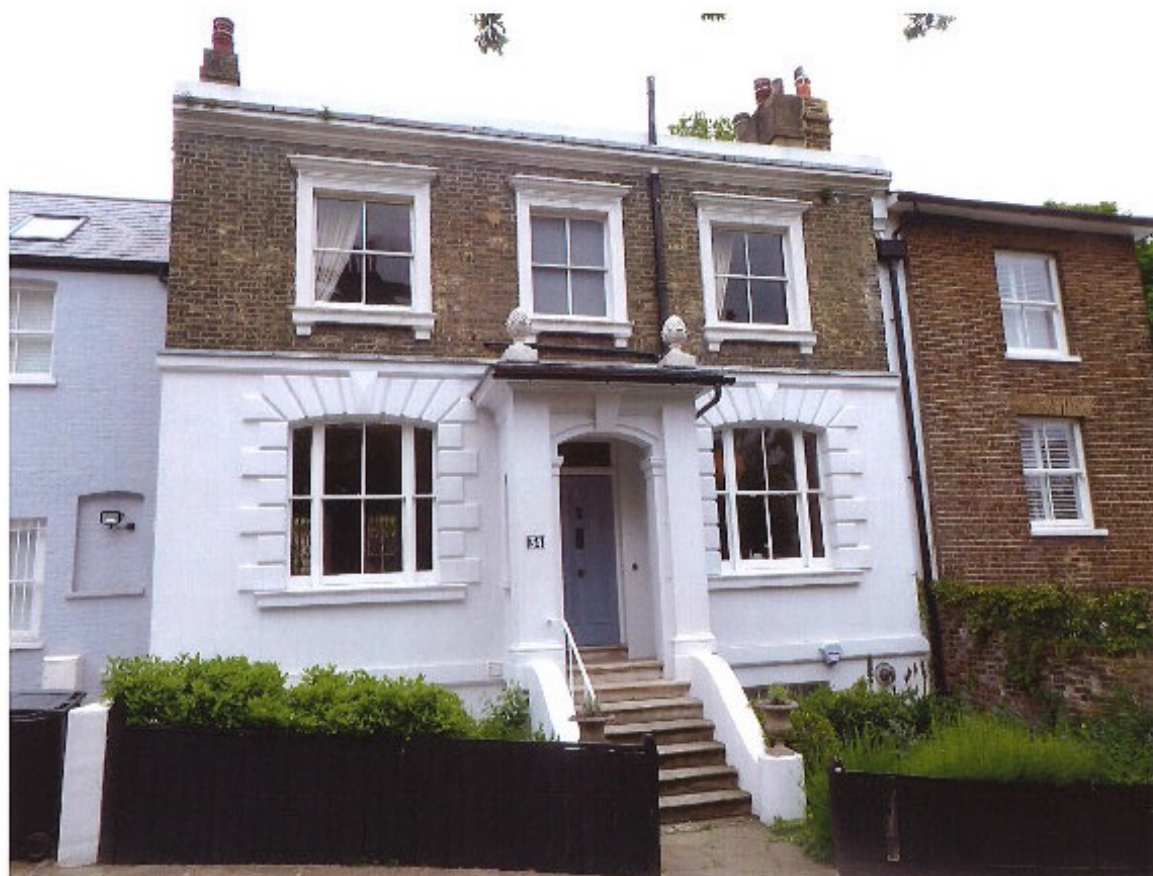
P1050729.JPG

There is some general deterioration to the sash windows and this is most notable at first floor level. The sills are deteriorating and as part of the external major works these windows will need to be overhauled. As some box frames are found to be affected by rot the replacement will be necessary as part of the works.

FRONT ELEVATION

Exchange all windows with wooden framed double-glazed windows of same style.

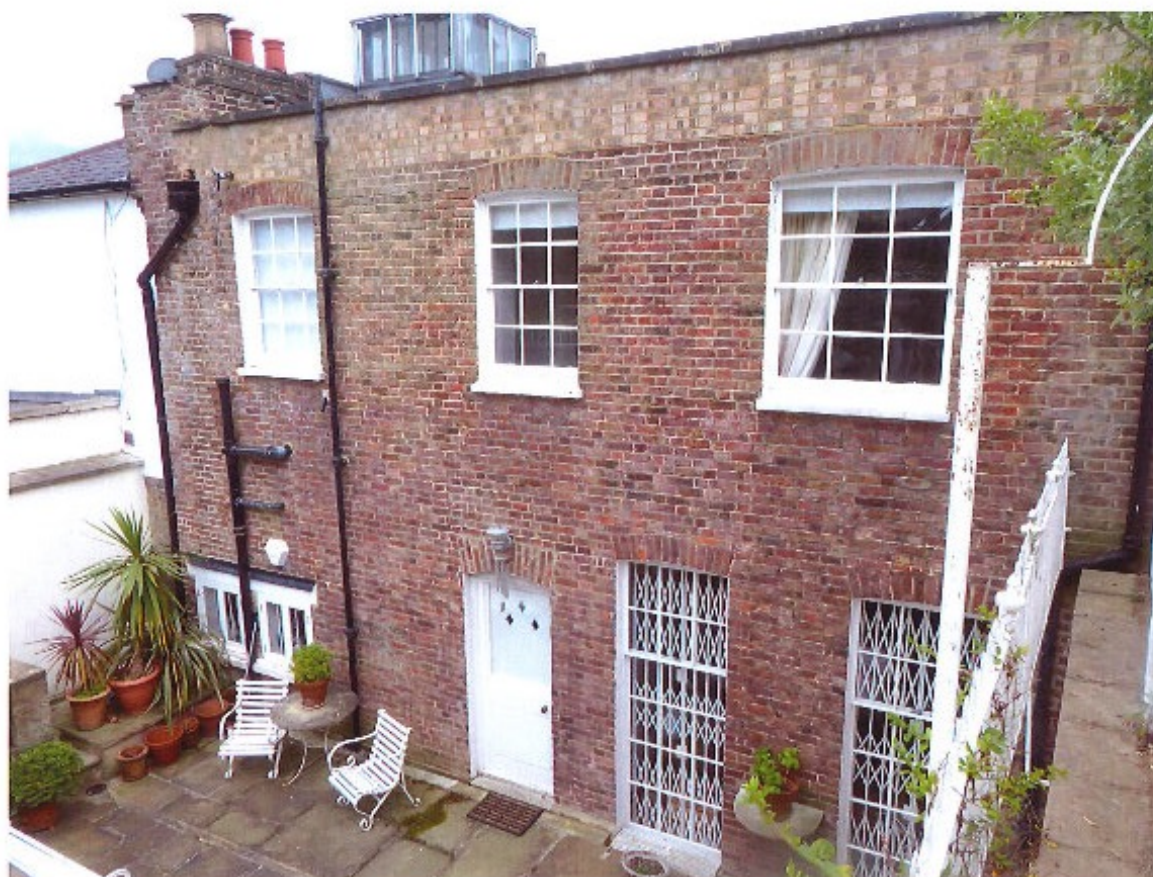
P1050714.JPG

At the rear of the property there are three sliding sash windows at first floor level. There is some general weathering and deterioration to the timber frames and again an overhaul is necessary.

REAR ELEVATION

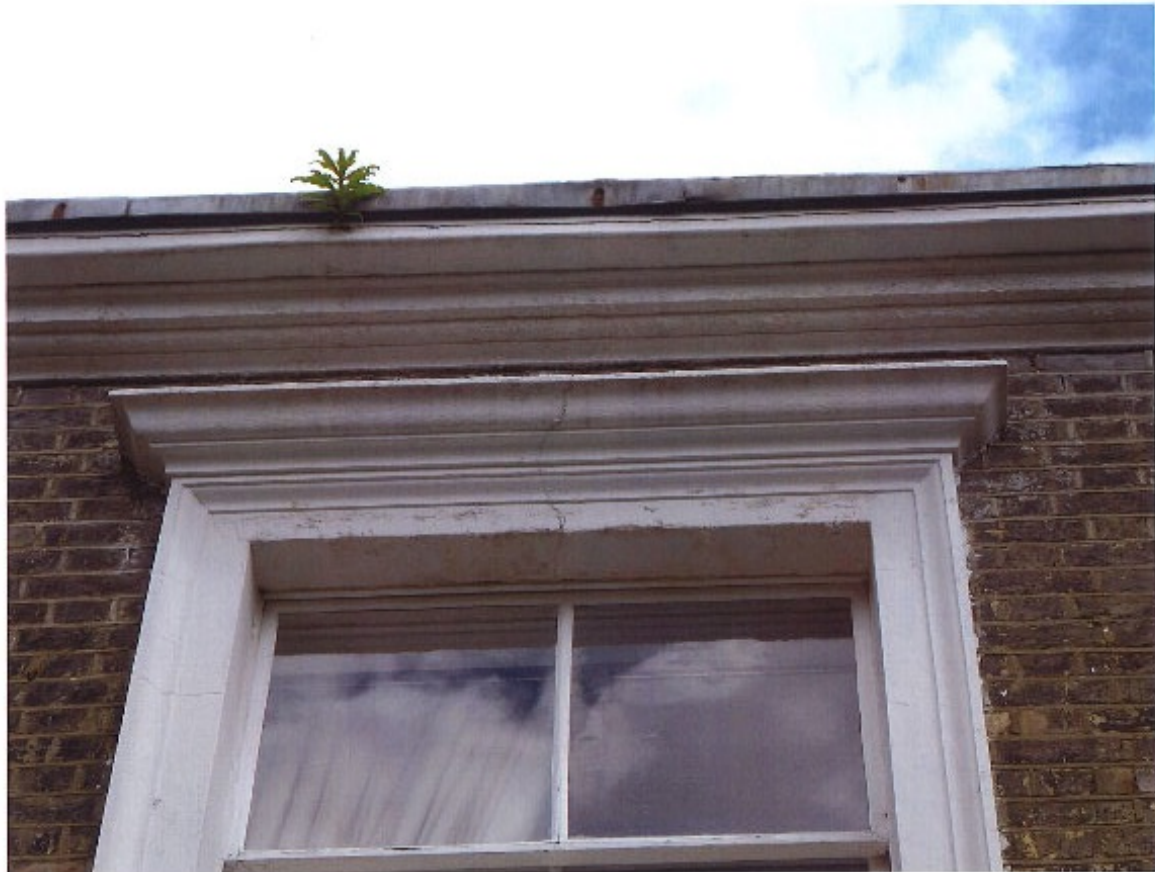
P1050744.JPG

Dampness has affected the decorations in numerous locations notable at high level to the front elevation around the tree first floor windows and also to the left side of the portico structure at high level. Painted timber surfaces are also beginning to show signs of failure

DAMPNESS AFFECTING TOP OF FRONT MAIN WALL.

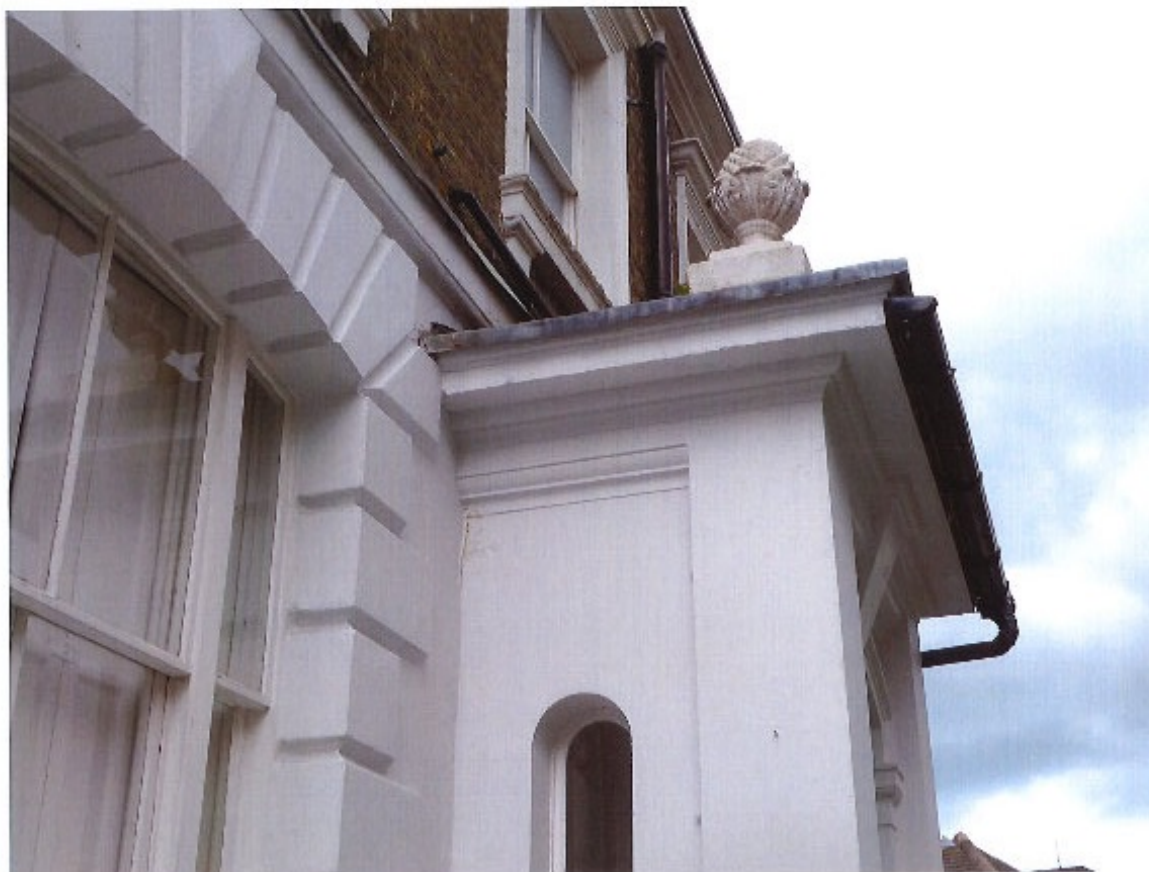
P1050826.JPG

DAMPNESS AFFECTING LEFT SIDE OF PORTICO STRUCTURE
