**FLAT 1, NO. 105 PRIORY ROAD,
WEST HAMPSTEAD, NW6 3NN**

Arboricultural Assessment Report

February 2020

Mr & Mrs Knights

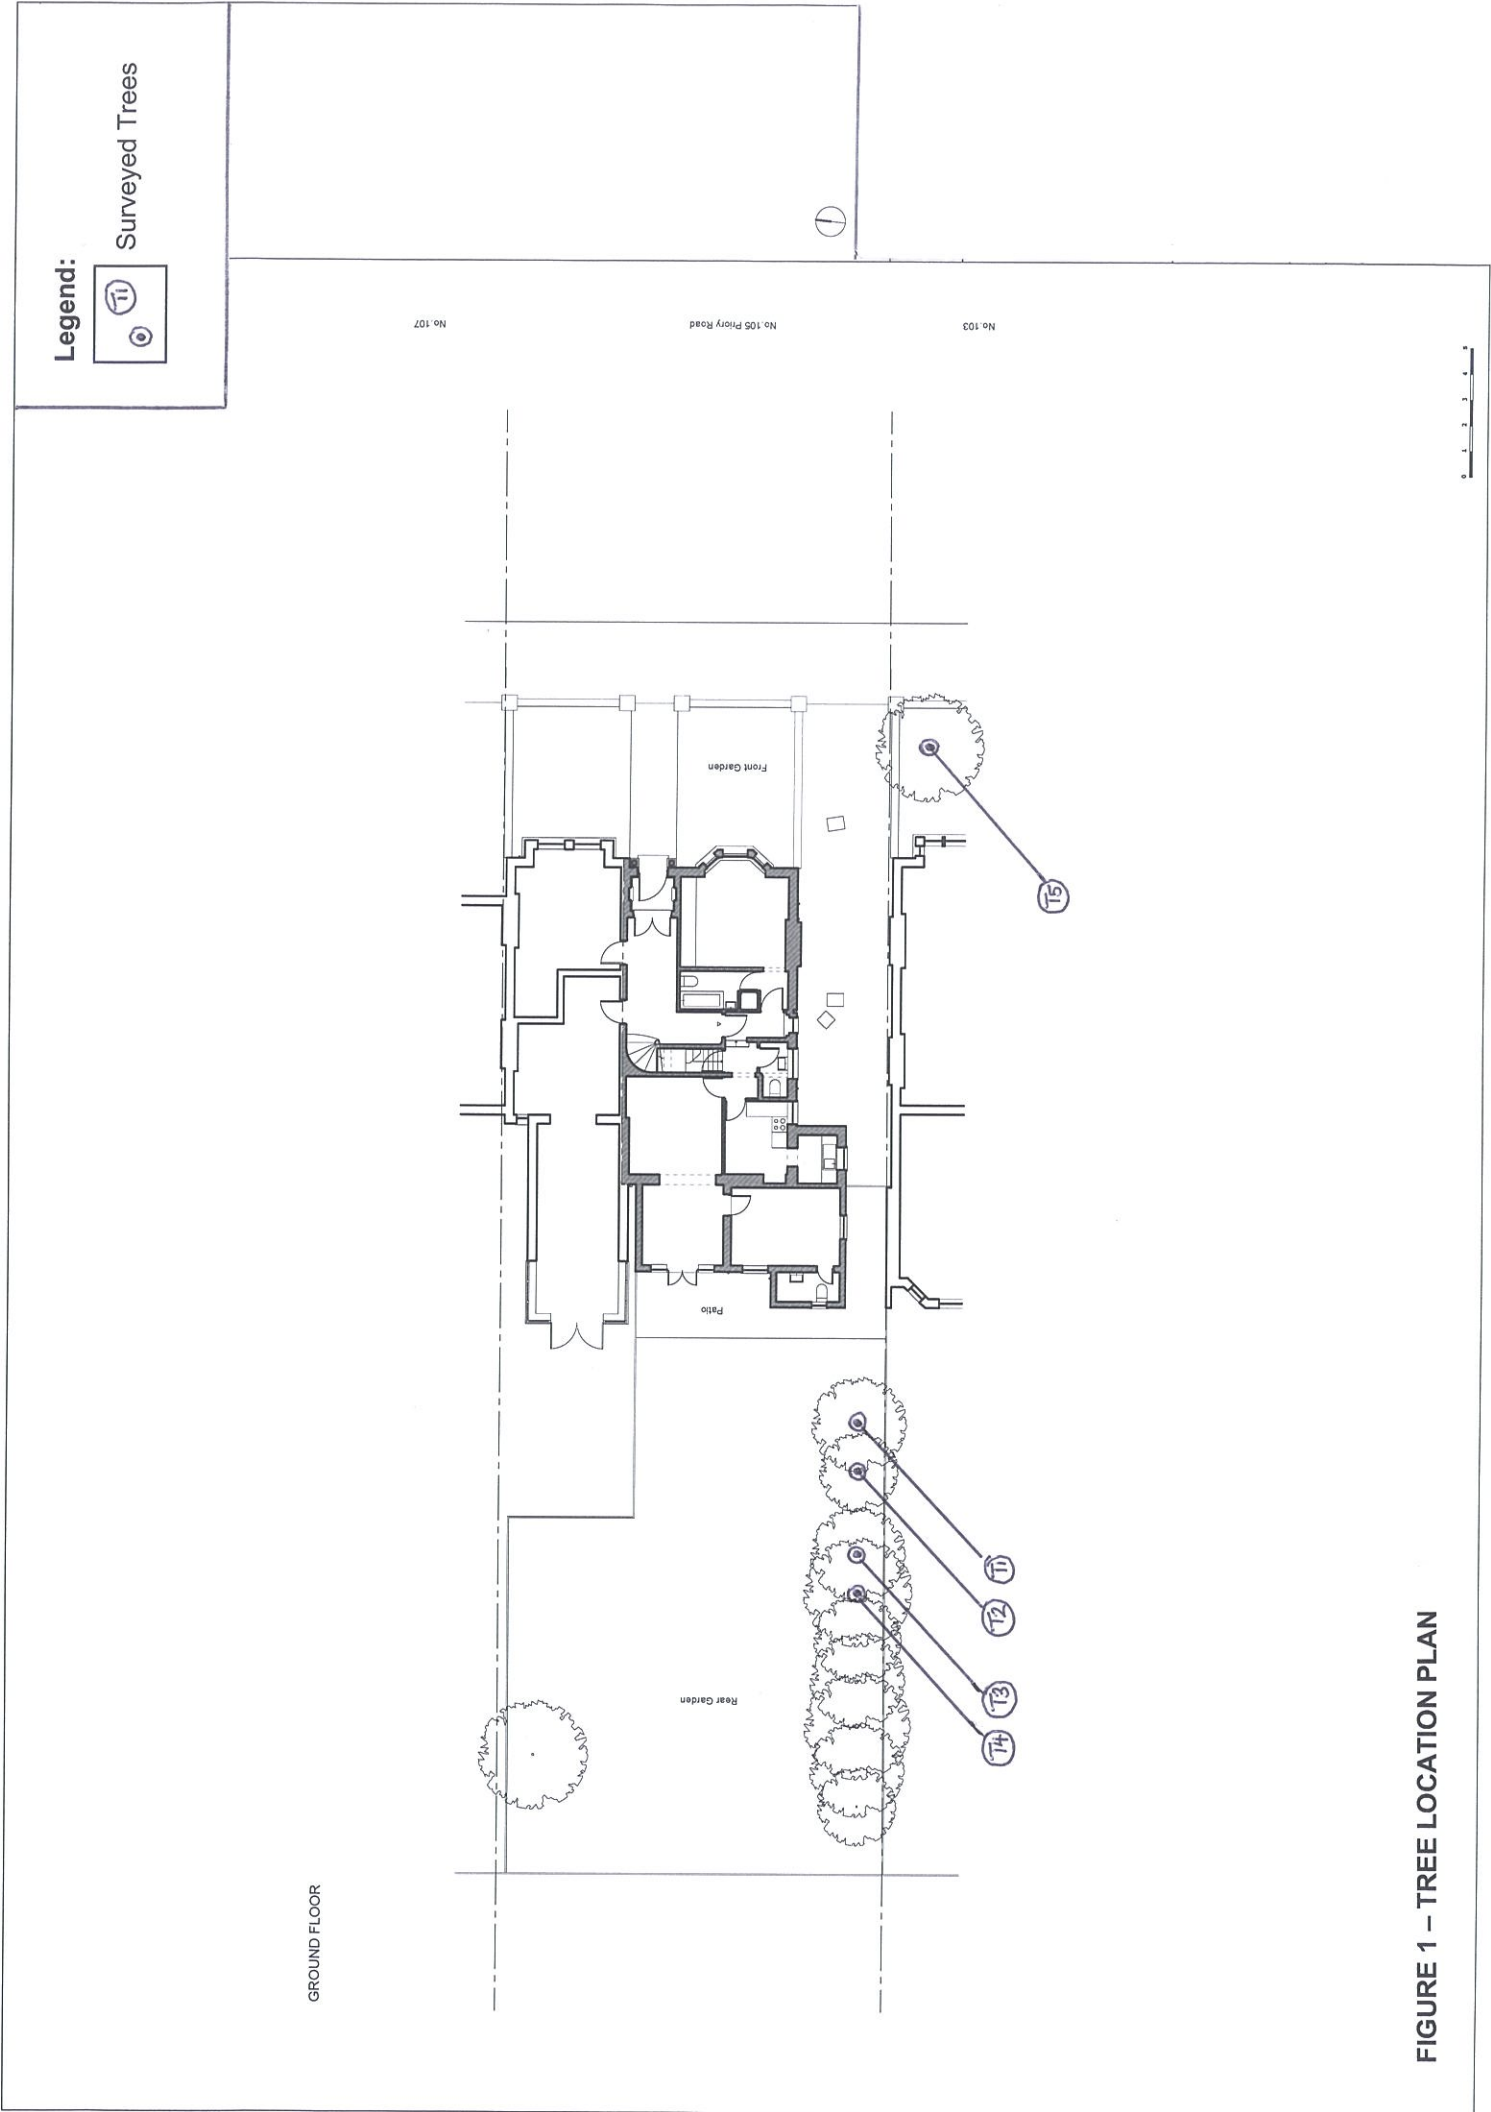
FIGURE 1 – TREE LOCATION PLAN

- 3.5 A total of five trees were recognised as the relevant tree resource, as shown in explanatory photographs at the rear of this Report.
- 3.6 An arboricultural schedule is attached as Table 1 and tree locations are shown in Figure 1.

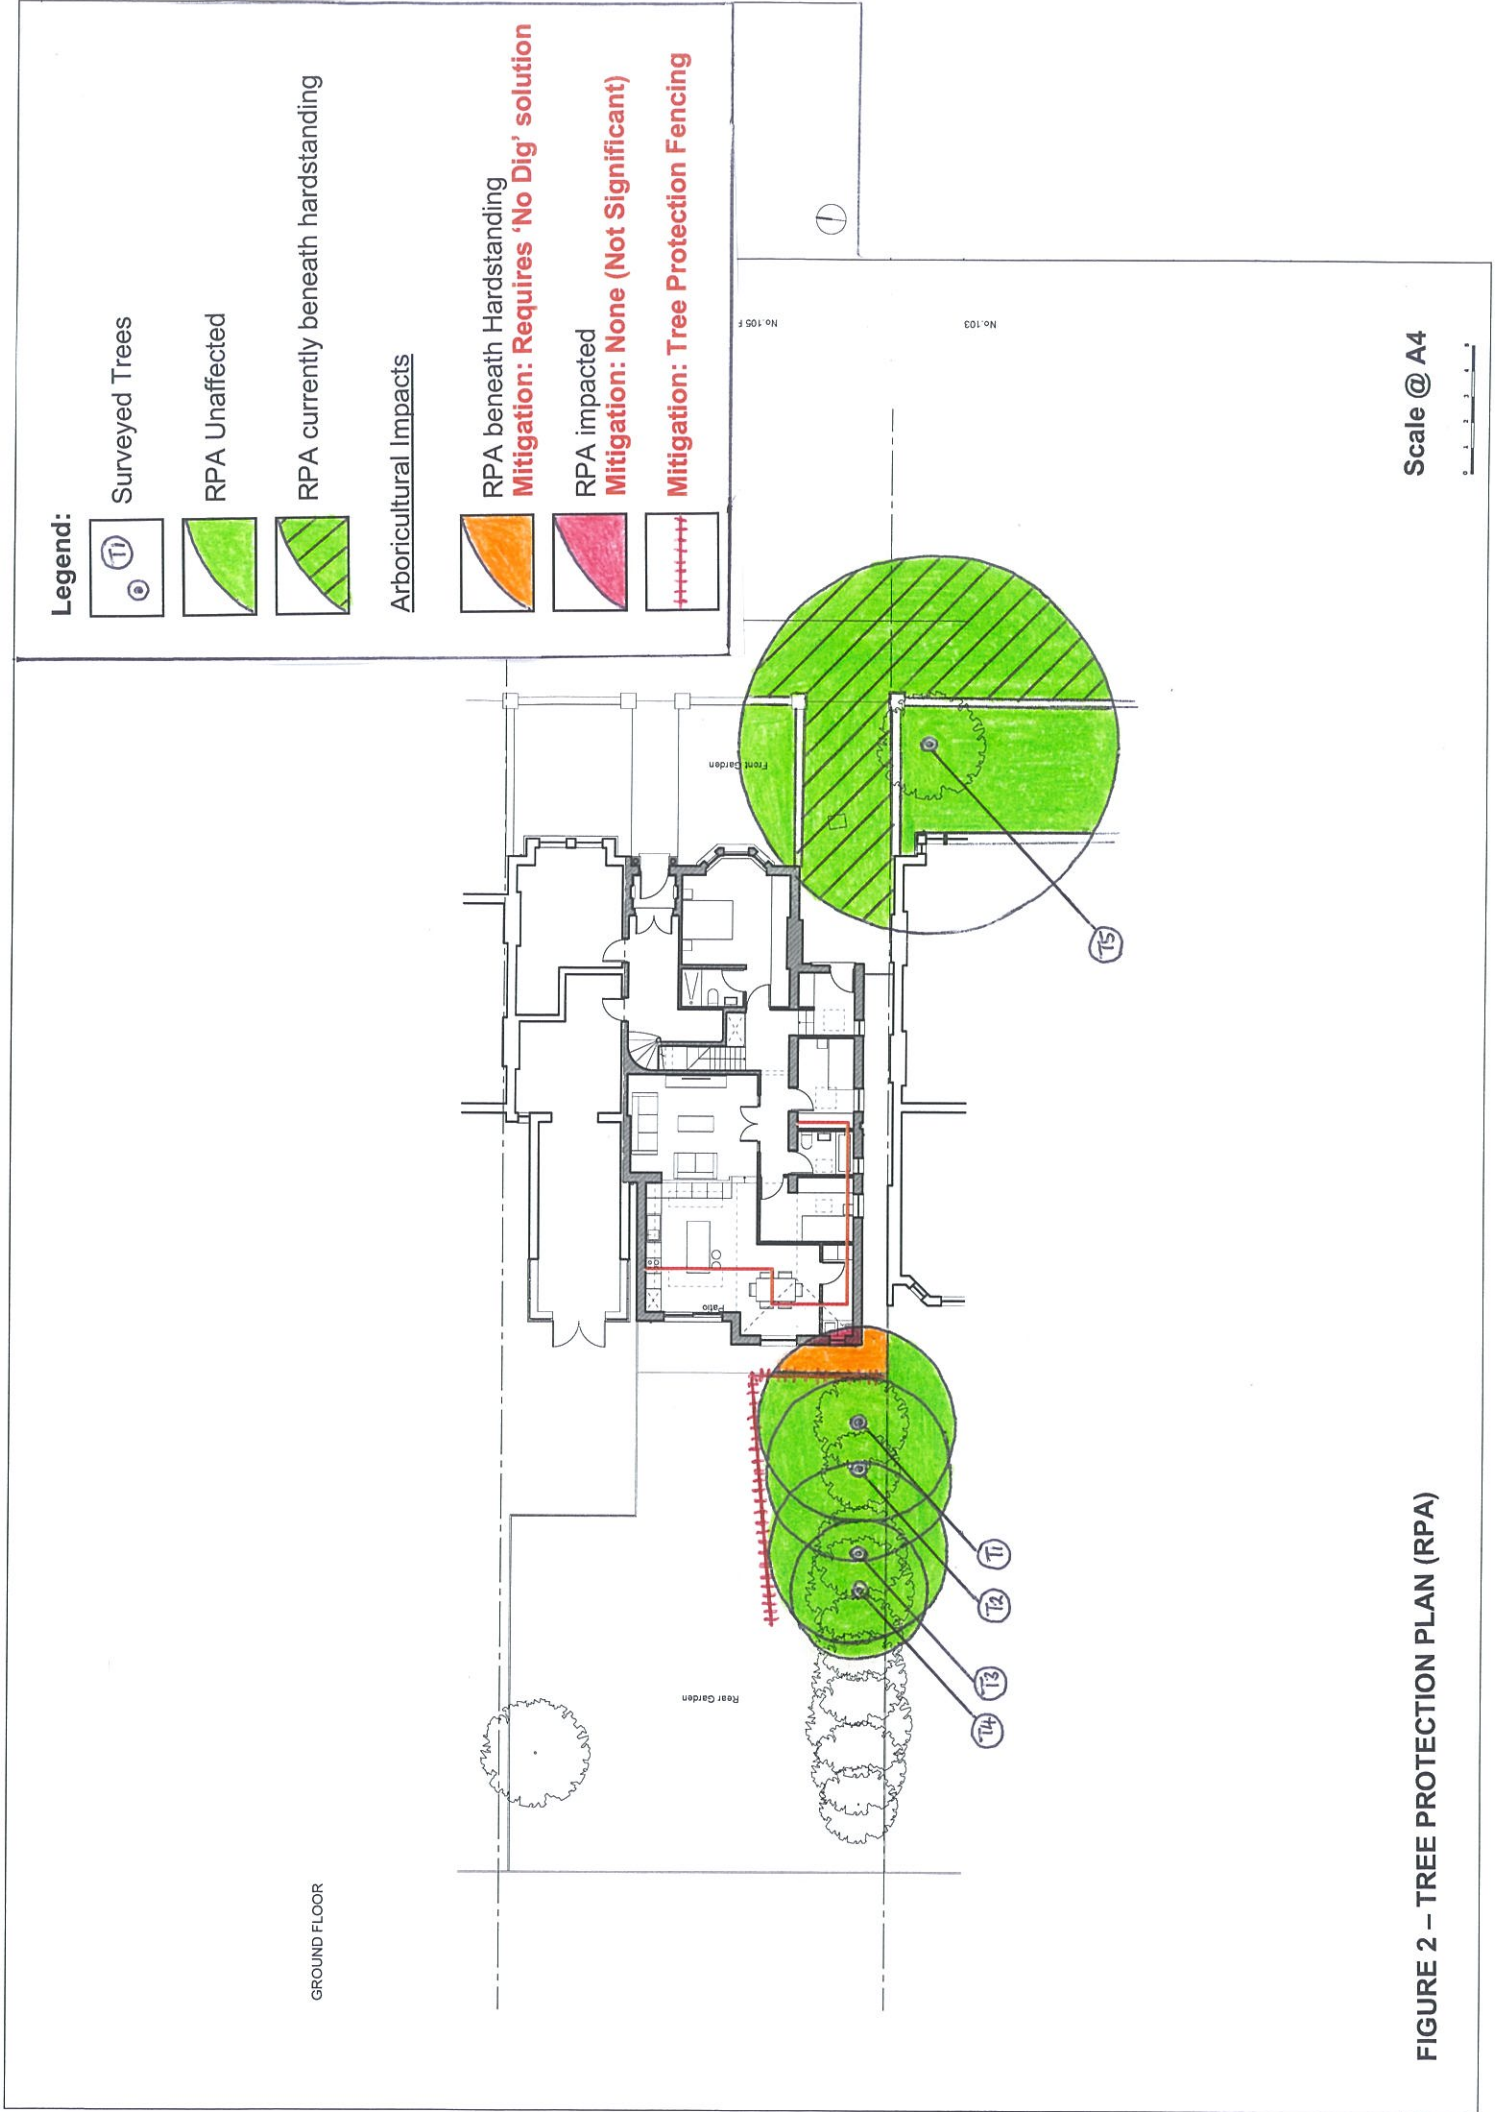
FIGURE 2 – TREE PROTECTION PLAN (RPA)

- 4.3 The foundations for the proposed new building have been carefully located so to minimise loss of the Root Protection Areas (RPAs).
- 4.4 Only a single tree (**T1**) would be impacted by the proposed flat extension but this would only result in the direct loss of less than 5% of the RPA, while a further 12% would be impacted by the proposed new hardstanding – see Figure 2.

- 4.5 These combined impacts upon the RPA of tree **T1** are not regarded as significant, however, it is recommended that the impact is mitigated by means of the following two actions:

1. Any excavations within a 500mm radius of the foundations would be hand-dug within the anticipated area of the RPA under the inspection of the Project Arboriculturalist. This would allow significant roots (larger than 25mm diameter) to be retained, especially the structural roots, and covered/watered as soon as possible to prevent desiccation. Where roots need to be lost they would be cleanly severed.

2. The new hardstanding surface would involve a 'No Dig' construction technique to retain the underlying root plate of tree **T1**.

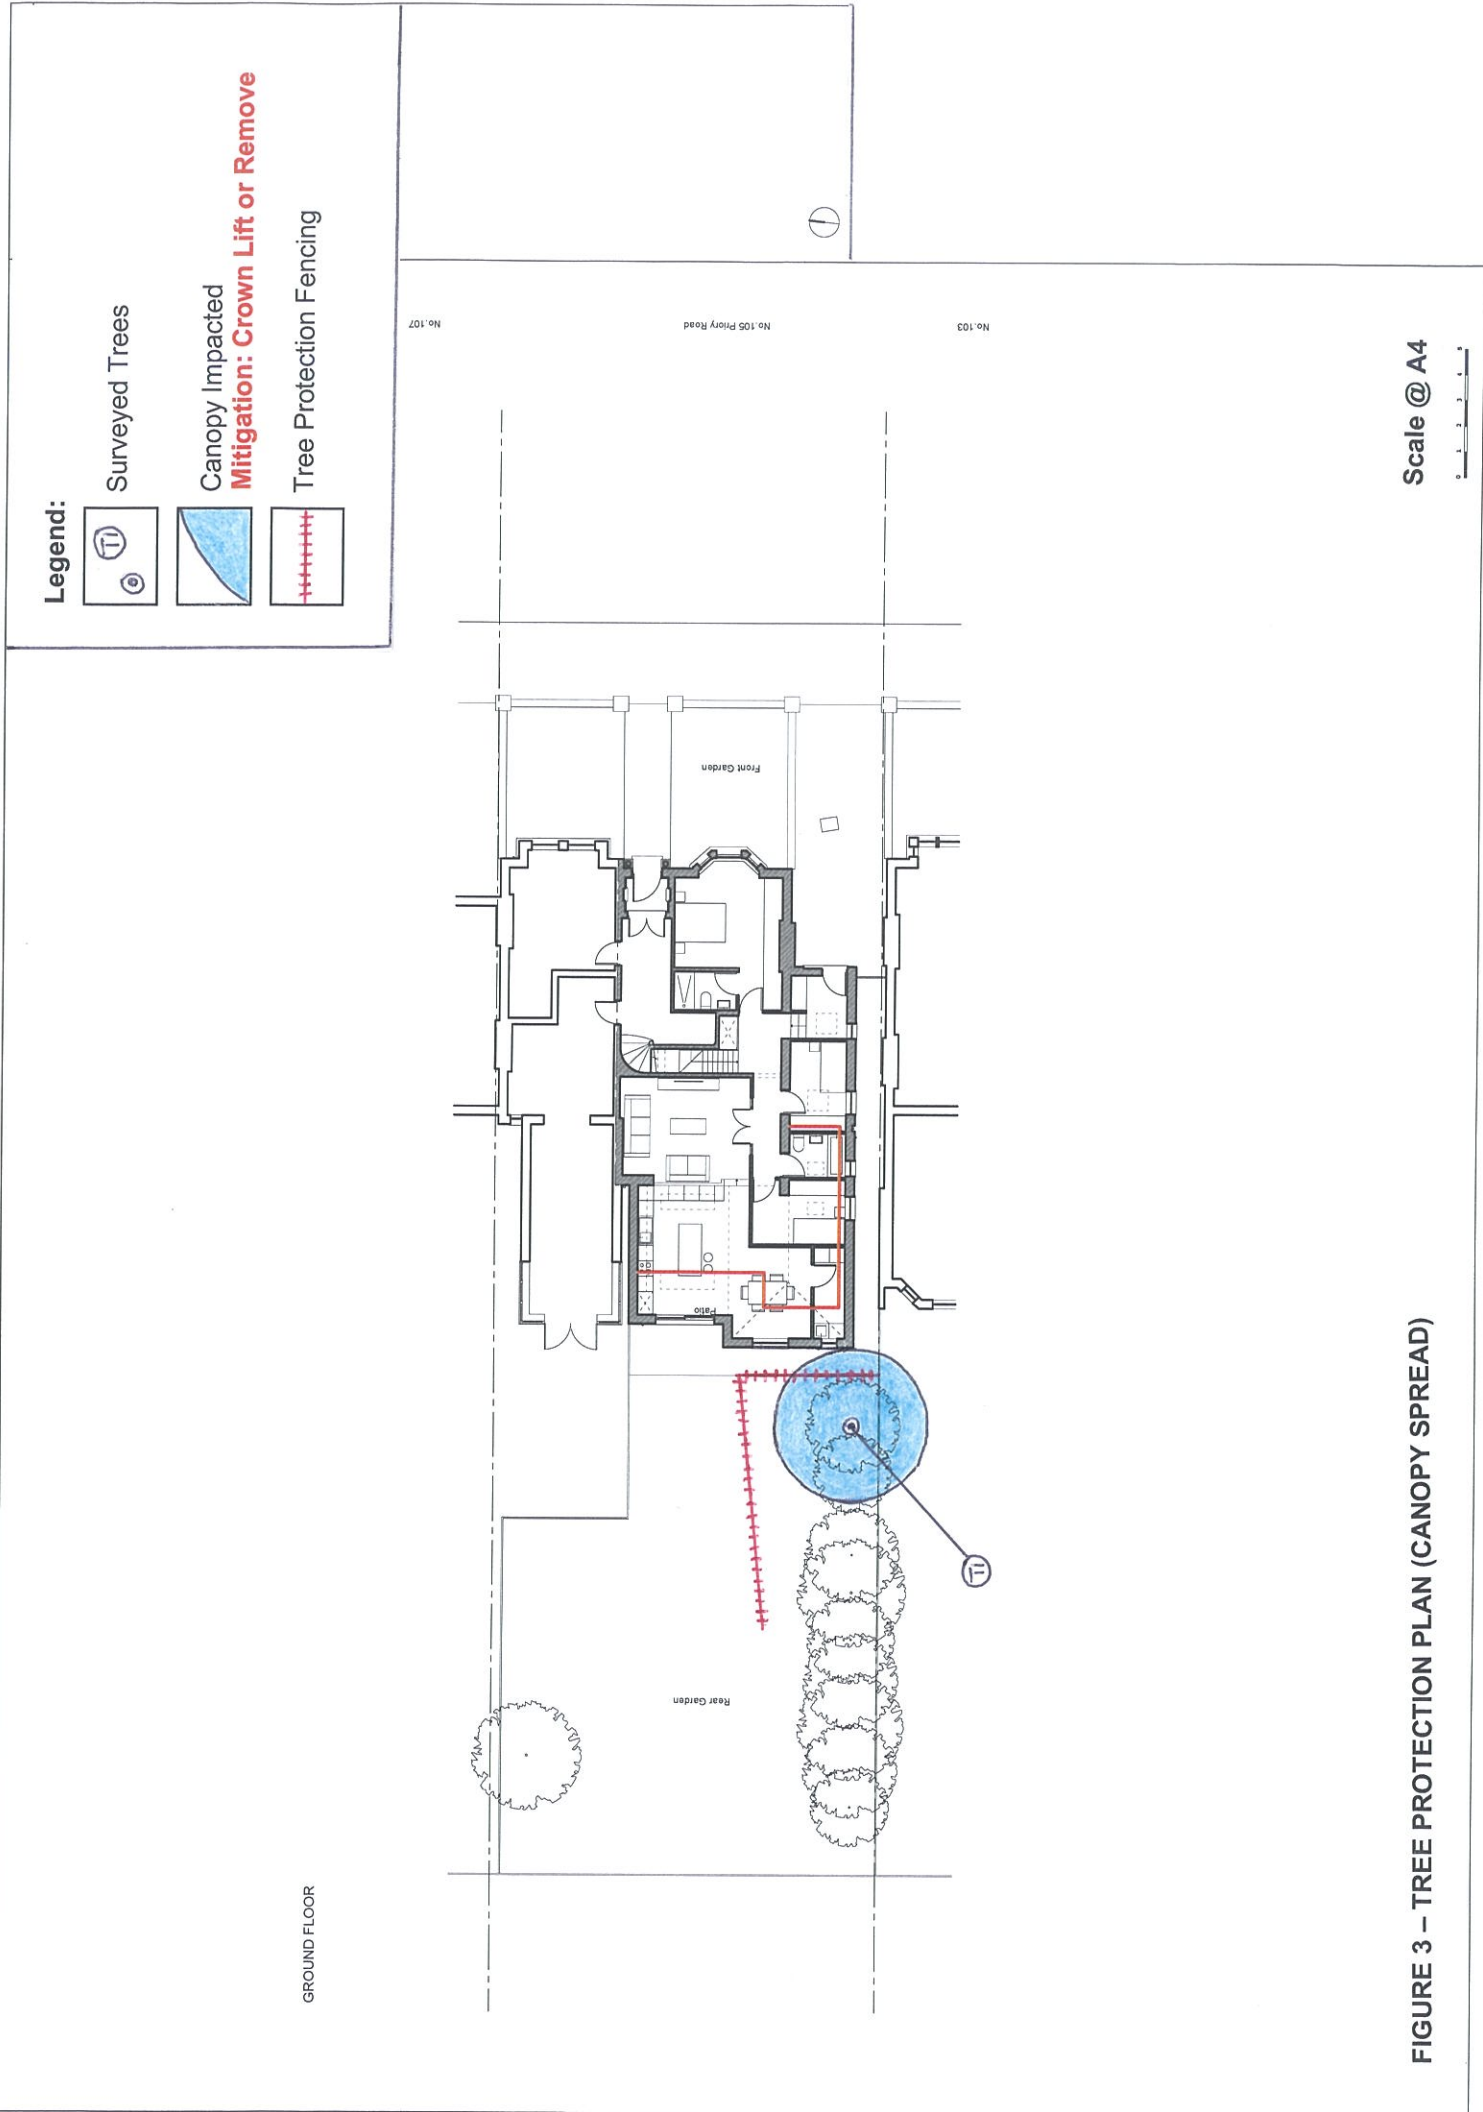
- 4.6 The new extension will not impact upon the canopy spread of the tree resource, including the nearest tree (**T1**), see Figure 3.
- 4.7 As tree **T1** was recently pollarded, its regrowth is mostly vertical rather than horizontal. There would be no significant change to the degree of shading upon the western face of Flat 1 as a result of the development, and there are numerous future management options such as:
- Crown reduction to prevent branches extending towards the property;
 - Periodic re-pollarding of the tree line containing trees **T1** to **T4**; or
 - Future removal of only tree **T1**.

- 4.8 The proposed construction will be based on a scaled Tree Protection Plan (TPP) – see Figures 2 and 3. These show where any potential RPA and canopy spread impacts occur and identify where arboricultural exclusion fencing (TPF) is required.
- 4.9 Any such fencing should be of the Type I TPF specification as set out in BS5837:2012 *Guide for Trees in Relation to Design, Demolition & Construction: Recommendations*. This is based on interlinking 3.5m lengths of 2m high Heras fencing, set on foot blacks, the Type 1 fencing being additionally secured in place using 1.2m long steel road-pins that will be driven into the ground.

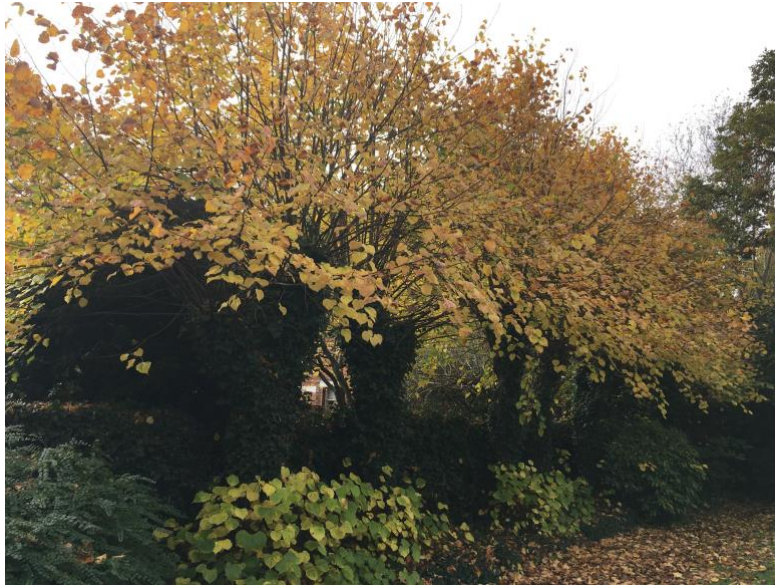
Looking SW along lime trees

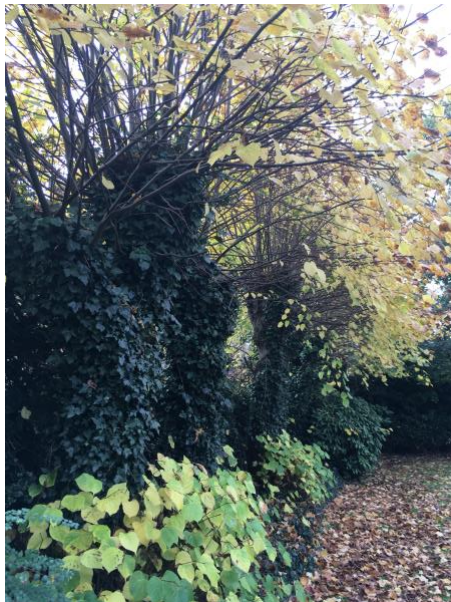
- 3.8 No significant physical constraints or infections were identified in the tree resource as identified within the Site.
- 3.9 Trees **T1** to **T4** have all been pollarded within the last two years and are now regenerating showing strong branch and epicormic stem growth. They are all covered in dense adherent Ivy *Hedera helix*.
- 3.10 Tree **T5** is surrounded by brick walls to the north and east, and both have cracks caused by the underlying root plate. In addition, the block-paved drive of property No. 105 has undulations that are similarly likely due to the underlying root plate from this tree.

Trees **T1** to **T4**

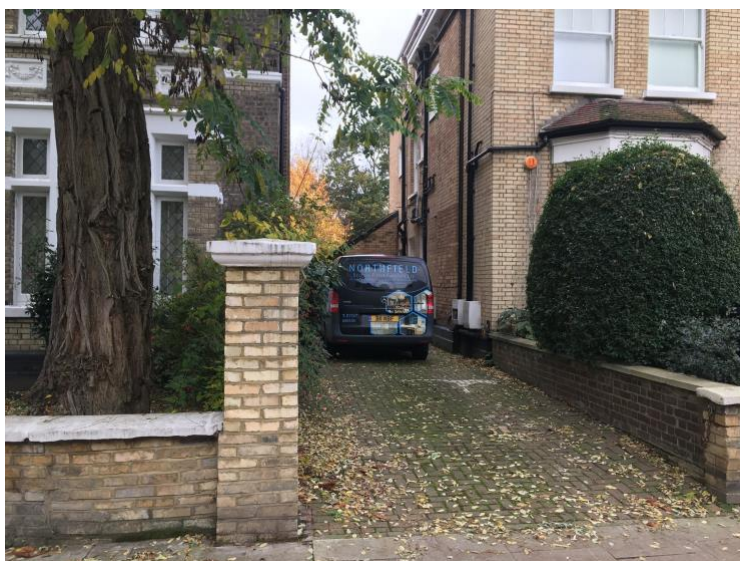
T5	<i>Robinia pseudacacia</i>	False-acacia	Maiden	620	7.44	14	4.5N, 5E, 4S, 5S	6	Stem pressing onto eastern (street) wall and causing wall to fracture and buckle, repairs evident. Also cracking of brick wall between property boundaries. Underlying root plate causing heave beneath drive of No. 105, resulting in lifting/slumping in blockwork.	None	A

Looking west along drive. Tree **T5**.

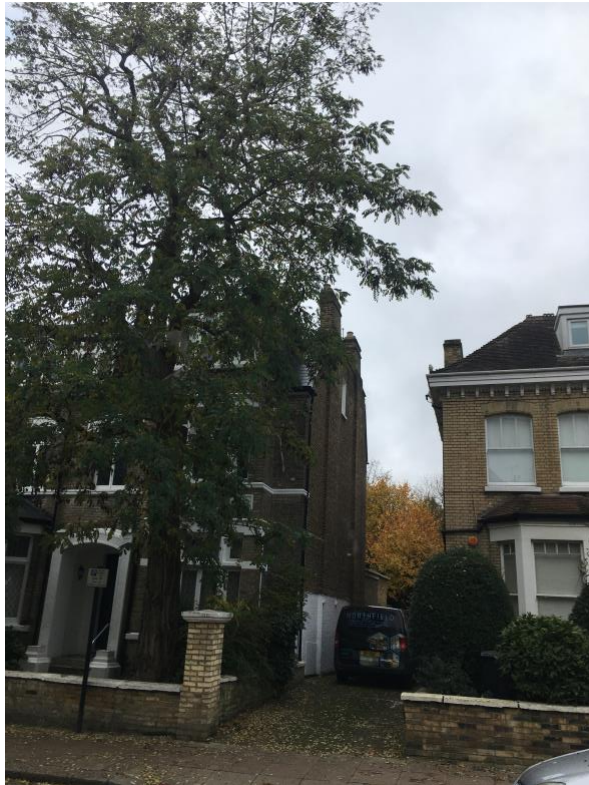
Adjacent tree **T5**

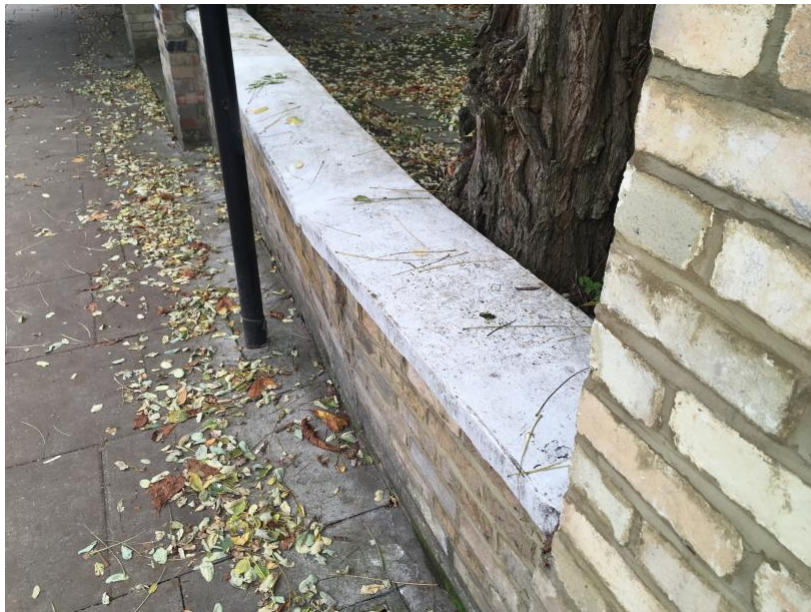
Bulging street boundary wall
beside tree **T5**
