**Project:** 4 John Street, London  
**Applicant:** James Moores

**Ref:** Jcsm.15/DAHS  
**Date:** 03.03.2020

- 1.1 This design, access and heritage statement is submitted in support of a Listed Building consent application relating works to secure movement to the existing façade.

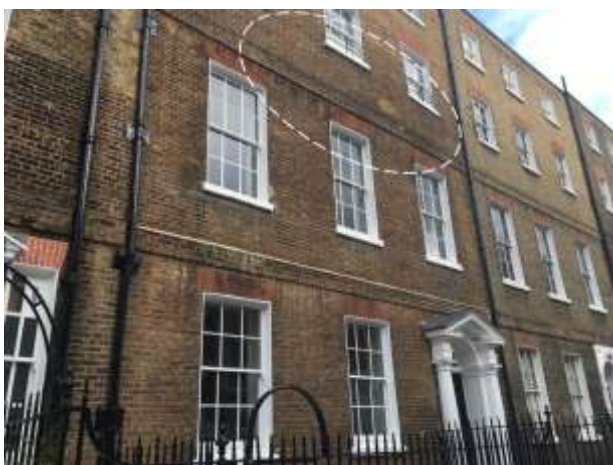
Bulging and cracking to the principal façade has been observed at second floor level. A subsequent visual survey suggests delamination of the outer face is the likely cause of the movement and misalignment. The full extent cannot be established without intrusive investigation.

Fig.03 Detail indicating location of delamination

- 4.1 The proposed scheme includes exploratory works to establish the extent of the delamination of the façade and to provide a long-term solution. The latter is achieved by rebuilding the affected area to its original detailing and construction.

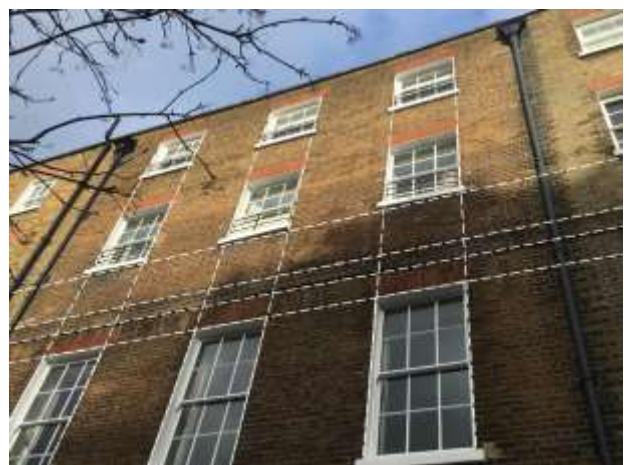
Fig.04 Grid mark-up showing distortion
