Arboricultural Impact Assessment,

Method Statement For:

11 Elsworthy Terrace

Date: 20th February 2020

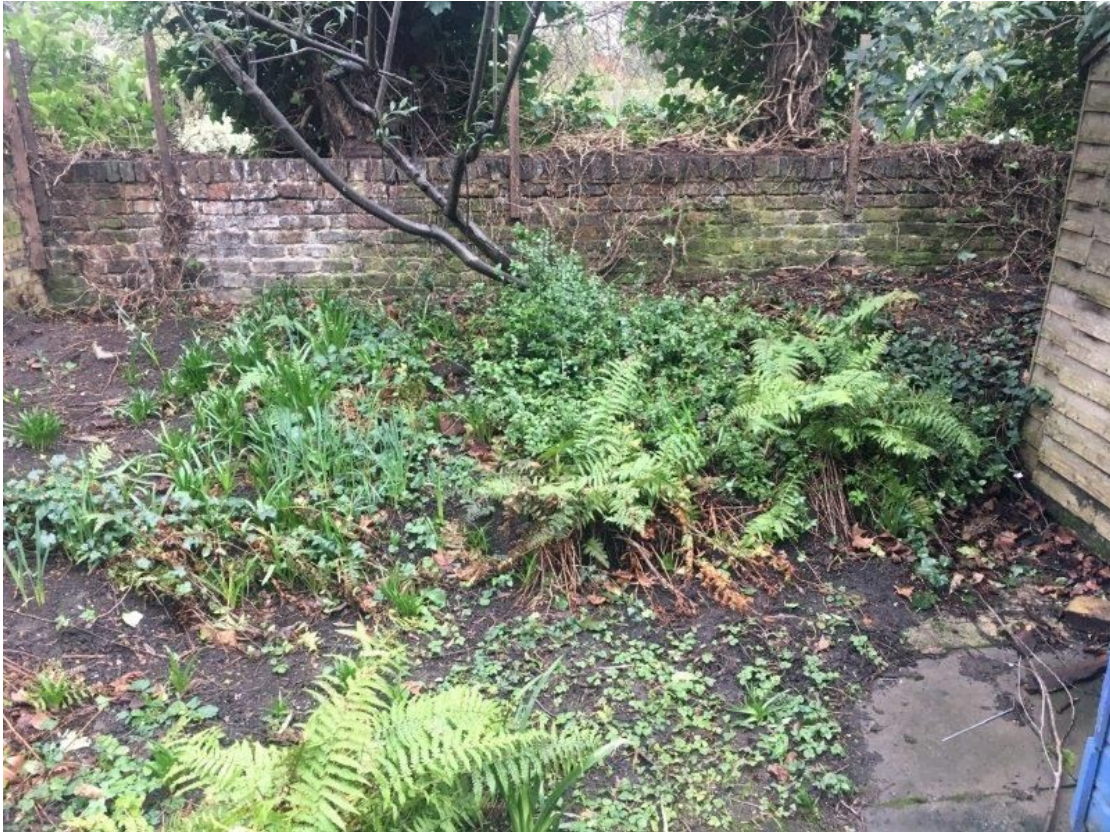
Photo 1: Raised area to be leveled off

The soil level along the rear boundary wall is approximately 500mm higher than the neighbouring garden where the three Limes are located. In lowering the soil level by approximately 250mm to allow for a flat and level base for the proposed development it is unlikely that any significant roots would be encountered and therefore damaged. During my site visit, I hand dug a few trial pits of up to 200mm in depth and found no roots that could have been from the three Limes. There is an existing stump from a previously felled tree in the NW corner of the area and it is likely any large roots found in this area would originate from this tree and not the Limes.

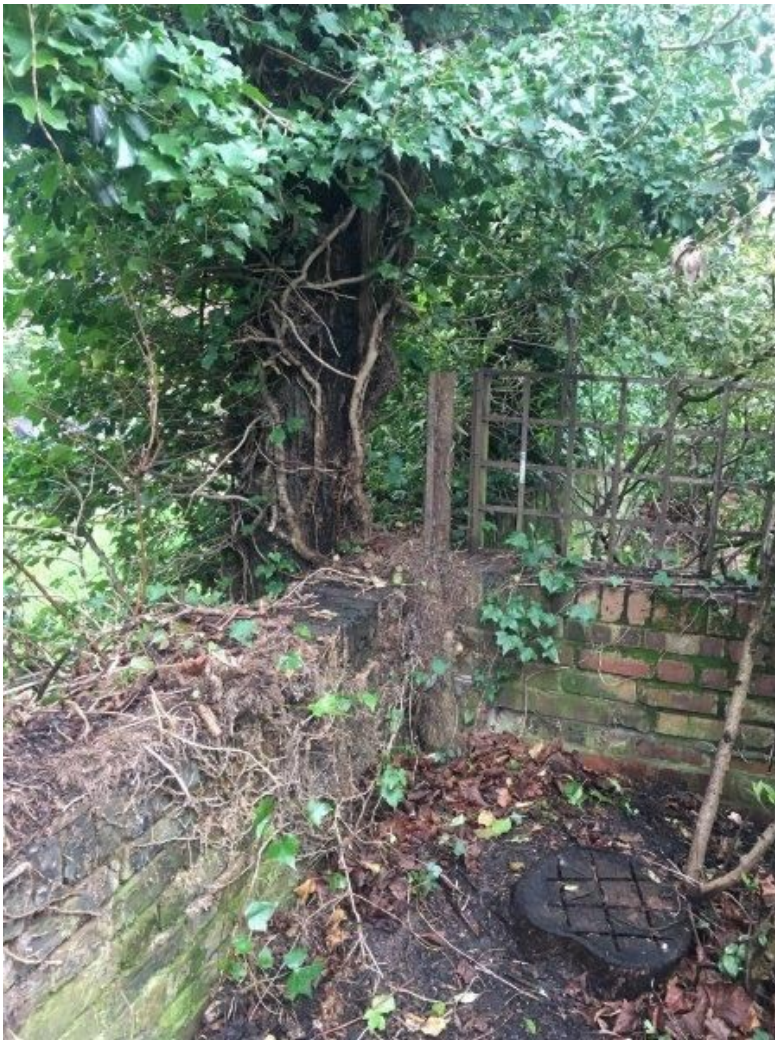
Photo 2: T1 close to boundary wall

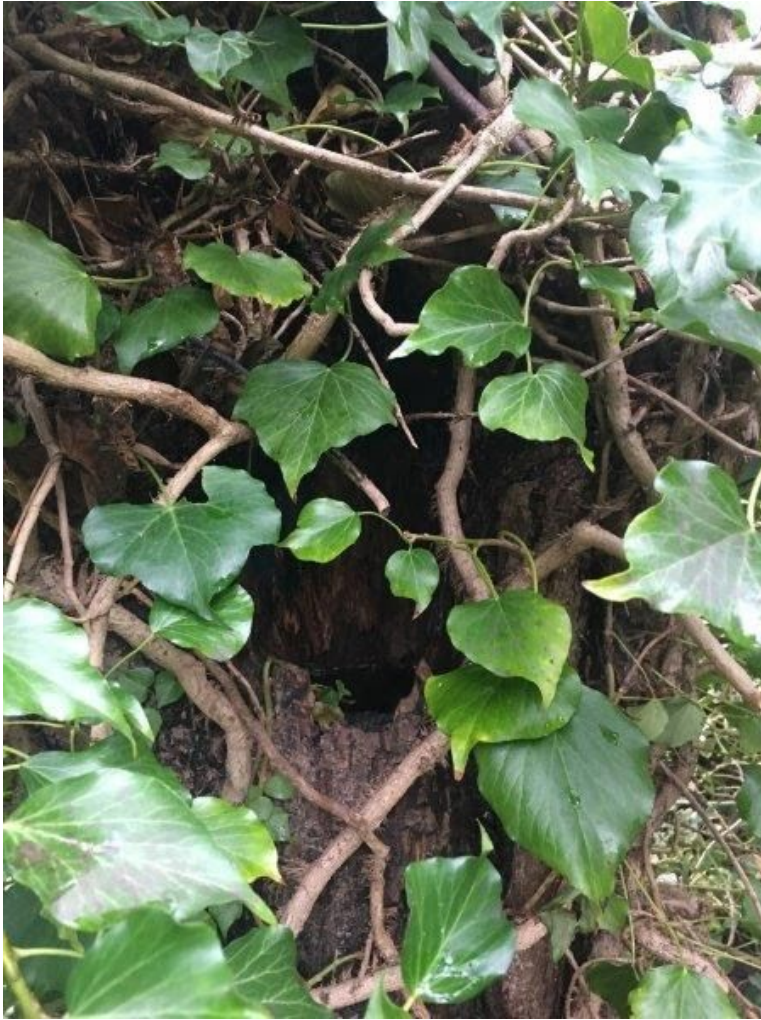
Photo 3: T1 Extensive cavity on main trunk

Tree no.	Species	Height (m)	DBH (mm)	Spread (m)	Age Class	Physiological Condition	Structural Condition	Preliminary Management Recommendations	Estimated Remaining Contribution	Category Grading
T1	<i>Tilia cordata</i> Lime	7	400	N1.5 E1.5 S1.5 W1.5	SM	Covered in dense Ivy. At 2m height large visible open cavity on the main trunk with poor residual wall thickness.	Weakened main union due to large cavity and poor attachment points	Low value tree, either remove and replace or reduce back to the recent pruning points as per general maintenance	<20	C3
T2	<i>Tilia cordata</i> Lime	7	370	N1 E1 S1 W1	SM	As above, Ivy clad and appears to be a similarly extensive cavity at the main trunk unions	Growing right up against the rear boundary wall with the main trunk already pushing against the wall.	Low value tree with no space for further trunk expansion. As above either remove and replace or maintain current pruning regime	<20	C3

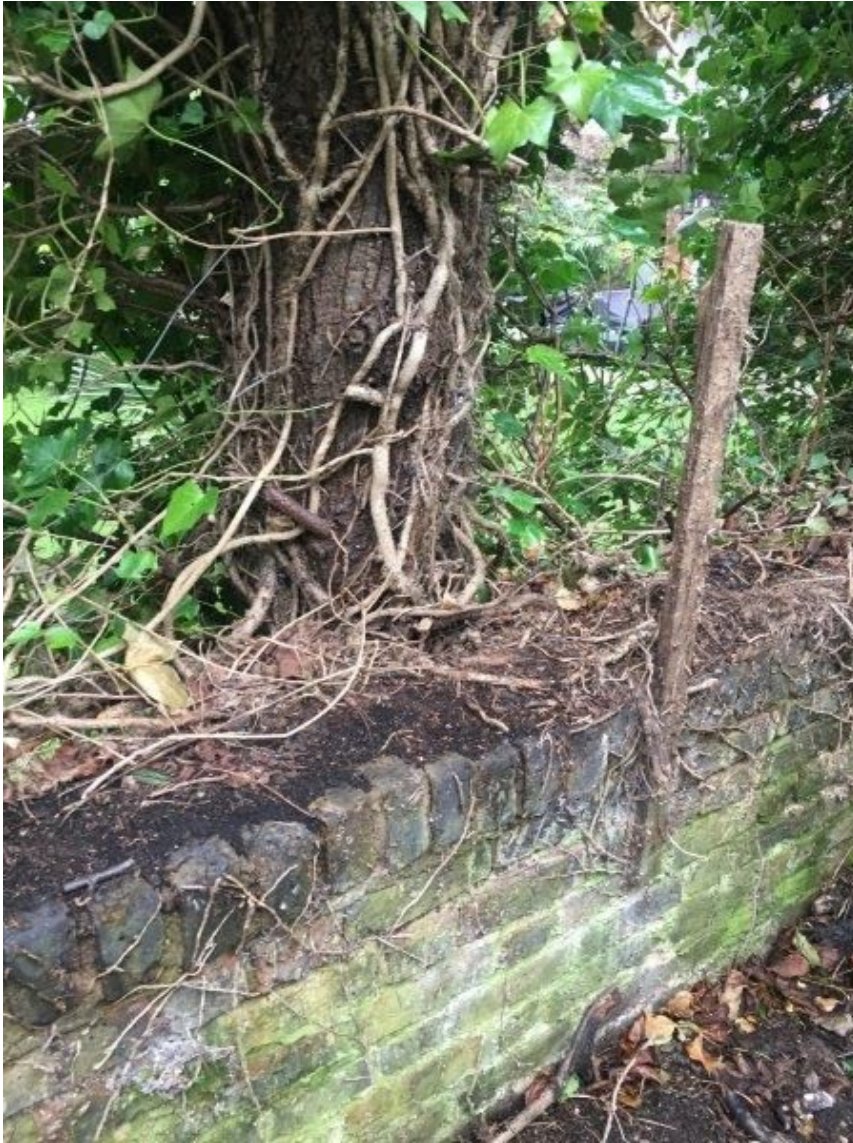
Photo 4: T2 trunk against boundary wall

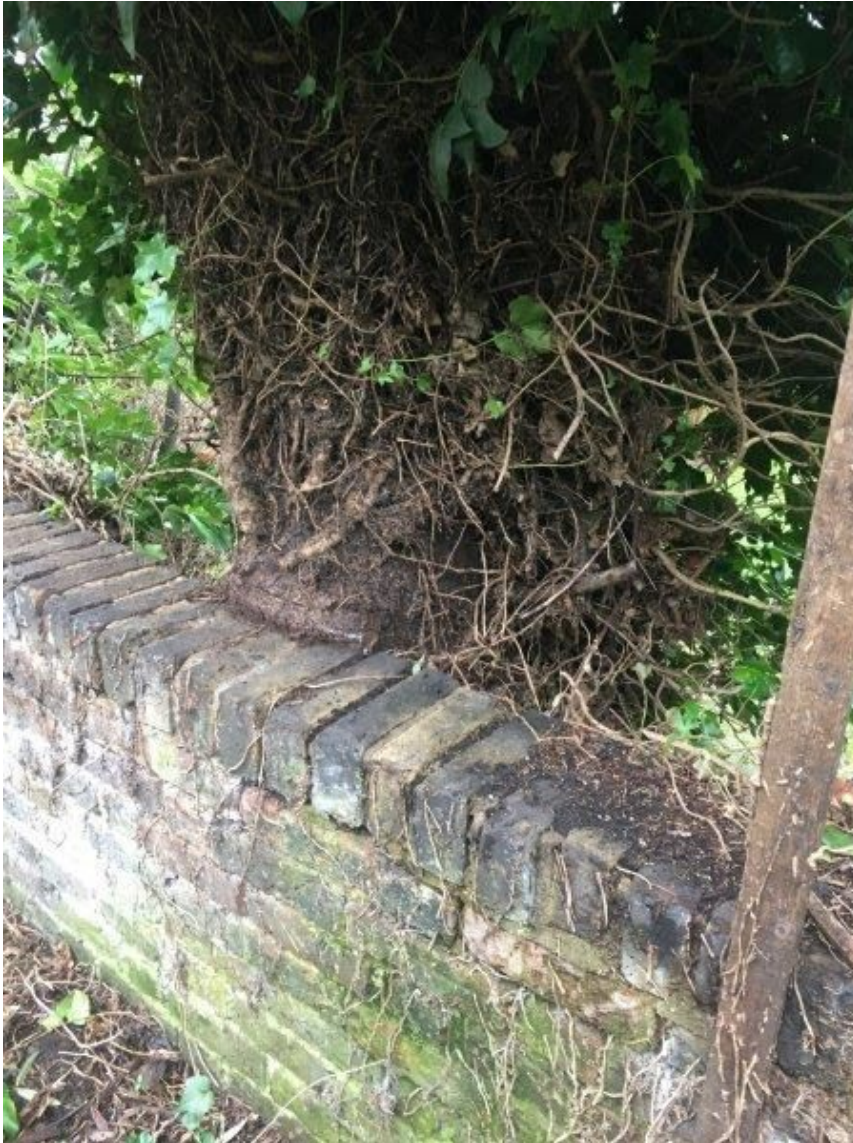
Photo 5: T3 Large trunk pushing against boundary wall

T3	<i>Tilia cordata</i> Lime	7	500	N2 E2 S2 W2	SM	Covered in very dense Ivy. making it hard to assess for structural defects	Growing right up against the rear boundary wall with the main trunk already pushing against the wall.	Low value tree with no space for further trunk expansion. As above either remove and replace or maintain current pruning regime	<20	C3
T4	<i>Magnolia x soulangeana</i> Magnolia	4	120	N1.5 E1.5 S1 W1	Y	Good	Good	Retain	>20	B2
