# Design and Access Statement and Incorporating Heritage Statement

## 3 Wren Street Roof Renewal and Building Maintenance rev. A

20.02.20

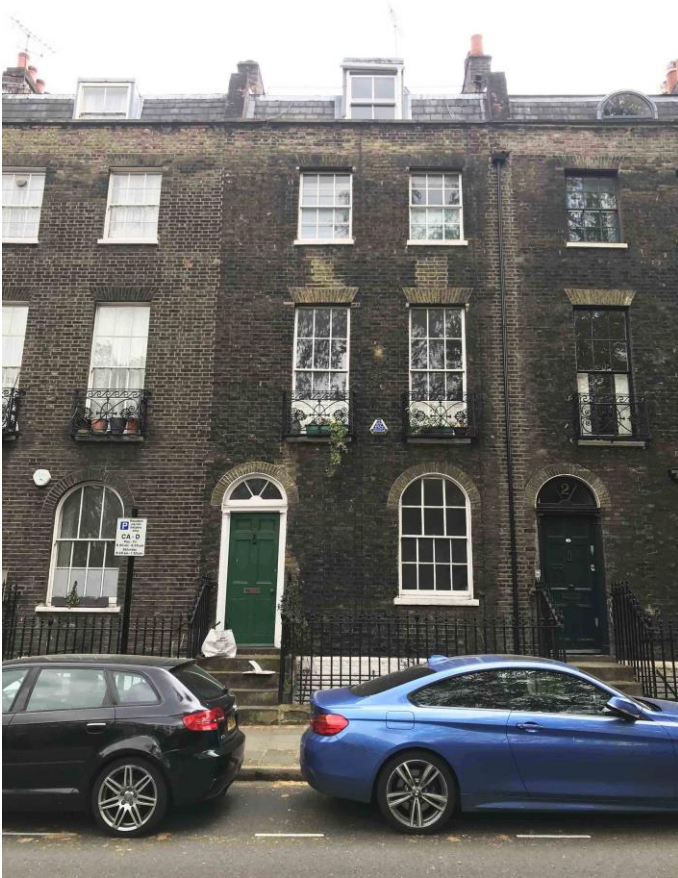
**3 Wren Street front façade**

The brickwork to the front façade is in general London yellow face brickwork and has survived intact with the previously described window and door arches that have been cleaned. The main façade though has been darkened through age and appears generally blackened. There has been some unsympathetic pointing done under the vertical rainwater pipe to the west side of the front façade full height and in two localized areas above the first floor windows and a smaller area and a couple of bricks around the front entrance door. This pointing appears to have been done in cement based mortar that is ‘heavy’ and modern in appearance and stands out visually inappropriately.

Steam clean the front façade gently of the blackened areas of the London yellow stock brickwork.

There are localised areas of blown pointing on the front façade, but here there are areas under the rainwater pipe to the west and in other localised areas over the first floor windows and around the front door where the brickwork has been pointed in a cement based mortar that has been heavily 'weatherstruck'. This is wholly inappropriate to the Georgian brickwork that was in this case simple flush pointed in a limed based mortar. The cement based mortar pointing must be carefully removed not damaging the existing brickwork, joints carefully raked out to take a new pointing key and repointed in a lime based mortar compound with a hygroscopic action to shed rain and initial moisture, but importantly allow for moisture to travel out of the mortar joints out of the brickwork generally allowing the brickwork to breathe.

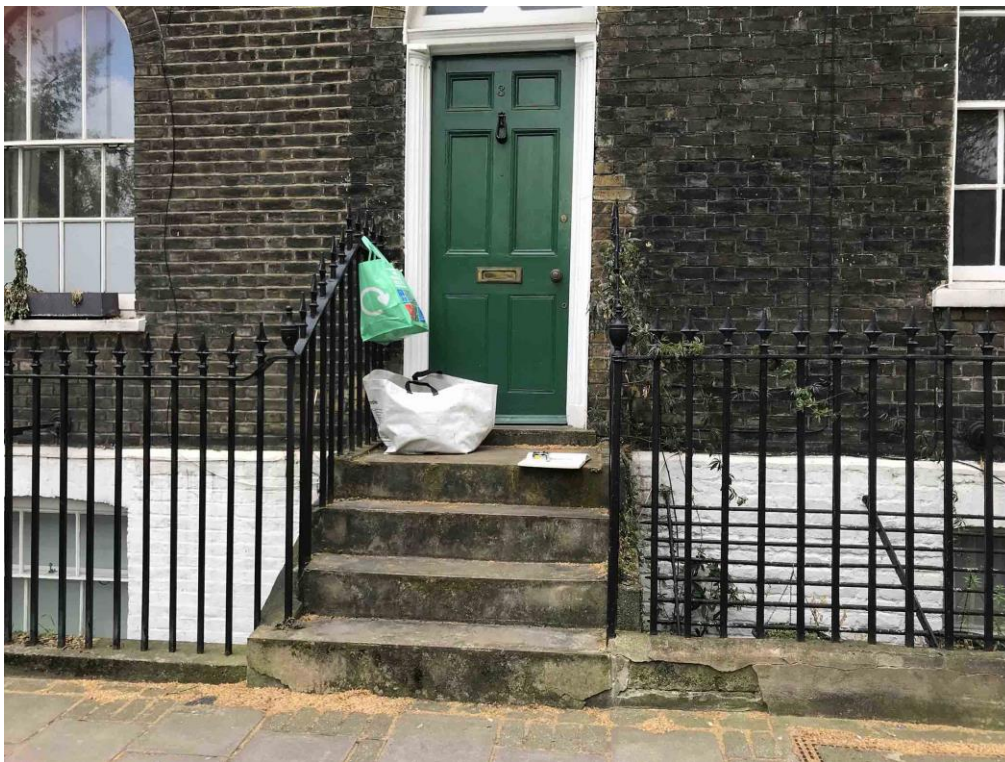
**3 Wren Street front steps**

At ground level there are original black painted iron railings with natural stone set stones and four steps up to the front door. Remedial repairs in the late 20<sup>th</sup> Century/ early 21<sup>st</sup> Century included applications of waterproof render to the railings set stones around the front lightwell and to the front stone paved steps. This remedial work has run its course and is now damp and has given a degraded appearance to the front ground level. The front steps appear subtly, but definitely out of proportion to the original too high. Presumably the steps and railing set stones were topped not only to waterproof the stonework but to raise the level in which to set the ironwork railings that will have rotted in time from contact with the stonework and will now require lengthening.

**It is proposed to gently break up the waterproof render to the front ground entrance steps and the railings set stones without damaging the existing stonework underneath using handtools only. The iron railings will have to be temporarily removed and stored to be refitted and lengthened as required. The front stone steps will have to be unearthed from the render and related previous alterations. And so it is unknown just how much will have to be replaced, this will have to be assessed at the time, recorded and monitored. There is some required archeology of sorts to bring the old original stonework back to life.**

**Once the stonework has been exposed and assessed, it is proposed to remove it and apply a resin based waterproofing system upon the original brick arch substrata and waterproof comprehensively before resetting the stone steps and lightwell railings setstones. Then the iron railings can be reset into the setstones and steps using molten lead.**

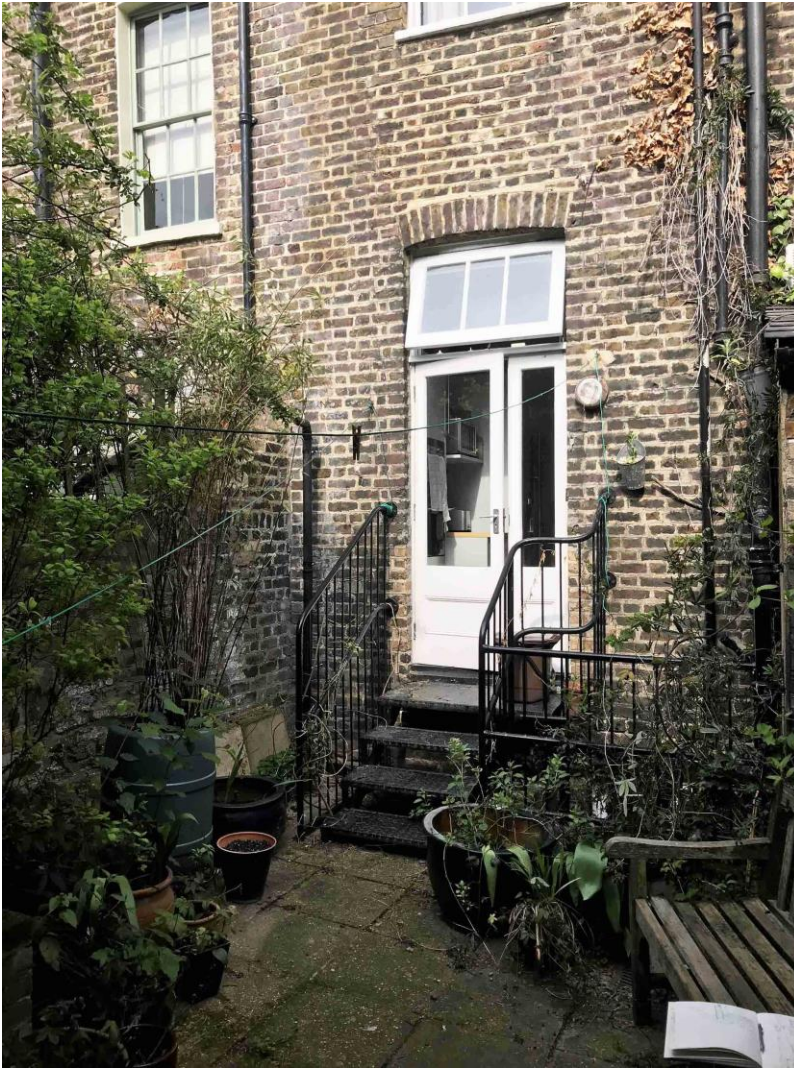
**3 Wren Street rear ground level access via kitchen**

The house in the rear gives on to a rear garden. There is also a single storey attached rear extension that very likely was originally a scullery. There is no visible evidence of the original conveniences, but undoubtedly this was somewhere in the rear garden. The existing kitchen is in the rear ground level room and this gives the present access to the garden via a door and window arrangement that appears to be a 20<sup>th</sup> Century intervention converted from a previous window. The single storey extension has a bricked-in window with the window arch still visible and a new window towards the east made in the original manner, so this might be an old alteration. The ground level rear access is now via the kitchen starts at a steel landing and steel steps that is more modern and not as sympathetic as it might be.

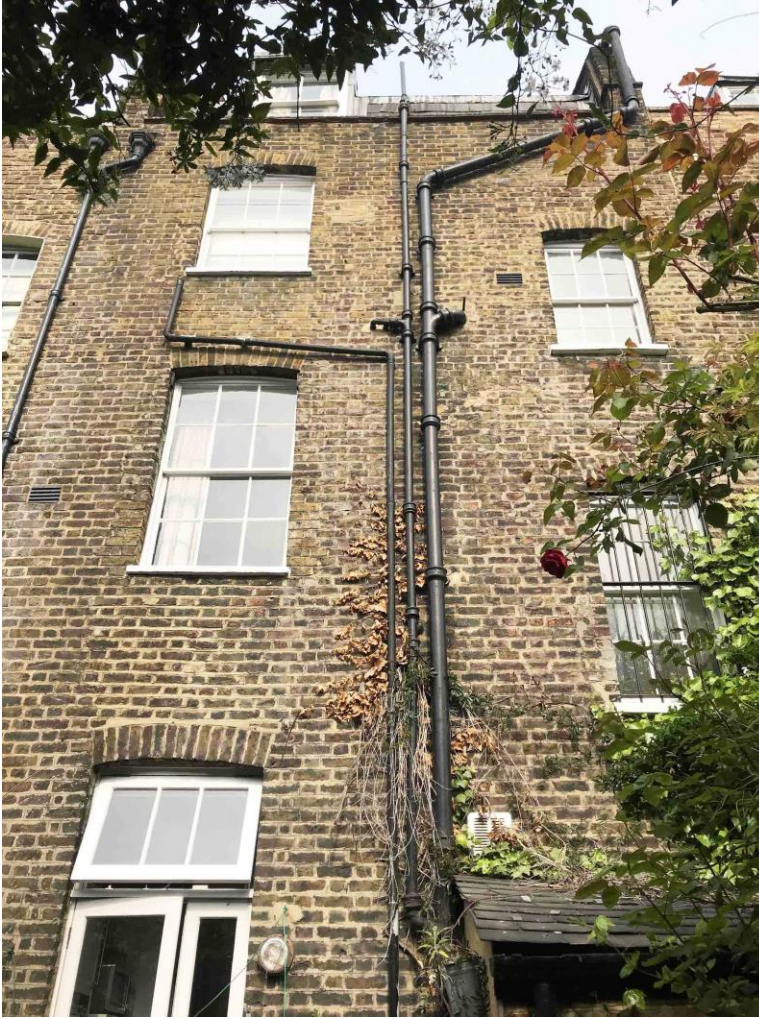
**3 Wren Street rear façade**

**The rear façade brickwork is intact okay in London yellow stock brick with a few reds sporadically mixed in. The rear brickwork façade is in need of repointing with some areas showing dilapidated and blowing pointing and other areas badly repointed. It is very mixed and needs to be gone over with a uniform treatment and for the future long term maintenance of the building.**

**The rear windows have brick arches and all are sliding sash timber painted white. There is a large cast iron soil vent pipe, and another waste vent pipe in cast iron as well as another cast iron rainwater with hopper to the west serving 2 and 3 Wren Street. Another unsympathetic black plastic drain pipe has been added from the second floor level bathroom that drops in front of one of the window arches and continues to the ground level.**

**Some considerable original lime based mortar pointing has blown and is efflorescing and falling off the rear façade. Here the existing brickcourse joints need raking out and repointing in a limed based mortar pointed flush. It is recommended too that the brickwork be sponge cleaned as it is repointed to ensure that there is no mortar staining of the brickwork face. There are areas to of inappropriate pointing where the individual bricks are not exposed entirely that is very crude and defacing. This pointing must be carefully removed before repointing. There are other areas of the same type of 'weatherstruck' cement based pointing too that need removal before repointing.**

**The proposed 50mm dia. bathroom waste drain is proposed to be rerouted internally back to the soil vent pipe without causing damage to original building fabric.**

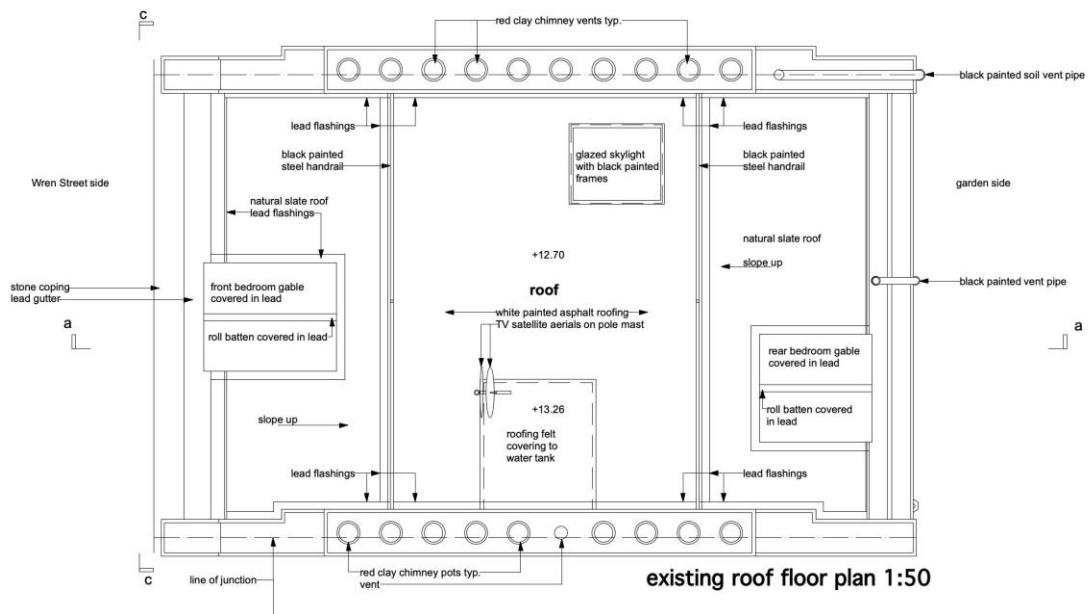
**The existing roof of 3 Wren Street is configured having two sloping portions front and rear with a centrally placed flat roof section or bay. This appears to be the original roof configuration and indeed this allows the third floor bedroom level volume to be as big as possible. The flat roof section also allows for access to the roof on a safe flat portion of it. The whole of the roof is flashed into the two party walls either side in lead throughout. The roofing stops short and behind the front and rear facades to formed lead gutters. Presumably the gables inform access for clearing the gutters that is required as they could easily block and being within the building on top would cause flooding in the event of a downpour.**

It is proposed to remove the roofing entirely throughout including lead flashings keeping the roof structure insitu and exposing it for inspection. The natural slates will be retained where possible and set aside for relaying. All lead flashing shall be recycled. The existing asphalt roofing shall be demolished and redecked in marine plywood for renewal in a lead coloured roofing membrane. The existing roof profiles are to be retained throughout and code 5 lead flashings renewed as per the existing. The revised roof section shall allow for a breather membrane under the natural slate sloping roof portions to allow for cross ventilation over Rockwool insulation cut to fit and over in two layers providing the thermal insulation the roof has never had and responsibly saving energy in the house generally. The same profiles are to be retained inside and externally. Lead clips are to be employed to the slates in the vertical portions of the slate roofing. The existing lead gutters front and rear are to be inspected and tested and renewed if found to leak.

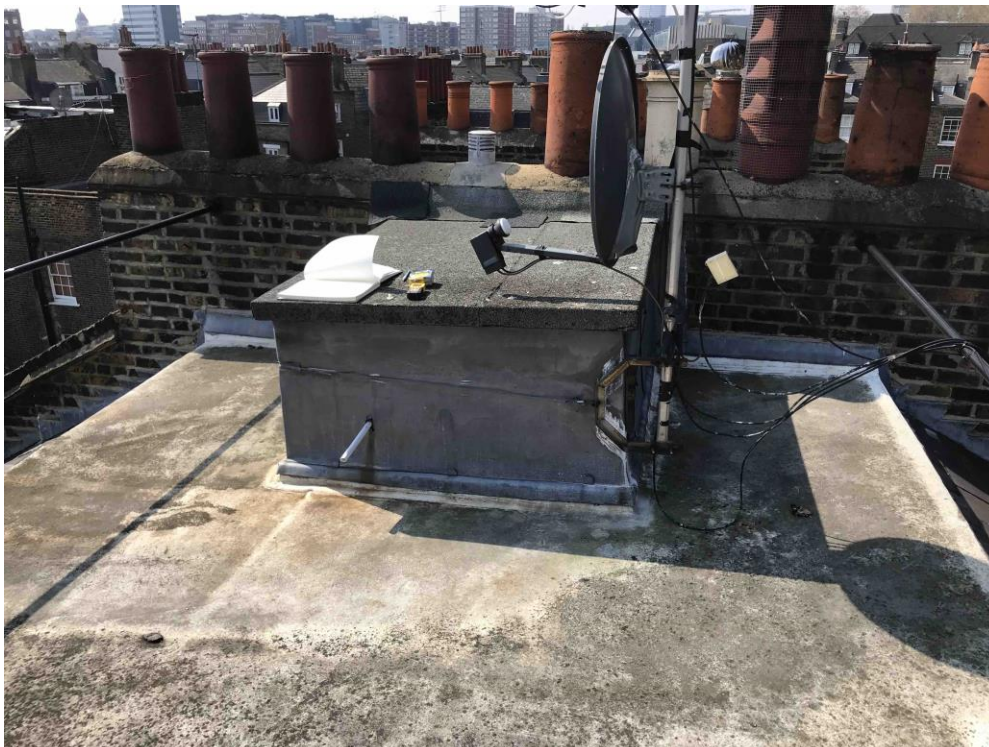
3 Wren Street main roof flat portion looking west

There is gravity fed water tank at the roof level to the west that is housed and weathered in a lead covered box with a top lid in felt roofing. This is quite sizeable and also supports the TV and satellite dishes and mast. On the east side there is the self raising glazed lid to the skylight and access hatch. These features are found within the central flat roof portion that is roofed in asphalt and painted white that has dimmed and is quite dirty now with moss. The present roof construction is uninsulated and unventilated as well. There is concern for the timber roof structure that remains hidden from view and inspection and maintenance. There are 2 no. steel handrails to the front and rear sides of the flat roof portion, these are in place for maintenance access safety only as all access to the flat roof can only for this reason. The handrails are not to full balustrade height and are not infilled.

It is proposed to reduce the water tank box in size in plan and to replace the top lid covering in a lead.

**5) Replace the existing black painted railings at the rooftop with renewed black painted handrailings up to the regulation height of 1100mm from the existing roof level.**
