BASEMENT IMPACT ASSESSMENT ADDENDUM_2
20A FERNCROFT AVENUE
LONDON
NW3 7PH

JOB NO: P19-461

DATE: 9th April 2020 – Rev 0

BS 5837:2012 Tree Survey Arboricultural Impact Assessment

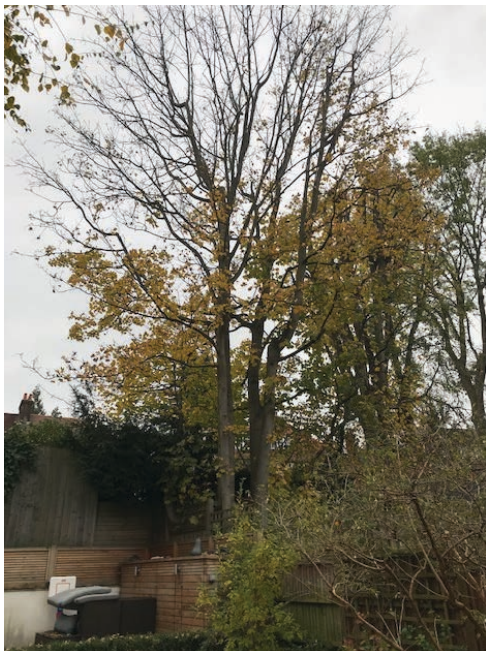
The only medium quality tree in the survey is the mature sycamore at the rear of the garden, this tree is multi-stem and has an extensive canopy but has been subject to tree work in the past. This tree is not located near the construction and will not be impacted.

T4 sycamore – located in neighbours garden with extensive canopy

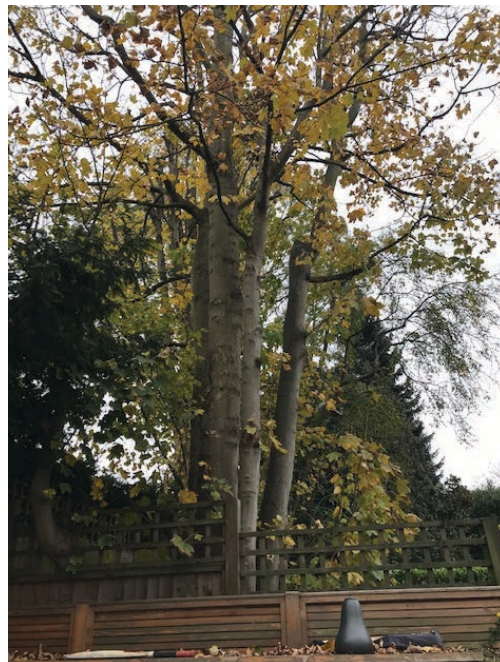
T4 tree is a large multi-stem mature tree which has been subject to tree work

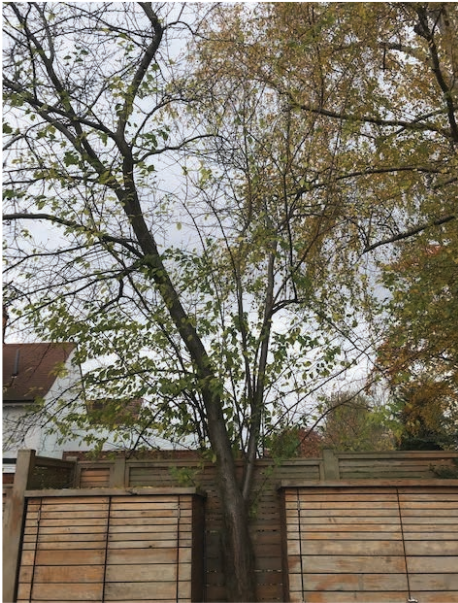
T1 Cherry with pronounced leaning stem due to proximity to T2 birch

This Category 'C' cherry (T1) is the owners tree, it suffers from having both a constricted canopy and also from its compromised planting position. The tree is out-competed by the adjacent and dominant T2 silver birch which has an extensive canopy. T1 can be shown to be leaning to the south to gain canopy space. The stem of T1 is also positioned between 2 storage sheds meaning that its planting area and drainage is not ideal. This tree is to be removed and a replacement tree further down the garden is proposed.

- 7.5 The proposed basement will extend further into the garden and will directly affect the T1 Cherry as its canopy and RPA are inside the intended basement area. It was noted however that T1 is lacking in vitality, it has a restricted rooting area and compromised drainage (due to its proximity to garden sheds on either side of its stem) and reduced light levels. It is proposed that this tree be removed and for a replacement tree to be planted further away from the house.

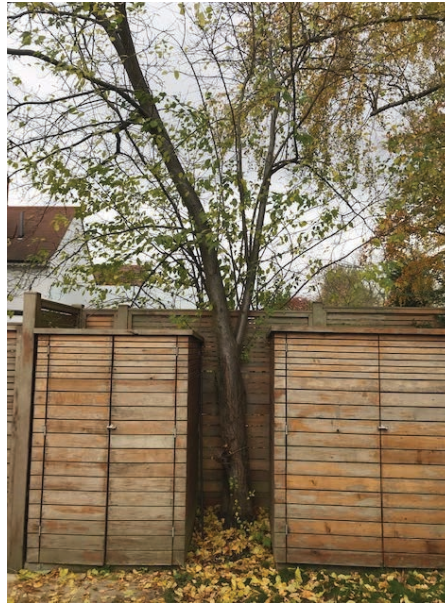
T1 Cherry is positioned close to fence and between 2 garden storage sheds

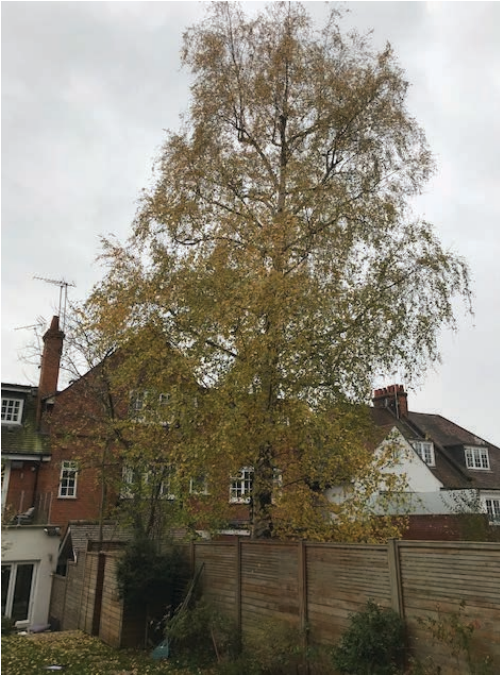
T2 Silver birch with extensive canopy – this is the neighbours tree (No. 20 Ferncroft)

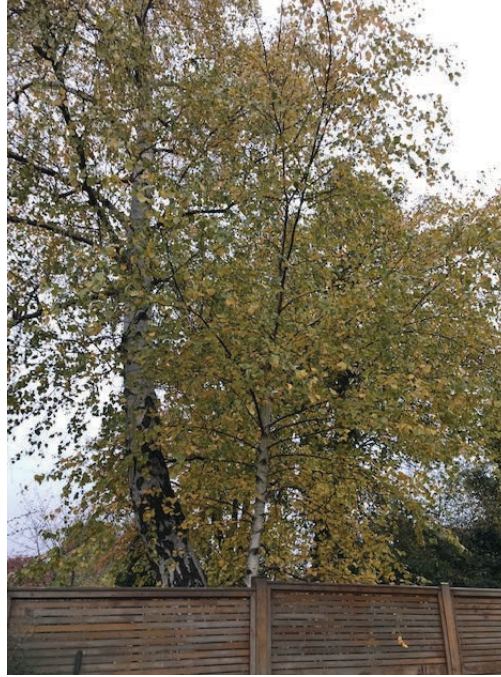
T2 Silver birch with slightly leaning stem and additional leader now developing

The above Category 'C' T2 silver birch is the neighbours tree (20 Ferncroft) and this tree was noted to have a slightly leaning form stem until 2m which then straightens. The stem has also developed a new small "leader" which is gaining dominance and is growing a new secondary canopy from this leader. T2 has an extensive canopy and provides good screening, privacy and seasonal interest.

- 7.7 The T2 Silver Birch is owned by the neighbours of 20 Ferncroft and as demonstrated in **Appendix 3**, there will be no disturbance to its RPA through the demolition, excavation or new basement construction. There is a risk of soil compaction to the RPA of T2, however this is being addressed by the installation of tree protection fencing to fully protect its RPA. T3 and T4 will similarly be set behind tree protection fencing to avoid root damage and soil compaction.

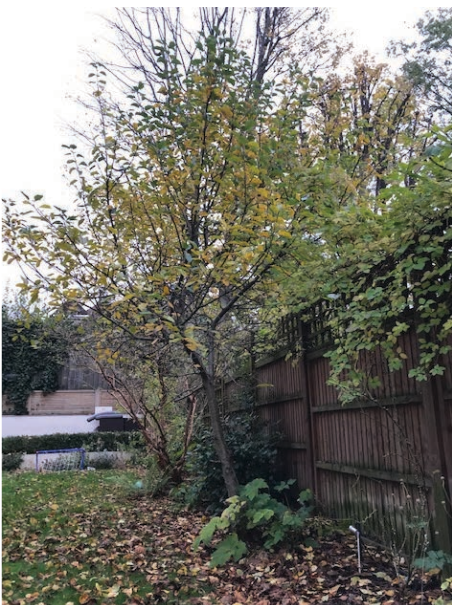
T3 Cherry is a small decorative tree located close to opposite fence – the tree has slight leaning form – leans to north.

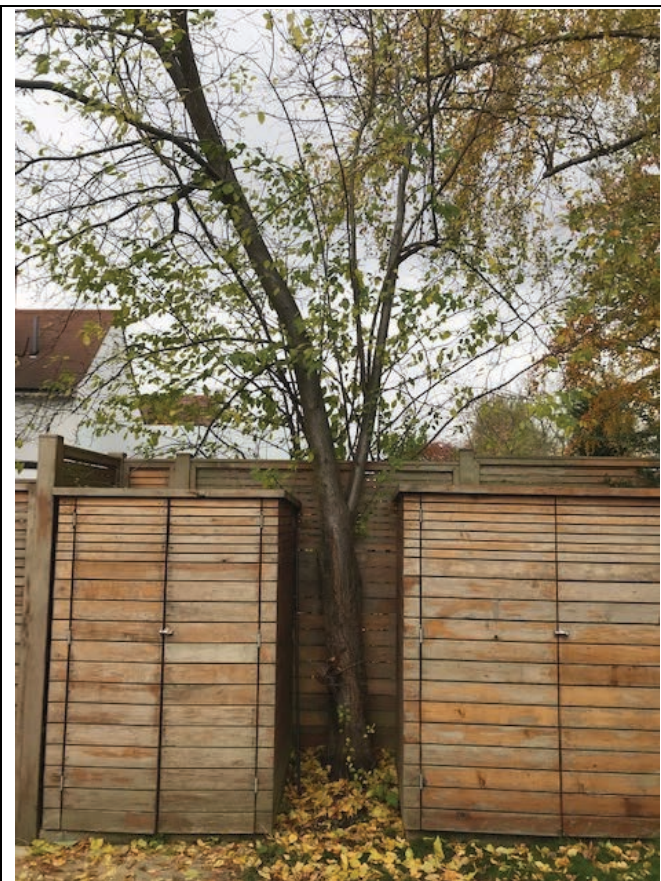
T1 Cherry with compromised rooting area and leaning form

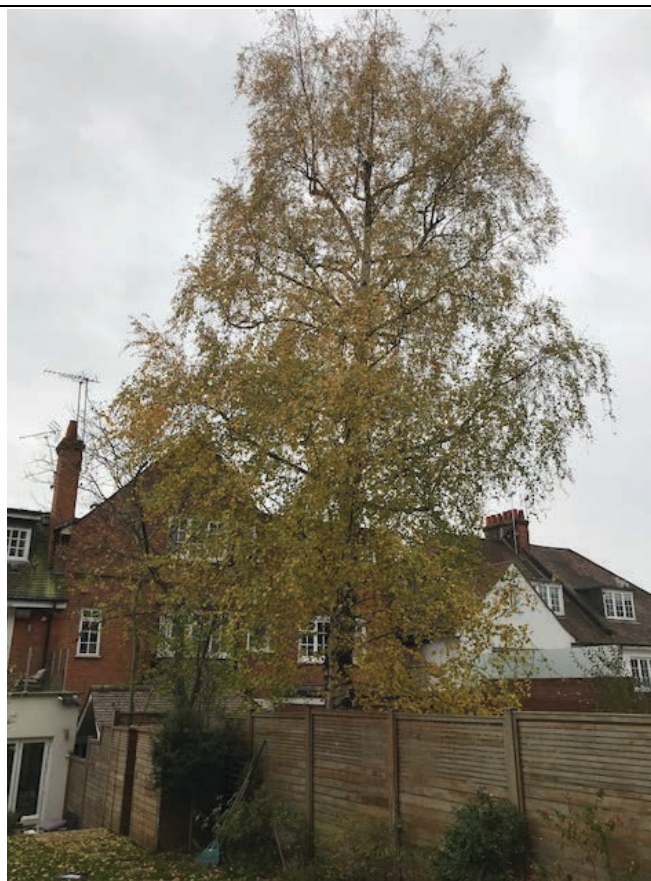
T2 Silver Birch with extensive canopy shown on right and T1 Birch to its left

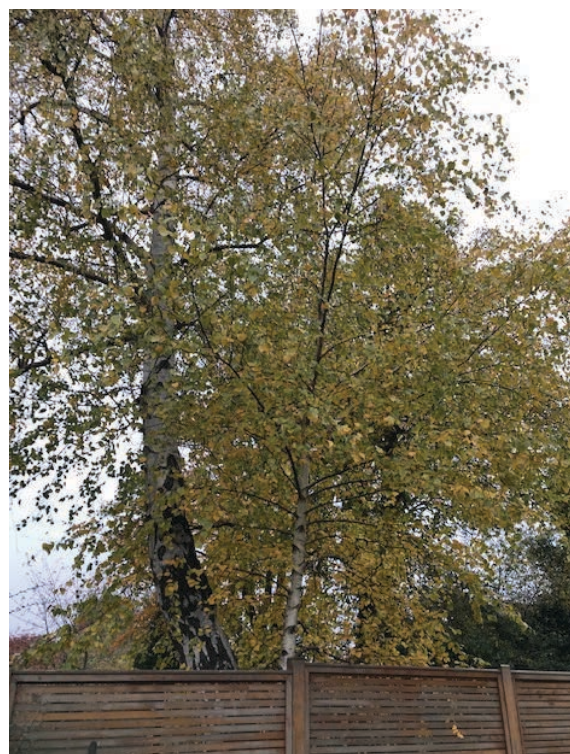
T2 Birch which has an additional sub-stem

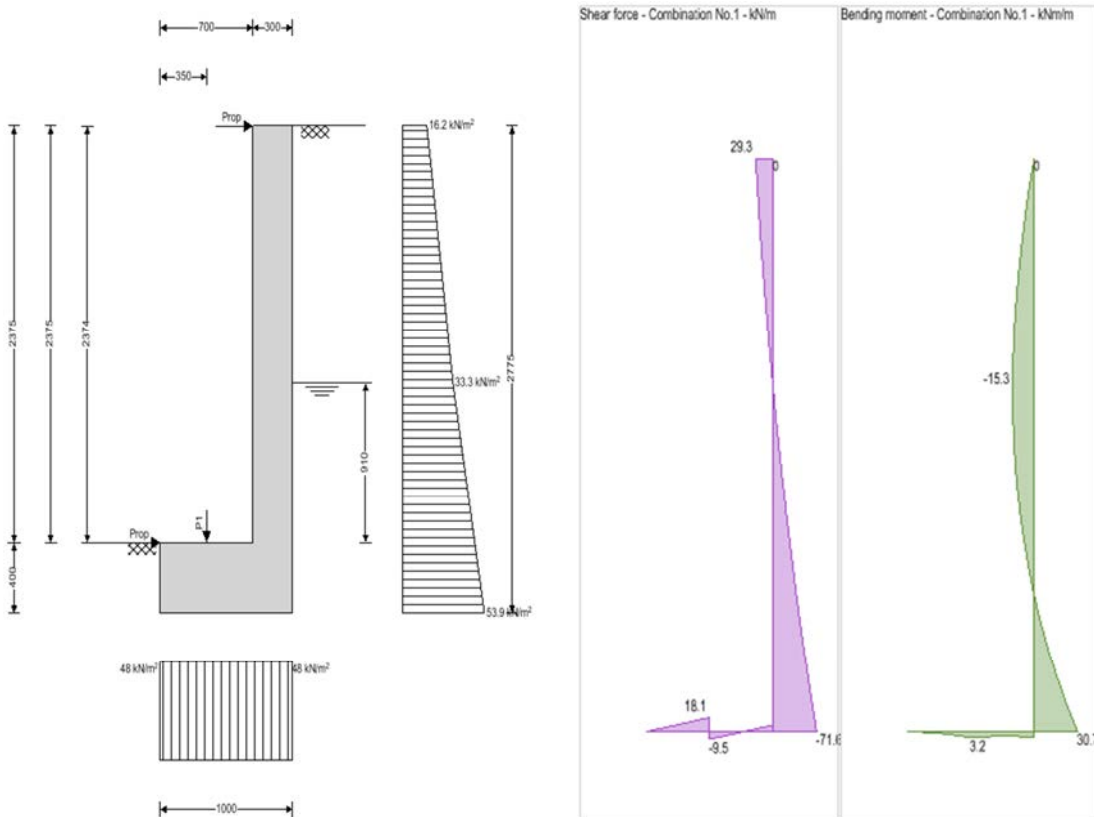
We have slightly changed our required shear reinforcement and modified the utilisations accordingly.

Image: Diagram of retaining wall with 910mm of water and relative shear and bending moment diagrams

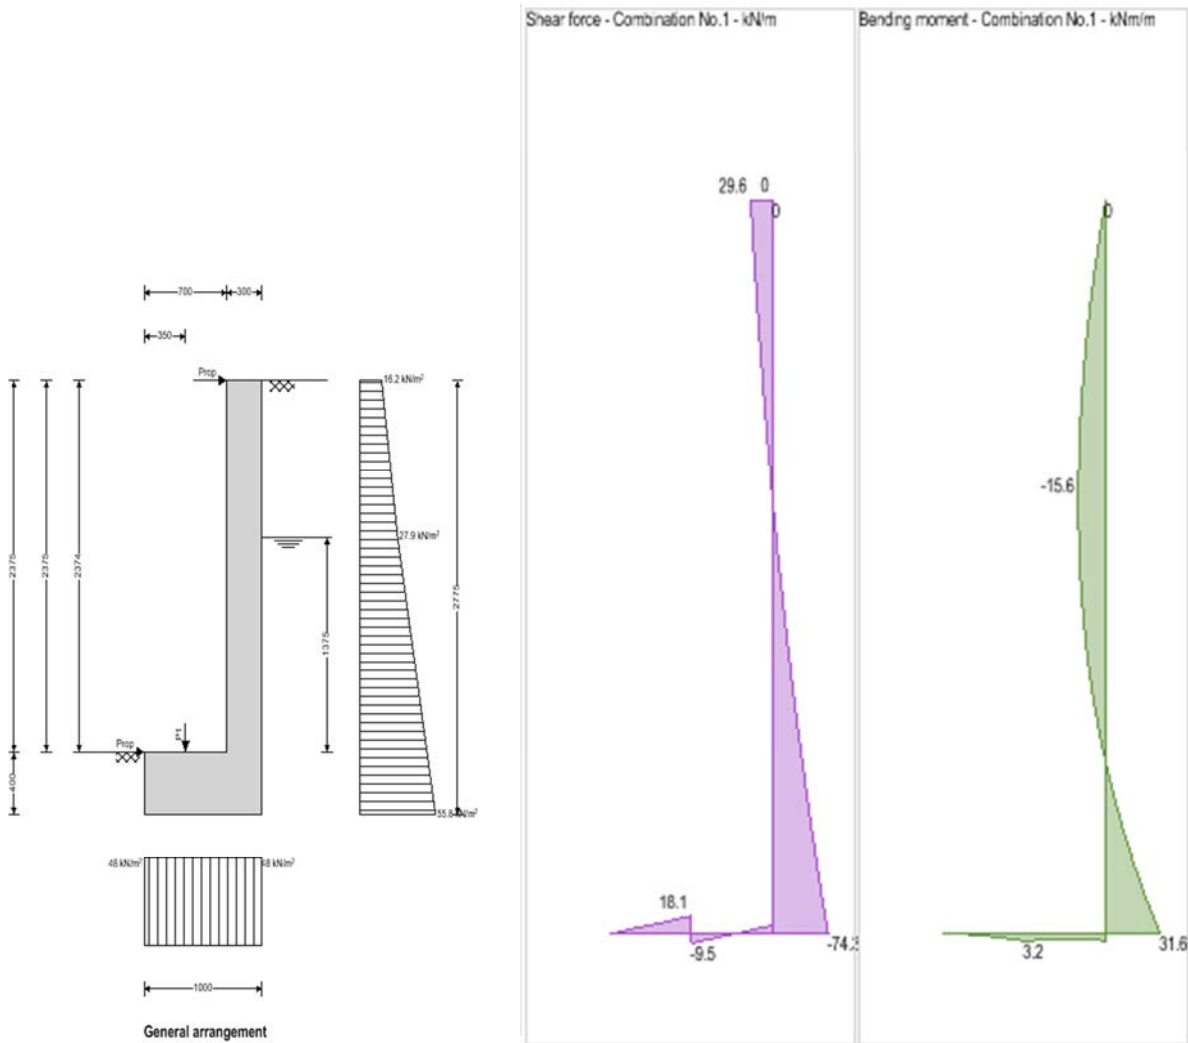
Image: Diagram of retaining wall with 1375mm of water (1m bgl) and relative shear and bending moment diagrams
