job  
**BRITISH MUSEUM  
38 RUSSEL SQUARE  
WC1**

title  
TYPICAL TIMBER REPAIRS

drg. no. **C1756/702/092** rev.

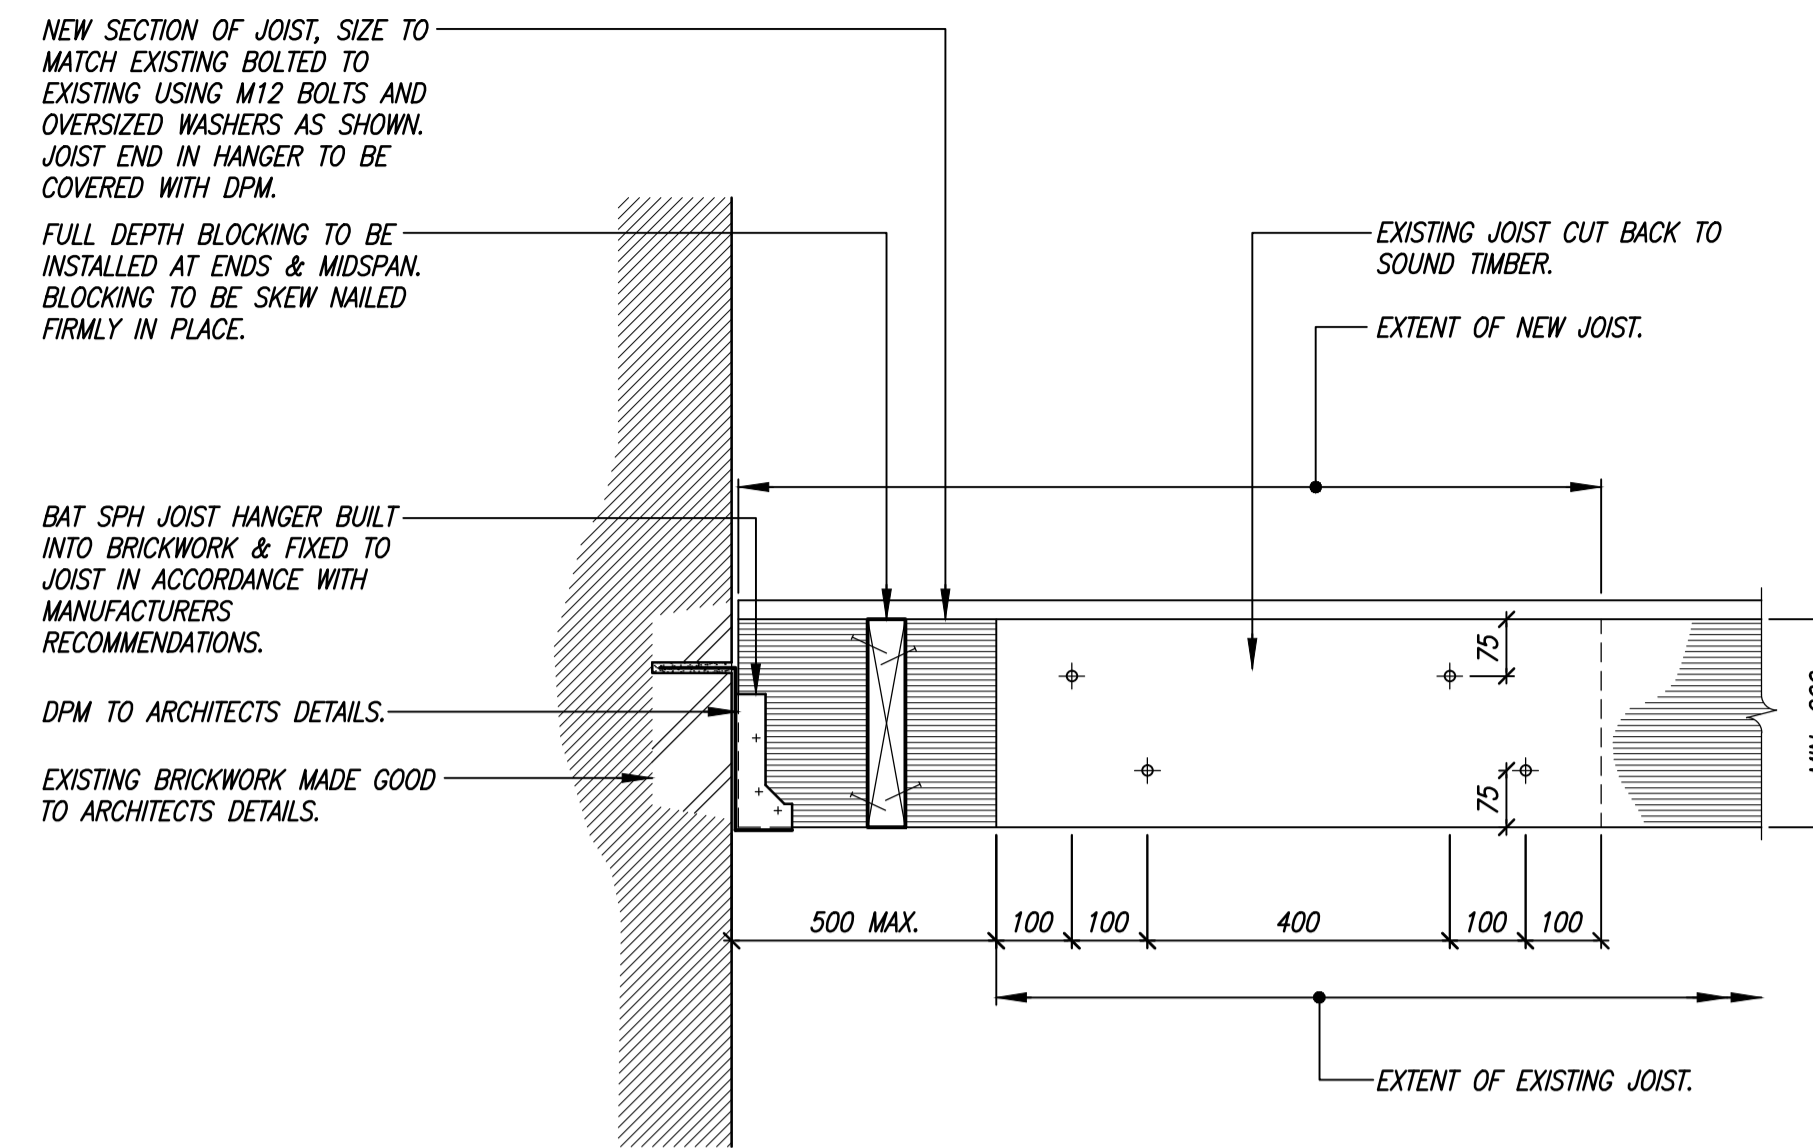
**TYPICAL REPAIR OF EXISTING ROTTEN JOIST END.**

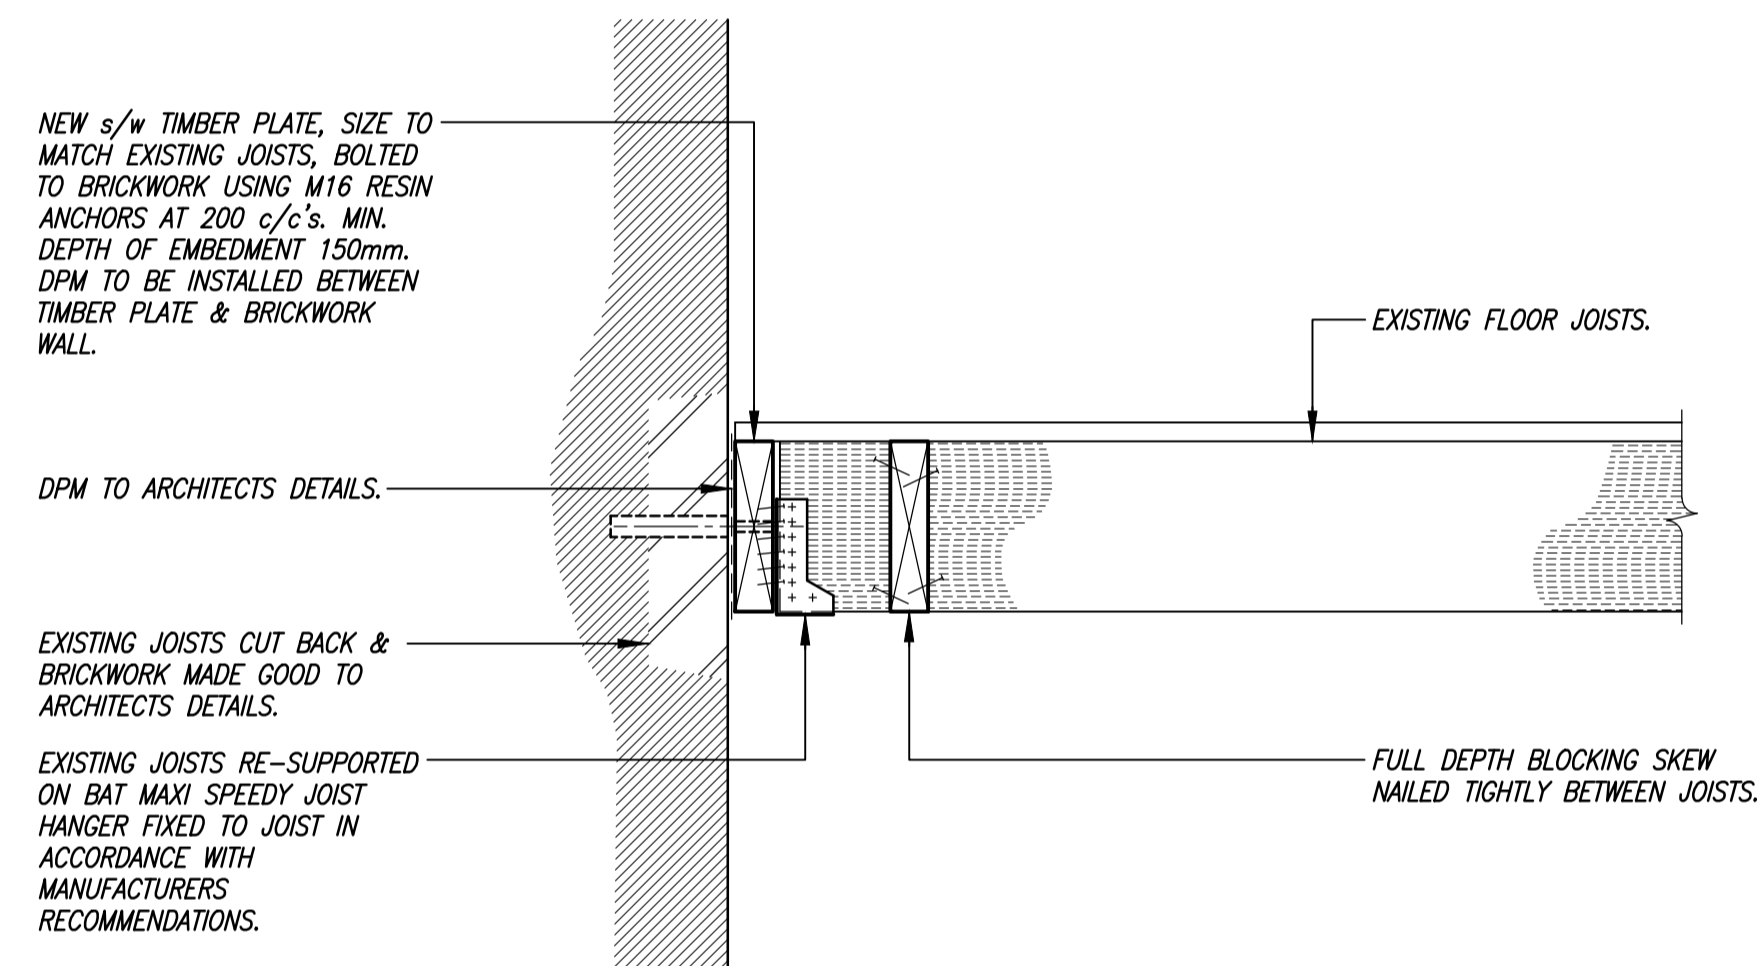
**TYPICAL DETAIL FOR ISOLATION OF EXISTING JOISTS FROM DAMP MASONRY.**

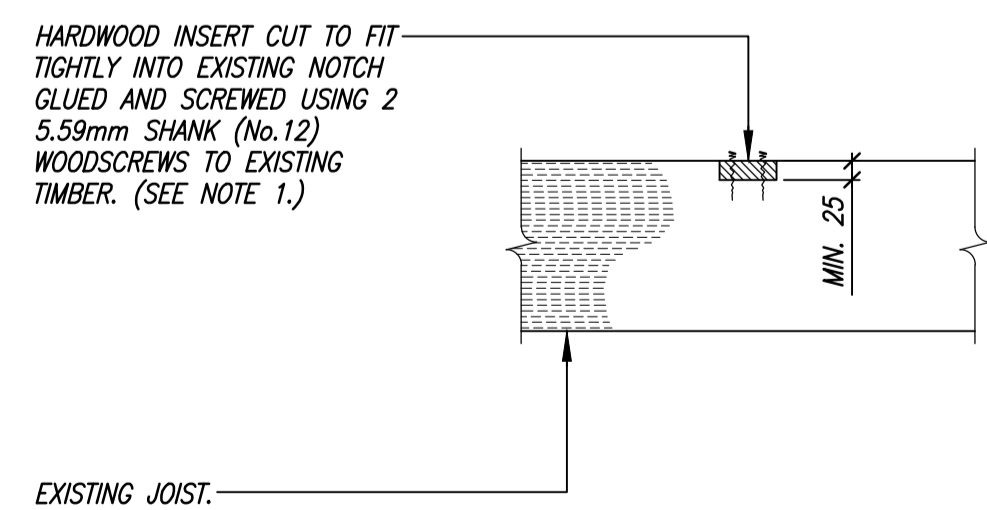
**TYPICAL REPAIR OF EXISTING NOTCHED JOIST.**

**FILLING OF EXISTING NOTCHES IN TOPS OF TIMBER FLOOR JOISTS:**

1. TRIM SIDES AND BASE OF EXISTING NOTCHES TO LEAVE NOTCH SMOOTH CLEAN AND RECTANGULAR. EXISTING NOTCH NOT TO BE ENLARGED BY GREATER THAN 5mm IN ANY DIRECTION.
2. LINE NOTCH WITH CLASS 3 GLUE TO BS-EN 314-2. GLUE TO BE USED STRICTLY IN ACCORDANCE WITH THE MANUFACTURERS RECOMMENDATIONS.
3. HARDWOOD INSERT TO BE HELD IN PLACE USING 2No. 5.59 SHANK (No.12) WOODSCREWS (MIN. 25mm EMBEDMENT INTO JOIST).

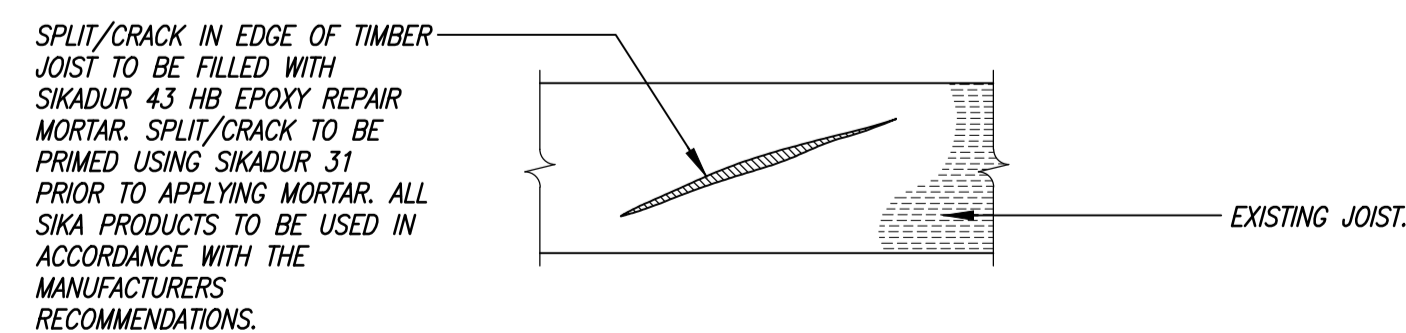
**TYPICAL REPAIR OF EXISTING JOIST WITH SPLIT/CRACK**
