2020/1523/P	98 Highgate West Hill N6 6NR	Amendments to proposed roof, dormer, side elevation window, side entrance and rear extension as granted by permission ref 2017/5939/P granted 18 December 2017 for erection of single storey lower ground floor rear extension, first floor rear part infill extension, rear and side dormer roof extensions; installation of four rooflights to the side roof slope; infill of first floor south side facing window and addition of first floor obscure glazed north side facing window	Thomas Sild
-------------	------------------------------------	--	-------------

Objection,

This application is classified as a minor amendment, it is not.

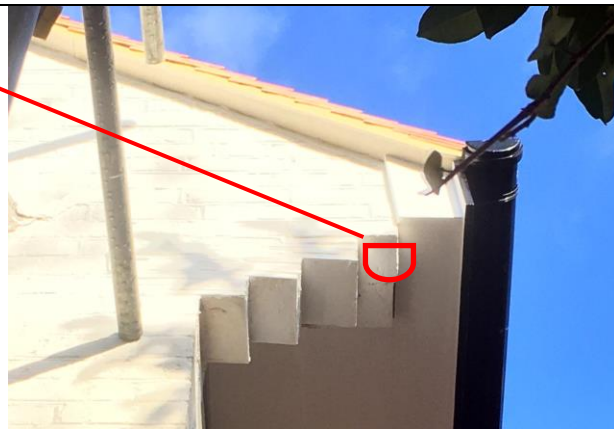
In the bay prior to reinstatement at least 3 rows of bricks and 2 'steps' were added above the original tiled 'steps' on each side of the bay raising the gutter by more than the single brick & step as indicated on the As-Built West Elevation.

Current eaves (south) at 98 HWH
Original roof line & gutter indicated in red

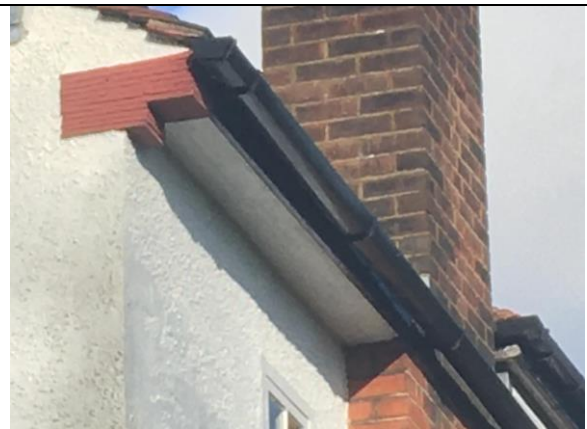
Eaves at 100 HWH, 98 would have been similar

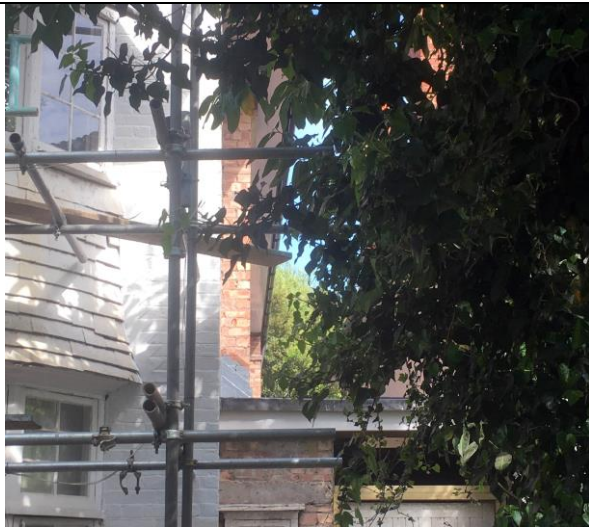
South

The As-Built west elevation shows the gutter of the bay roof at the same elevation as for the original roof, this is not the case. As can be seen on the photograph above it is higher matching the eaves of the raised bay roof. This level is maintained around the house meaning the eaves for the whole house are raised and the walls have been heightened, the new bricks on the north wall are just visible and those in the west wall are more obvious in the photos below

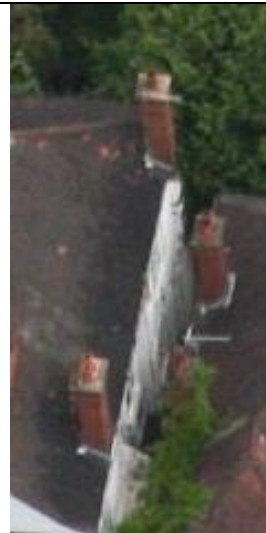
Original south, roof extends to edge of chimney

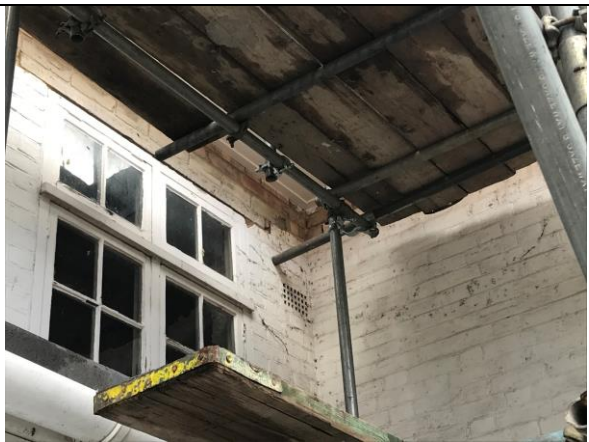
West, note new bricks over window

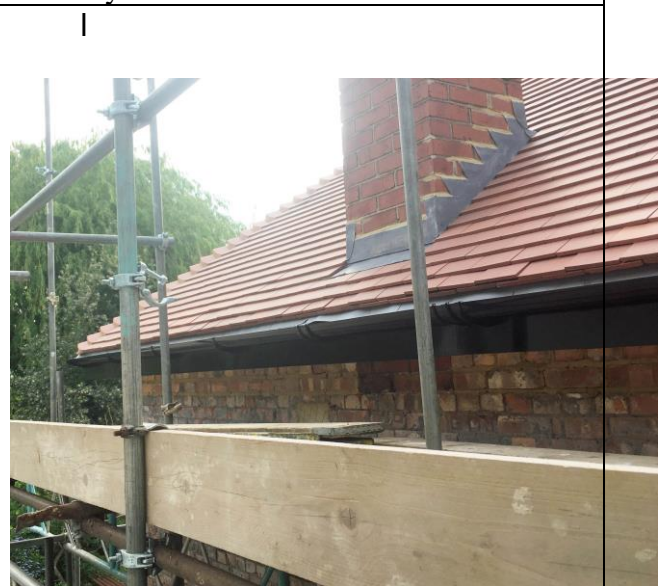
North

The As-Built roof plan shows the roof finishing in line with the chimney, the photograph shows it extends beyond. Note the drawings showing the north chimney stack projecting beyond the north wall are incorrect, it is flush as indicated on the 2013 survey drawing in the accompanying NMA Statement. It is possible the width of the roof has not changed significantly here, just raised, the drawings are too inaccurate to say.

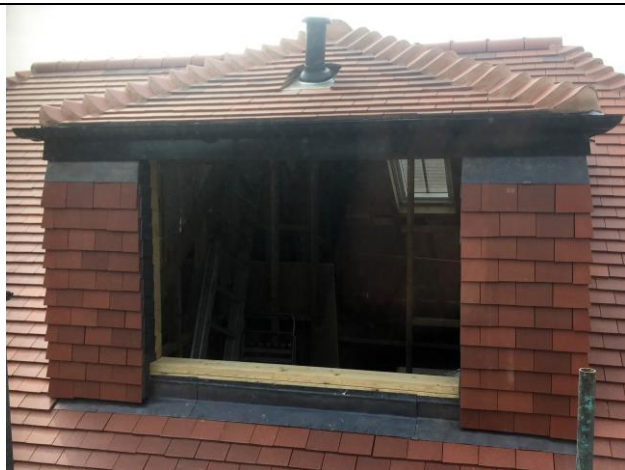
The north dormer now has a hipped roof, the top of which is not 500mm below the main ridge as required in CPG – Altering & extending your home.

There is a pipe sticking out of the roof, this is not shown on any drawing and is an eyesore when viewed from the stairs in the neighbouring house.

A large (100mm?) pipe projects out of roof
Roof < 500mm below ridge
Flat part of roof missing

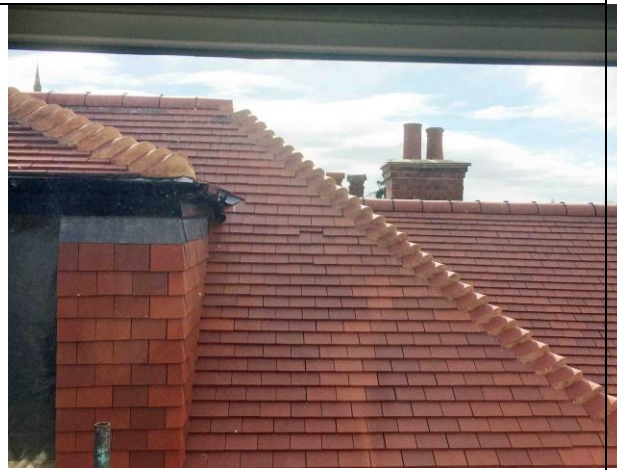
The North Elevation As-Built drawing shows the western wall of the dormer well to the west of the end of the ridge, this isn't the case, they are in line. Has the main ridge been extended or the dormer moved east?

Main roof ridge in line with west side of dormer

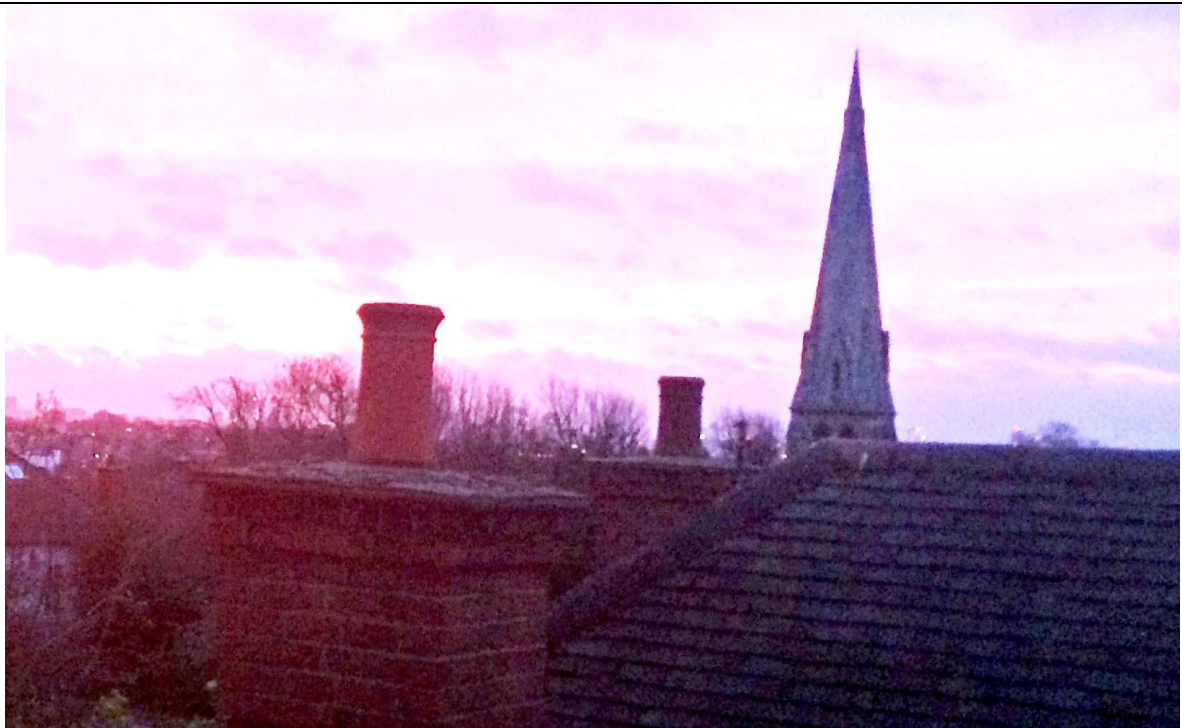
A few years ago the owners of 97 took photographs from their attic room which showed part of the windows in the tower of St Anne's, this view is no longer present and can only be replicated by having the camera outside the room at a level above the top of the window frame.

Original view from attic room

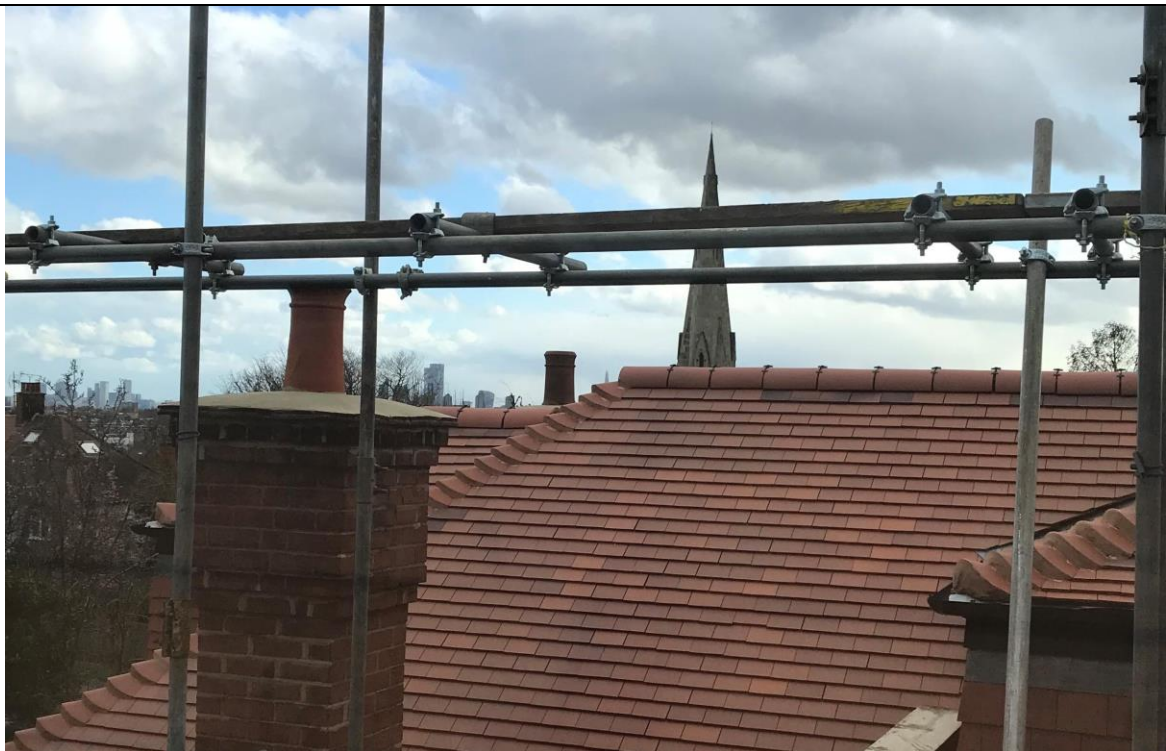
Current view, note only part of the window in the spire is visible and none of the window in the tower.

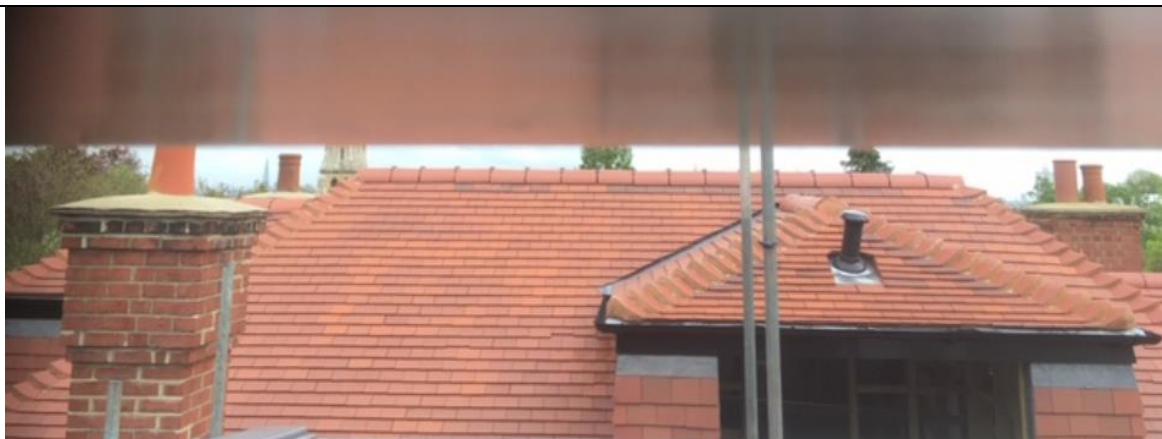
Current view from very top of 97 attic window

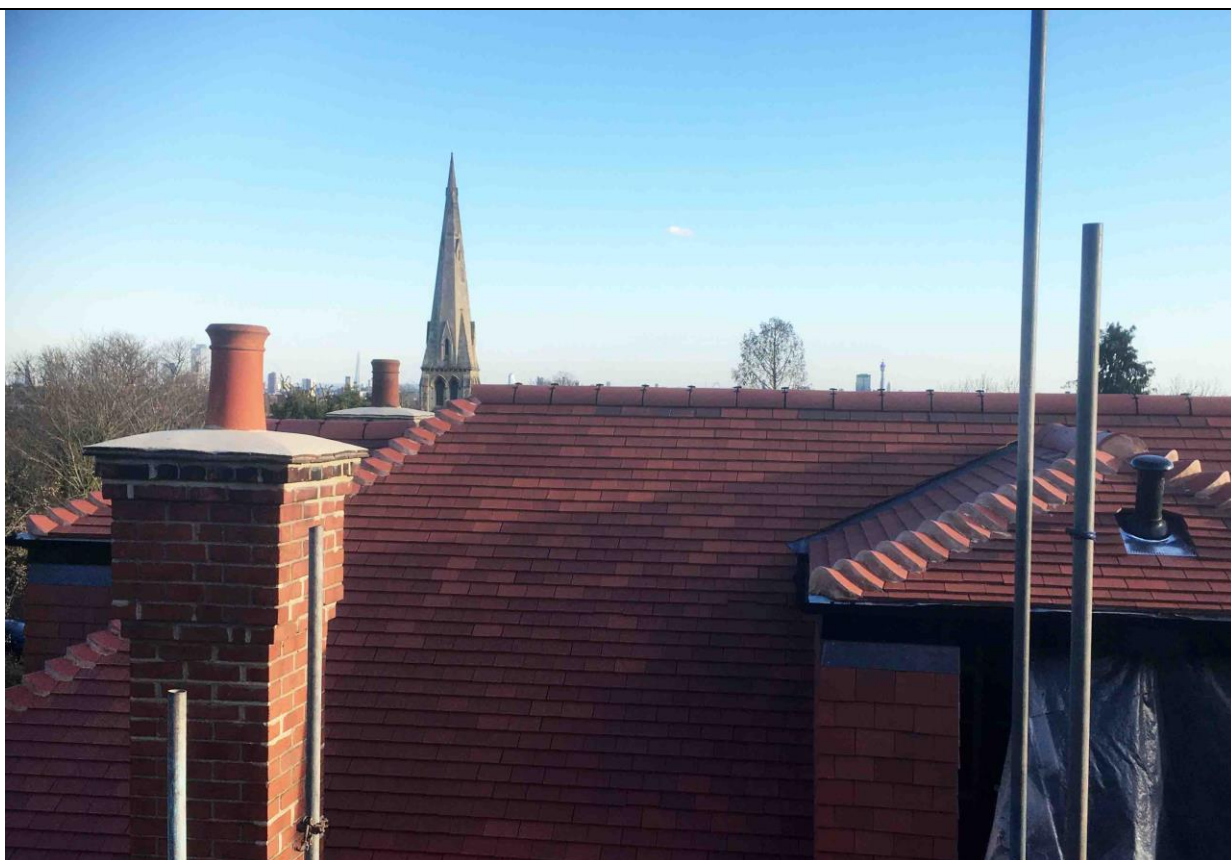
To match earlier view of church spire camera needs to be raised above the top of the attic window resulting in more of the trees further south being seen.

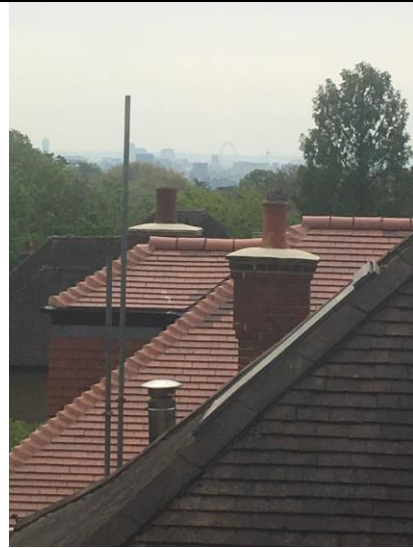
In addition to the apparent lengthening of the ridge (or moving of the dormer) identified in (e) the eastern end of the ridge does not accord with the As-Built drawing, the ridge extends to overlap the stack of the northside chimney, not stop before as the As-Built indicates.

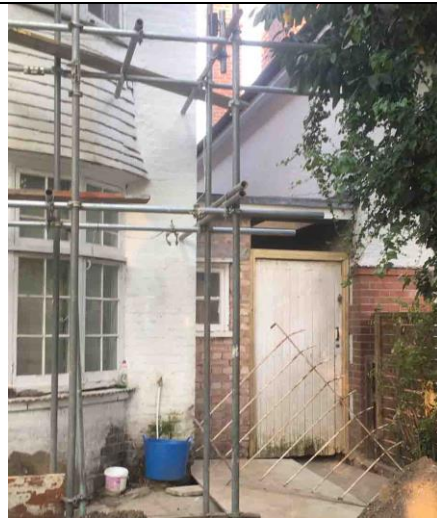
The As-Built West Elevation shows the sloping tiled roof of the original side extension. The As-Built Roof Plan indicates this doesn't exist, instead it is a flat roof.
