**FLAT 1, NO. 105 PRIORY ROAD,
WEST HAMPSTEAD, NW6 3NN**

Arboricultural Assessment Report

May 2020

Mr & Mrs Knights

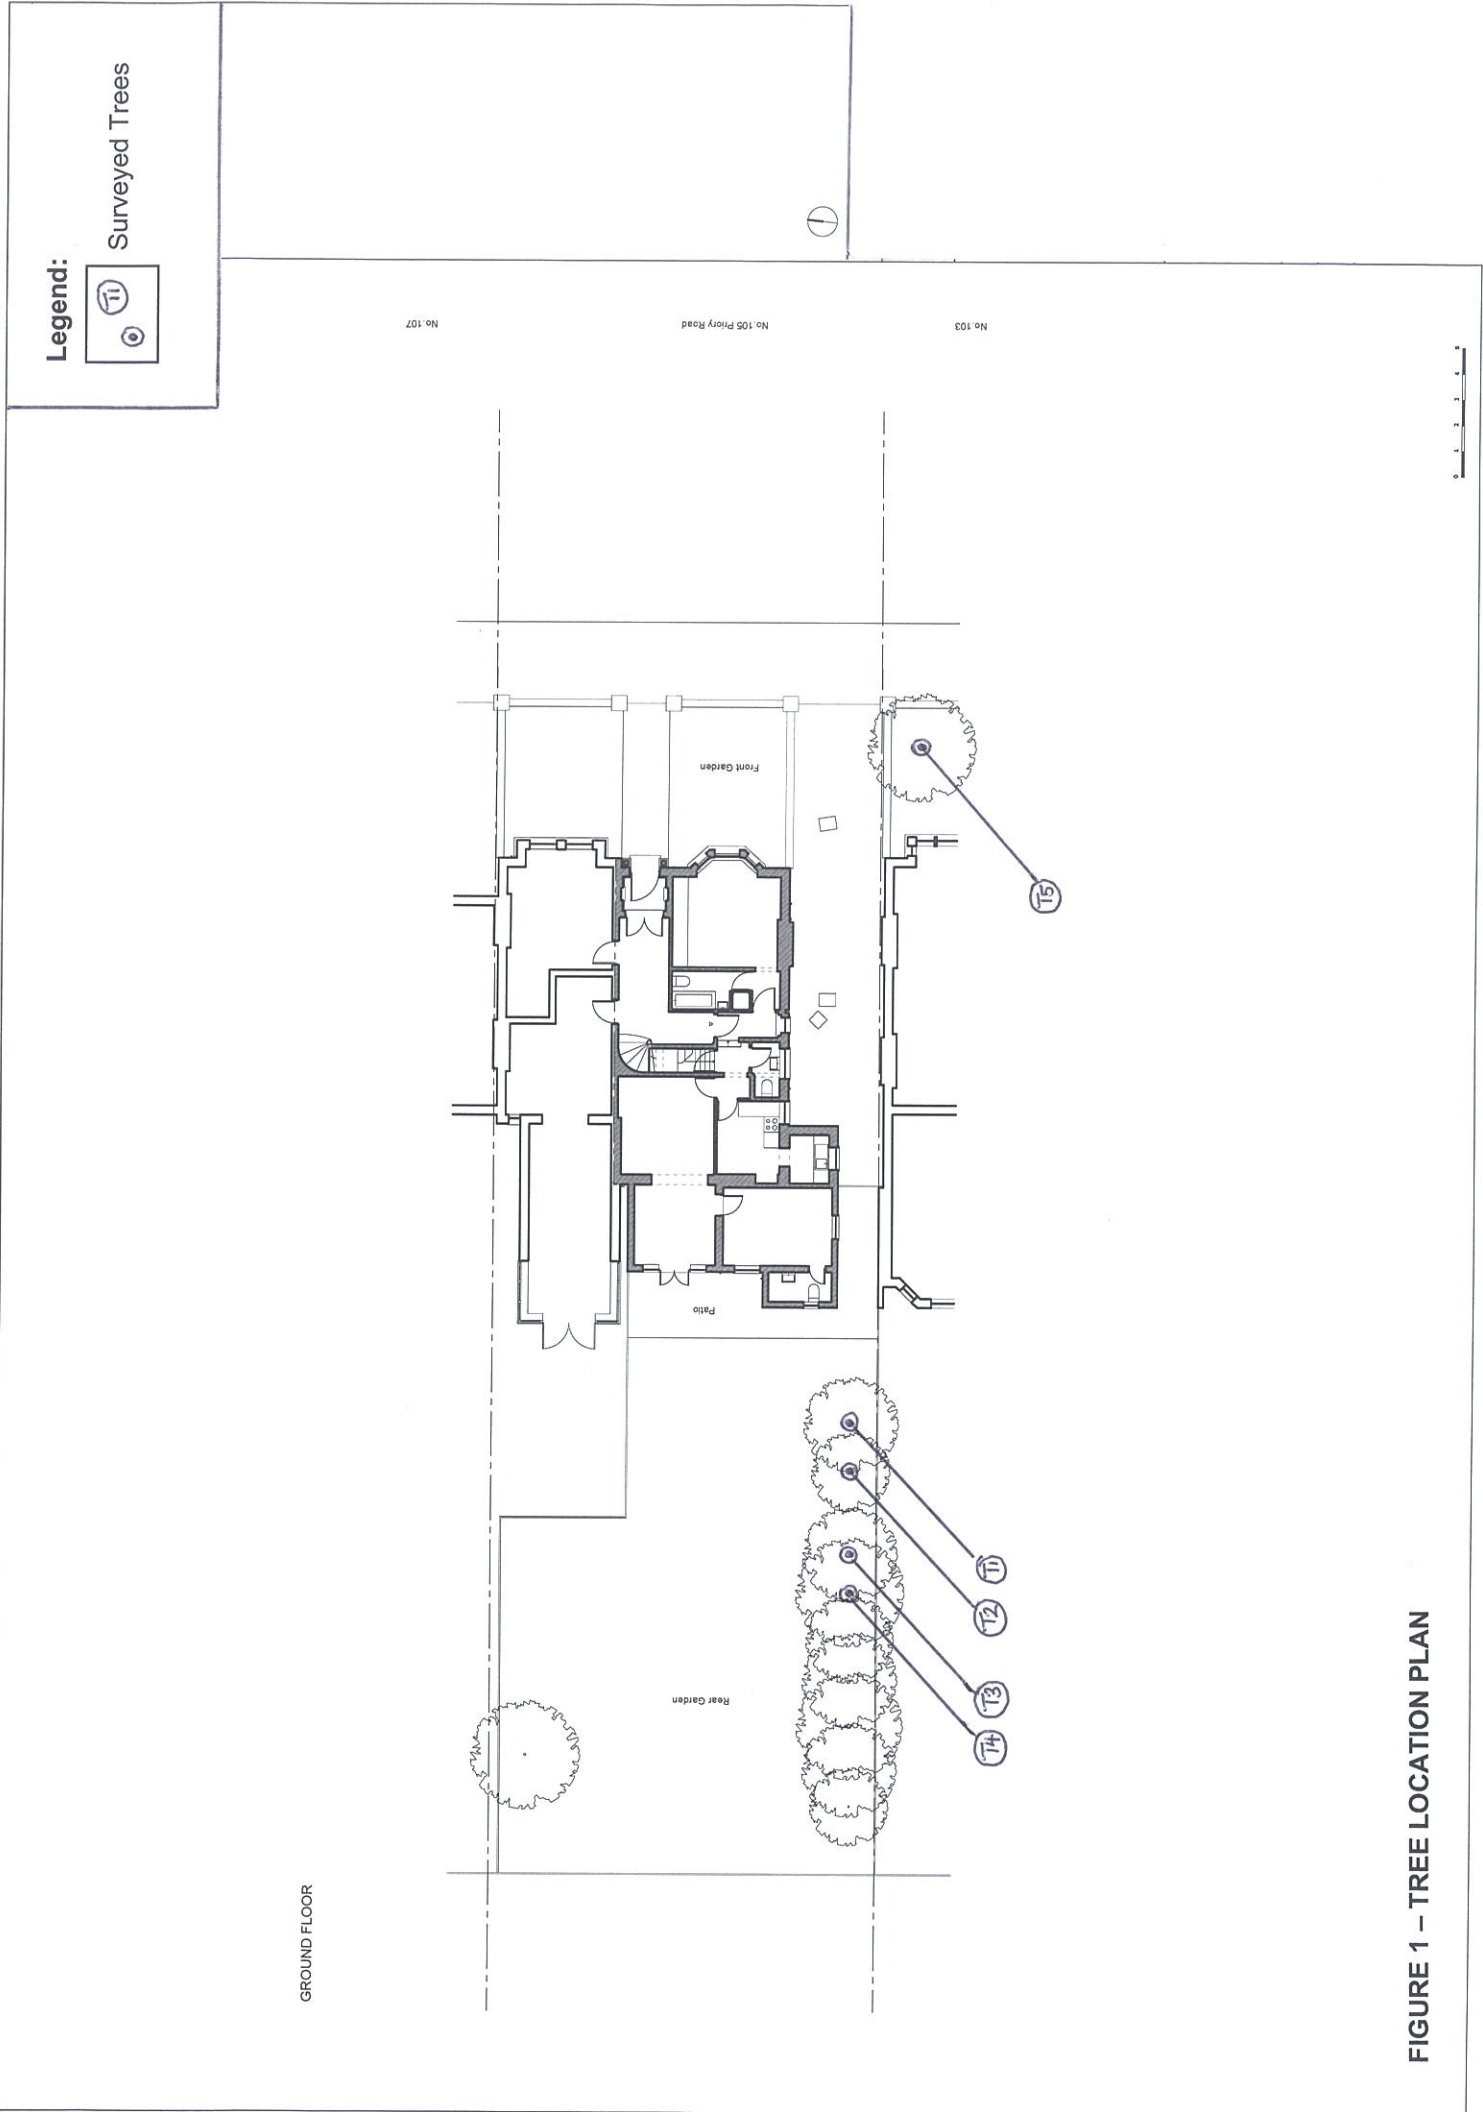
FIGURE 1 – TREE LOCATION PLAN

- 3.5 A total of five trees were recognised as the relevant tree resource, as shown in explanatory photographs at the rear of this Report.
- 3.6 An arboricultural schedule is attached as Table 1 and tree locations are shown in Figure 1.

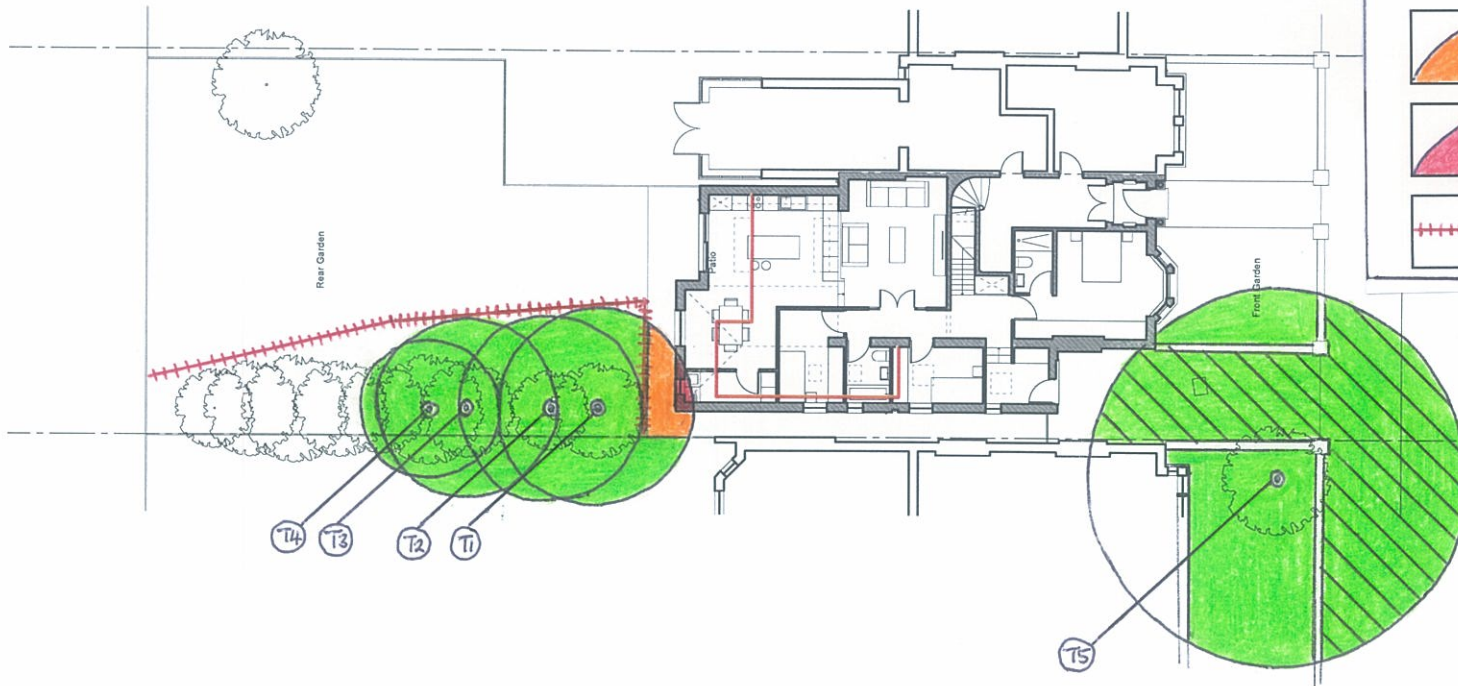
FIGURE 2 – TREE PROTECTION PLAN (RPA)

- 4.3 The foundations for the proposed new building have been carefully located so to minimise loss of the Root Protection Areas (RPAs).
- 4.4 Only a single tree (**T1**) would be impacted by the proposed flat extension but this would only result in the direct loss of less than 5% of the RPA, while a further 12% would be impacted by the proposed new hardstanding – see Figure 2.

- 4.5 These combined impacts upon the RPA of tree **T1** are not regarded as significant, however, it is recommended that the impact is mitigated by means of the following two actions:

1. Any excavations within a 500mm radius of the foundations would be hand-dug within the anticipated area of the RPA under the inspection of the Project Arboriculturalist. This would allow significant roots (larger than 25mm diameter) to be retained, especially the structural roots, and covered/watered as soon as possible to prevent desiccation. Where roots need to be lost they would be cleanly severed.

2. The new hardstanding surface would involve a 'No Dig' construction technique to retain the underlying root plate of tree **T1**.

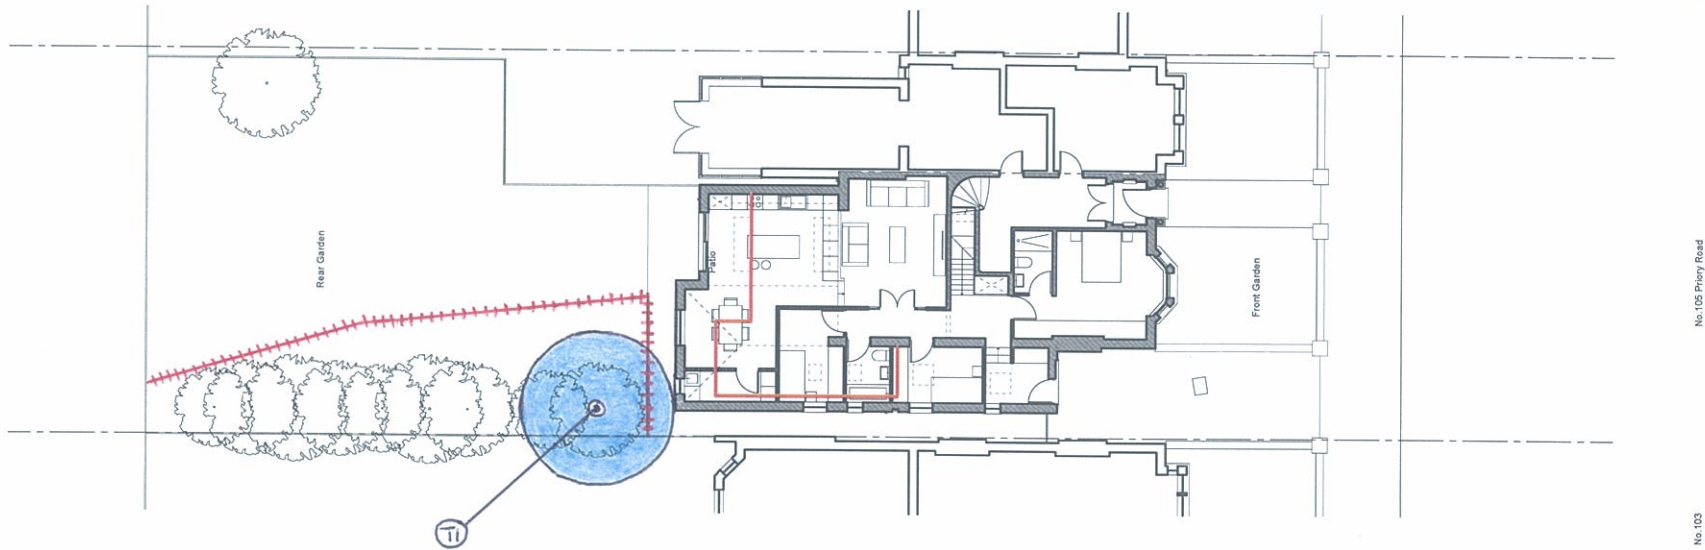
FIGURE 3 – TREE PROTECTION PLAN (CANOPY SPREAD)

- 4.6 The new extension will not impact upon the canopy spread of the tree resource, including the nearest tree (**T1**), see Figure 3.
- 4.7 As tree **T1** was recently pollarded, its regrowth is mostly vertical rather than horizontal. There would be no significant change to the degree of shading upon the western face of Flat 1 as a result of the development, and there are numerous future management options such as:
- Crown reduction to prevent branches extending towards the property;
 - Periodic re-pollarding of the tree line containing trees **T1** to **T4**; or
 - Future removal of only tree **T1**.

- 4.8 The proposed construction will be based on a scaled Tree Protection Plan (TPP) – see Figures 2 and 3. These show where any potential RPA and canopy spread impacts occur and identify where arboricultural exclusion fencing (TPF) is required.
- 4.9 Any such fencing should be of the Type I TPF specification as set out in BS5837:2012 *Guide for Trees in Relation to Design, Demolition & Construction: Recommendations*. This is based on interlinking 3.5m lengths of 2m high Heras fencing, set on foot blacks, the Type 1 fencing being additionally secured in place using 1.2m long steel road-pins that will be driven into the ground.

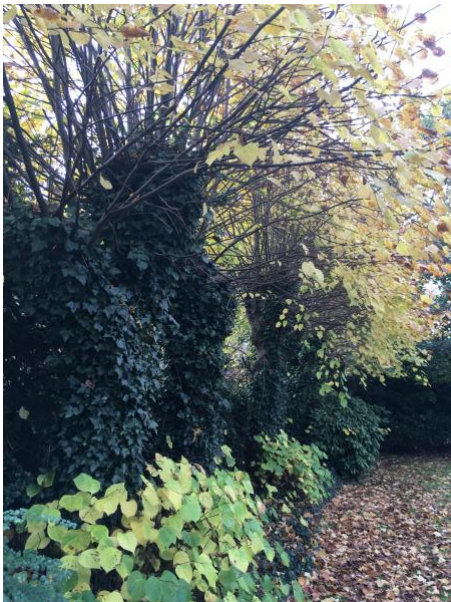
- 3.8 No significant physical constraints or infections were identified in the tree resource as identified within the Site.
- 3.9 Trees **T1** to **T4** have all been pollarded within the last two years and are now regenerating showing strong branch and epicormic stem growth. They are all covered in dense adherent Ivy *Hedera helix*.
- 3.10 Tree **T5** is surrounded by brick walls to the north and east, and both have cracks caused by the underlying root plate. In addition, the block-paved drive of property No. 105 has undulations that are similarly likely due to the underlying root plate from this tree.

Trees **T1** to **T4**

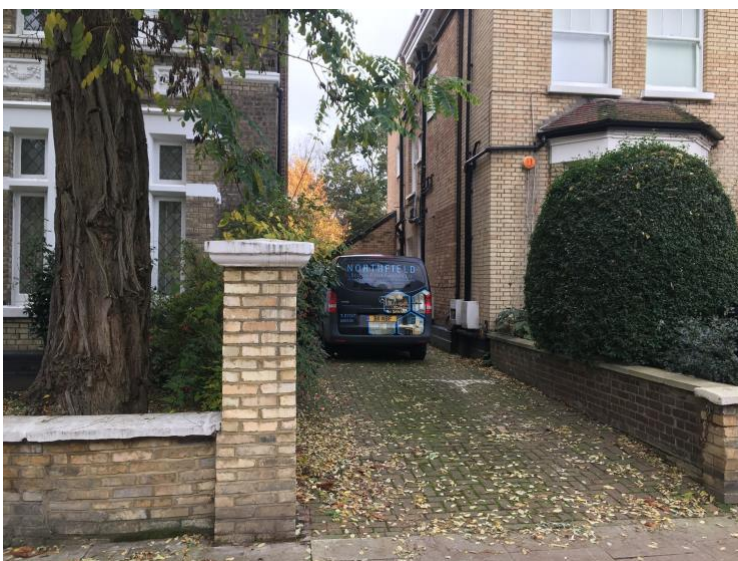
T5	<i>Robinia pseudacacia</i>	False-acacia	Maiden	620	7.44	14	4.5N, 5E, 4S, 5S	6	Stem pressing onto eastern (street) wall and causing wall to fracture and buckle, repairs evident. Also cracking of brick wall between property boundaries. Underlying root plate causing heave beneath drive of No. 105, resulting in lifting/slumping in blockwork.	None	A

Looking west along drive. Tree **T5**.

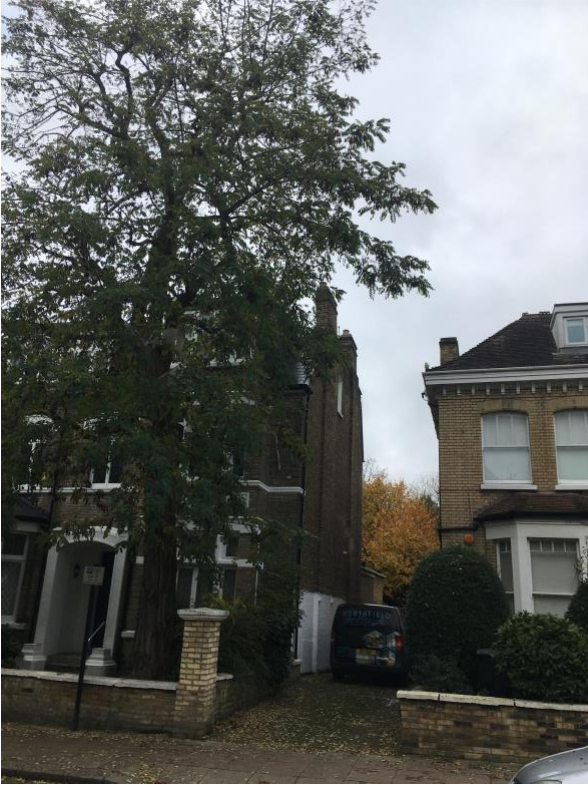
Adjacent tree **T5**

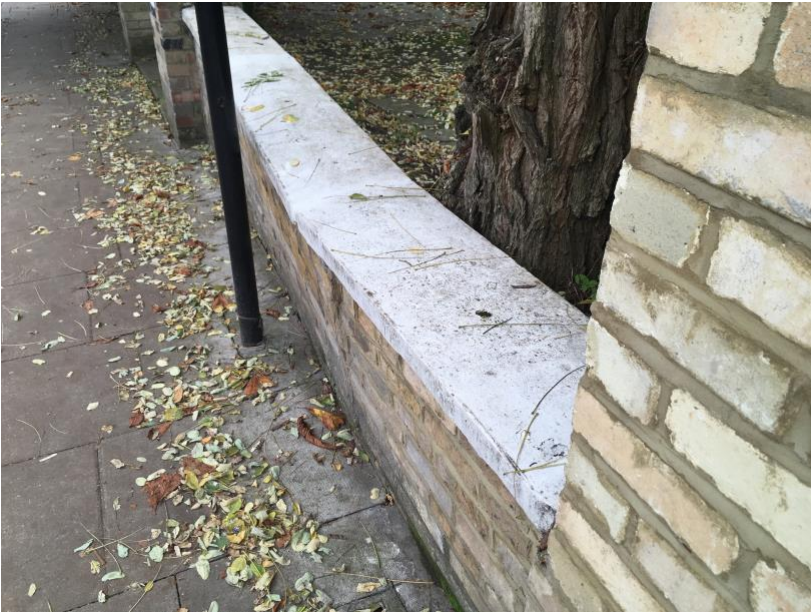
Bulging street boundary wall
beside tree **T5**
