42 Bedford Square

*Application for Listed Building Consent
for alterations to the main house*

Design and Access Statement

December 2017

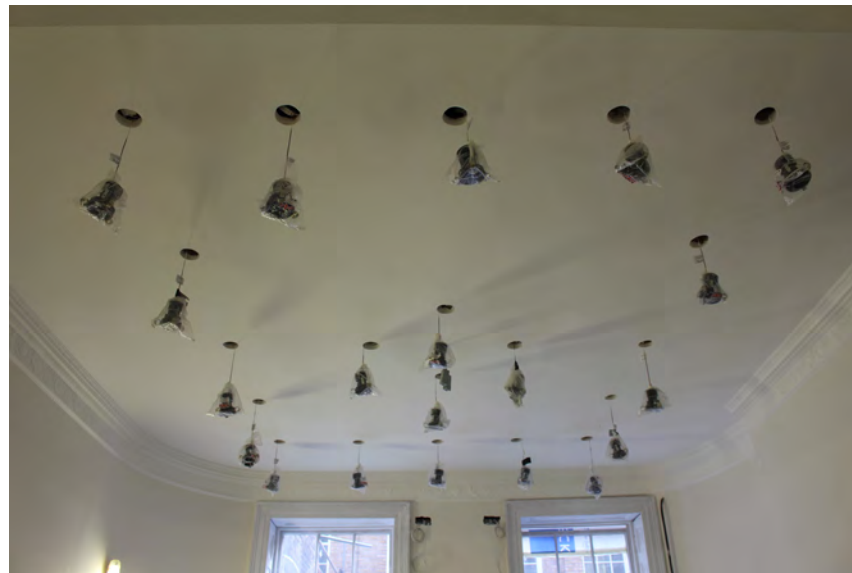
Holes created in lath and plaster ceiling at ground floor level

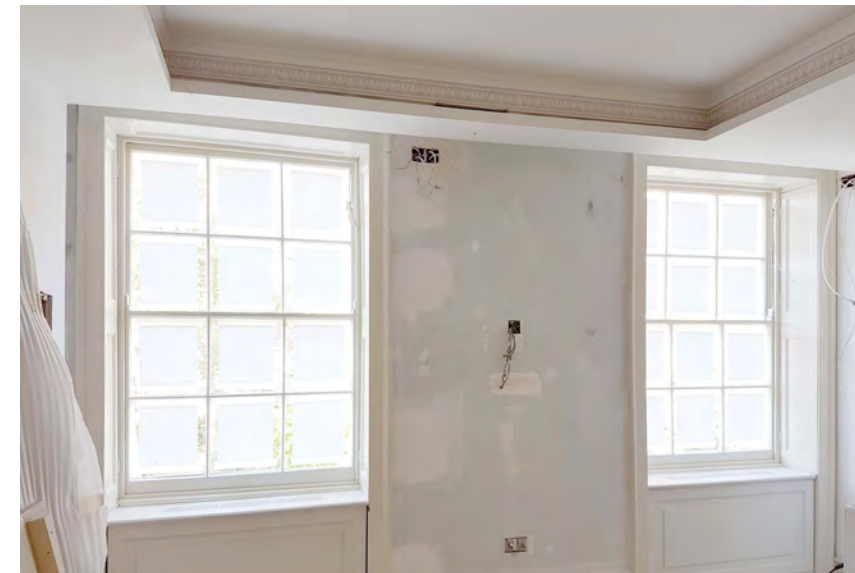
Modern 'coffer' ceiling arrangement at the second floor level

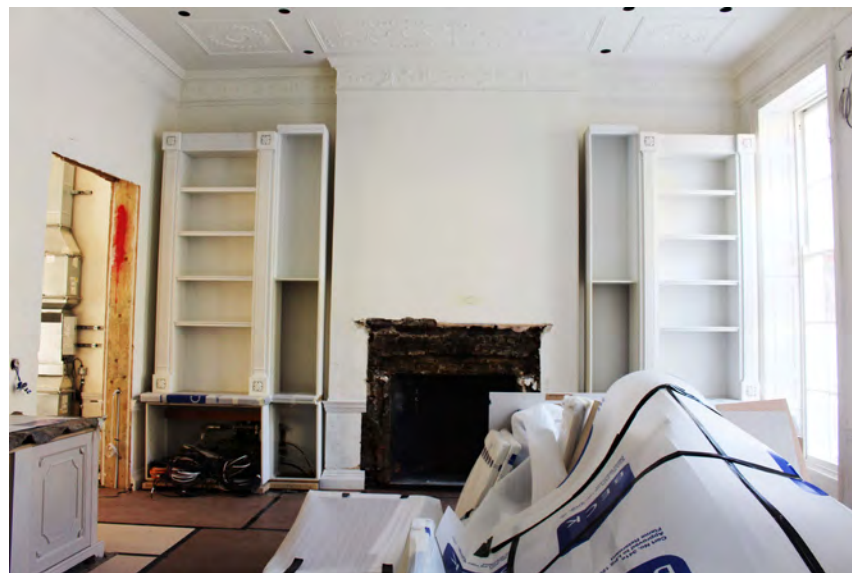
Existing fireplace removed from wall at first floor reception room. Fireplace in safe storage.

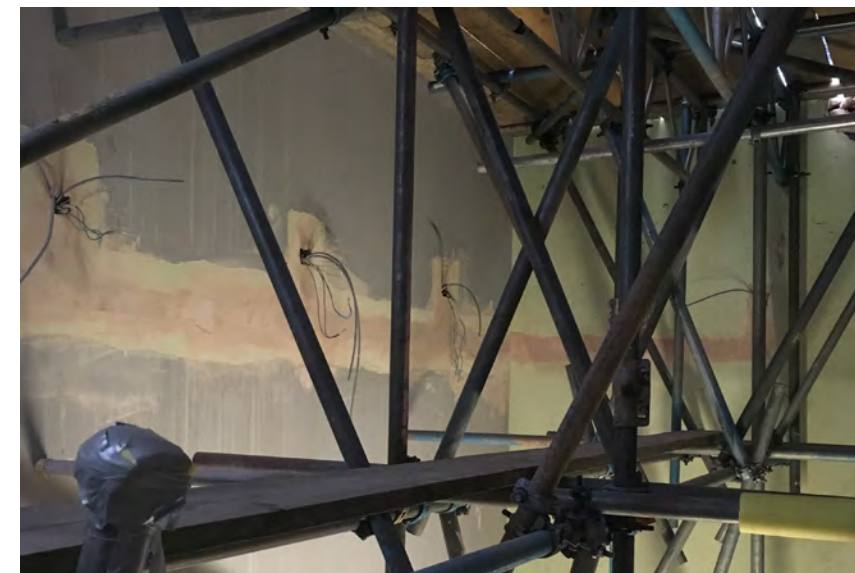
Modern plaster repairs throughout stair well to be replaced with lime plaster to match existing.

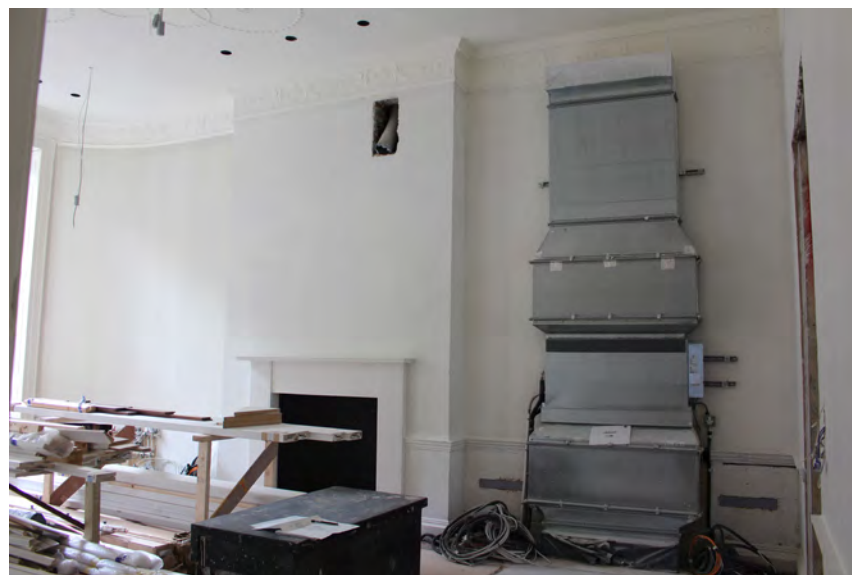
Section of masonry wall removed and excessive scale of fan coil unit.

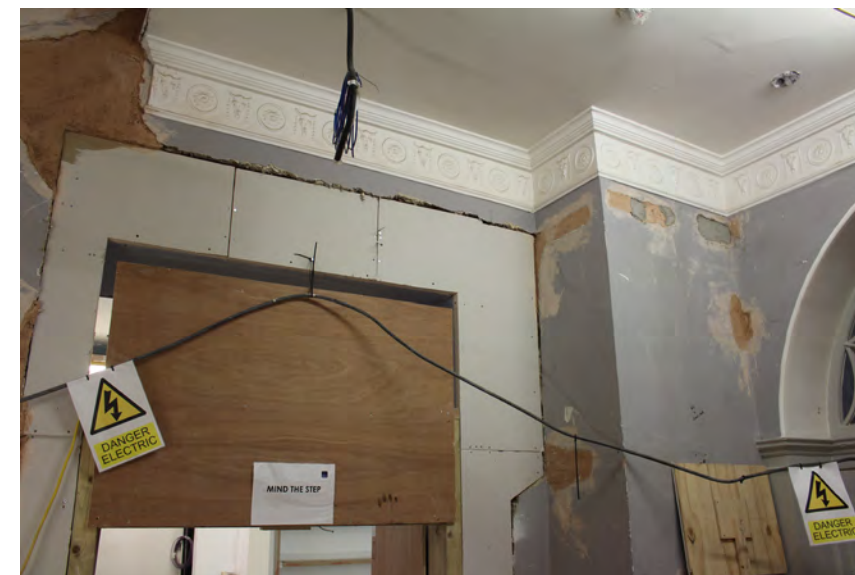
Existing door opening enlarged. Making good of opening in modern materials..

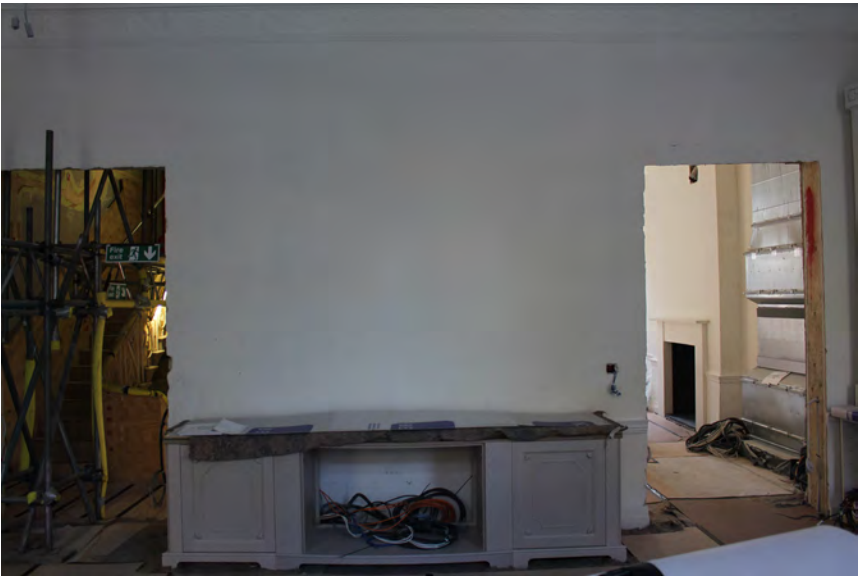
Enlargement and relocation of existing door openings at first floor level

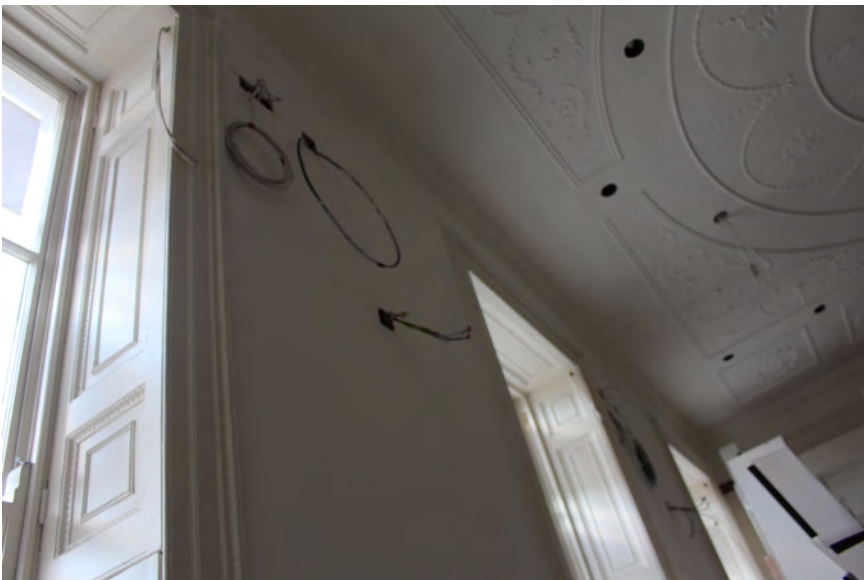
High level socket outlet locations adjacent to windows at first floor. Holes in decorative ceiling

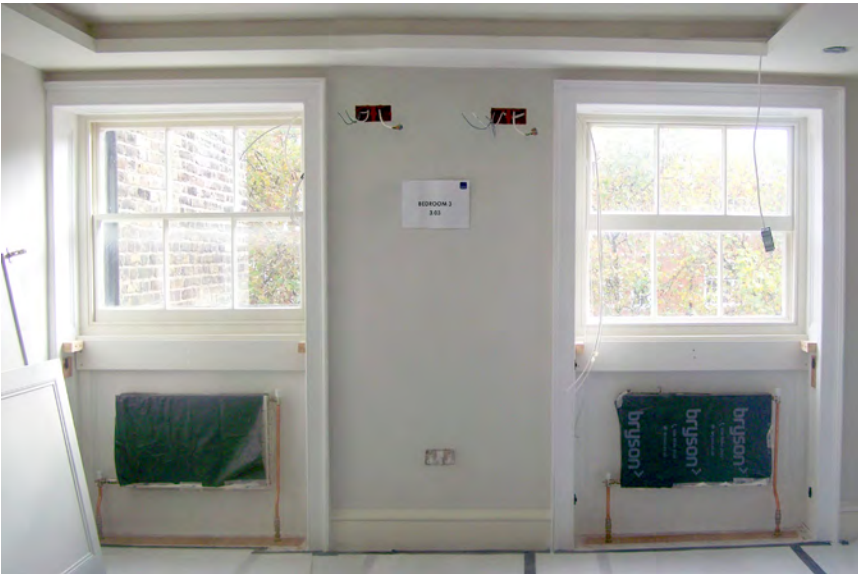
Modern 'coffer' ceiling at third floor rear bedroom.

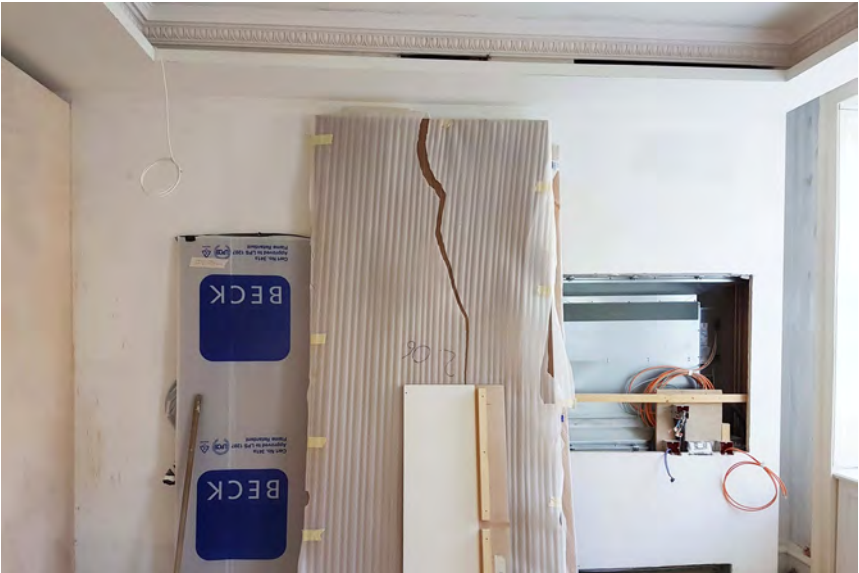
Modern ceilings and partitions at second floor master bedroom

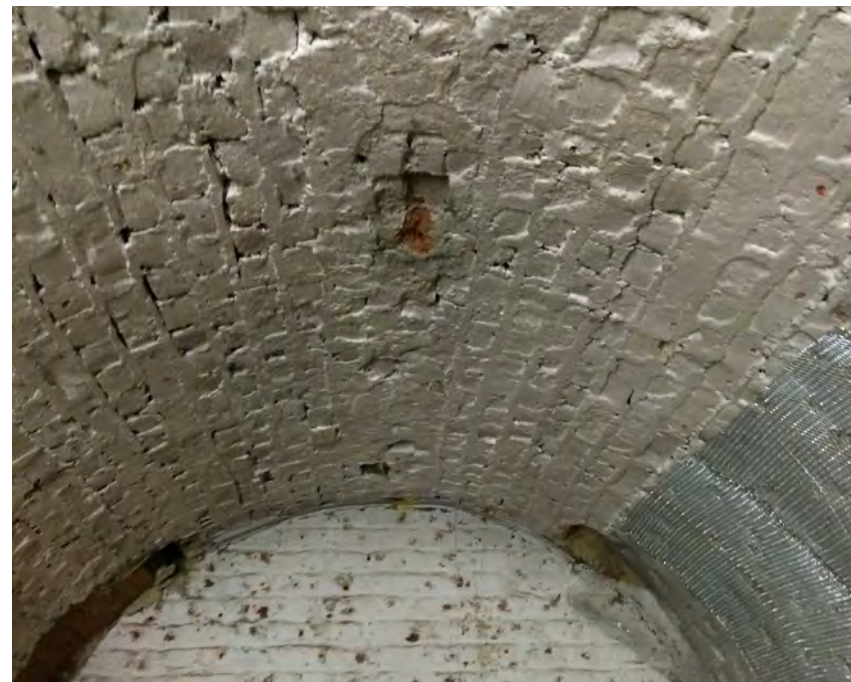
Images provided by the Contractor taken from within the wine cellar vault. Note the inconsistency of the brickwork and mortar and existing paint and gauze finishes. It is noted that with the exception of the outer facing brickwork to Bedford Square, the inner bulk of place brick work is generally irregular and of poor quality.

As the current construction works commenced and the modern partitions, wall finishes and ceilings were carefully removed from this area, the condition of the brickwork was revealed. Unfortunately, what was discovered was that the brickwork and mortar joints are inconsistent and provide a messy

appearance that does not suggest an intended finished appearance. In addition, the brickwork is already painted and was covered in a metal gauze that it is assumed help form the substrate for previous plasterboard linings.

The images, p14, illustrate the condition of the brick structure. It is proposed that the brick work is concealed once again. This provides the opportunity to create an insulated space suitable for wine cellar storage as well as ensuring a uniform finish that is fully reversible.

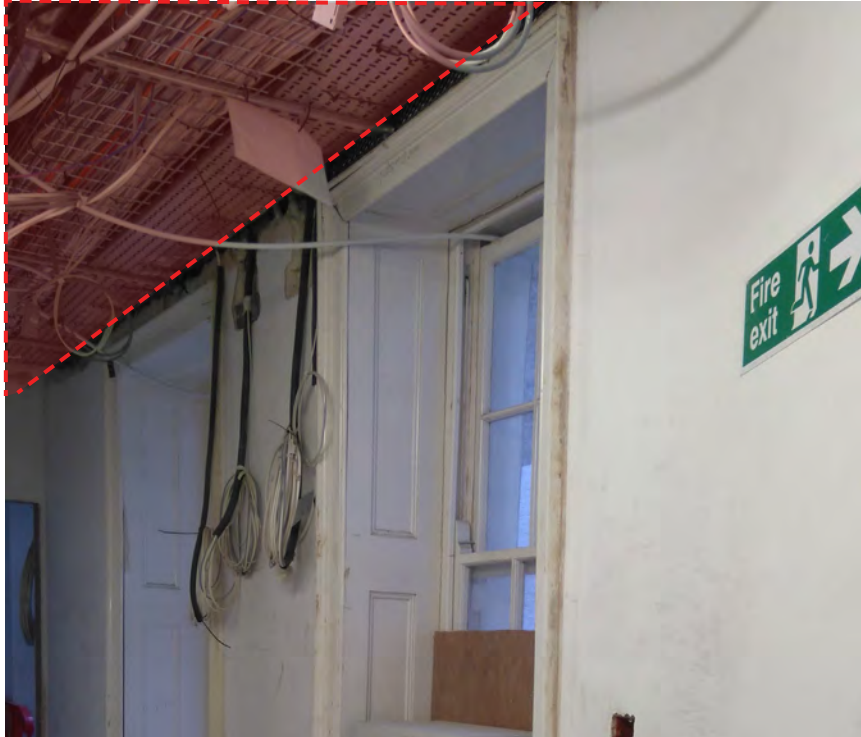
B.01. Ceiling to be reinstated above window architrave.

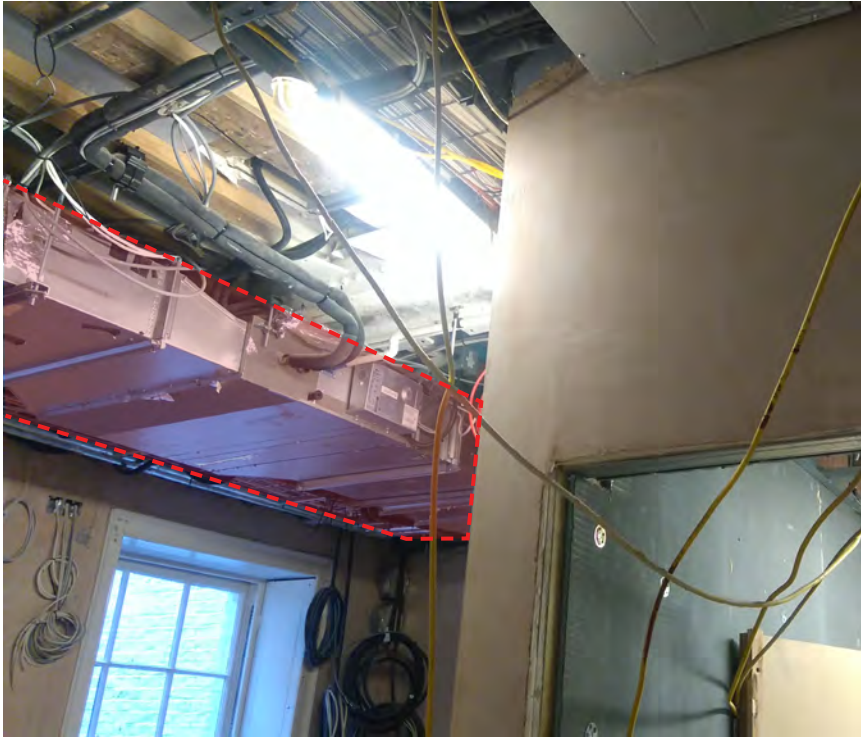
B.08. High level fan coil unit to be reduced and relocated. Ceiling to be reinstated above window architrave.

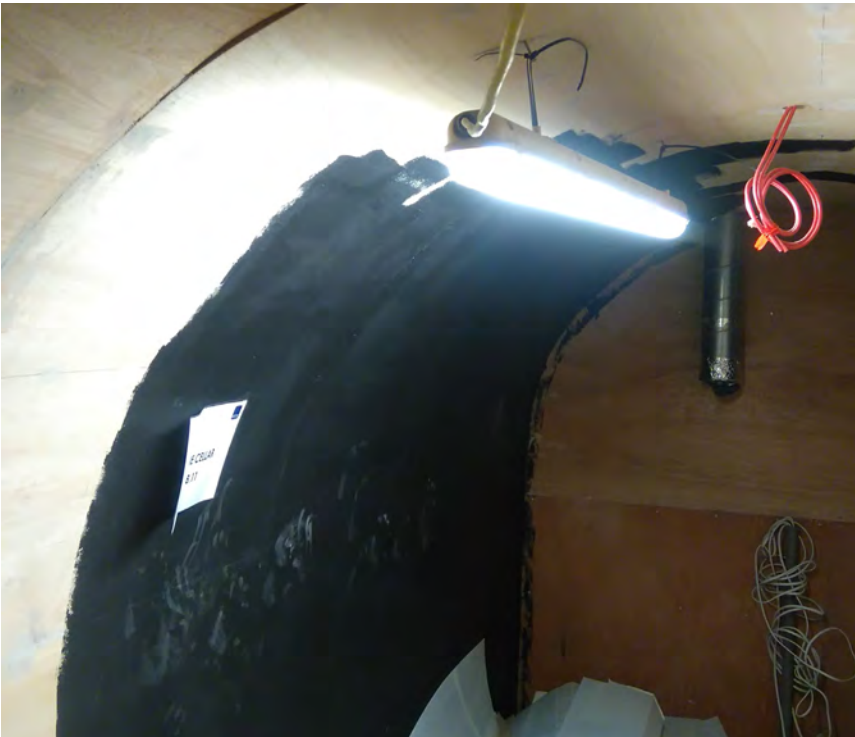
B.11 Wine Cellar

B.11. Ply lining over poor quality brickwork to be painted black and new timber battens installed.

General_
Brickwork discovered to be in poor condition has been lined with an insulation and plywood in a similar fashion to the as existing situation. Oak timber batten proposals to line the arched vault.

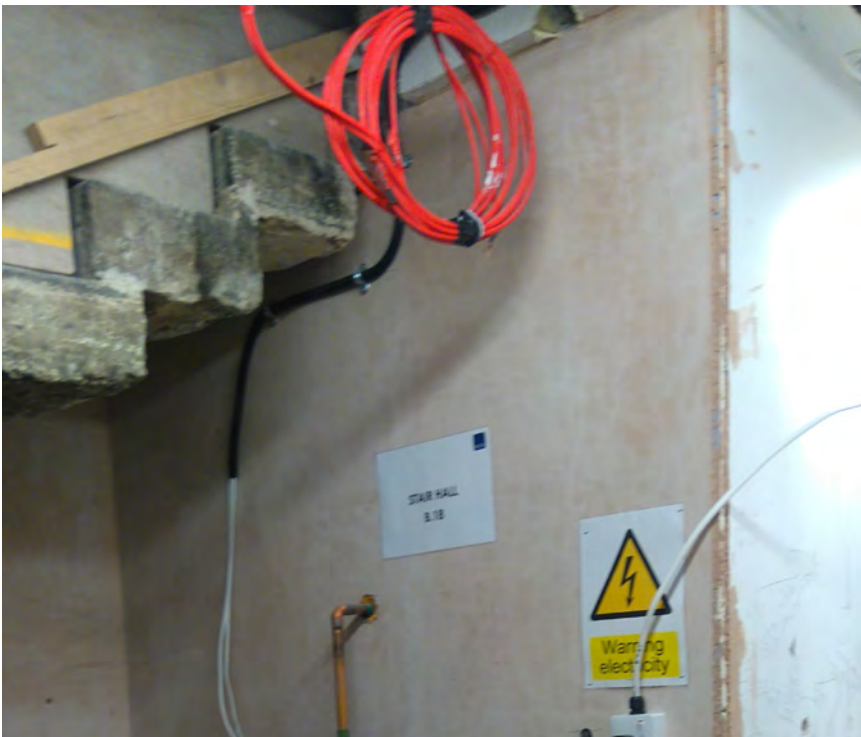
B.18 Lower Ground Stair Hall

B.18. Cupboard doors to be installed below secondary stone stair. Projecting volume to be retained.

High level services to be concealed above suspended ceiling at consented height.
Below stair cupboard doors to be installed.
Stone floor finish and skirting to be implemented and space decorated. 4 panelled timber doors to be installed to all rooms at lower ground floor in accordance with discharge of condition 4 of the 2014/4634/L application.

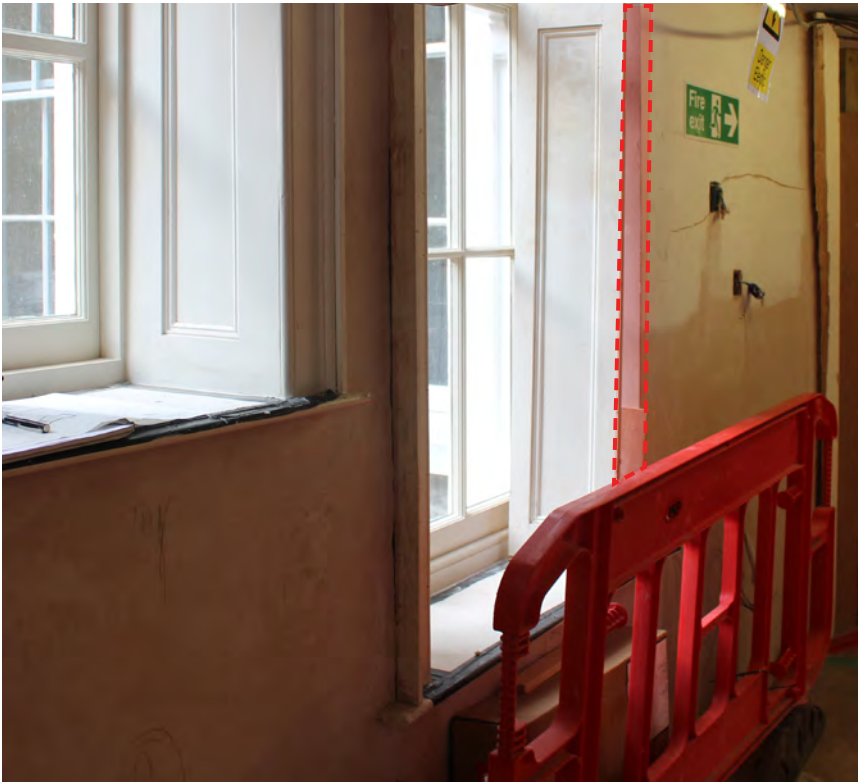
0.01. Missing window architrave to be reinstated

General_
Missing window architrave to be reinstated. Area to be finished and decorated.

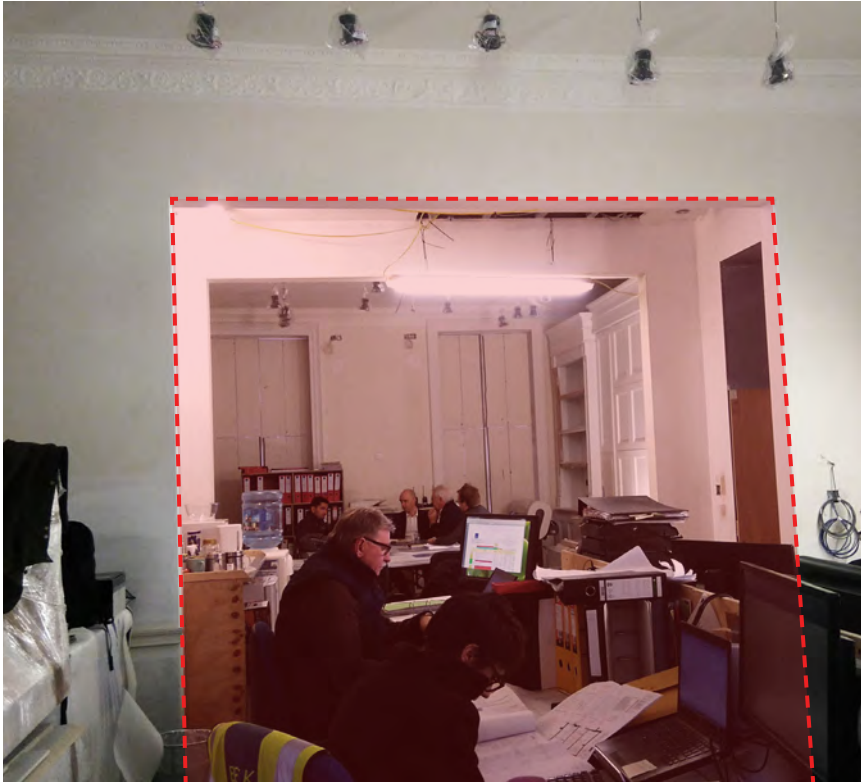
0.05. Newly formed opening to be reduced to match details of the consented scheme.

General_
Reduce newly formed opening between dining room and living room to match consented scheme. Reduce scale of fan coil unit. Repair and redecorate throughout.

Ceilings_
Carry out careful removal works to all new ceiling penetrations for recessed light fittings. Implement repair works to lath and plaster ceiling in accordance with drawings and methodologies. Rely on central location only for ceiling mounted lighting. Redecorate.

Internal walls_
Carry out repair works to damaged plasterwork in materials and methodology to match the existing adjacent. High level socket outlets adjacent to windows to be carefully removed and made good. Socket outlets above fireplace on chimney breast to be removed.

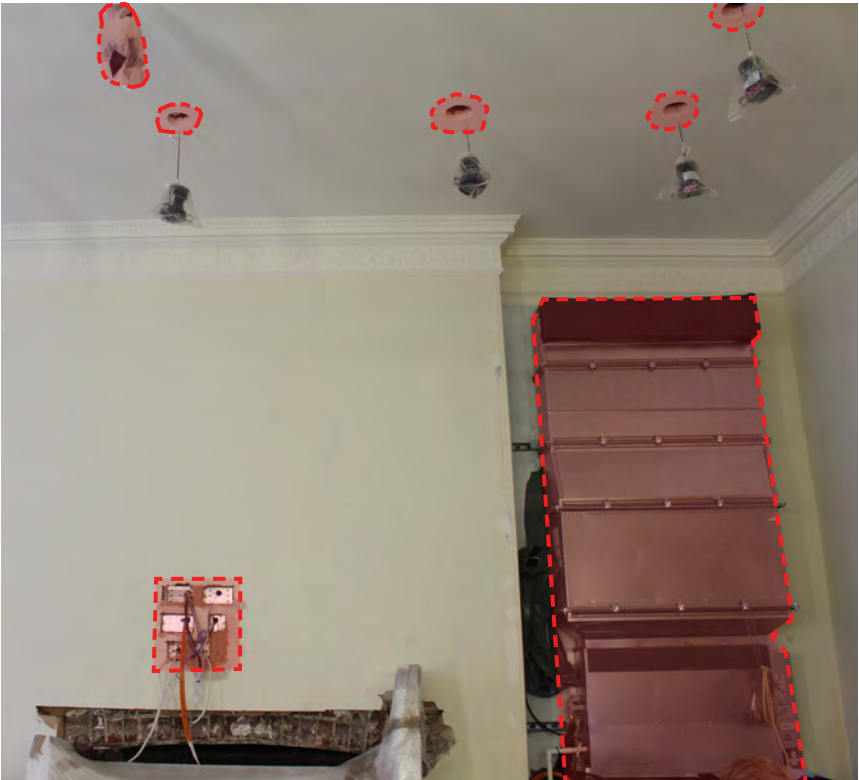
Image of Dining Room Fireplace elevation illustrating fan coil unit to be reduced, ceiling penetrations to be repaired and socket outlets above fireplace to be removed.

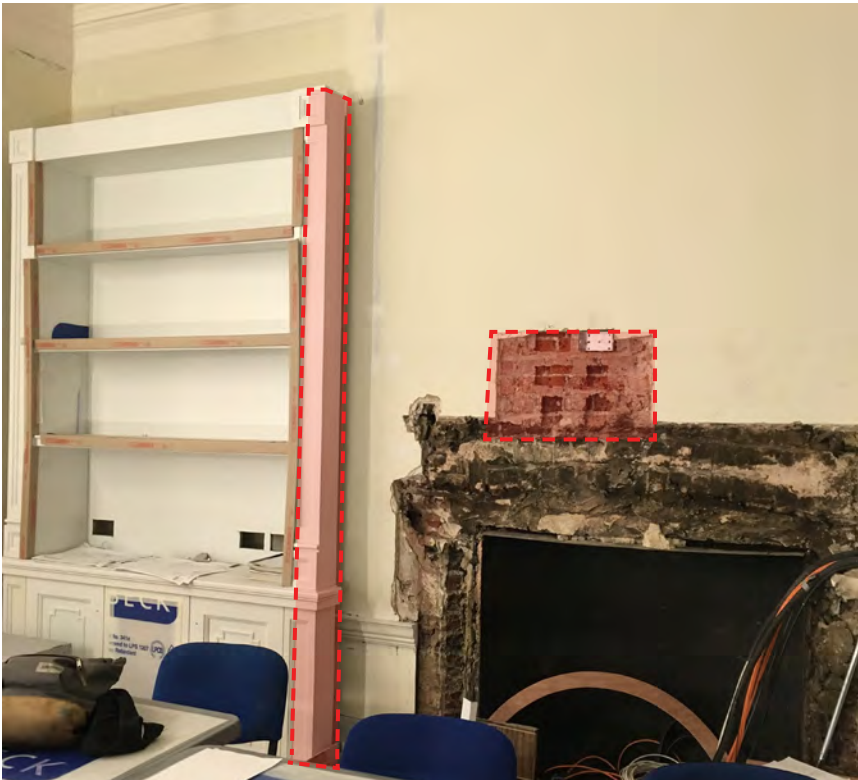
0.06 Image of Living Room Fireplace elevation illustrating socket outlets above fireplace to be removed and example of current furniture design overlapping chimney breast feature.

Internal Walls_
Carry out repair works to damaged plasterwork in materials and methodology to match the existing adjacent. High level socket outlets adjacent to windows to be carefully removed and made good. Socket outlets above fireplace on chimney breast to be removed.

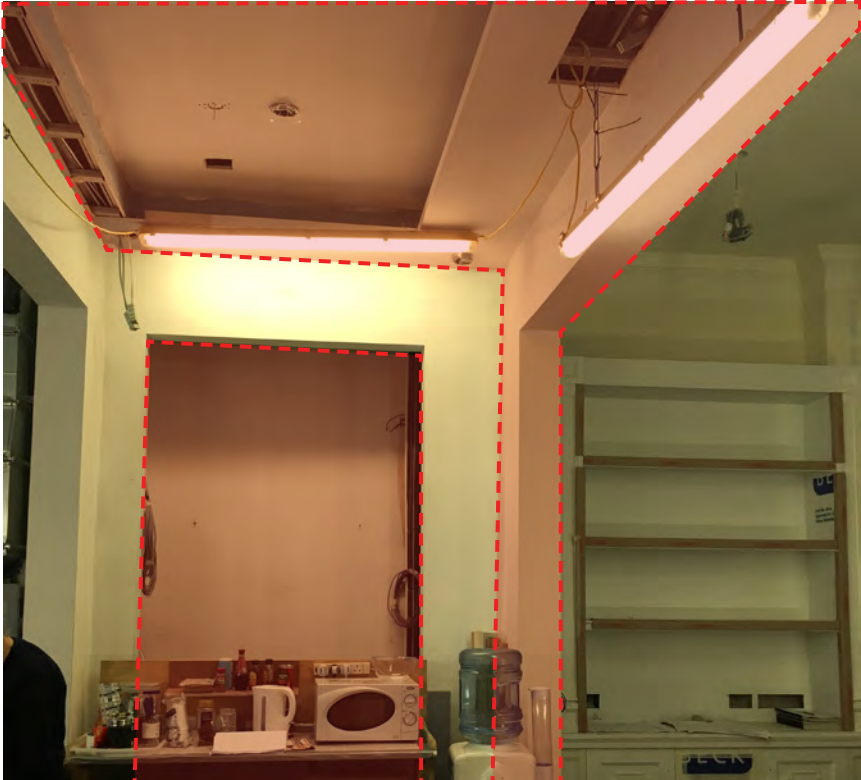
0.06 Image of central area of Living Room illustrating enlarged openings, modern nib partitions and modern suspended ceiling area all to be carefully removed and reinstated.

General_
Enlarged door opening between living room and stair hall and cupboard door opposite to be returned to their original opening sizes and existing retained doors and surrounding joinery to be reinstated. Modern nib walls and central suspended ceiling to be carefully removed. Reduce scale of fan coil units. Adapt furniture design. Repair and redecorate throughout.

Ceilings_
Carry out careful removal works to all new ceiling penetrations for recessed light fittings. Implement repair works to lath and plaster ceiling in accordance with drawings and methodologies. Rely on two centralised locations for

ceiling mounted lighting. Redecorate. Modern suspended ceiling in 'coffer' arrangement to be carefully removed and adjacent fabric repaired and redecorated as necessary.

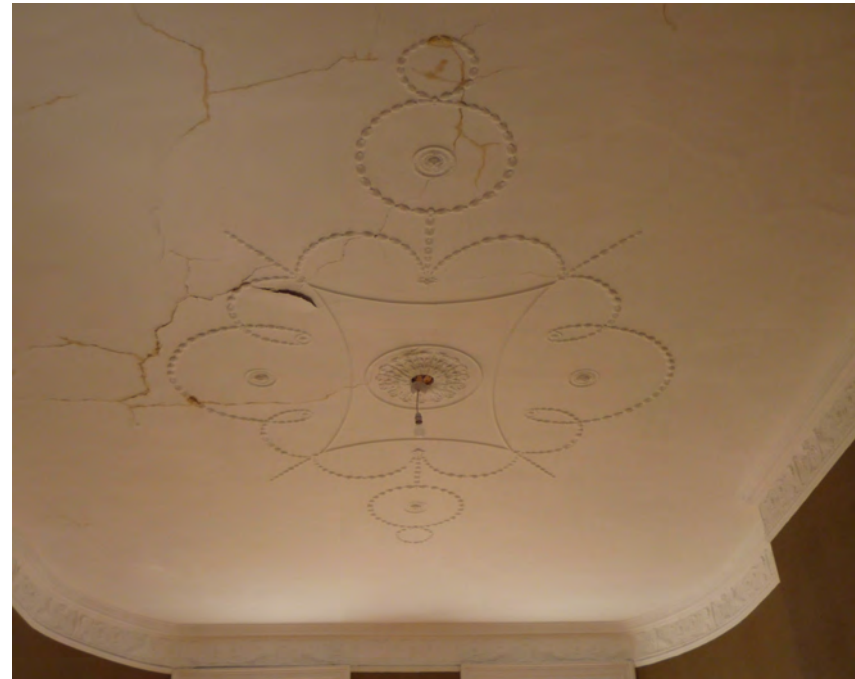
Image taken of the damaged decorative plaster ceiling to the rear room of the first floor prior to the 2014 application.

The decorative plaster ceiling to the front room comprises scrolled arabesques, trophied panels and swags. The room behind has a decorative ceiling of swags and putti. Prior on site it was noticed in the rear room that delamination of the plasterwork from the laths had manifested itself in a series of cracks across the ceiling and large sections of the plasterwork were sagging, requiring urgent remedial action.

The ceiling to the rear room has undergone a programme of repair and consolidation to address the areas of delaminating plasterwork and to ensure the retention of the original design. This work has been carried out by a reputable specialist, George Jackson.

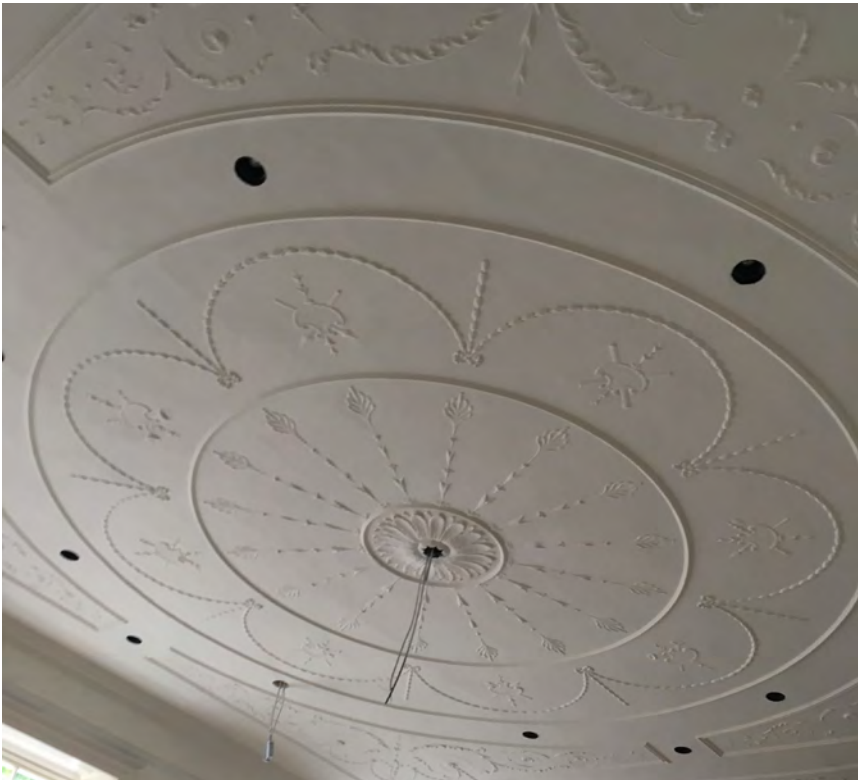
Ceiling to front room illustrating the redecorated and refurbished ceiling and further works requiring reinstatement.

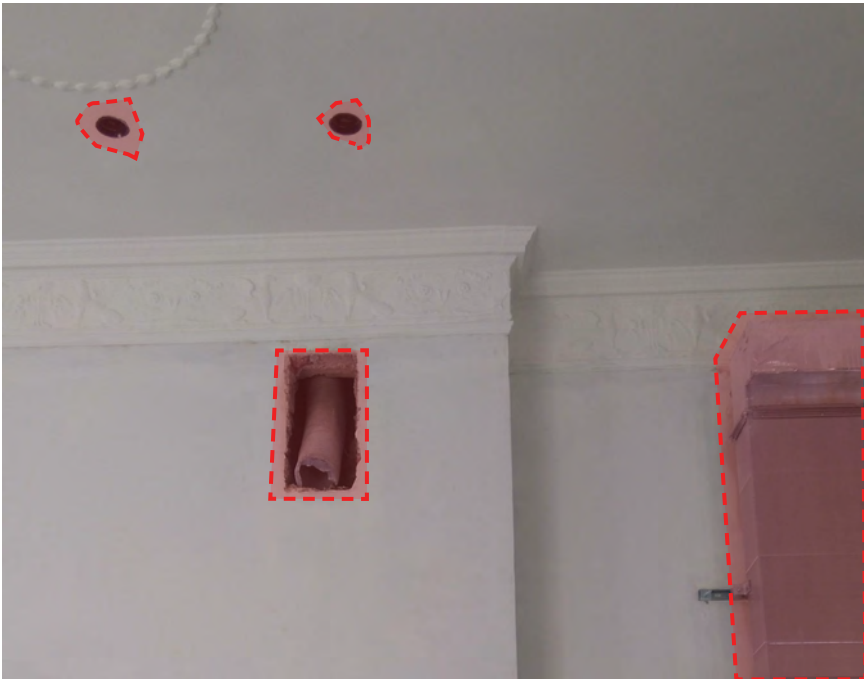
1.03. Penetrations in ceiling and chimney breast to be repaired. Fan coil unit to be significantly reduced in scale.

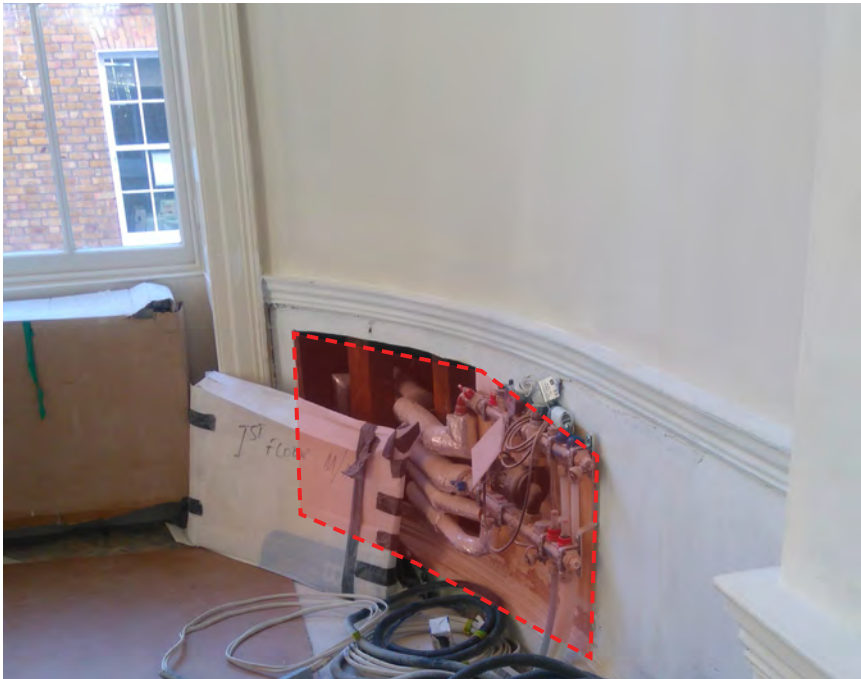
1.03. Underfloor heating manifold to be relocated to concealed location in rear bay lift hall. Timber panel to be reinstated.

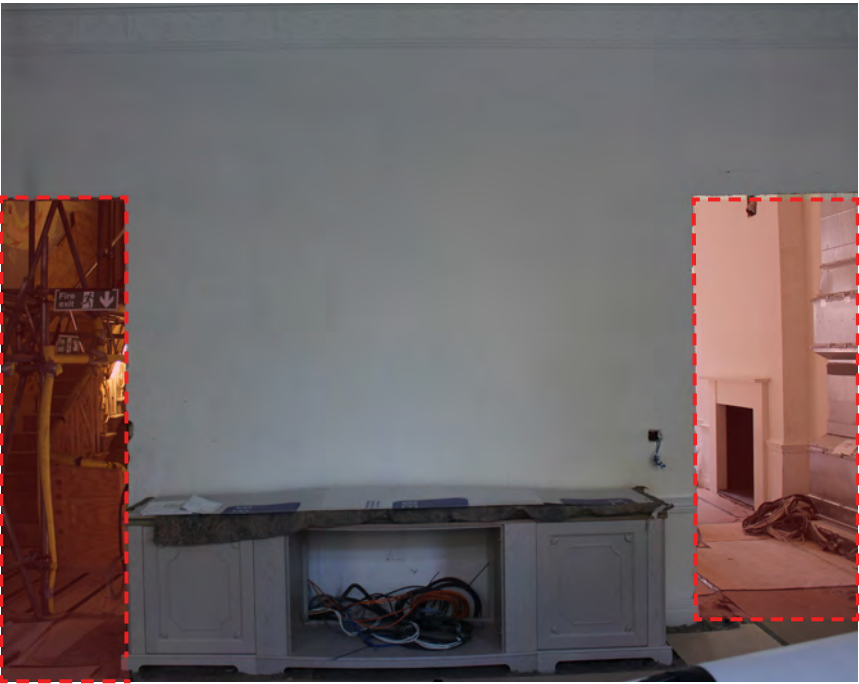
1.04. Relocated and enlarged openings to be reinstated to match original locations and scale

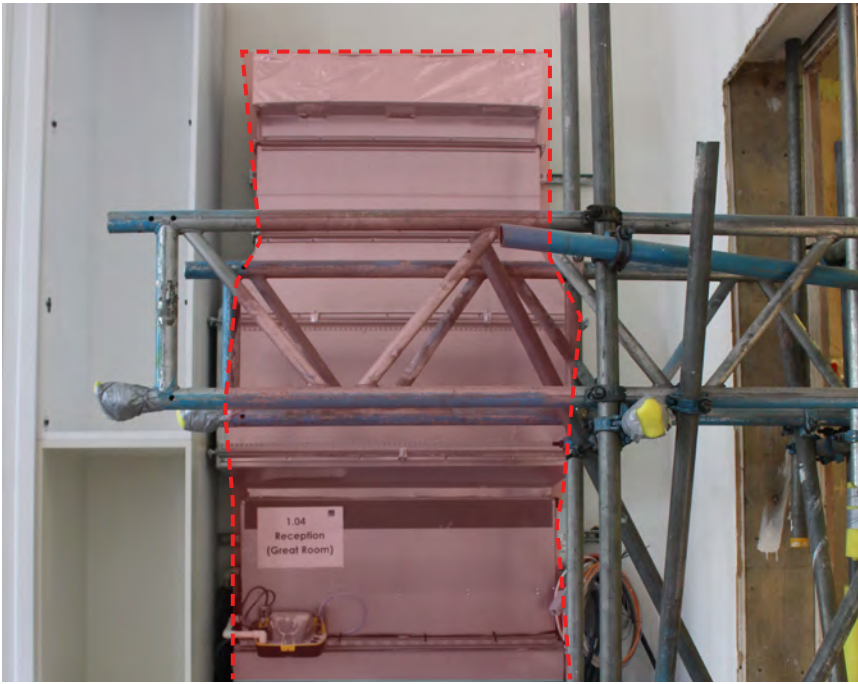
1.04. Scale of fan coil units to be reduced and to become floor mounted.

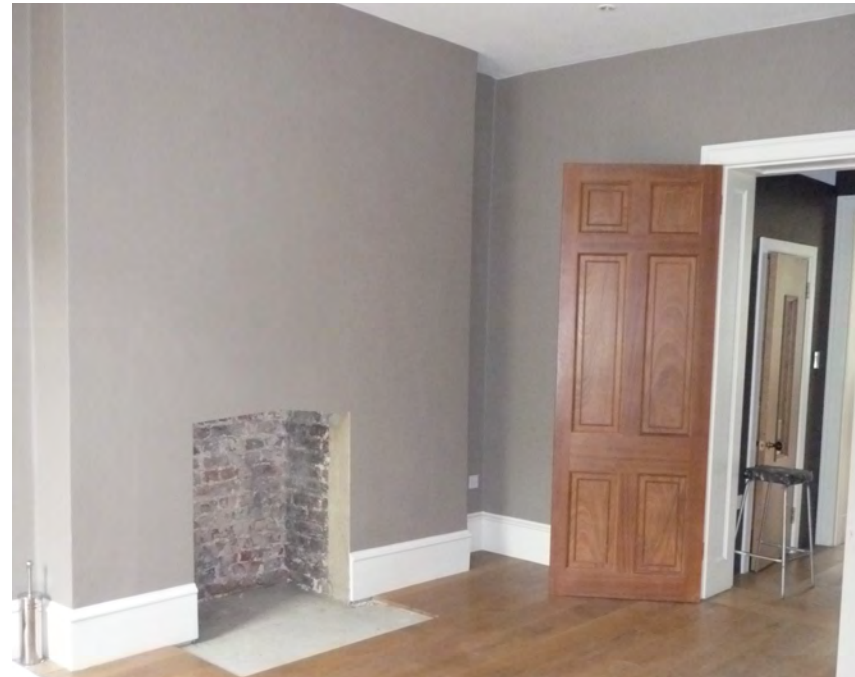
Image taken within the second floor rear bathroom prior to the 2014 application. Note the modern door opening, lighting, lack of fireplace and concrete hearth construction.
