174 Regents Park Road

*Rebuilding of the Closet Wing
~ Design + Access Statement ~*

May 2020

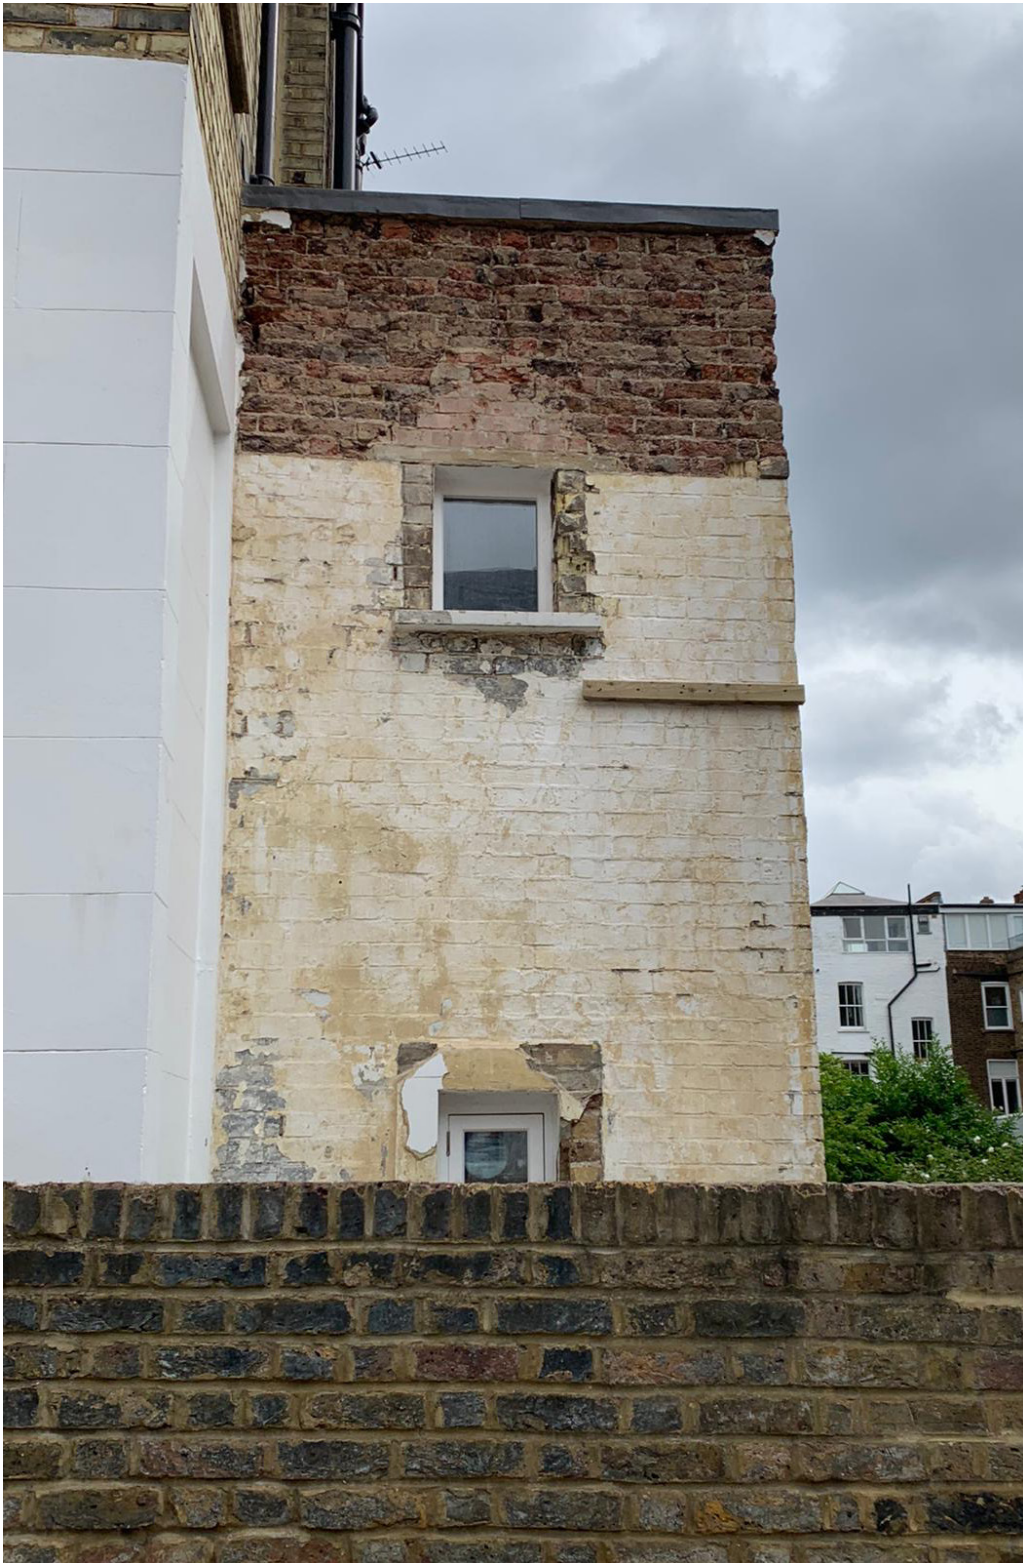
After removing the facing render the SW elevation is found to be a patchwork of different aged brick. Much of it is not original.

Figure 6 : View of the SW closet wing elevation from Berkley Road

The proposal is to clad the structure in reclaimed stock brickwork to match the original character. The bond is to be Flemish to match the period.

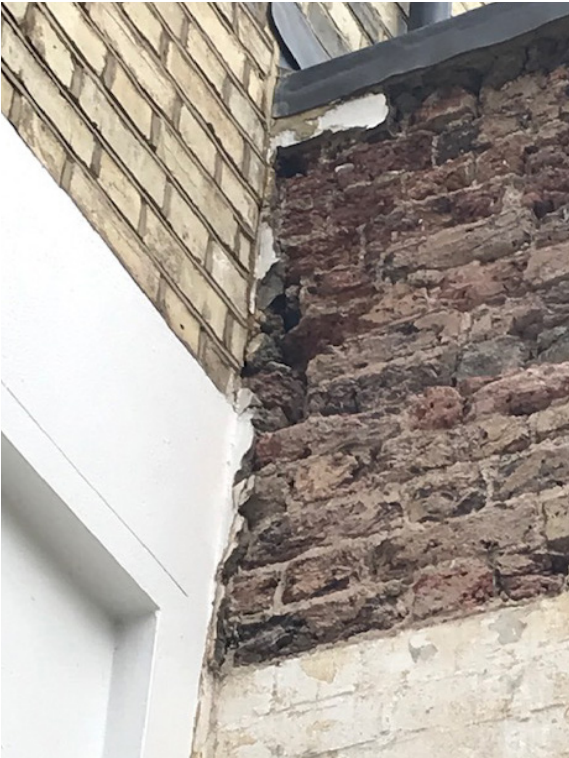
Figure 9 : View of the eroded brickwork on the corner of the closet wing

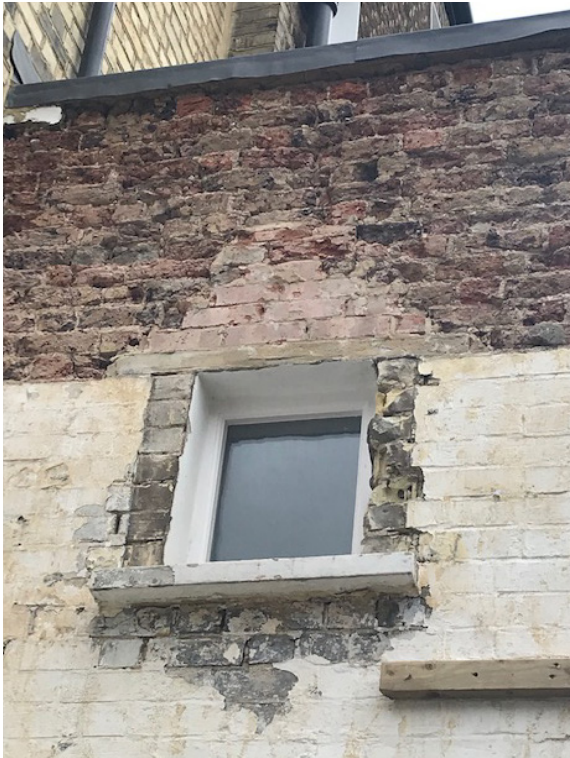
Figure 10 : View of the upper window and patched brickwork

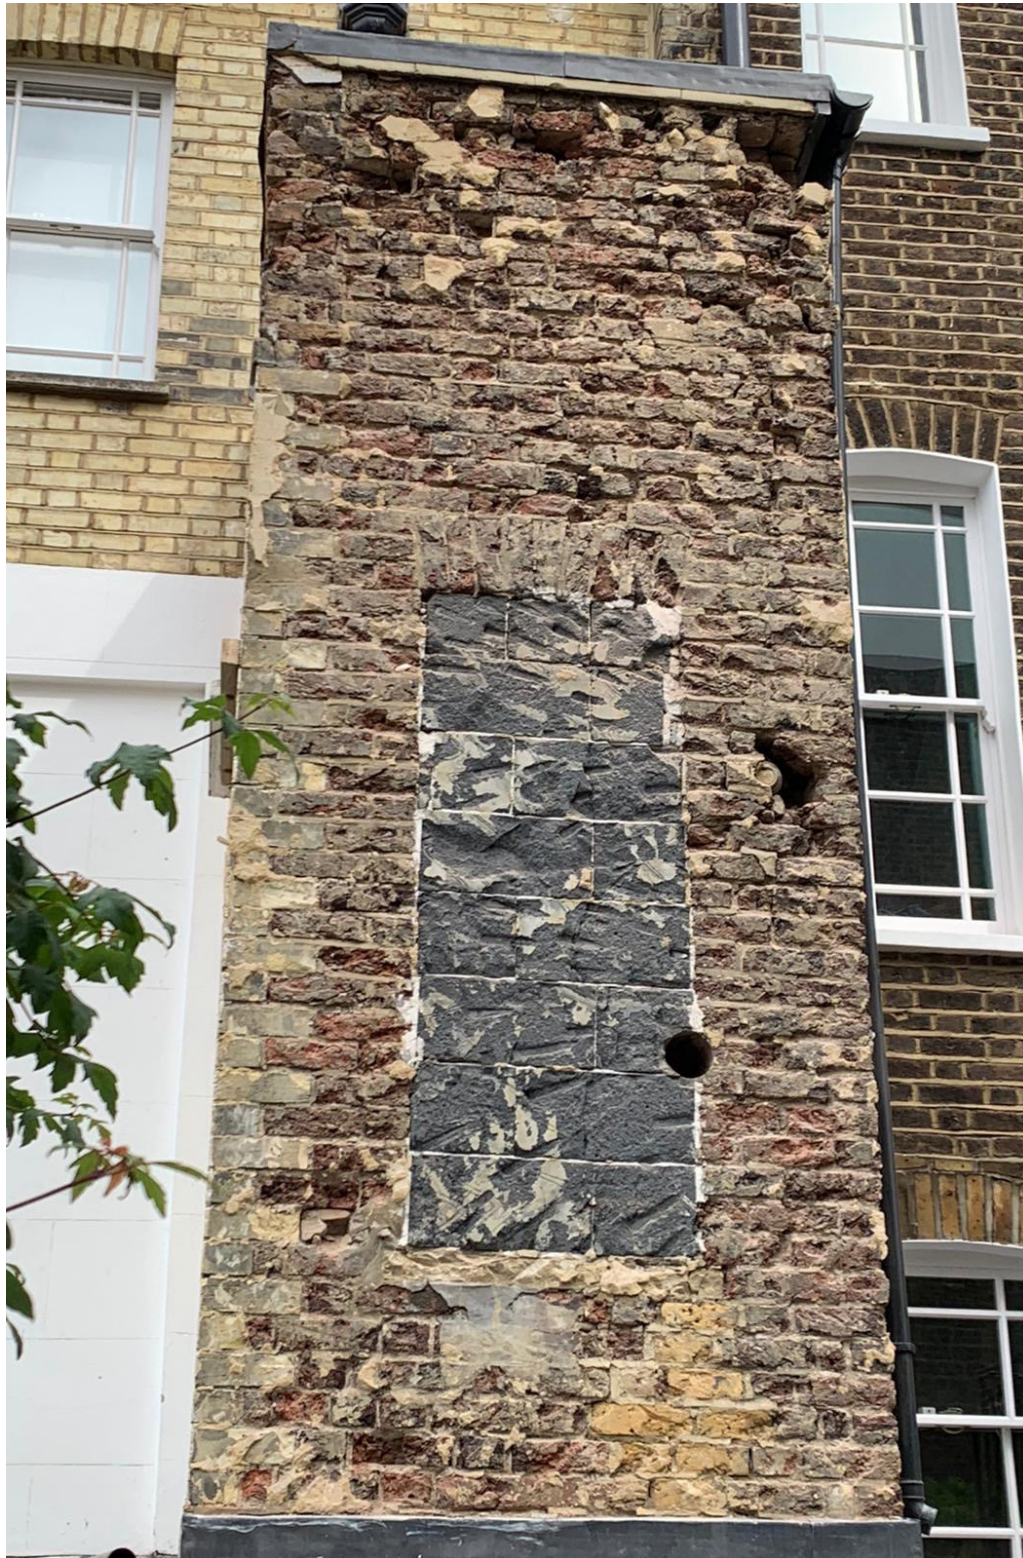
The SE elevation is found also to have very poor brickwork. The removal of the render additionally revealed a full height window opening that has been blocked up.

Figure 11 : View of SE elevation from the garden.

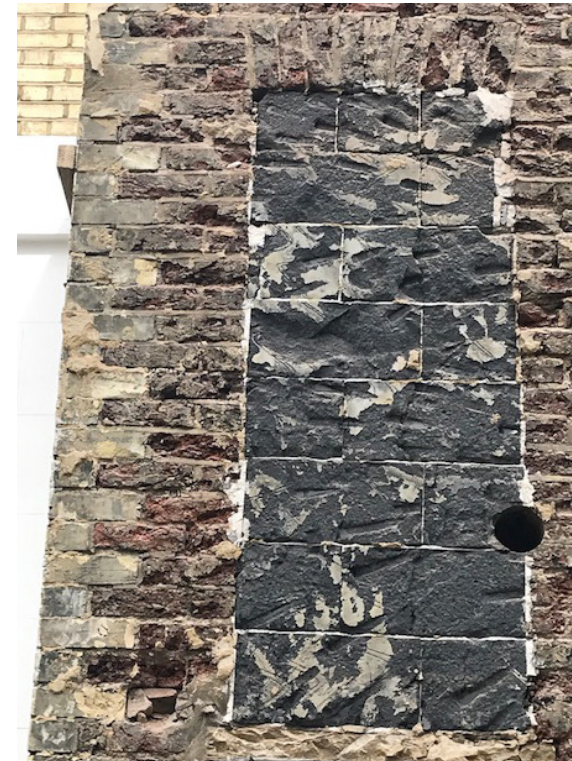
Figure 12 : View of the blocked window

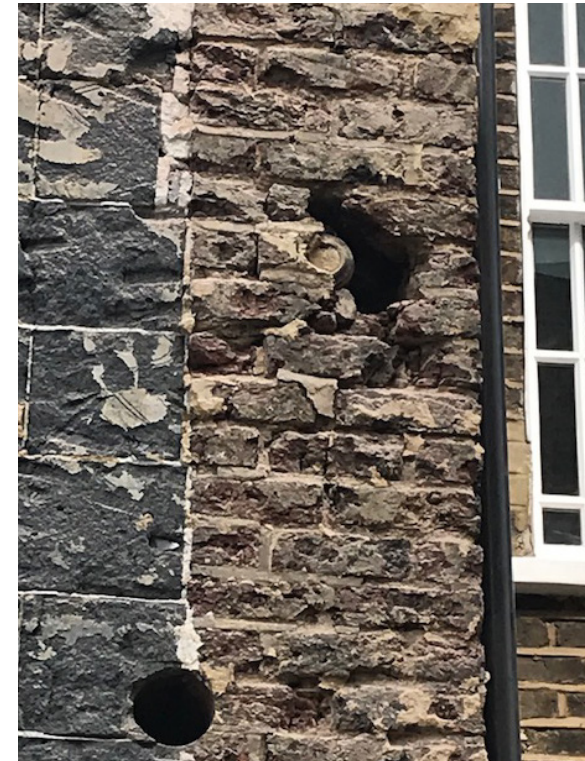
Figure 13 : Detailed photographs of the holes in the existing brickwork

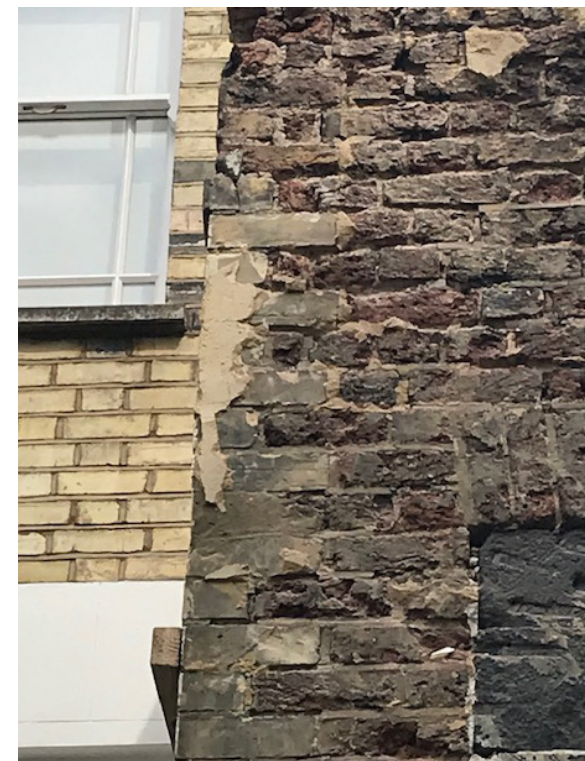
Figure 15 : Detailed photograph of the the poor corner brickwork

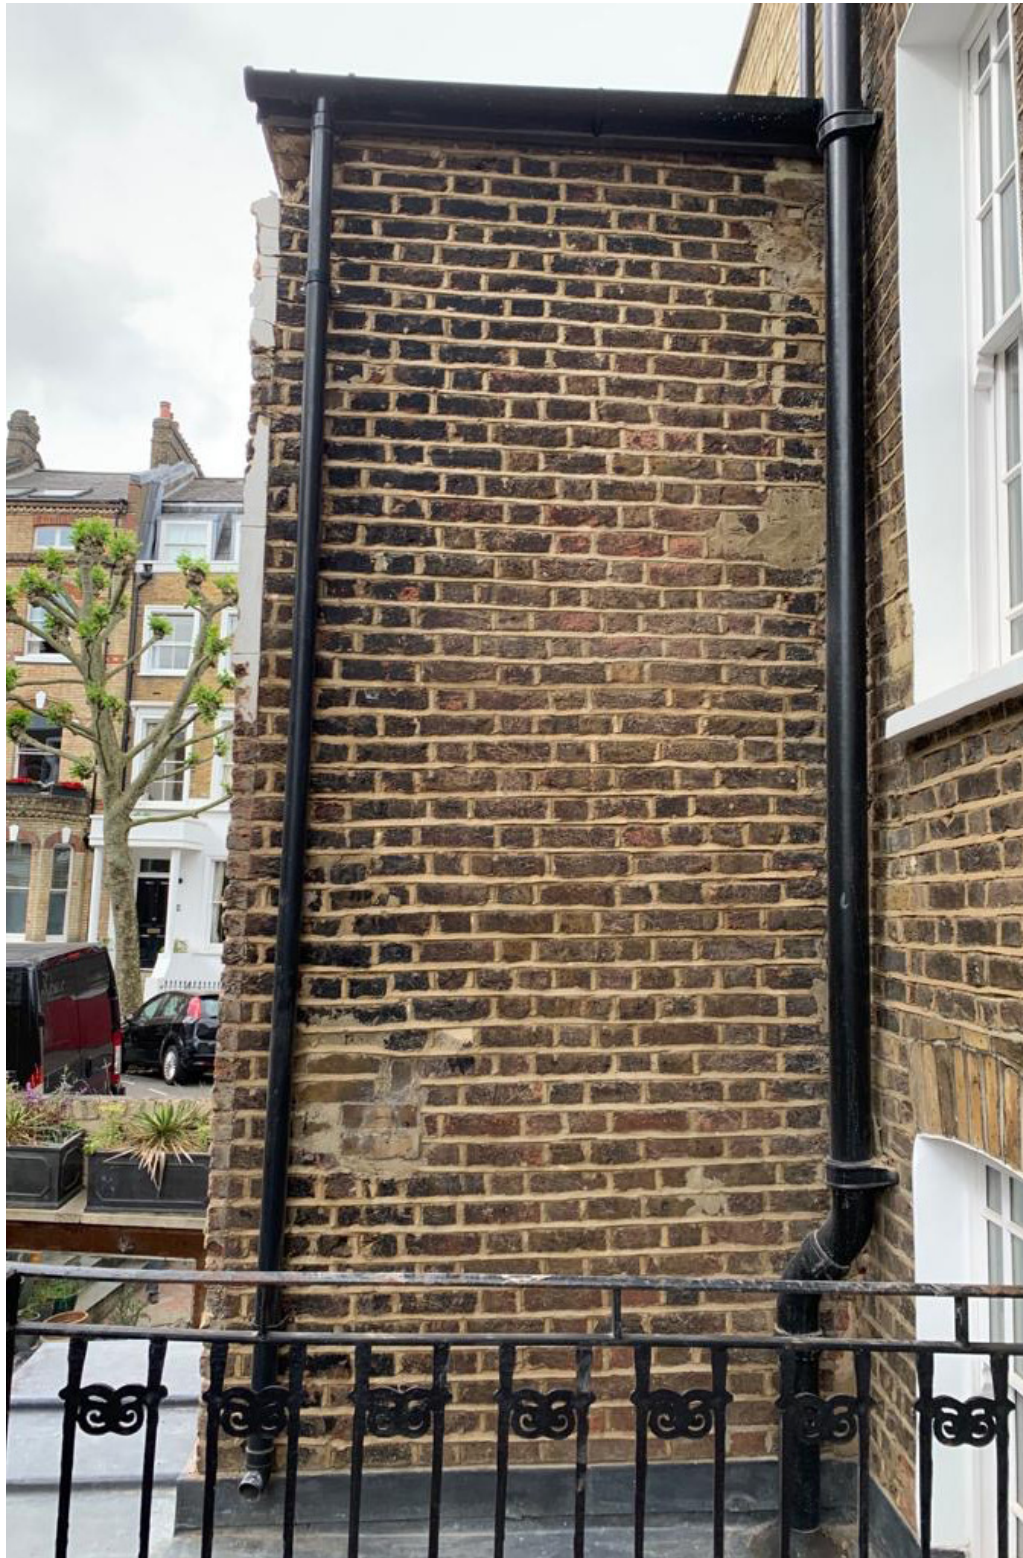
The NE elevation has been re-pointed in recent years. However the joint between the main building and the closet wing is found to be separated due to movement described in the appended engineer report. The brickwork has been poorly patched.

Figure 16 : View of the NE facade from the ground floor balcony

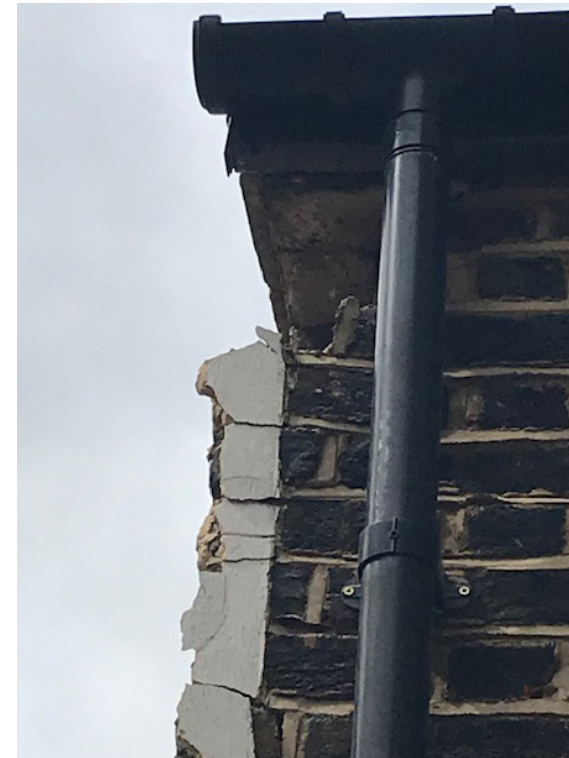
Figure 17 : Detailed photograph of the poor corner brickwork + plastic downpipe.

The proposal is to rebuild the structure to match the existing massing and fenestrations exactly. The existing rainwater goods are to be updated to cast iron from PVC. The roof was granted permission for rebuilding in August 2019 (2019/1480/P.)

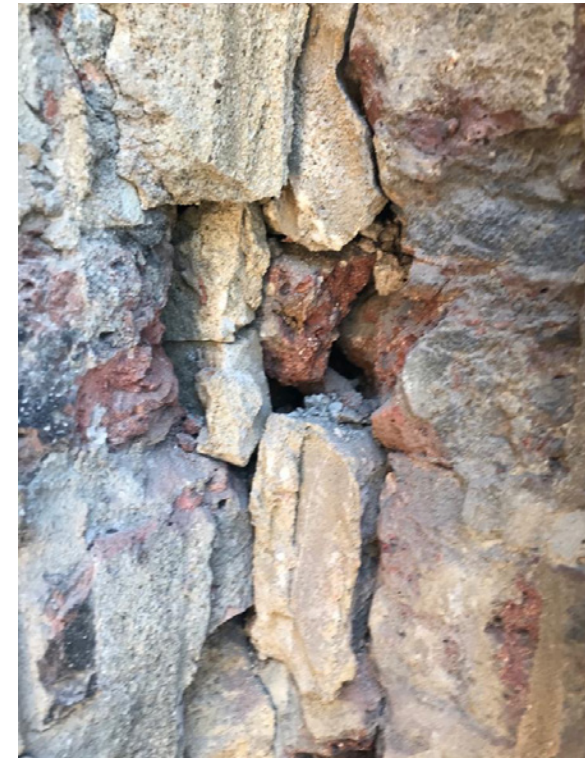
Figure 18 : Detail of the open joint between the main building and the closet wing.

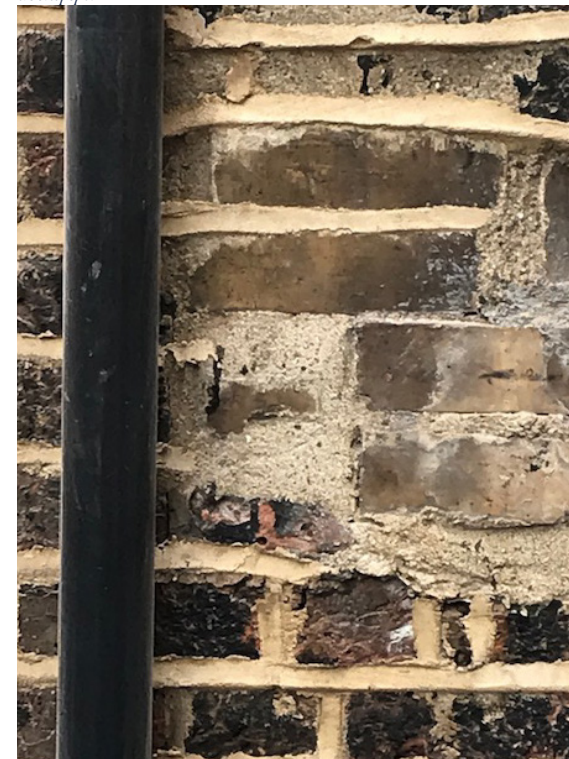
Figure 19 : Poor quality infill work

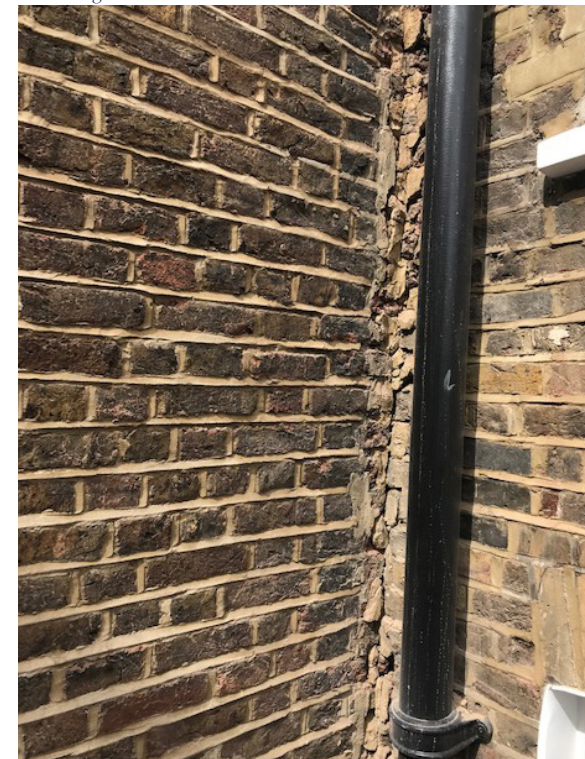
Figure 20 : Exposed open joint between the closet wing and the main house.

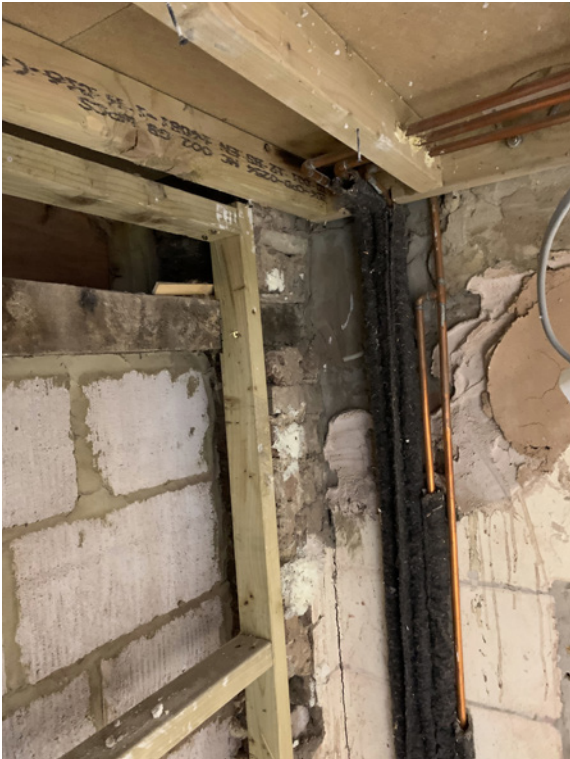
The internal site views show that the closet wing structure has been undermined by previous works carried out at the property in 2012 (2012 - ref. 2012/4284/P.)

Figure 21 : Patchwork of services and structural blockwork

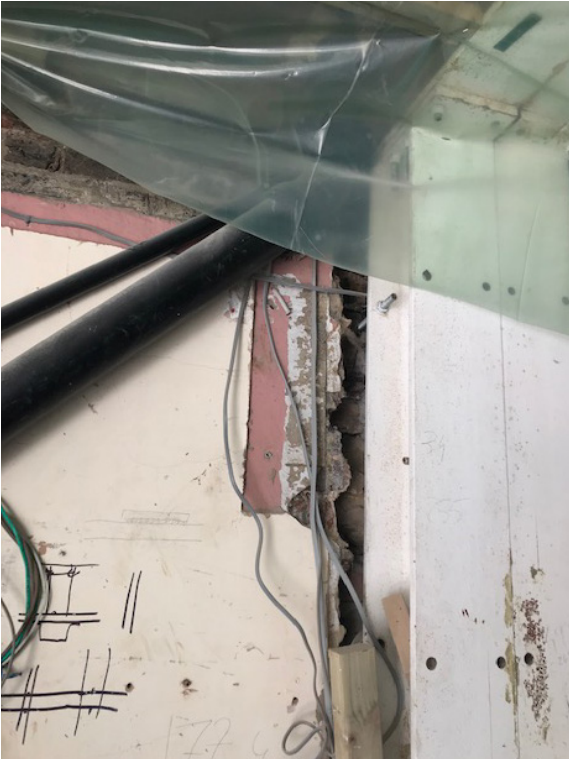
Figure 24 : Steel columns inserted into closet wing wall

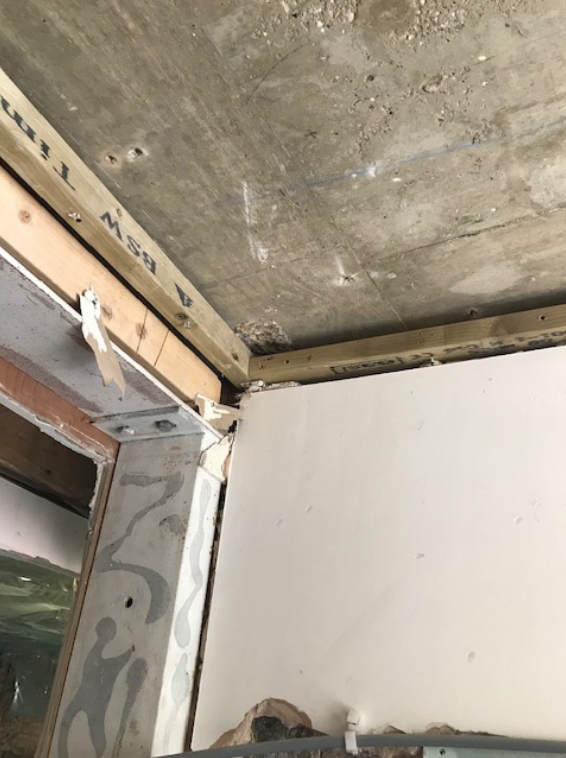
Figure 22 : Steelwork inserted in 2012

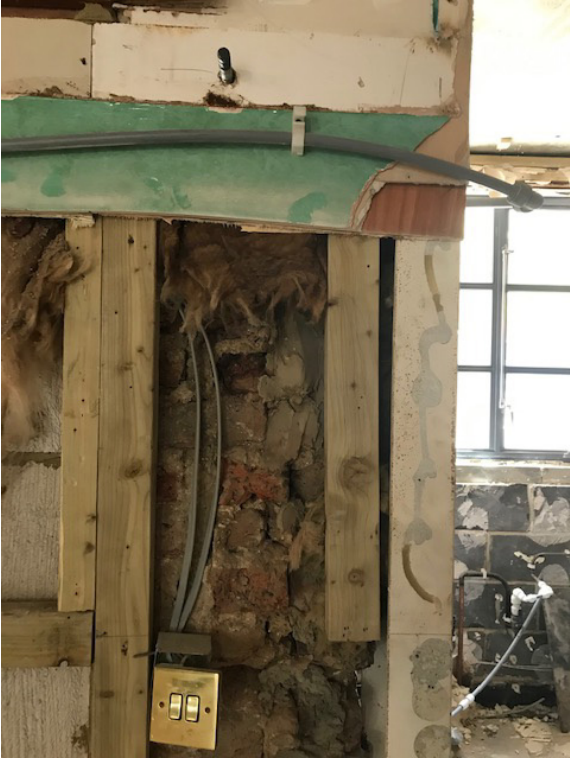
Figure 23 : Old masonry patched and altered

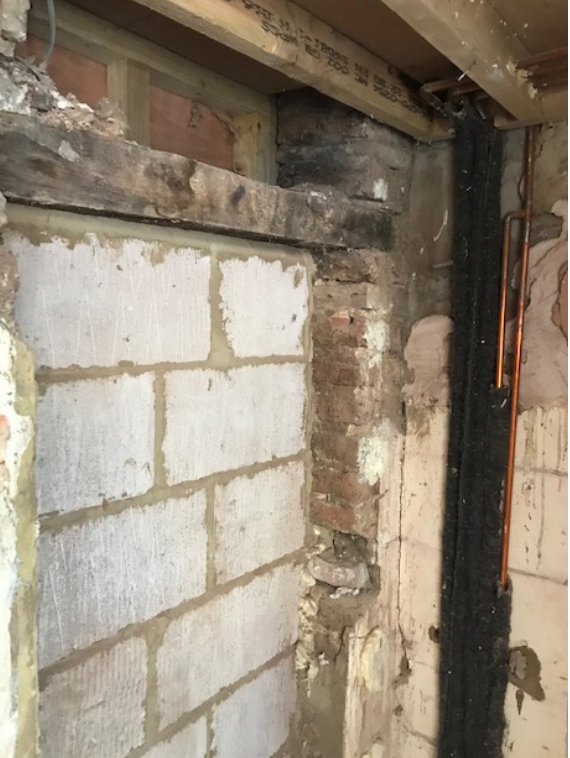
Figure 27: Blockwork wall infill
