Landmark Trees

ARBORICULTURAL IMPACT ASSESSMENT REPORT FOR:

69 Avenue Road
London
NW8 6HP

Ref: KSR/69AVR/AIA/02a

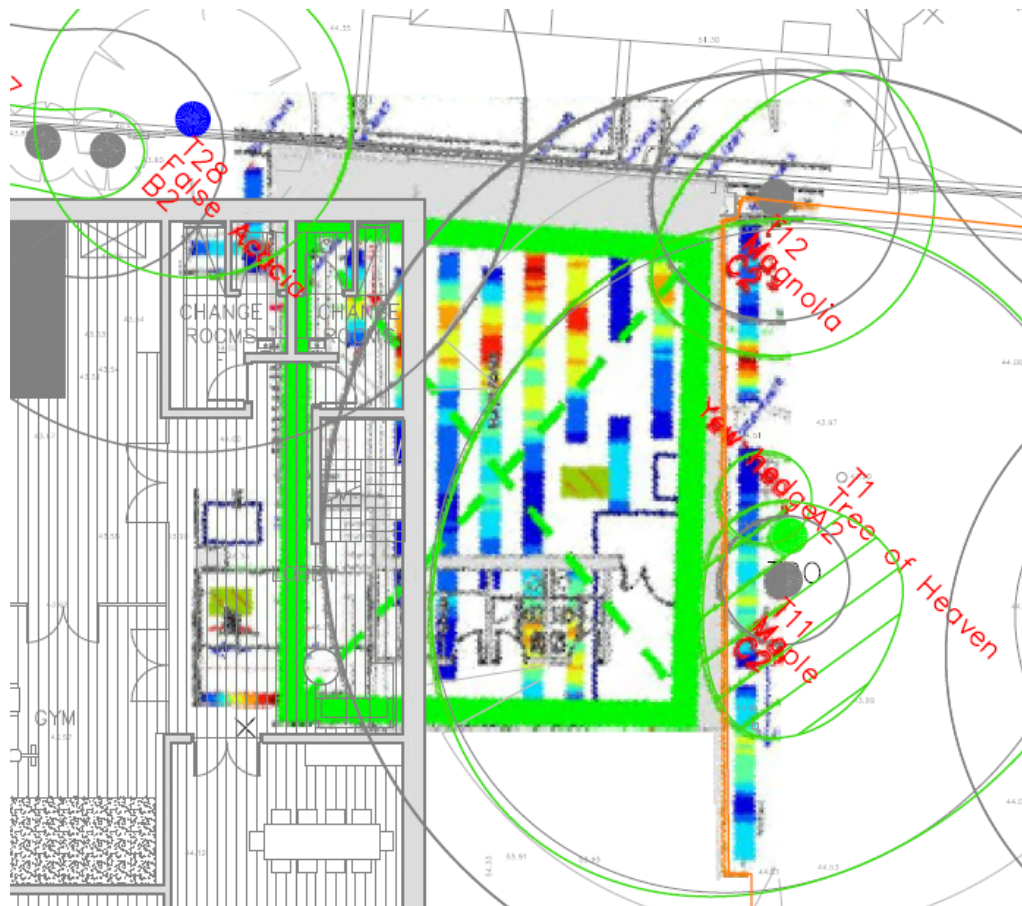
Extract 1: Root densities beneath existing structure

- 4.1.3 In BS5837, paragraph 4.6.2 states that RPA's should reflect the morphology and disposition of the roots; where pre-existing site conditions or other factors indicate that rooting has occurred asymmetrically, a polygon of equivalent area should be produced. Modifications to the shape of the RPA should reflect a soundly based arboricultural assessment of likely root distribution. **We previously adopted a prudent principle of modification whereby the priority area for root protection is not distributed beneath the existing dwelling and thus showed a modified RPA for T1. However, ground penetrating radar (see Extract 1 below) has since shown that it is rooting beneath a lighter part of the building and therefore we have not adopted the modified RPA in this assessment.**

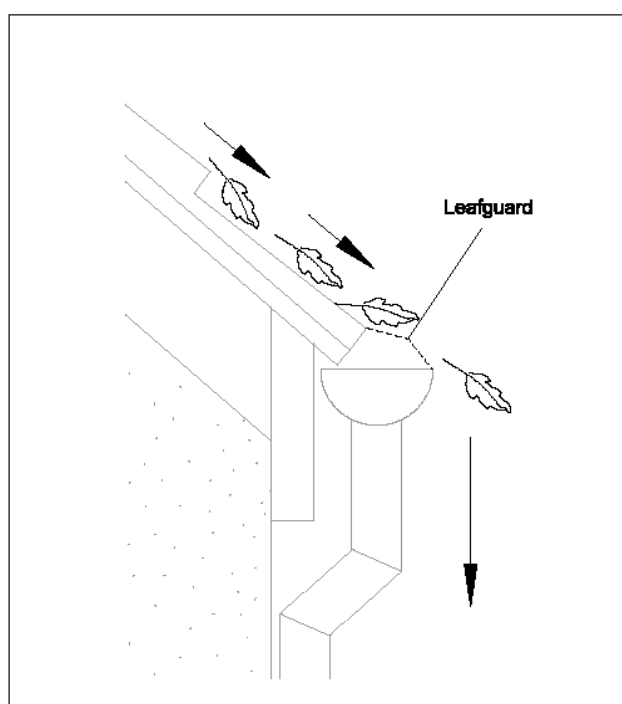
Figure 5: Filtration traps, as shown above, could be fitted on the gutters which can easily be maintained at 2-3m above ground.

- 6.3.2 Nuisance deposition can be further mitigated with routine maintenance, light pruning / deadwooding and the fitting of filtration traps on guttering (see Figure 5 below).
- 6.3.3 The shading impacts can be mitigated by building design, with the provision of dual aspect windows and choice of room layout. Some minor crown reduction may be necessary, but not such as to impose a burden of frequent, repetitive management.
