PROJECT TITLE <b>42 BEDFORD SQUARE</b>	
PROJECT NUMBER P2005698	SCALE @ A1
DRAWING TITLE 0.06 LIVING ROOM CHIMNEY PIECE GROUND FLOOR PLAN REPAIR WORKS	DATE 03.2019
DRAWING NO. (33)AD002_MH	REVISION B

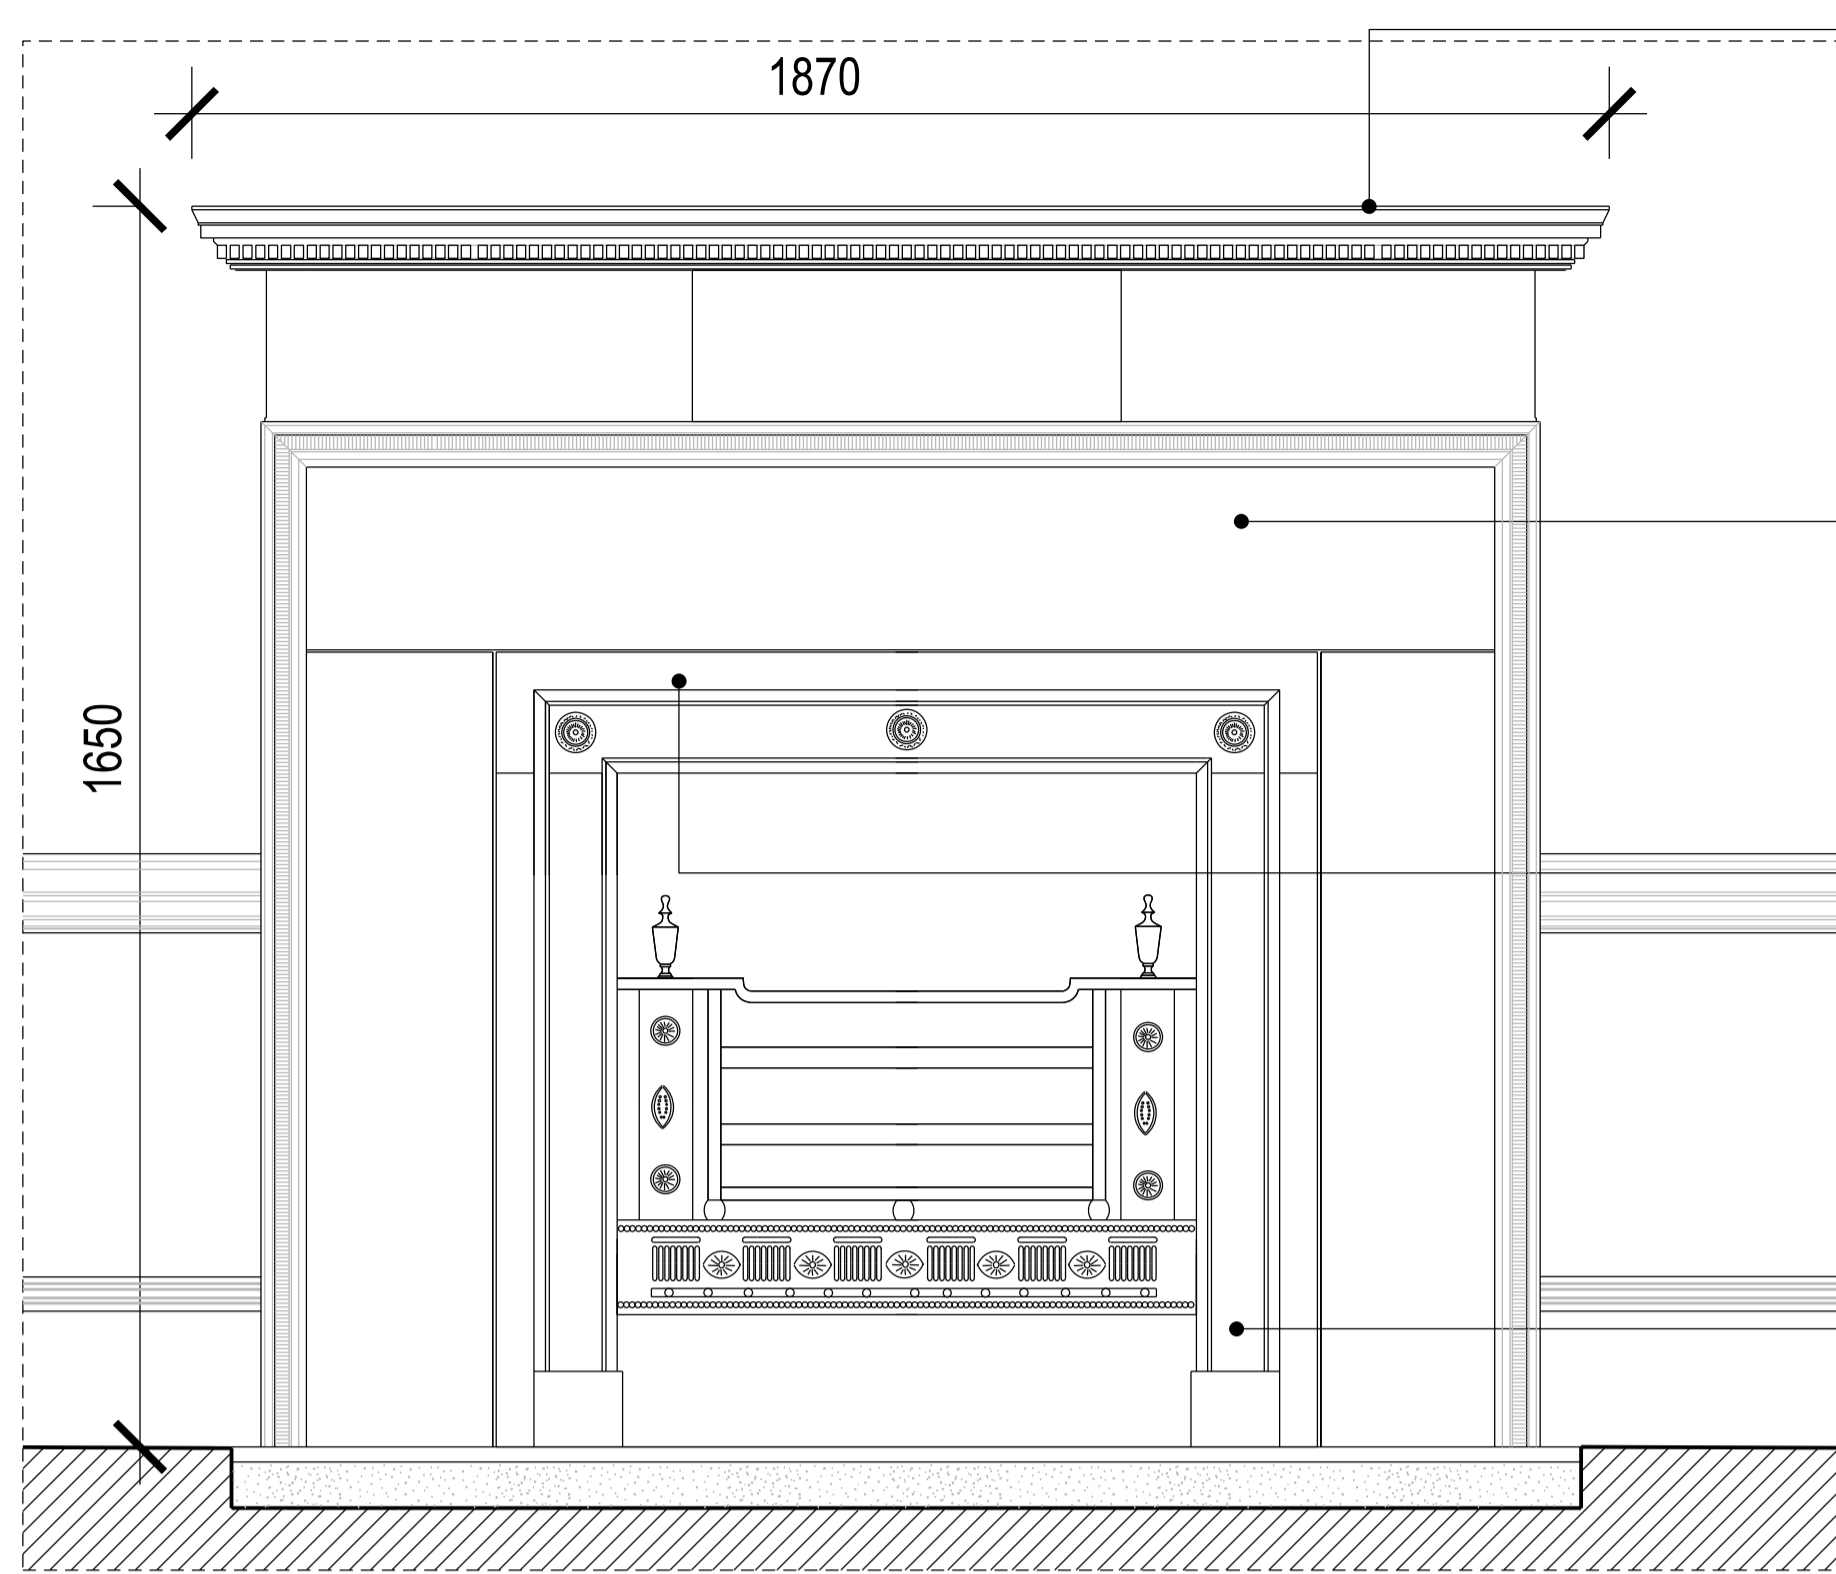
**01** CHIMNEY PIECE ELEVATION  
scale 1:10

Original timber and plaster ornate moulded chimney piece to be reinstated.

Existing Carrara marble slips

Metal slips required to cover the gap between the register grate and marble front piece. This is to be carefully measured on site and match the material of the installed grate.

Haywood register grate by Jamb. All dimensions to be checked on site in relation to the reinstated fireplace, the register grate to be aligned with the back side of front marble pieces.

Clean, repair and carefully reinstate original pieces to their original location. Add new pieces in a like for like basis, when missing or not able to be repaired.

Clean and repair existing firebox and integrate new marble hearth to match the existing from the photos and the chimney piece as closely as possible.

Tiles to be removed, register grate to be inserted in a 18th century style appropriate to age + style of building.  
To be discussed with local planning authority prior to submitting to discharge of conditions.

Redecorate painted elements, using same colour and type of paint, as existing.

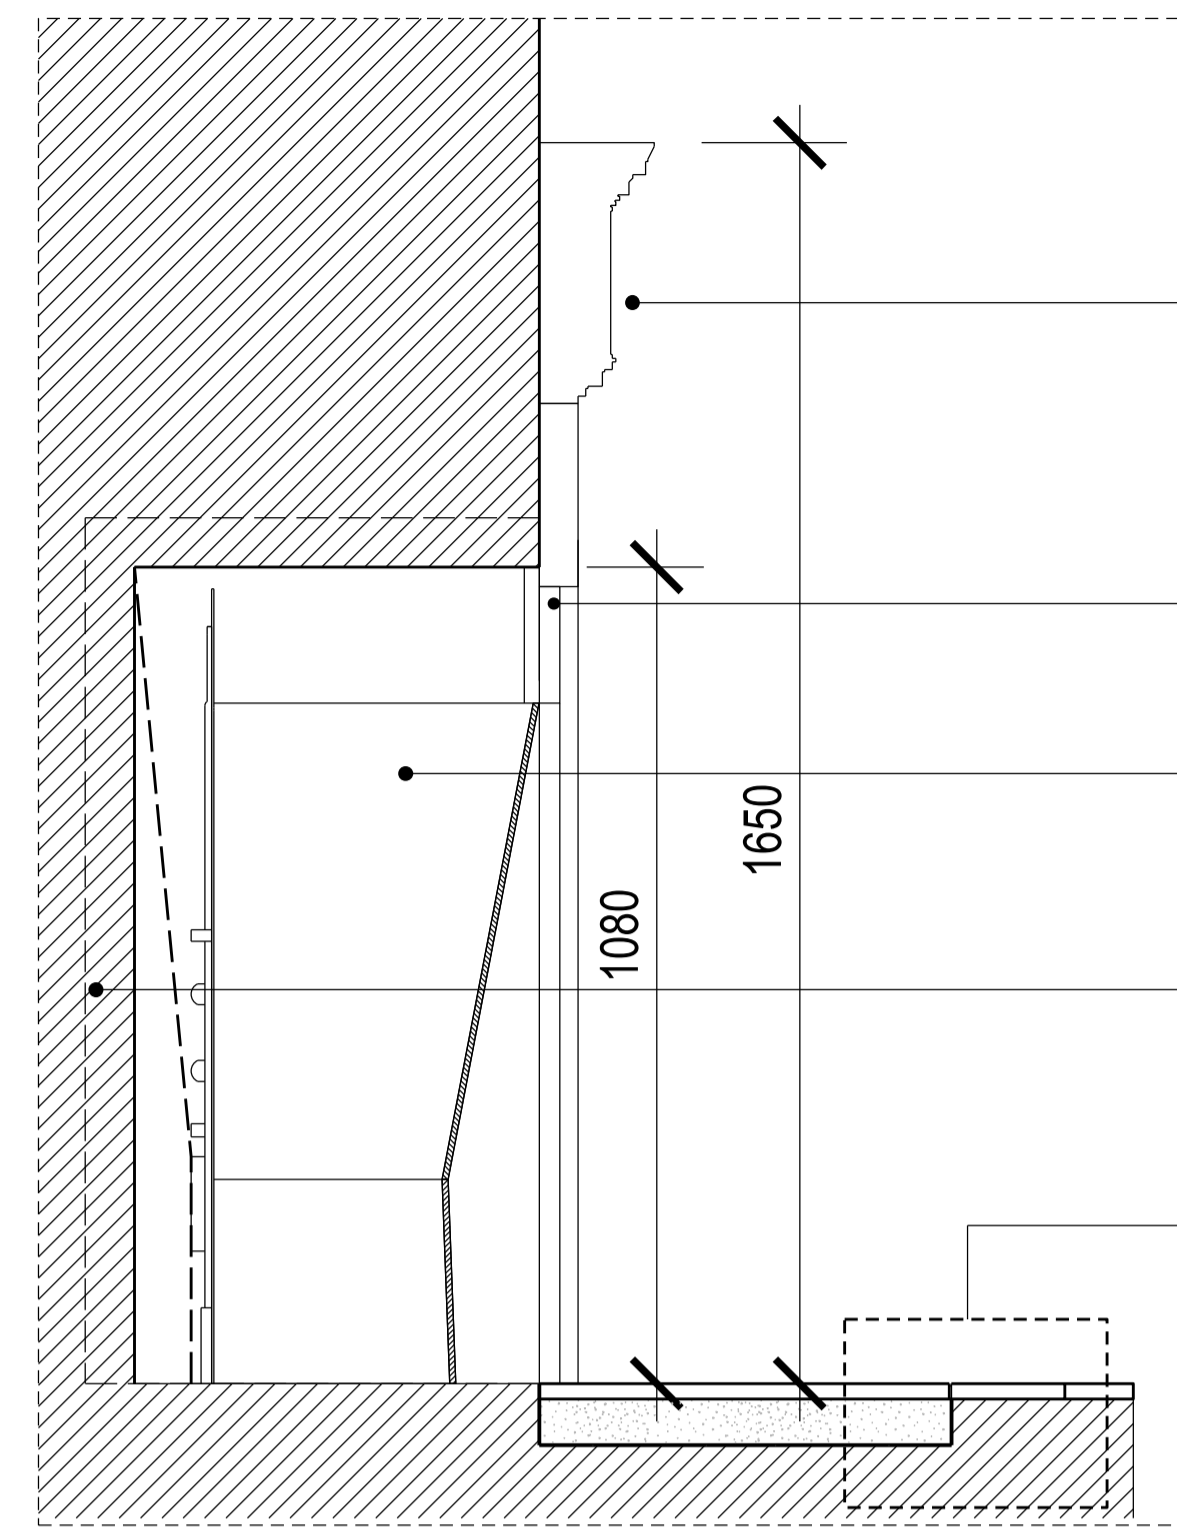
**02** CHIMNEY PIECE SECTION  
scale 1:10

Profile section as Existing

Metal slips required to cover the gap between the register grate and marble front piece.

Haywood register grate by Jamb.

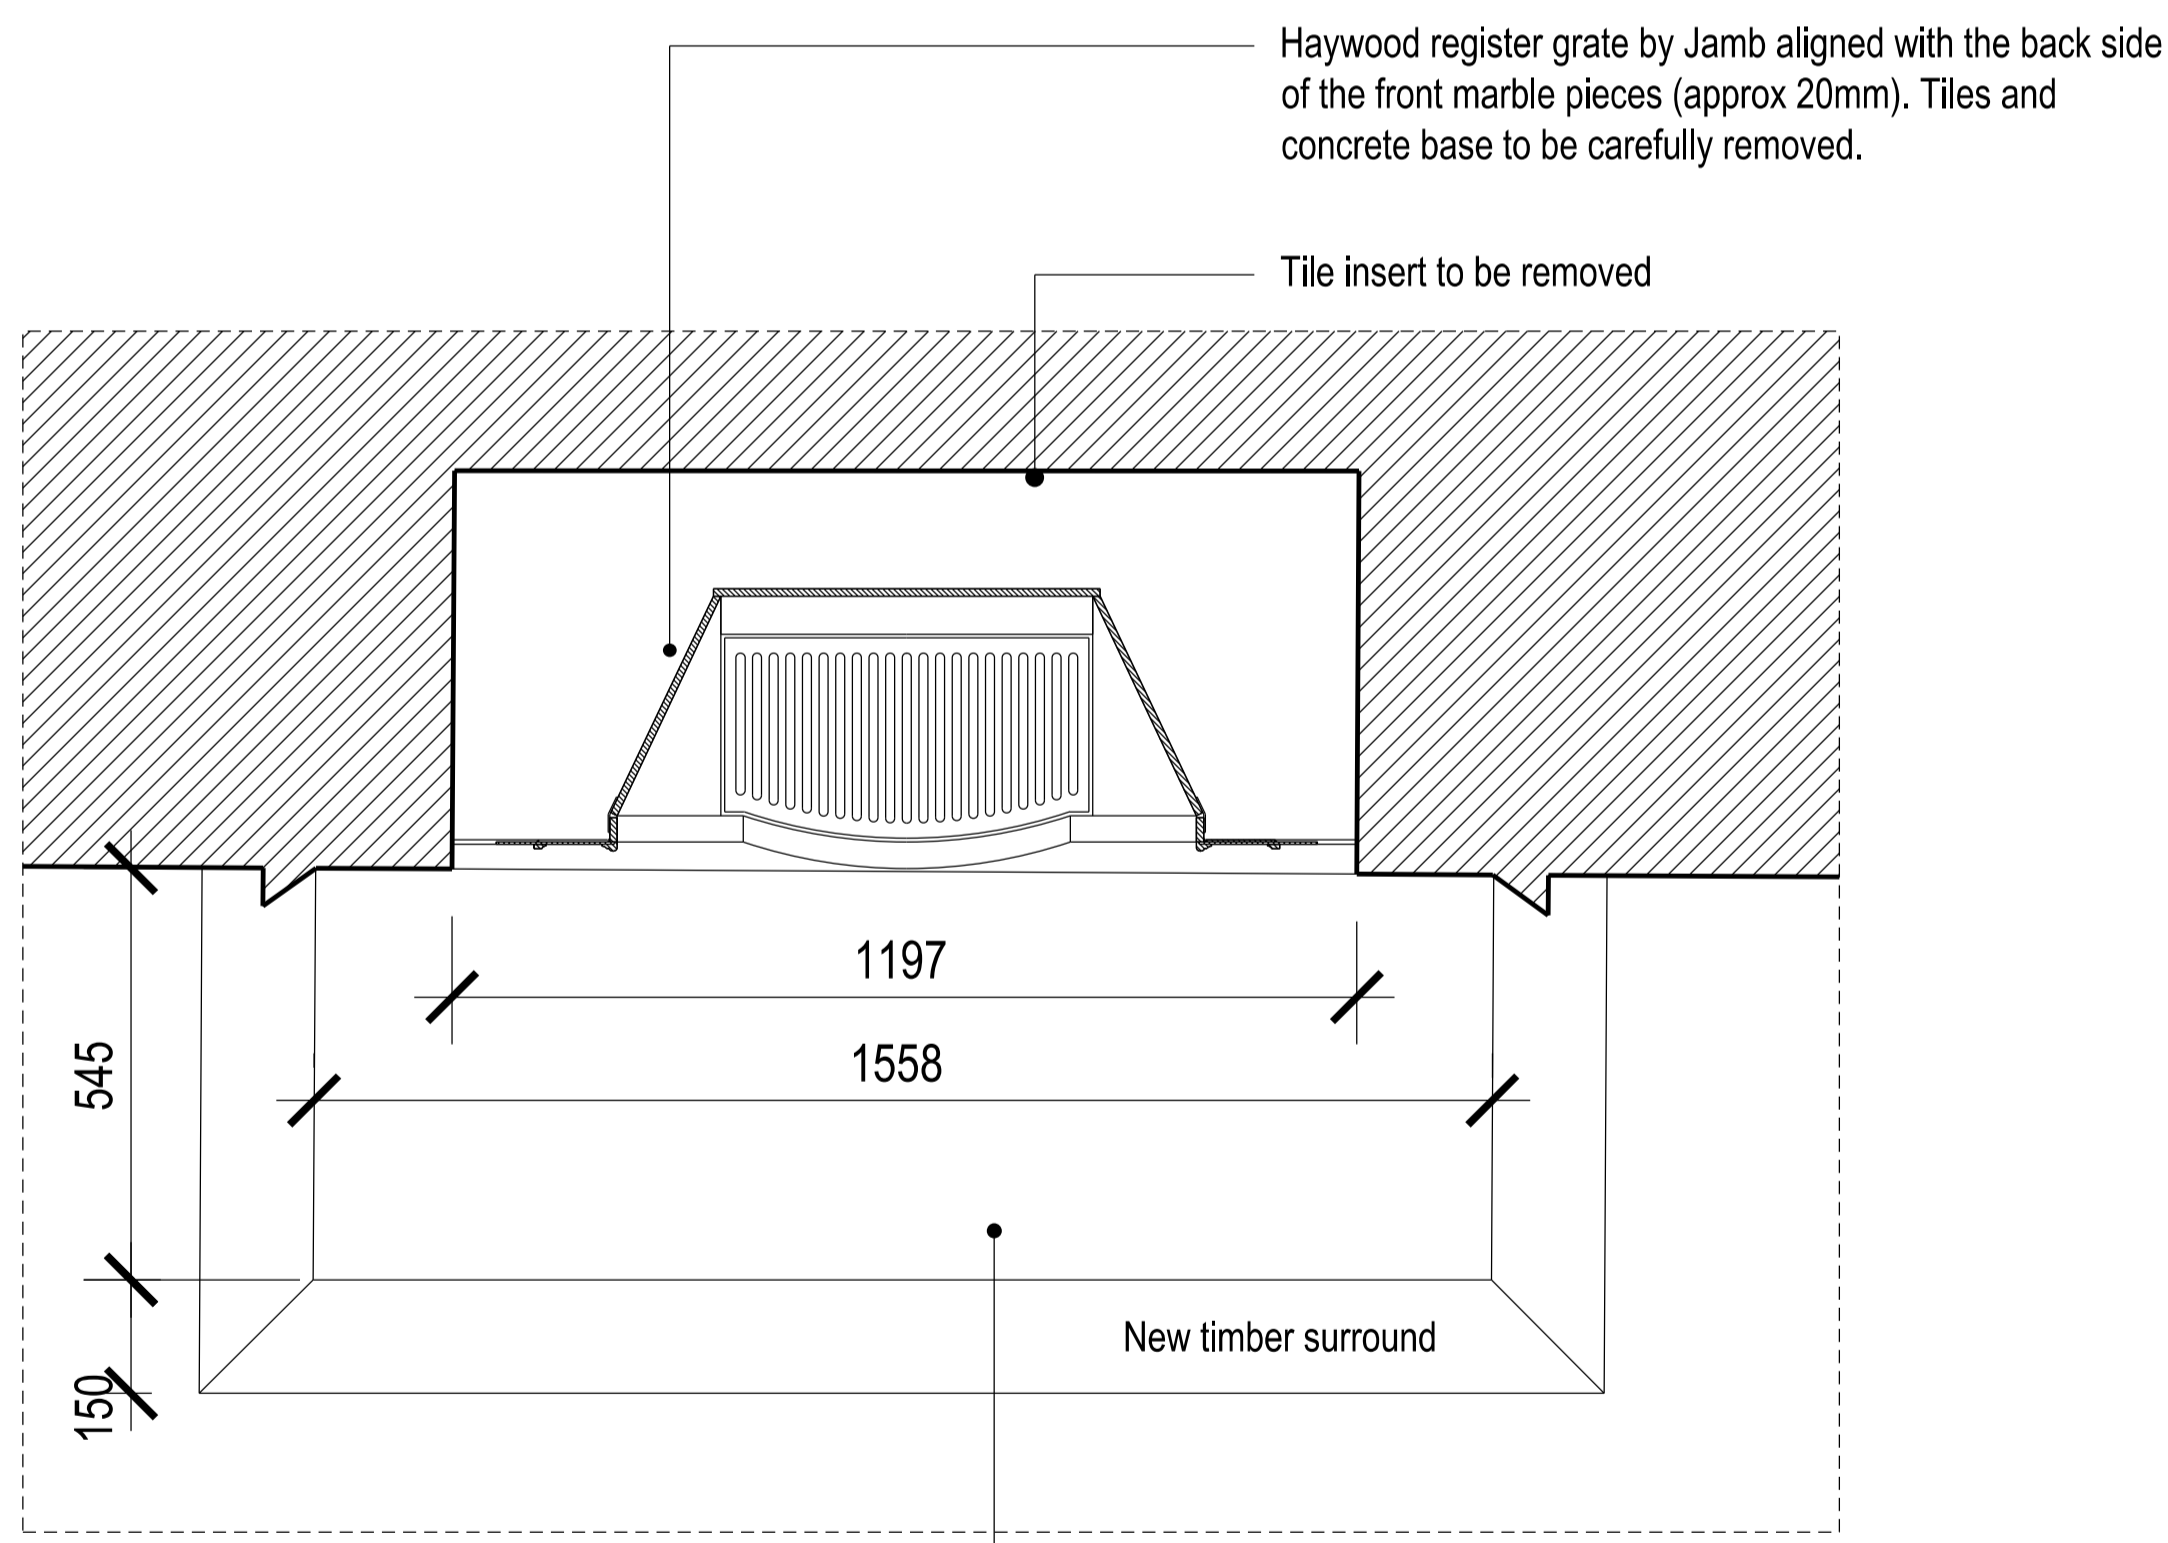
**04** CHIMNEY PIECE AND HEARTH PLAN VIEW  
scale 1:10

Tile insert to be removed

Floor coverings have been removed and the previous hearth stone has not been retained.

Haywood register grate by Jamb aligned with the back side of the front marble pieces (approx 20mm). Tiles and concrete base to be carefully removed.

New timber surround

New marble hearth stone to match others in the house.

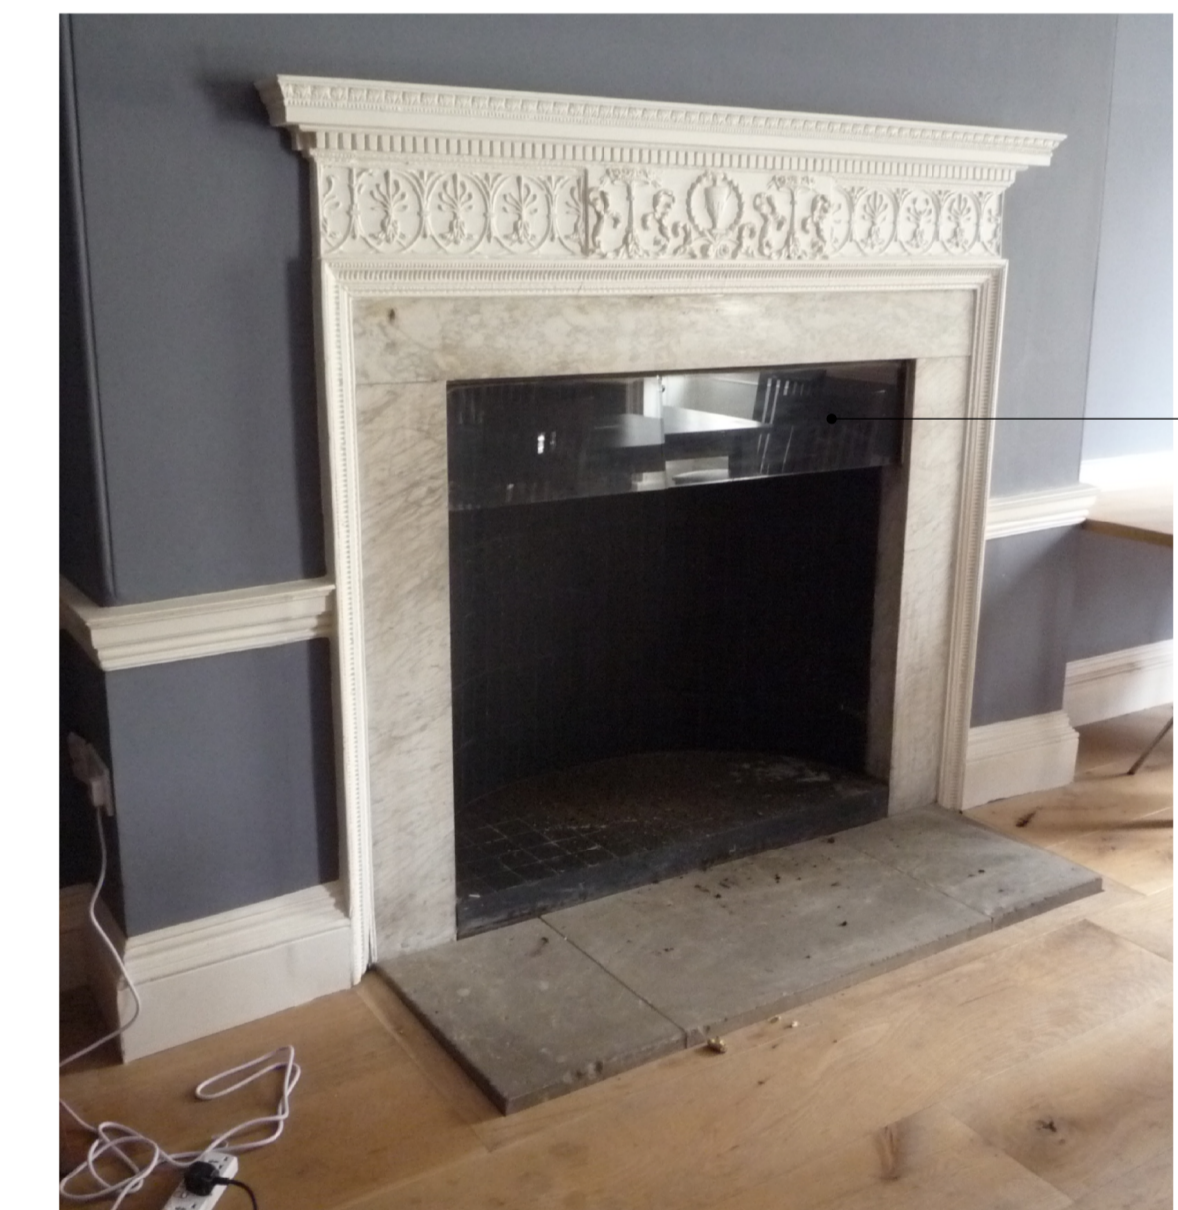
CHIMNEY PIECE IN ONSITE STORAGE TO BE REINSTATED

Please note non original glass piece not to be reinstated.
