Design and Access Statement

Title:	250 Grays Inn Road, London WC1X 8JR
Date:	19/8/2019
Project number:	J9648
Site:	250 Grays Inn Road, London, WC1X 88JR
Applicant:	KMK Ltd
Agent:	Property Tectonics, Titan Court, 2 nd Floor, 3 Bishop Square, Hatfield, AL10 9NA
Application:	Listed Building Consent
Issue:	Five (June 20)

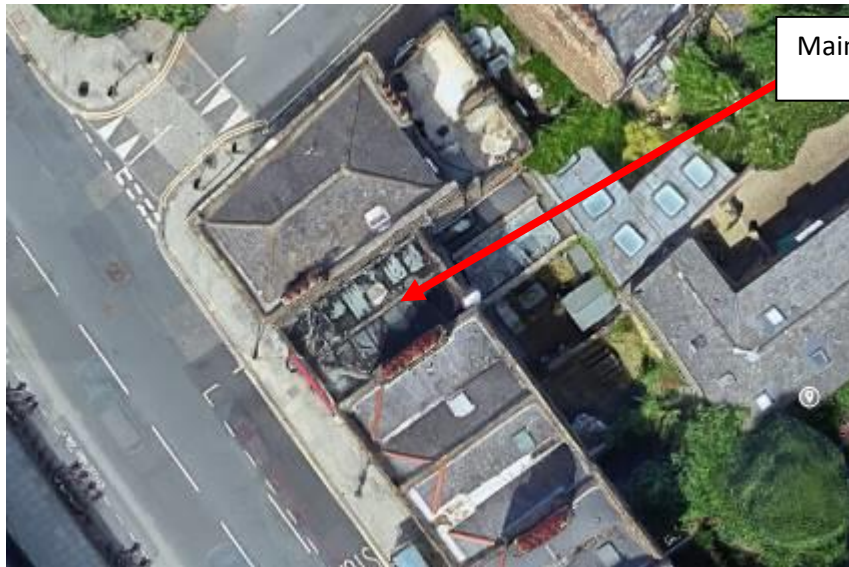
Photo No. 2 – Main Roof

The roof comprises a typical centre valley timber framed main roof with front and central parapet gutter.

The existing weatherings to the roof comprised a variety of different materials, including mineral felt, liquid bitumen and “flashband” type of material.

The existing roof coverings are in a very poor condition and are beyond repair. Numerous patch repairs to the roof coverings have been undertaken in the past. The roof coverings have caused extensive water ingress into the property resulting in damp and loose wall and ceiling finishes. The roof timbers are completely rotten and have, in part, previously collapsed.

It is proposed to retain the sound roof timbers, with new roof timbers provided as required. The required existing roof coverings are to be replaced with Natural Welsh slates secured to a breathable vapour barrier. The parapet gutters are to be replaced with lead stepped, tapered parapet and valley gutters. All Leadwork in accordance with recommendations of Leas Sheet Association.

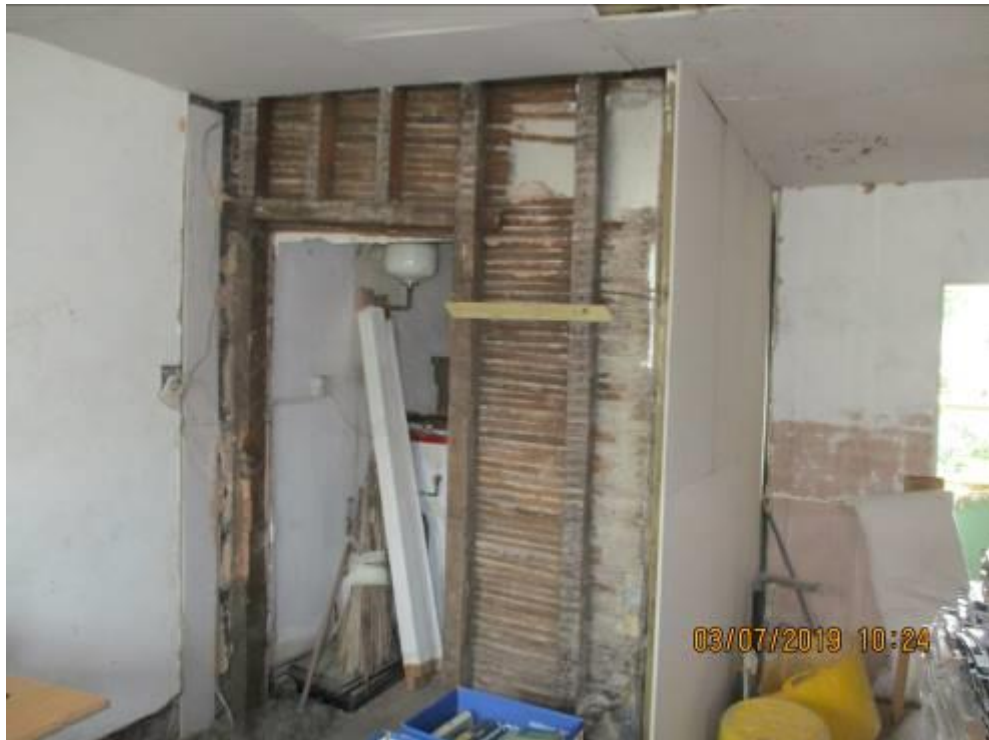
Due to water ingress problems via the main roof, there are extensive areas of defective wall plaster to both solid and stud external and internal walls and partitions. The ceiling plaster at second floor level requires complete replacement.

Photo No. 4 – Missing Internal Wall Plaster

The ceiling at second floor level is to be replaced with plasterboard. The solid external walls are to be replaced with a traditional wet plaster system. The lath and plaster internal walls are to be repaired and made good with existing and new matching timber laths and a traditional wet lime plaster finish.

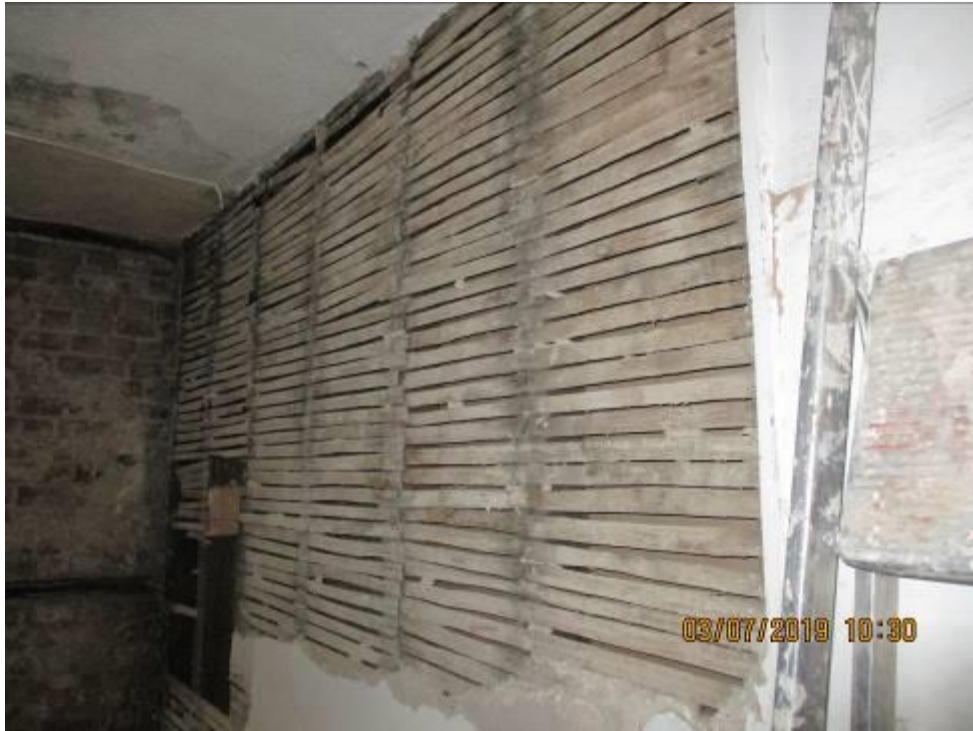
Photo No. 5 – Missing Internal Wall Plaster

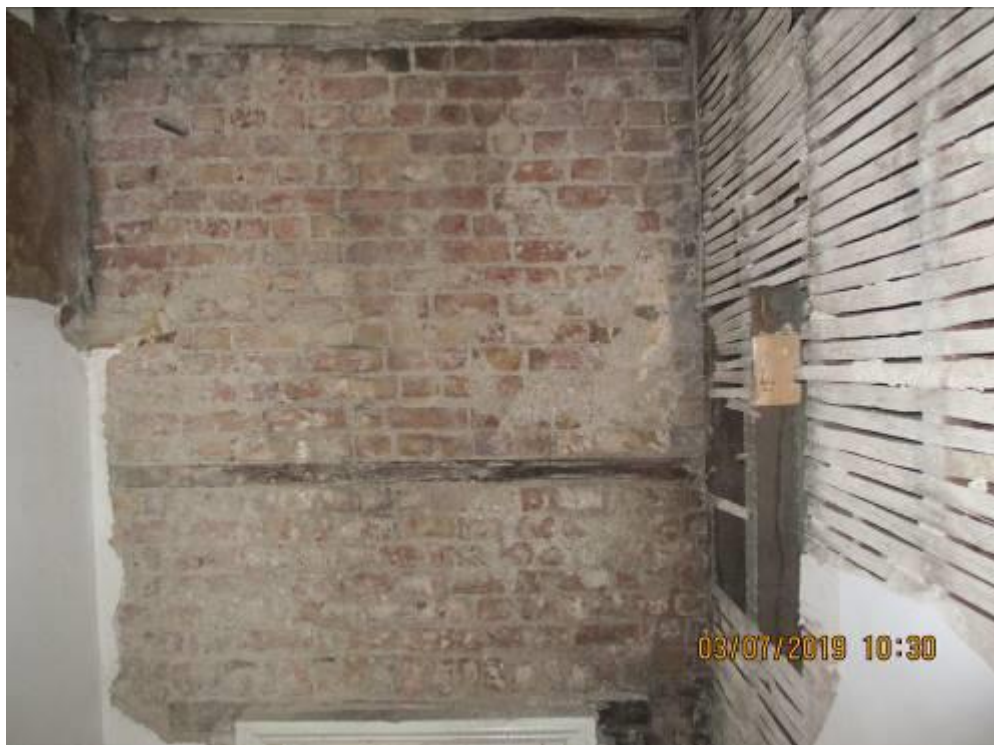
Photo No. 6 – Missing Internal and External Wall Plaster

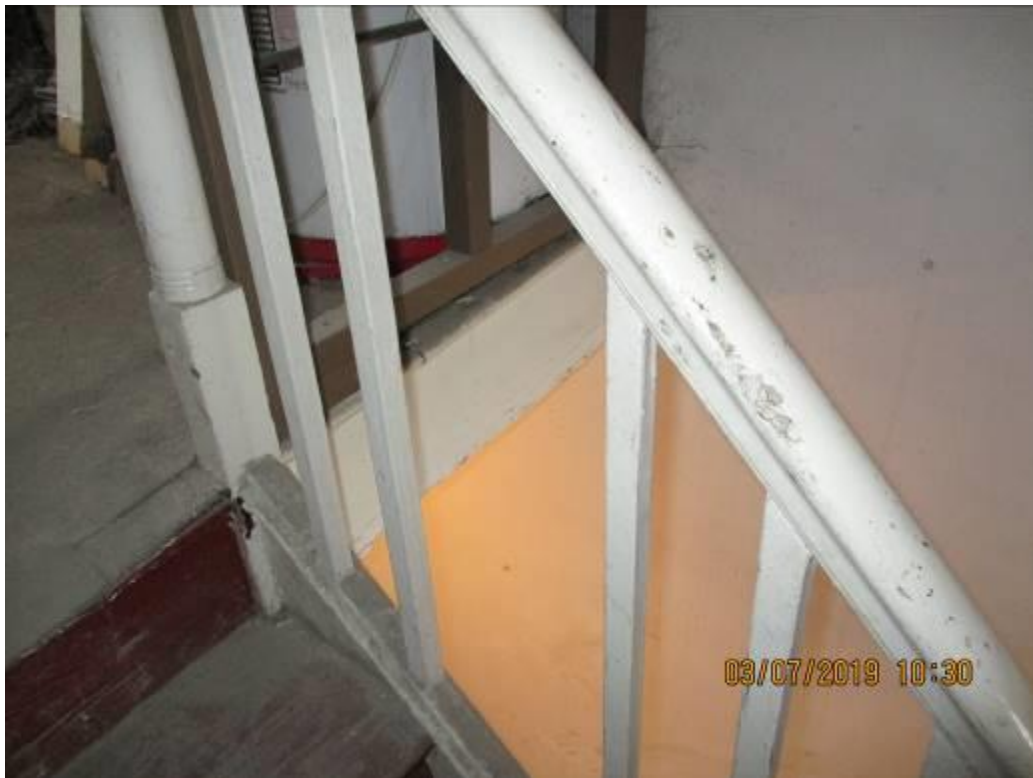
A number of missing balusters were noted to the main timber internal staircase. At second floor level there is no handrail/balustrade at second floor. It is proposed to install approximate 25 x 25 softwood timber balusters where missing and install a matching section of handrail/balustrade at second floor level.

Photo No. 7 – Missing Timber Balusters

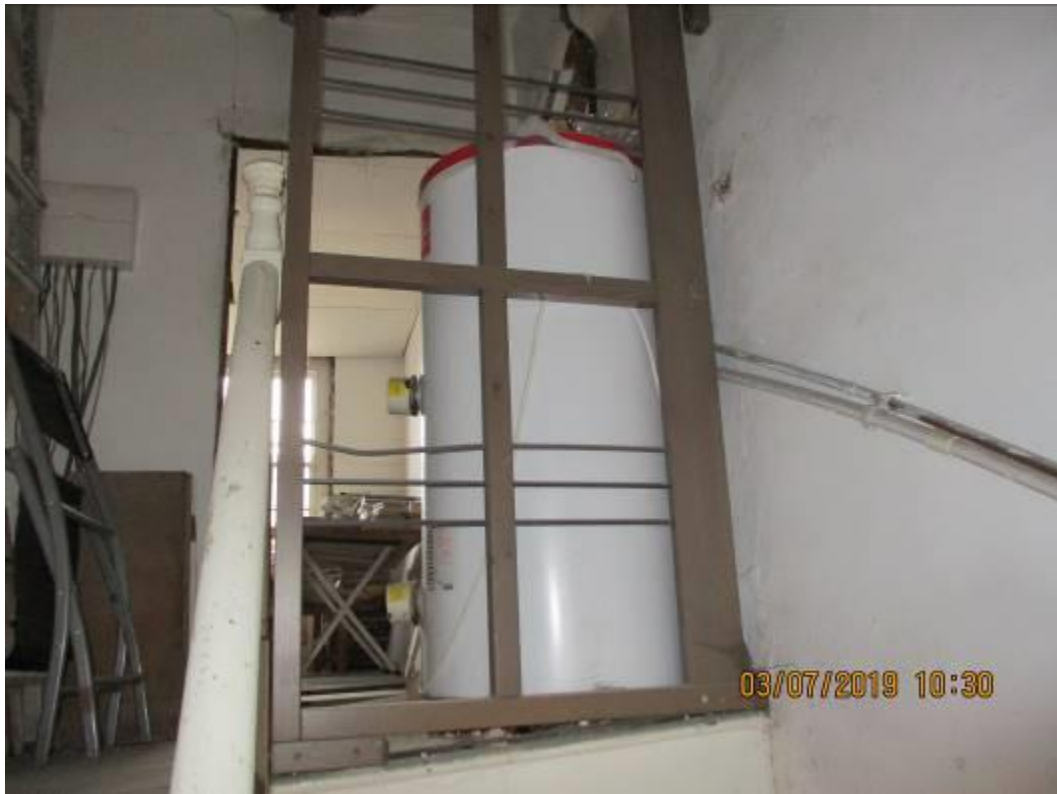
Photo No. 8 – Missing Timber Handrail

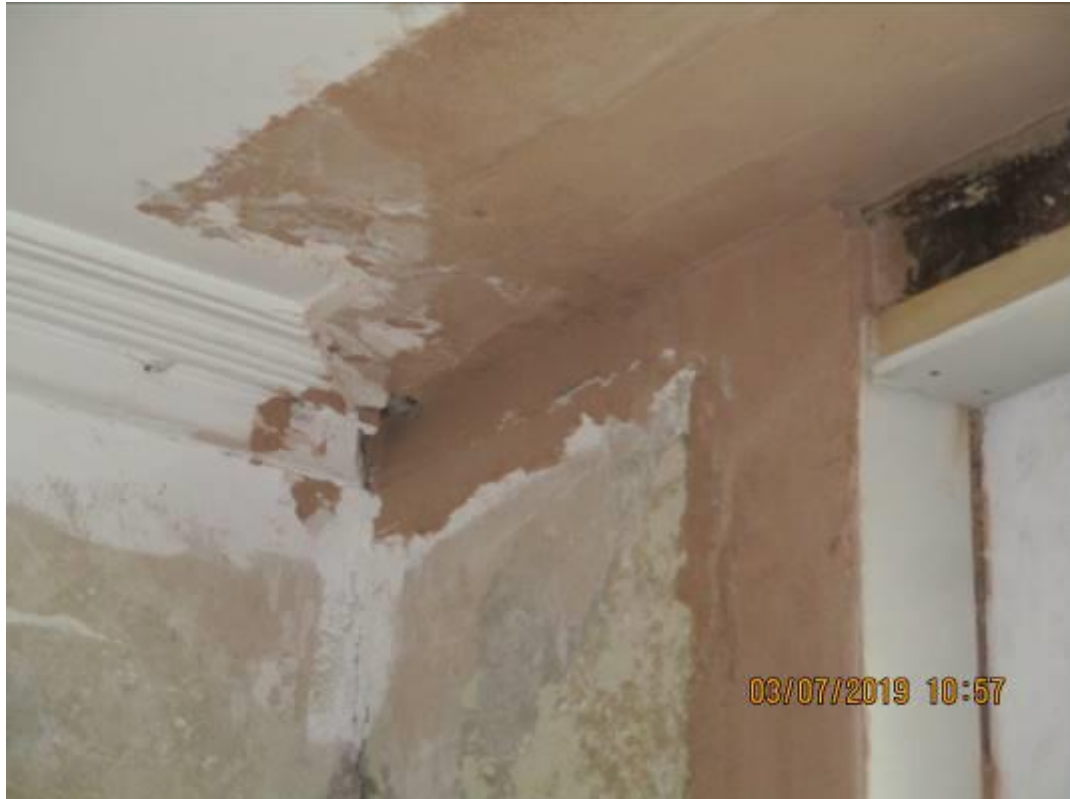
Within various rooms to the upper parts of the property, the external timber mounted picture rail and moulded plaster cornice are missing or have been removed. It is proposed to reinstate or replace the missing cornice and picture rail with identical matching timber picture rails and plaster cornices.

Photo No. 9 – Missing Moulded Cornice and Picture Rail
