The Heath & Hampstead Society

To London Borough of Camden, Tree Preservation Team

Planning Ref: 2020/1757/T (documents from 2020/0306/T)
Address: 9 Willoughby Road NW3 1RT
Case Officer: Tom Little
Date: 12th June 2020

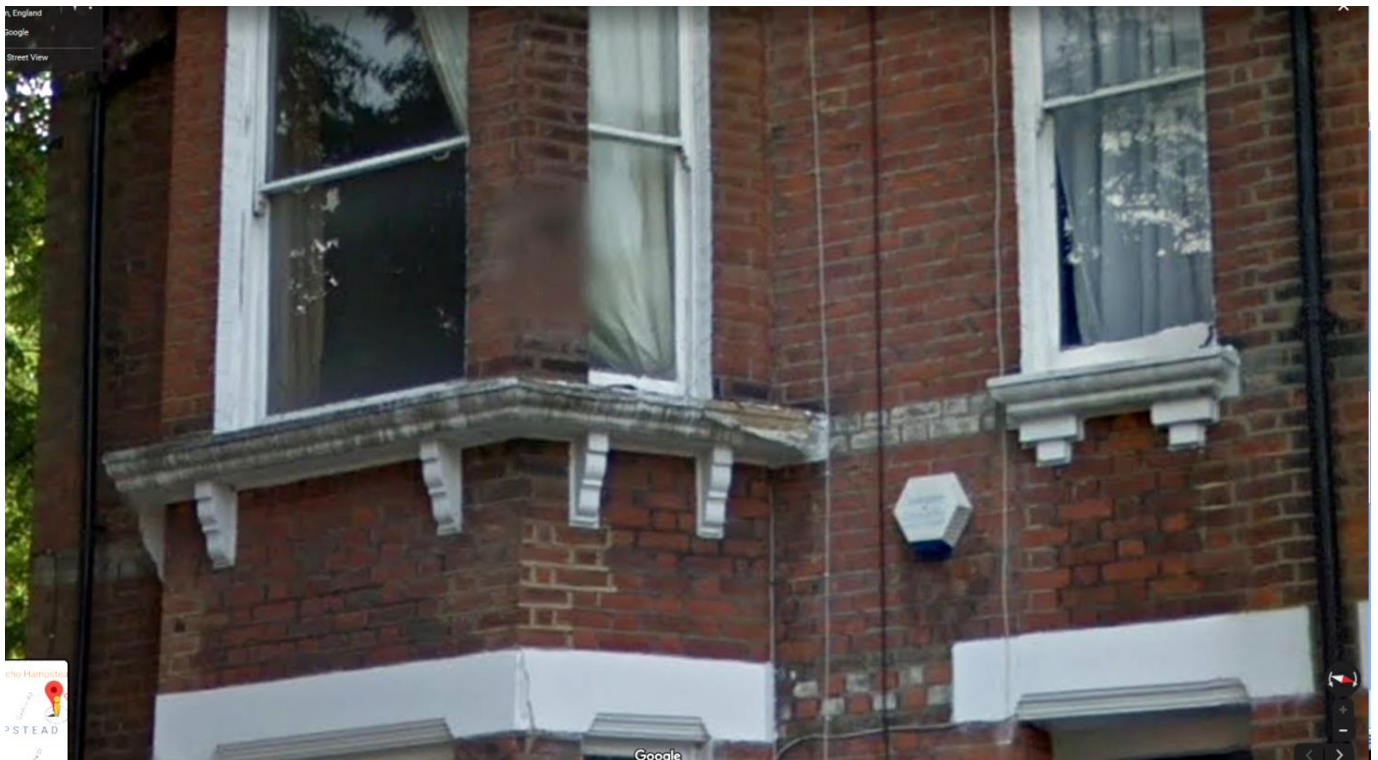
Complete freedom from any cracking is an impossibility in Hampstead, long-standing repeat mortar joint repairs demonstrating this well in 9 Willoughby Road.

May 2012 showing many different mortar repairs over the years

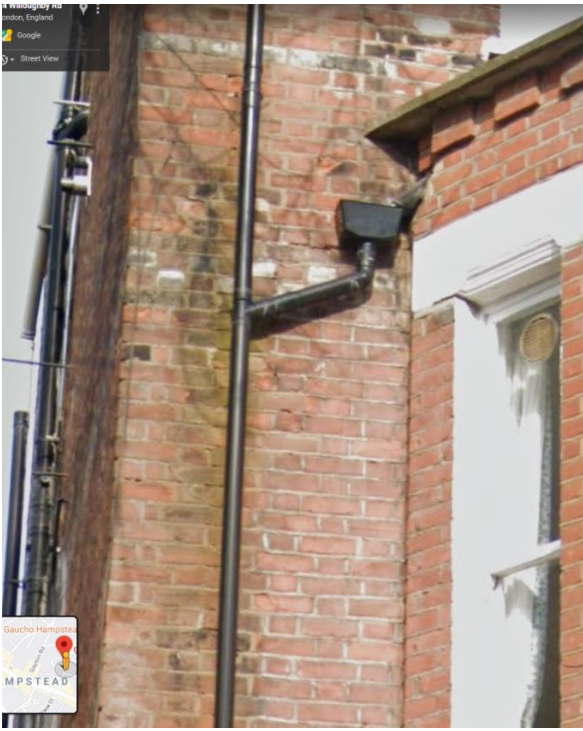
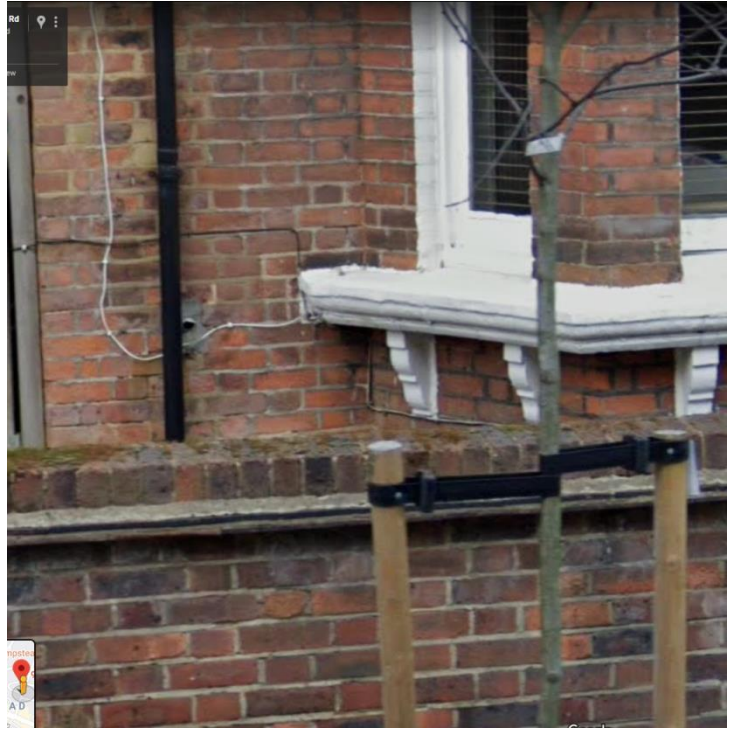
April 2019: the outside has been painted, but downpipes are still in a bad way. What state the drains?

The following photographs show the downpipes and guttering and no doubt the drains themselves remain in an appalling state, indicating that drains surveys should be the first thing to be done, followed by lining all drains with cracks and fixing any failed/broken joints. With silt erosion beneath the drains and other subsidence elsewhere they are bound to have been strained or dropped and leaking. Having fixed these, continuous movement monitoring can then be done, not to then state whatever the outcome "the pattern of movement indicates it's the trees" but to see if this has fixed the movement problem sufficiently - moving it from Grade 3 to 1 or 0 - and to see if further movement can be diagnosed from the patterns of movement in relation to
