2020/1523/P	98 Highgate West Hill N6 6NR	Amendments to proposed roof, dormer, side elevation window, side entrance and rear extension as granted by permission ref 2017/5939/P granted 18 December 2017 for erection of single storey lower ground floor rear extension, first floor rear part infill extension, rear and side dormer roof extensions; installation of four rooflights to the side roof slope; infill of first floor south side facing window and addition of first floor obscure glazed north side facing window	Thomas Sild
-------------	------------------------------------	--	-------------

Objection,

These comments update the earlier comments following the opening of the Non-Material Amendment Statement to public view on 11-Jun-20

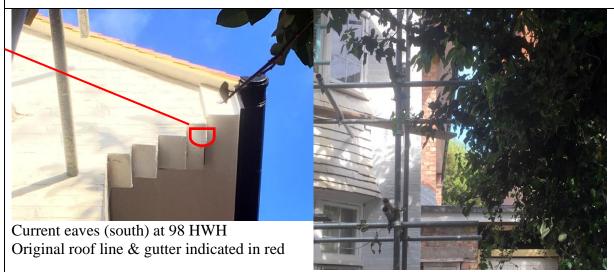
In the bay prior to roof reinstatement at least 3 rows of bricks and 2 'steps' (making 5 in total, not 4 as shown on the Proposed drawings) were added above the original 3 tiled 'steps' on each side of the bay, raising the gutter/eaves by c.300mm.

The additional steps in the bay (5 steps not 4 as indicated on Proposed drawings) widened the eaves for the south side and this increase extends the full depth of the house. The rear (east) chimney stack is in line with the gutter/eaves not projecting beyond as shown on the As-Built roof plan and just visible in the aerial photograph taken from Bing Maps of the original house prior to works starting. The southern chimney stacks project beyond the wall of the house.

South showing widened eaves extend full length of house

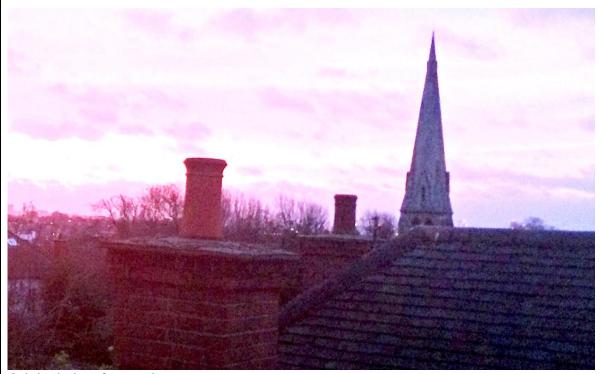
Original view from attic room

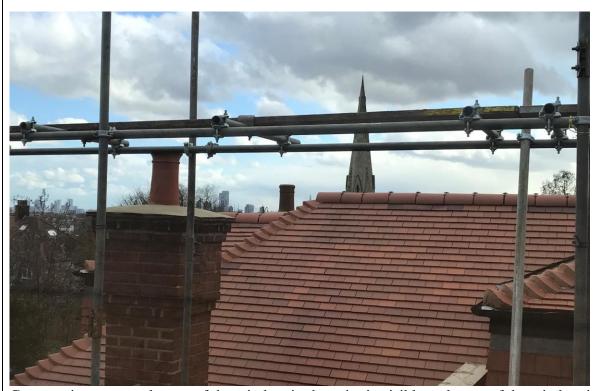
Current view, note only part of the window in the spire is visible and none of the window in the tower.

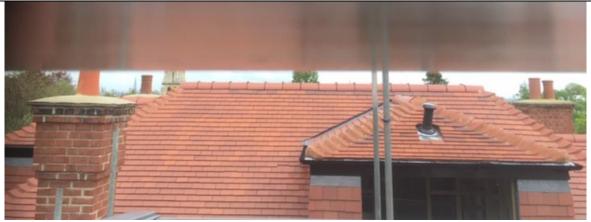
Current view from very top of 97 attic window

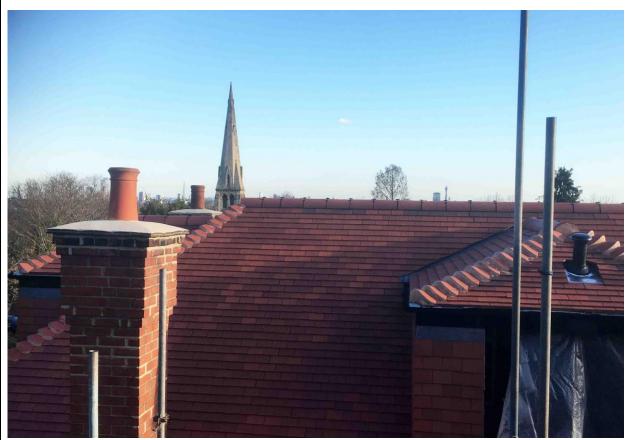
To match earlier view of church spire camera needs to be raised above the top of the attic window.

Using the 2 fixed points, the church tower & the window in 97, and conservatively estimating that 2m of the church tower is no longer visible from the original viewpoint then the ridge has been raised by c.125mm.

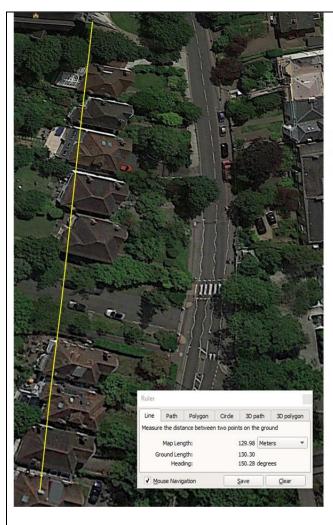
Distances (from Google Earth)

- (a) Window to ridge, 8.15m
- (b) Window to church, 130.3m

Estimated height of spire no longer visible, 2m (at 130.3m distance)

Equivalent height at 8.15m = 125mm

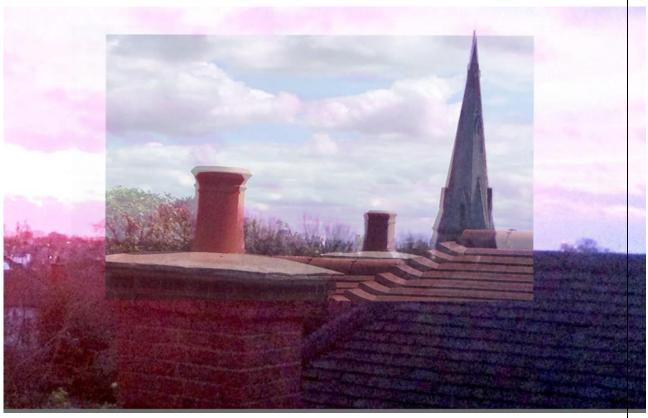
Overlaying the current view with the pre-works view shows the 125mm increase. Note, the haunching for the chimney pots has been renewed probably moving the pots
